Milford Opportunities Project

TE HUAKAUE KNOBS FLAT PRELIMINARY SITE INVESTIGATION

24 APRIL 2024

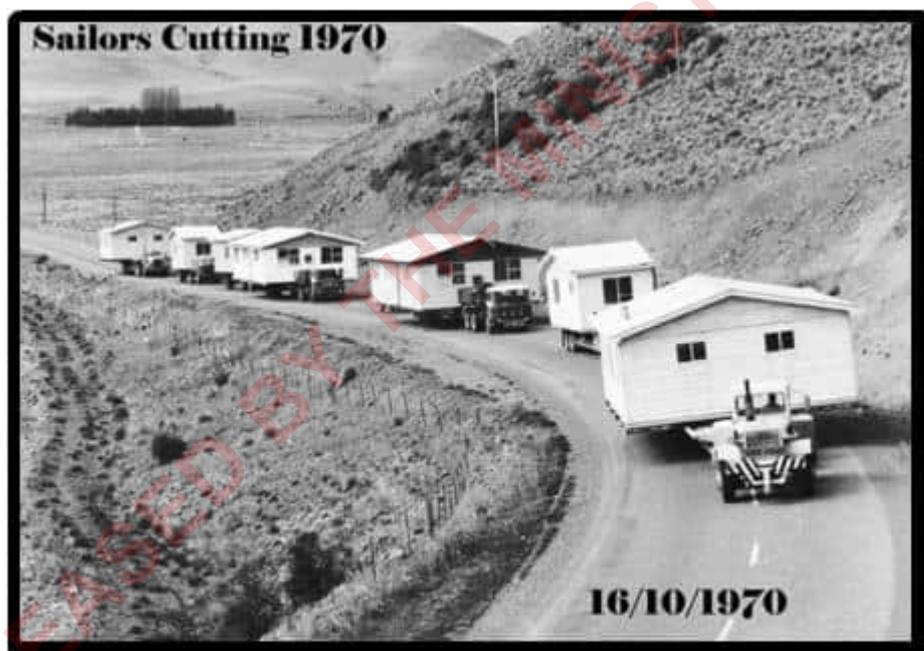
Figure 3-1: Prefabricated houses being moved to Twizel following the construction of the Waitaki hydro dam in 1970.

Huts that were placed in the 1970s for workers on the road are thought to be prefabricated transportable buildings that would have been removed when the MoW left the site. An example of prefabricated temporary huts used by MoW workers is shown in Figure 3-1 below for the construction of the Waitaki hydro dam.

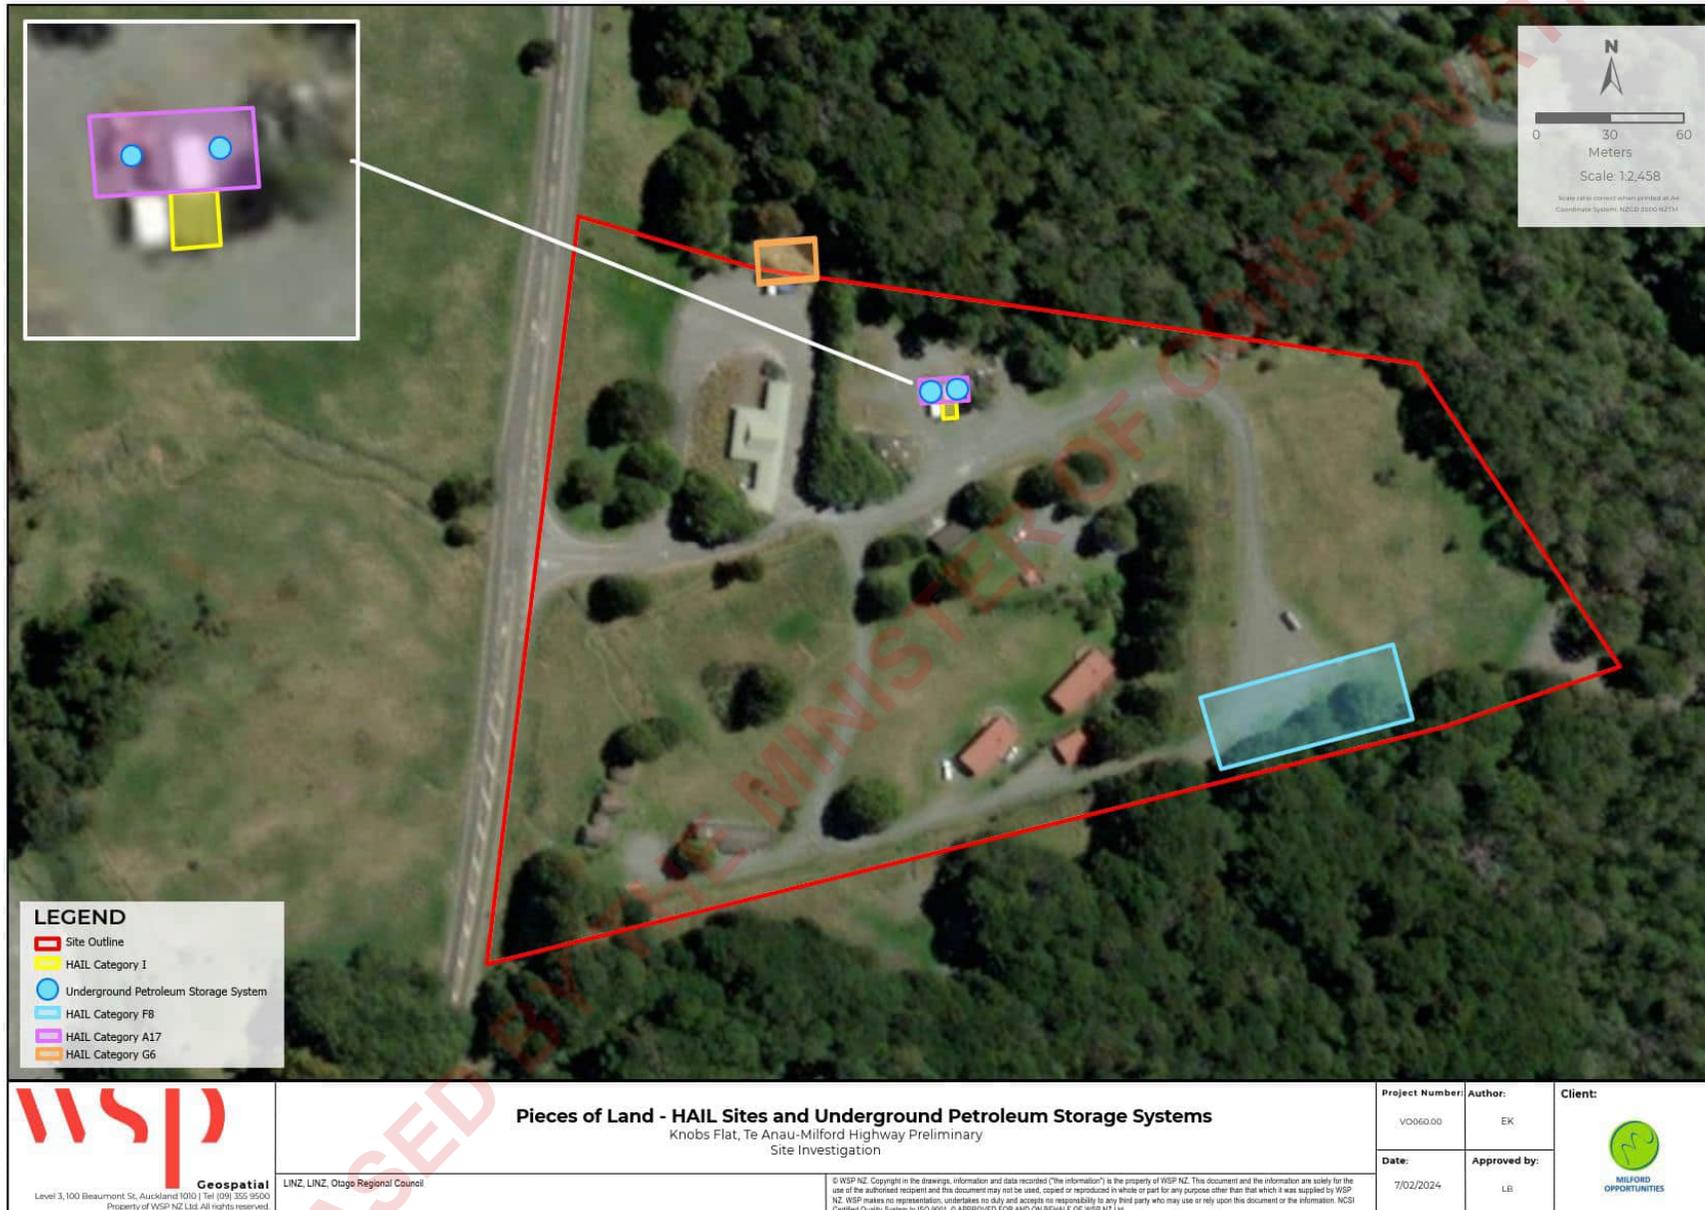
Figure 7-1: Pieces of Land (PoL) requiring further investigation should ground disturbance occur.

'PIECE OF LAND'	HAIL CATEGORY	VERIFIED/ UNVERIFIED	CONTAMINANTS OF CONCERN	RECEPTOR	RISK
UPSS 1	A17	Verified	Petroleum Hydrocarbons; metals	Human Health	Low
				Ecological	Low
UPSS 2	A17	Verified	Petroleum Hydrocarbons; metals	Human Health	Low
				Ecological	Low
UPSS 3	A17	Verified	Petroleum Hydrocarbons; metals	Human Health	Low
				Ecological	Low
Transport yard	F8	Unverified	Petroleum Hydrocarbons; metals	Human Health	Low
				Ecological	Low
Landfill sites	G3	Unverified	Metals, petroleum hydrocarbons	Human Health	Low
				Ecological	Low
Wastewater Treatment	G6	Verified	Metals, sVOC, biological hazards, nutrients (ammoniacal nitrogen)	Human Health	Low
				Ecological	Low
Generator building	I	Unverified	Lead based paint	Human Health	Low
				Ecological	Low
Other buildings	E1	Unverified	Asbestos	Human Health	Low
				Ecological	Low

- Should any ground disturbance be planned in the locality of the defined Pieces of Land a Detailed Site Investigation be undertaken prior in order to further assess the risks to human health and the environment;
- An accidental discovery protocol is put in place during ground disturbance on the site and a Contaminated Land Specialist is to be contacted should any unexpected ground conditions be encountered.
- This PSI report is submitted to the regional authority to facilitate updating the HAIL database.

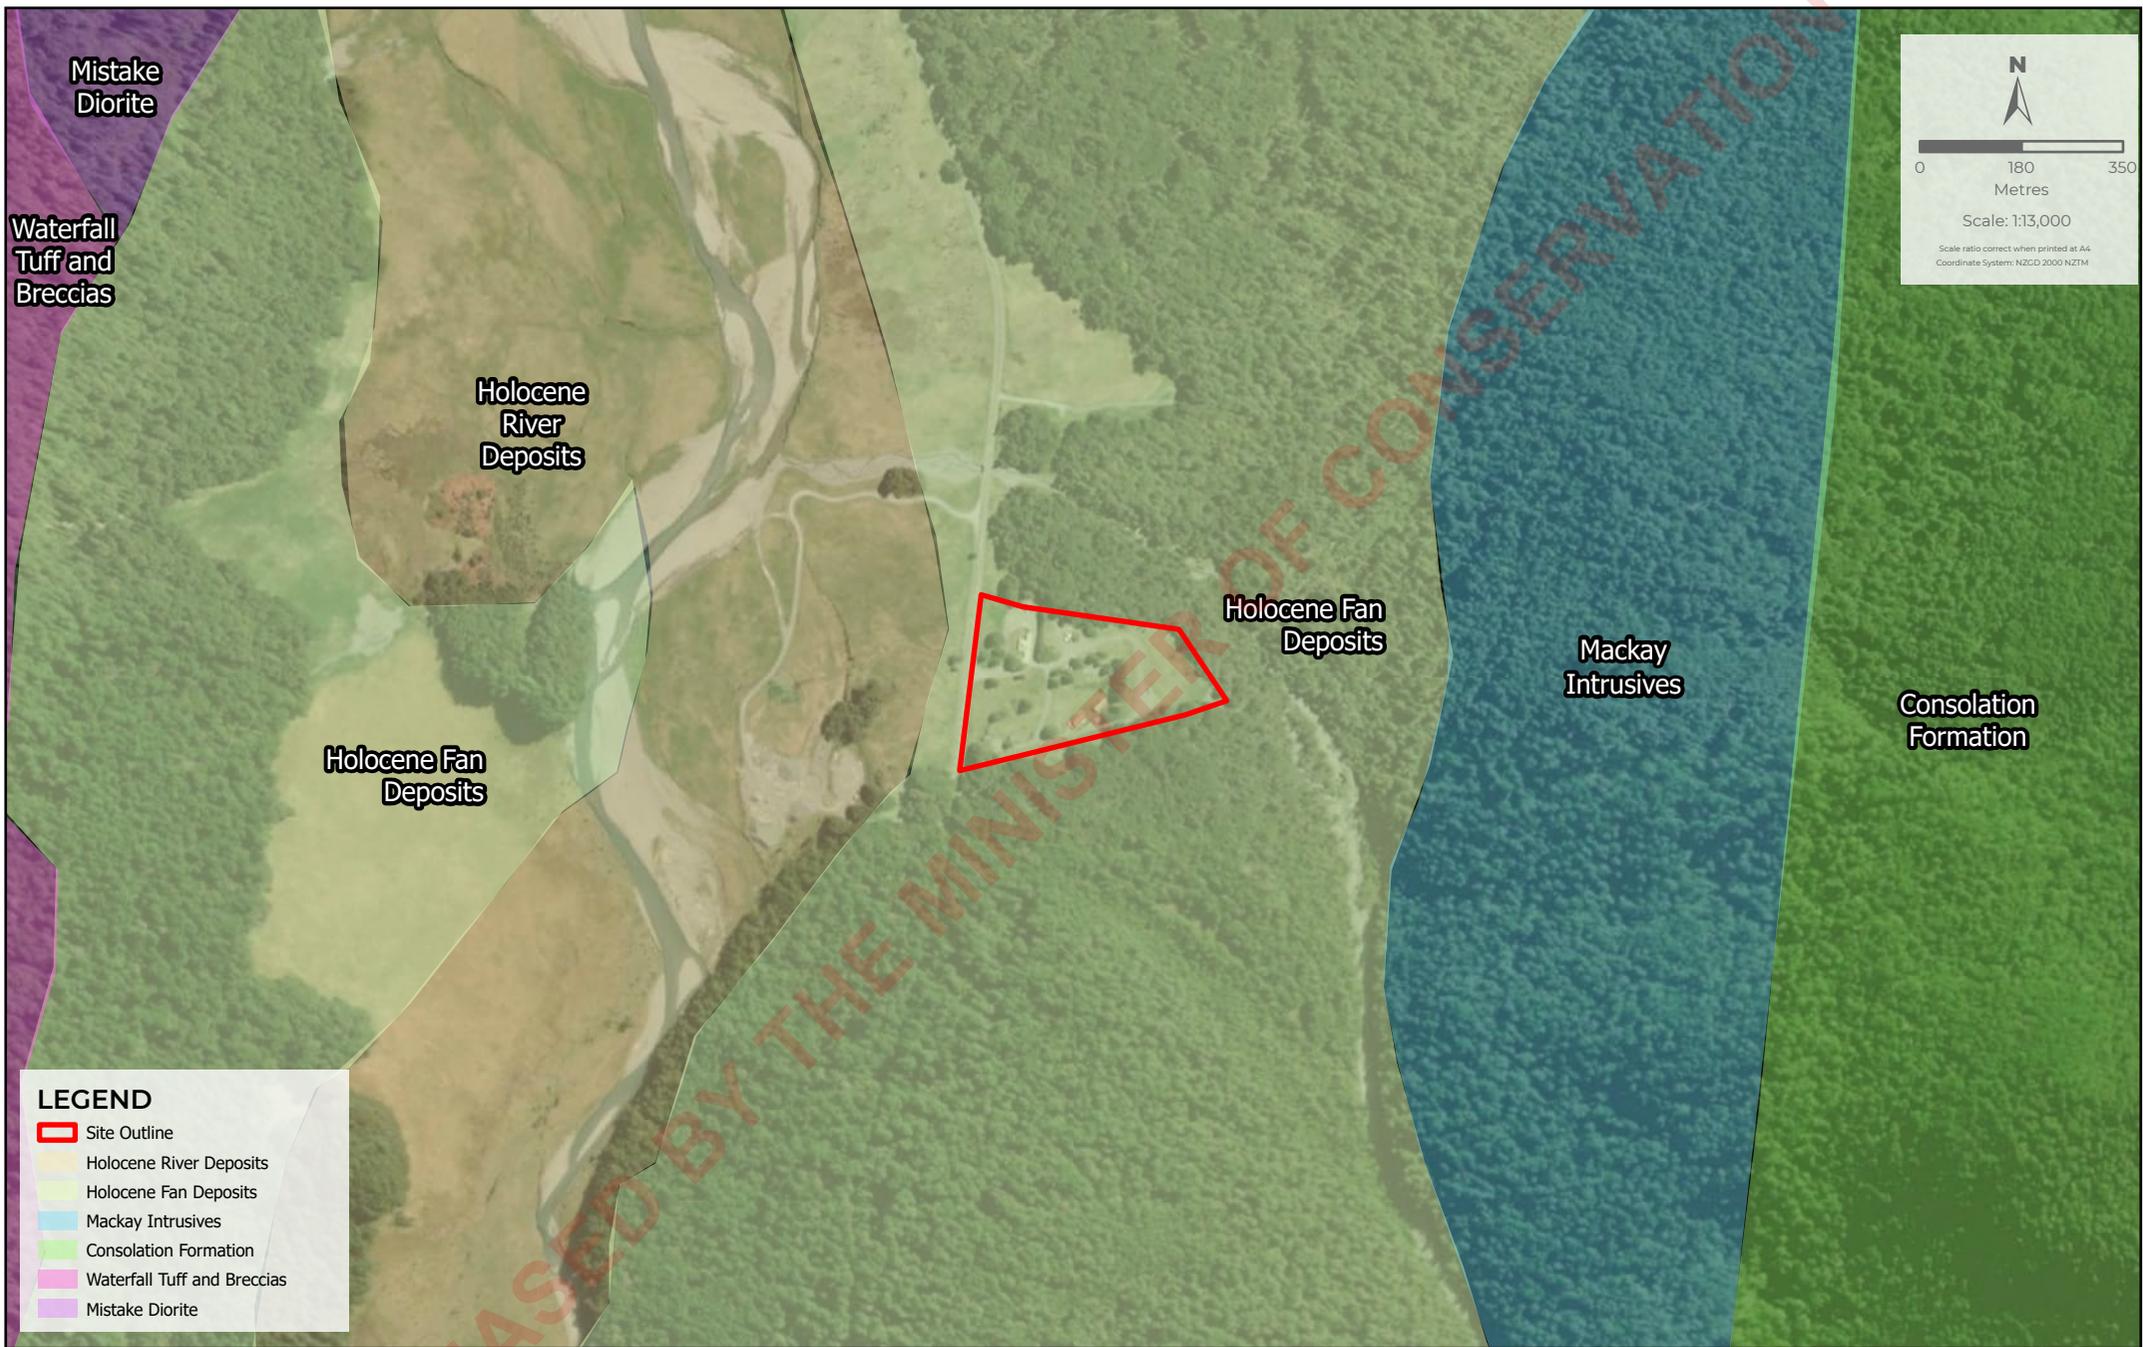
The Institute of Geological and Nuclear Sciences 1:250,000 geological map for the area describes the geology at the site as Holocene fan deposits (GNS Science, 2023). The deposits comprise loose, commonly angular, boulders, gravel, sand, and silt forming alluvial fans, and grading into scree upslope.

The geology west of the site, along the Eglinton River, comprises Holocene river deposits with unweathered, loose, bouldery gravel, sand and mud in modern floodplains.

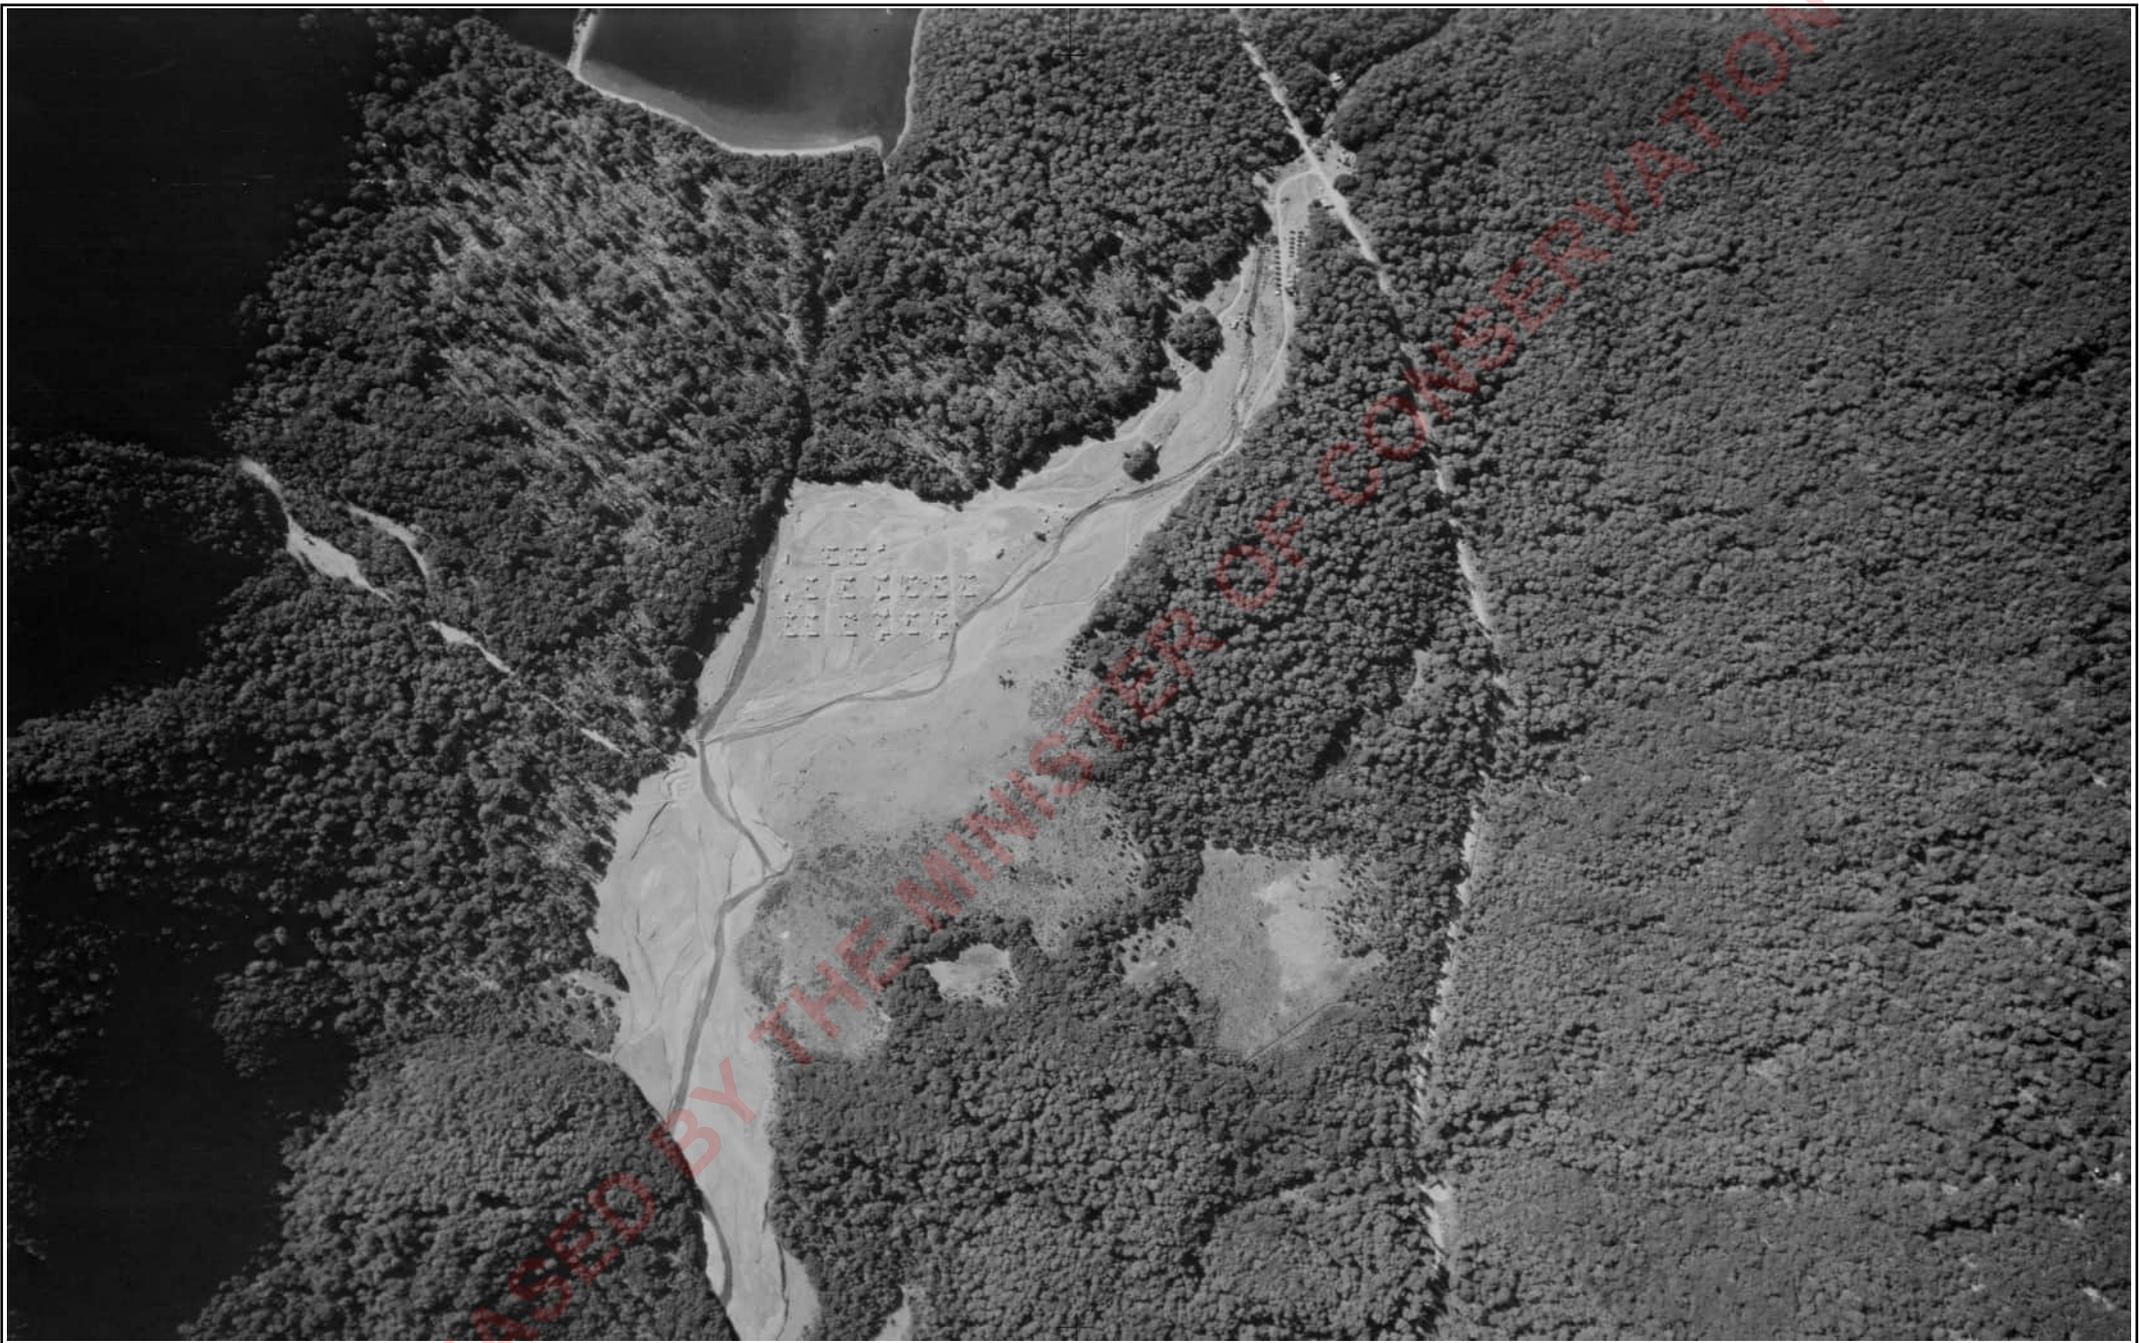
Figure 5 - Cascade Creek 1939 Imagery

Aerial imagery of the 1930s camp is not available for Te Huakaue Knobs Flat, however a campsite thought to be of a similar nature was pictured at Ōtāpara Cascade Creek in 1939 and available from Retrolens. The aerial image can be found in Figure 5, Appendix A.

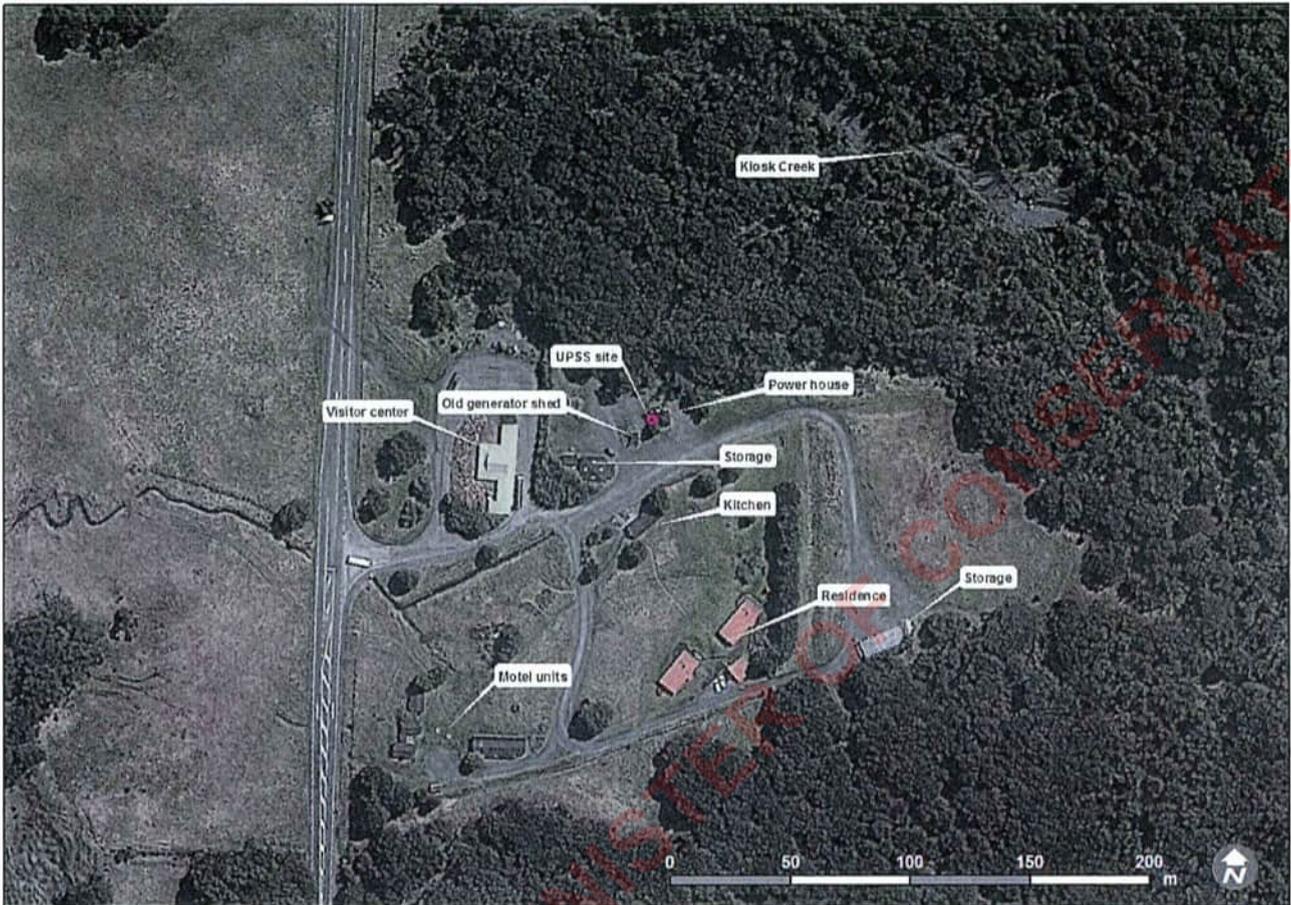
Figure 2-2 Aerial photograph showing the location of the UPSS site

It is understood that on 28 March 2001, Fuelquip services Ltd removed two UPSS tanks (one 9,000L diesel and one 4,500L 96-octane petrol) from the site. Soil samples were taken during a site investigation and found elevated levels of petroleum hydrocarbons in the base and walls of the tank pit. Two of the samples collected showed elevated concentrations of TPHs (C₇-C₉ and C₁₀-C₁₄) above MfE Tier 1 acceptance criteria for a commercial/industrial land use (pathways: protection of maintenance and excavation workers, indoor inhalation, heavy fraction associated with diesel). One of the samples also recorded an elevated benzene concentration exceeding the route specific pathway for the protection of maintenance/excavation workers and indoor inhalation.

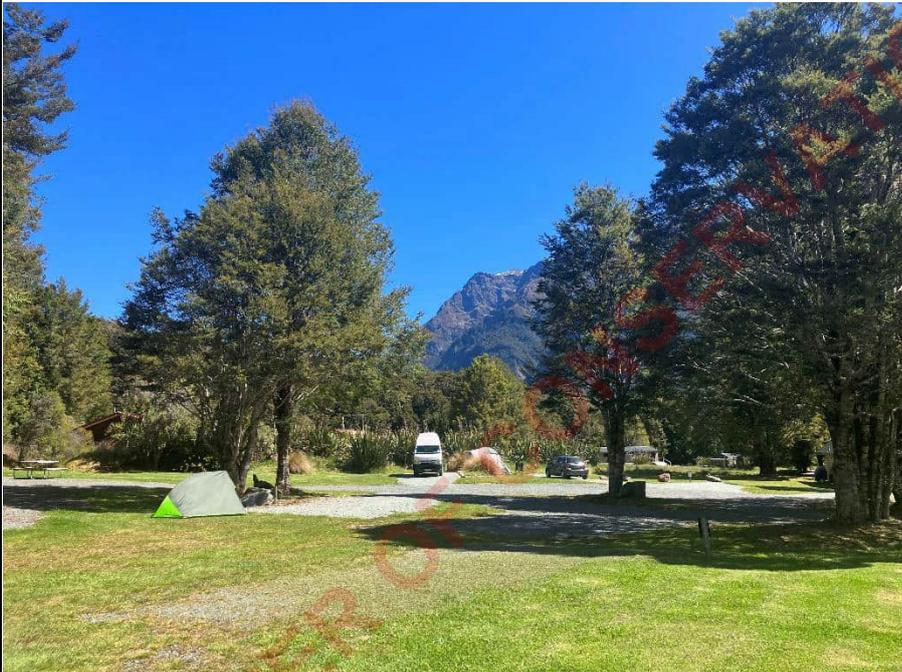
Photo No.	Date	
1	20/11/2023

Description The site investigation took place on 20 November 2023 by a WSP Environmental Engineer. The site is accessed via a gravel driveway off Te Anau-Milford Highway and leads to the grassy flats. The site is currently operated as a campsite.

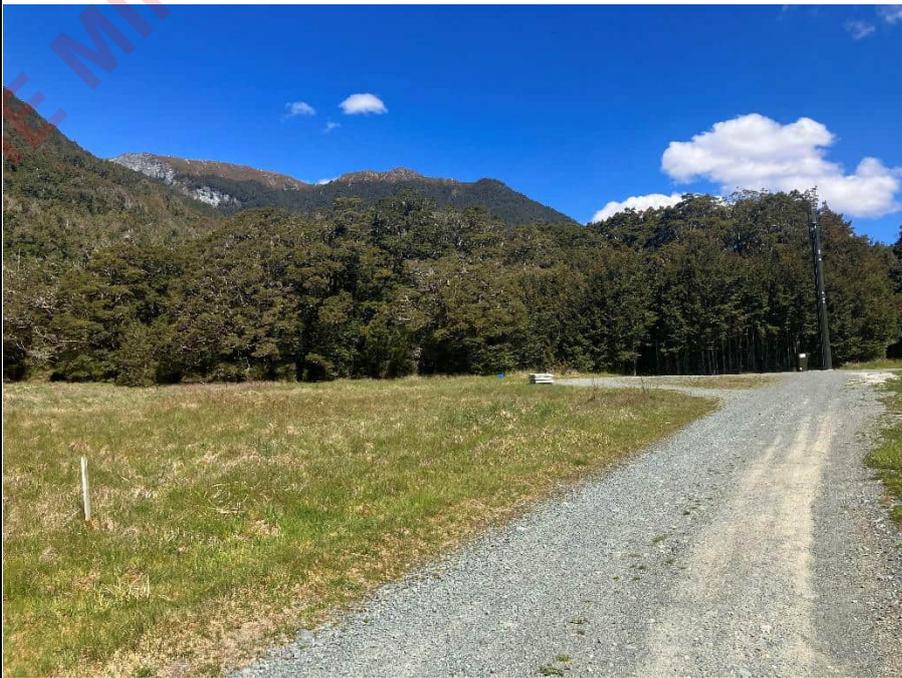
Photo No.	Date	
2	20/11/2023

Description The eastern part of the site comprises a vacant grassed area. A cell tower can be seen along the south-eastern boundary of the site.

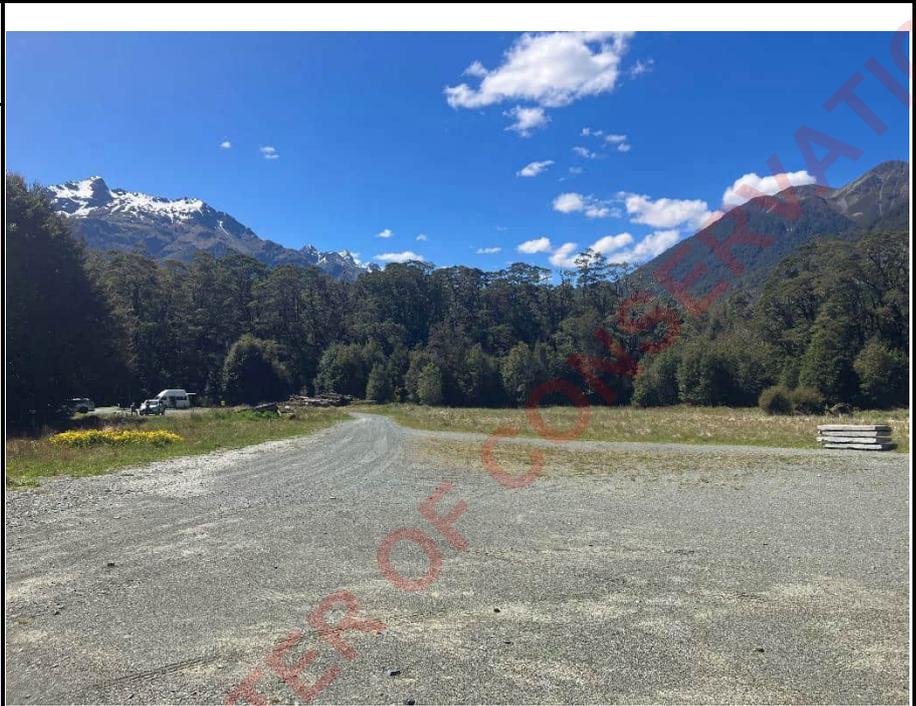
The site is surrounded by beech trees. The eastern part of the site is covered with grass and a gravel driveway. Several concrete panels are stored on the site.

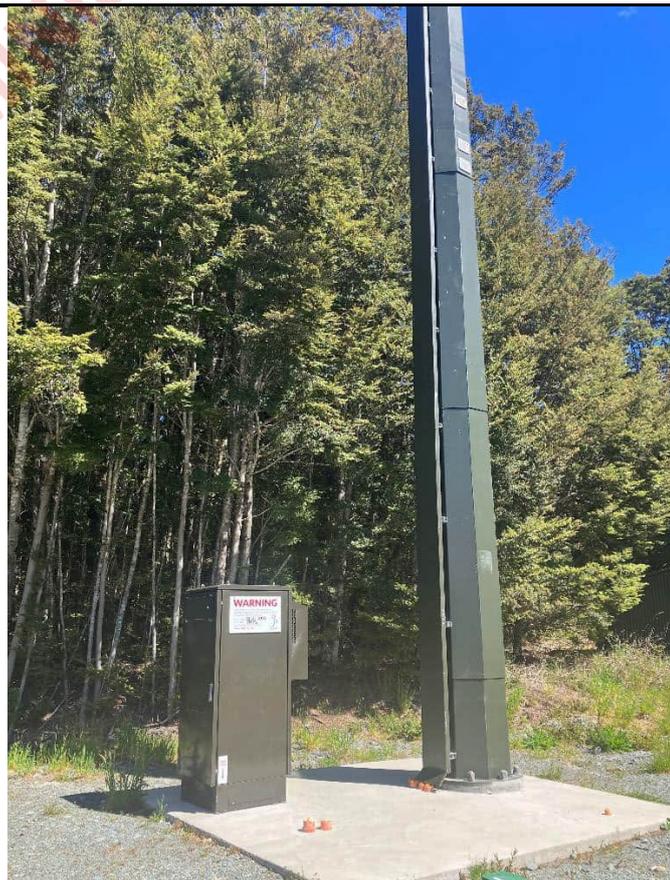
Photo No.
4

A cell tower is located along the south-eastern boundary of the site.

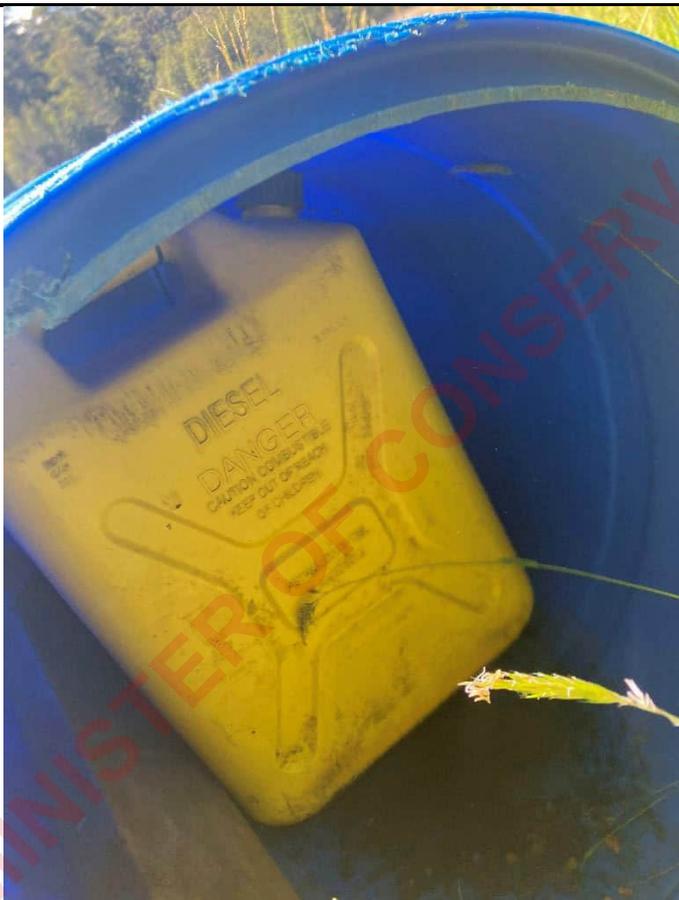
Photo No.	Date	
5	20/11/2023

Description An empty barrel with empty diesel container was found near the cell tower.

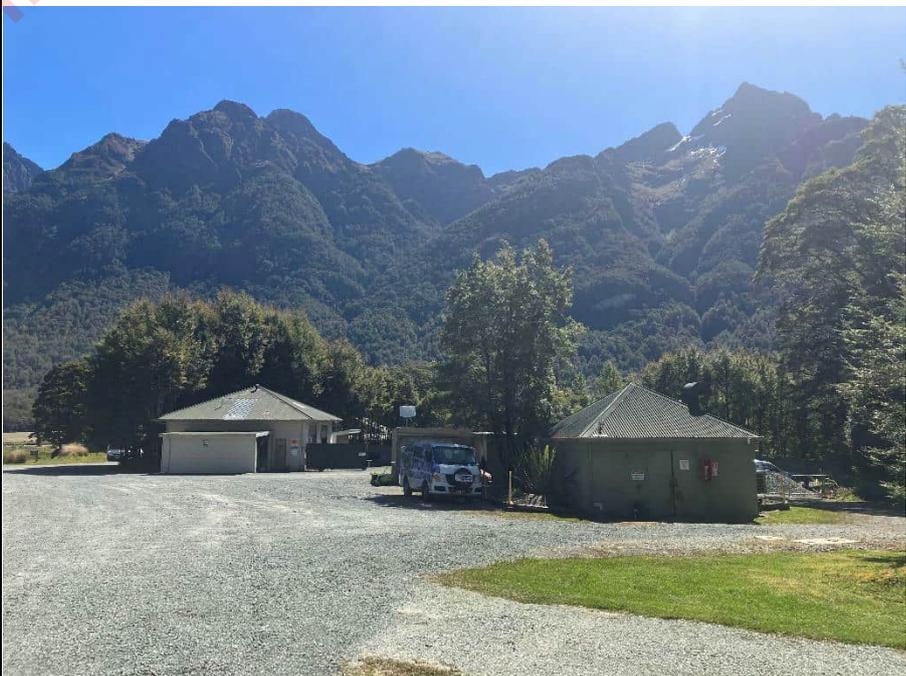
Photo No.	Date	
6	20/11/2023

Description Overview of the northern part of the site, looking west towards the Te Anau-Milford Highway. The green powerhouse can be seen with an old shed behind and storage shed/workshop in the background.

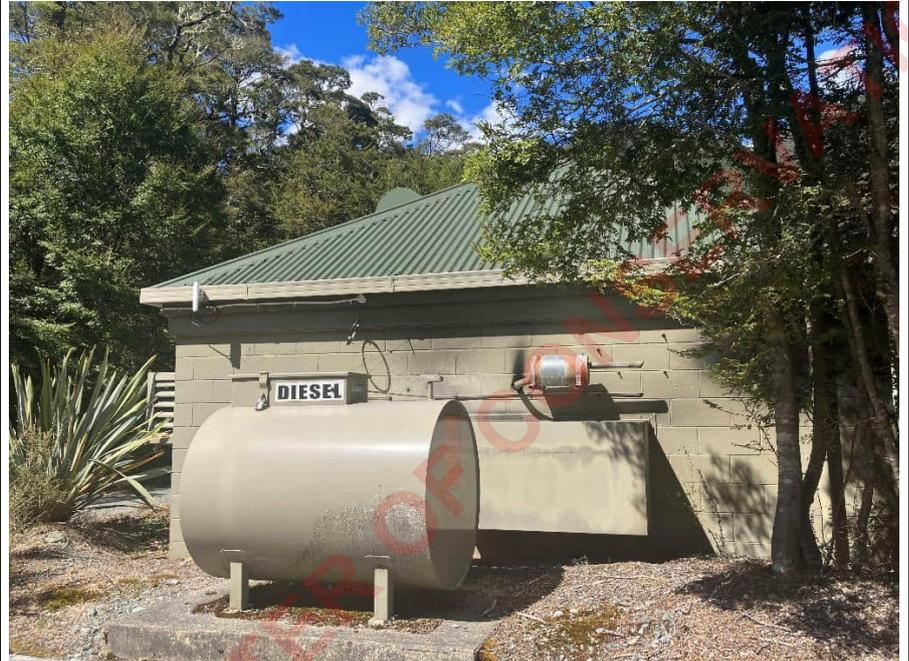
A 1,000L above ground diesel tank was noted during the site visit. The tank is located alongside the hydroelectric power generator and is used for backup power generation.

An above ground diesel storage tank was noted on a concrete slab outside the powerhouse.

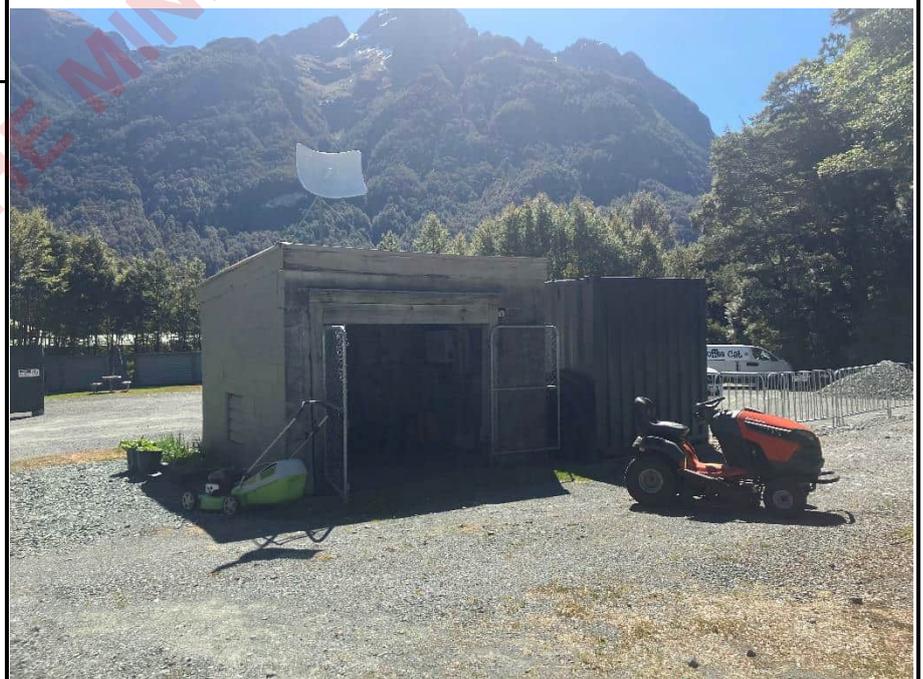
Photo No.	Date
8	20/11/2023

An old shed is noted, currently used for storage of miscellaneous items.

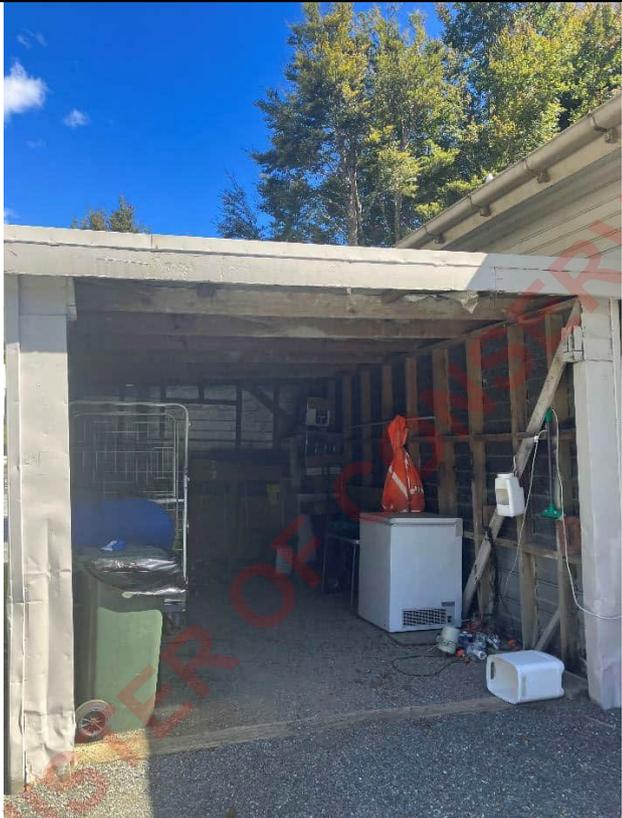
Photo No.	Date	
9	20/11/2023

Description A large storage shed is seen on the site. No olfactory evidence of contamination was noted.

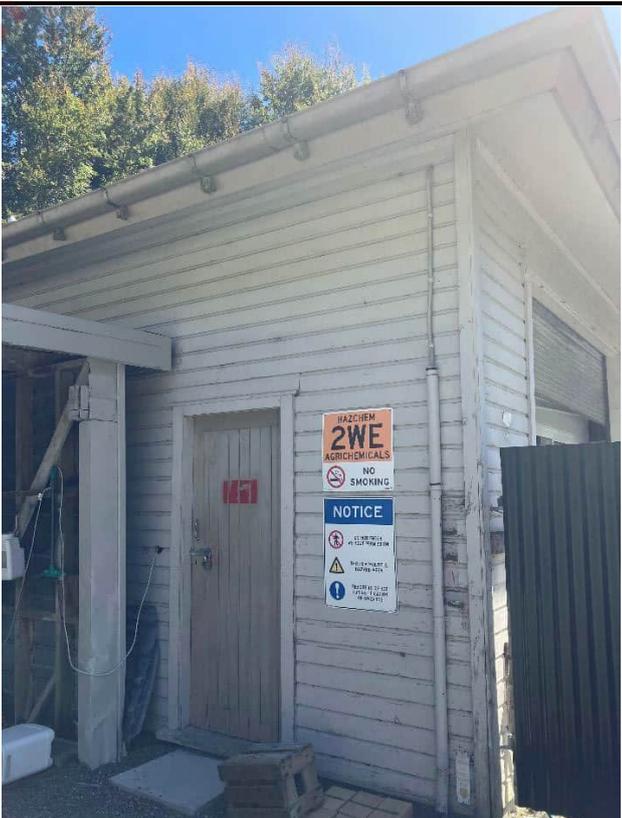
Photo No.	Date	
10	20/11/2023

A workshop was noted with miscellaneous items, such as a fridge and green bin, adjacent to a shed with a Hazchem 2WE (Agrichemicals) sign on the front door. The area was covered with hardpacked gravel.

Description A large shed was seen with a HAZCHEM sign for agricultural chemicals.

Furthermore, a storage shed/workshop was noted on the site with a hazardous chemicals sign for agrichemicals. However, as no locations of significant dieback were noted indicating a hotspot of contamination and no spray tanks were noted, contamination is expected to be confined

exclusively to locations where an accidental release of an agrichemical has occurred. Accidental releases are noted in the MfE's HAIL guidance as exclusions and as such HAIL category A1 has been disregarded from the assessment.

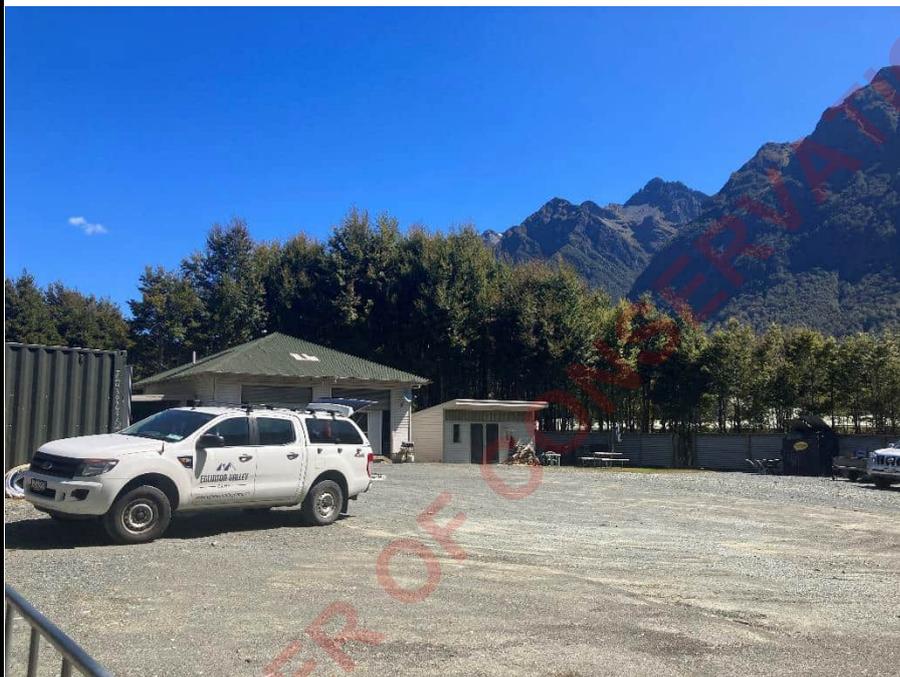
The storage sheds are located in the north-eastern corner of the site on a hardpacked gravel area.

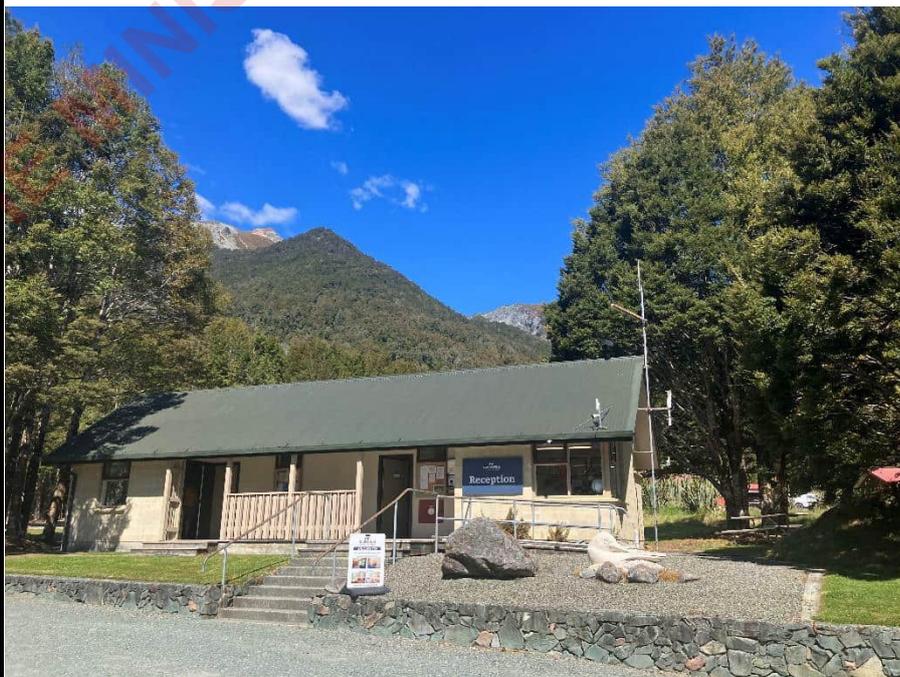
Photo No.	Date
12	20/11/2023

A reception building is located in the center of the site with amenities for the campground visitors.

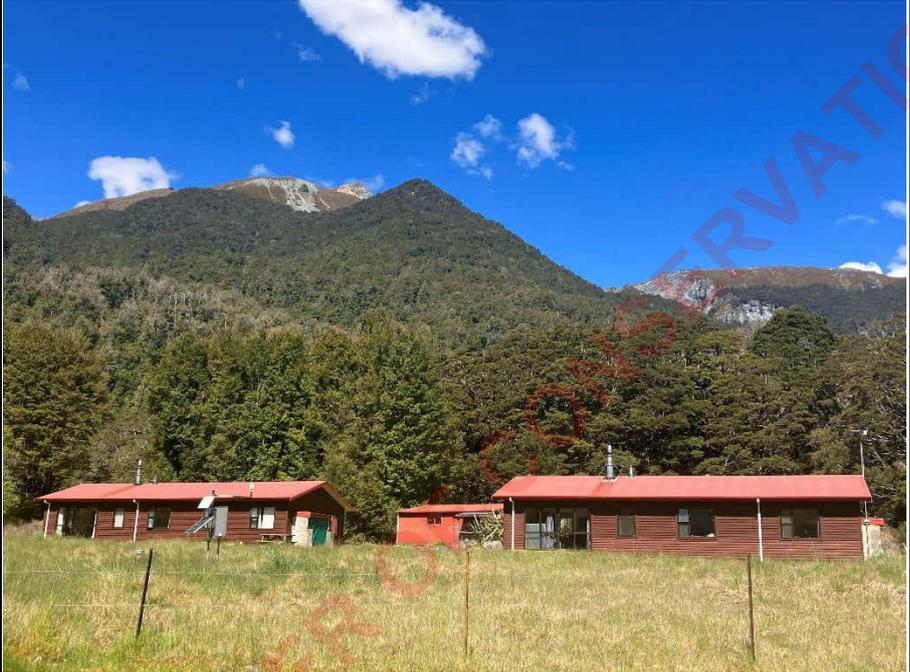
Photo No.	Date	
13	20/11/2023

Description The majority of the site is grassed. Visitor accommodation cabins are located in the southern part of the site.

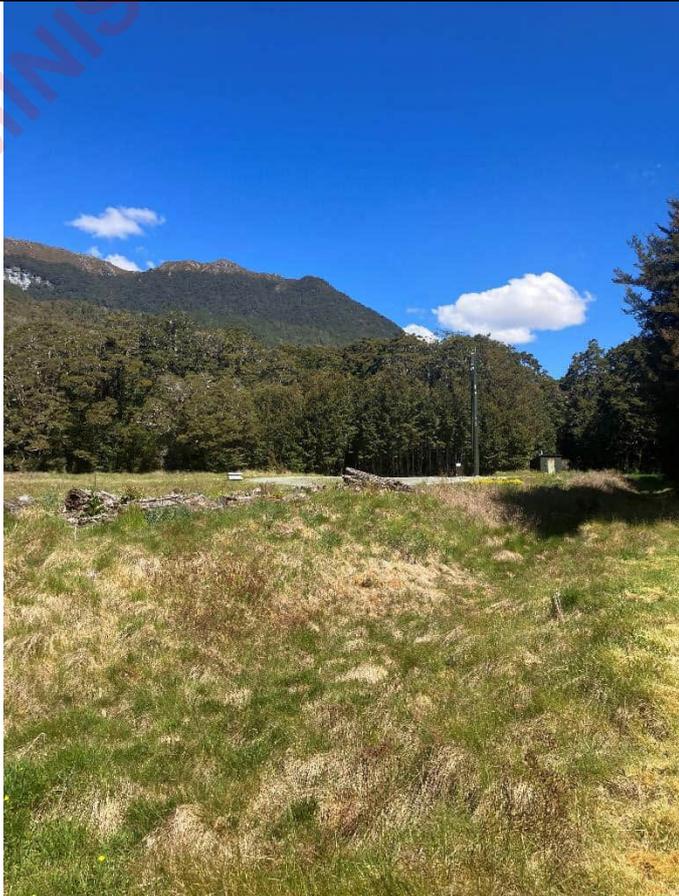
Photo No.	Date	
14	20/11/2023

Description An overgrown gully separates the eastern part of the site from the main campsite area.
