# Channel Morphology and Sediment Transport Regime of the Lower Waikanae River

Jon Tunncliffe  
The University of Auckland  
School of Environment

Department of  
Conservation  
*Te Papa Atawhai*

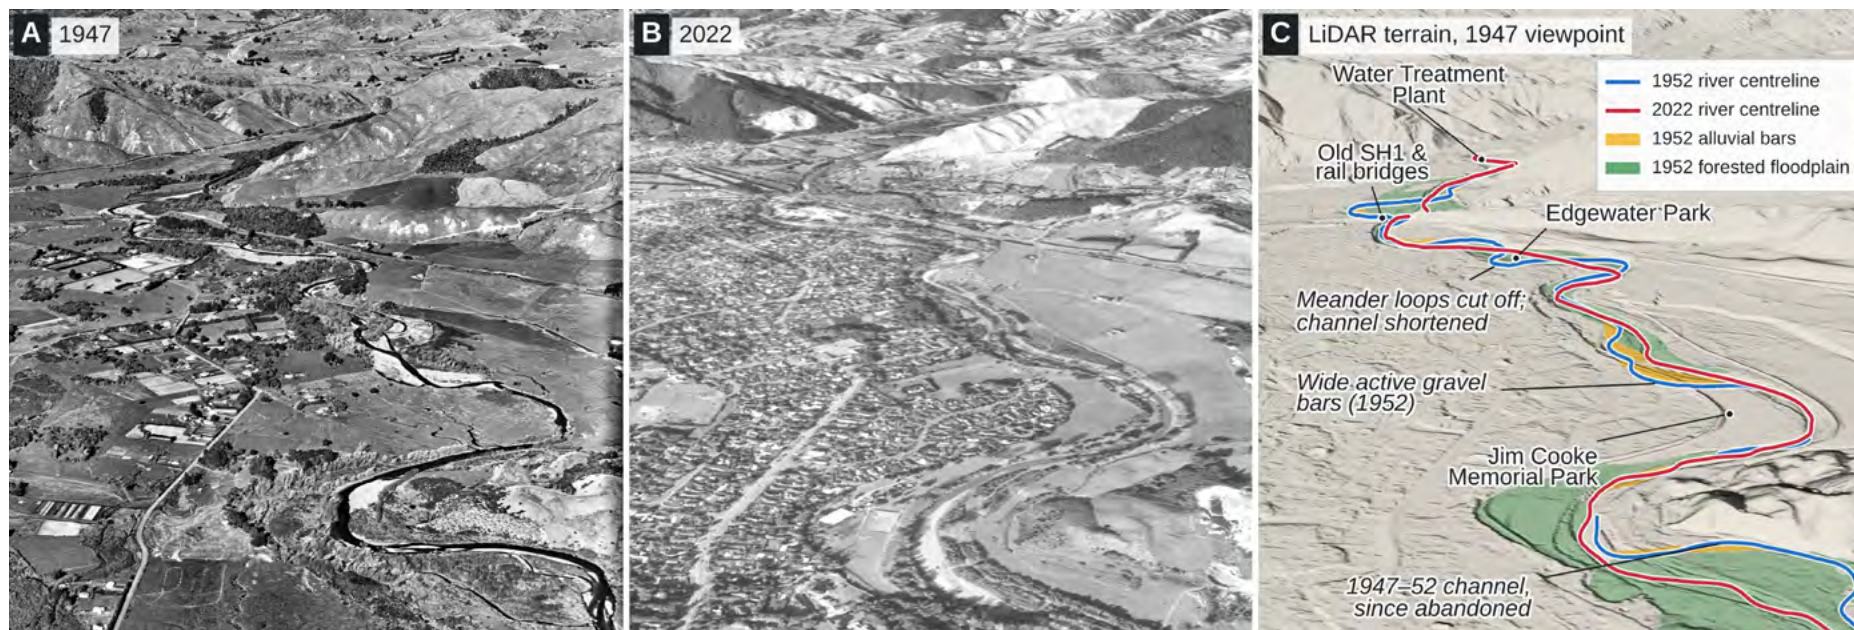
**Figure 1-2** The Waikanae River in 1947 (left; Whites Aviation) and 2022 (right). In 75 years the river has changed from a bifurcating channel with a mosaic of bars and floodplain surfaces to a single, straightened and confined channel. This report examines the processes and decisions behind that change.

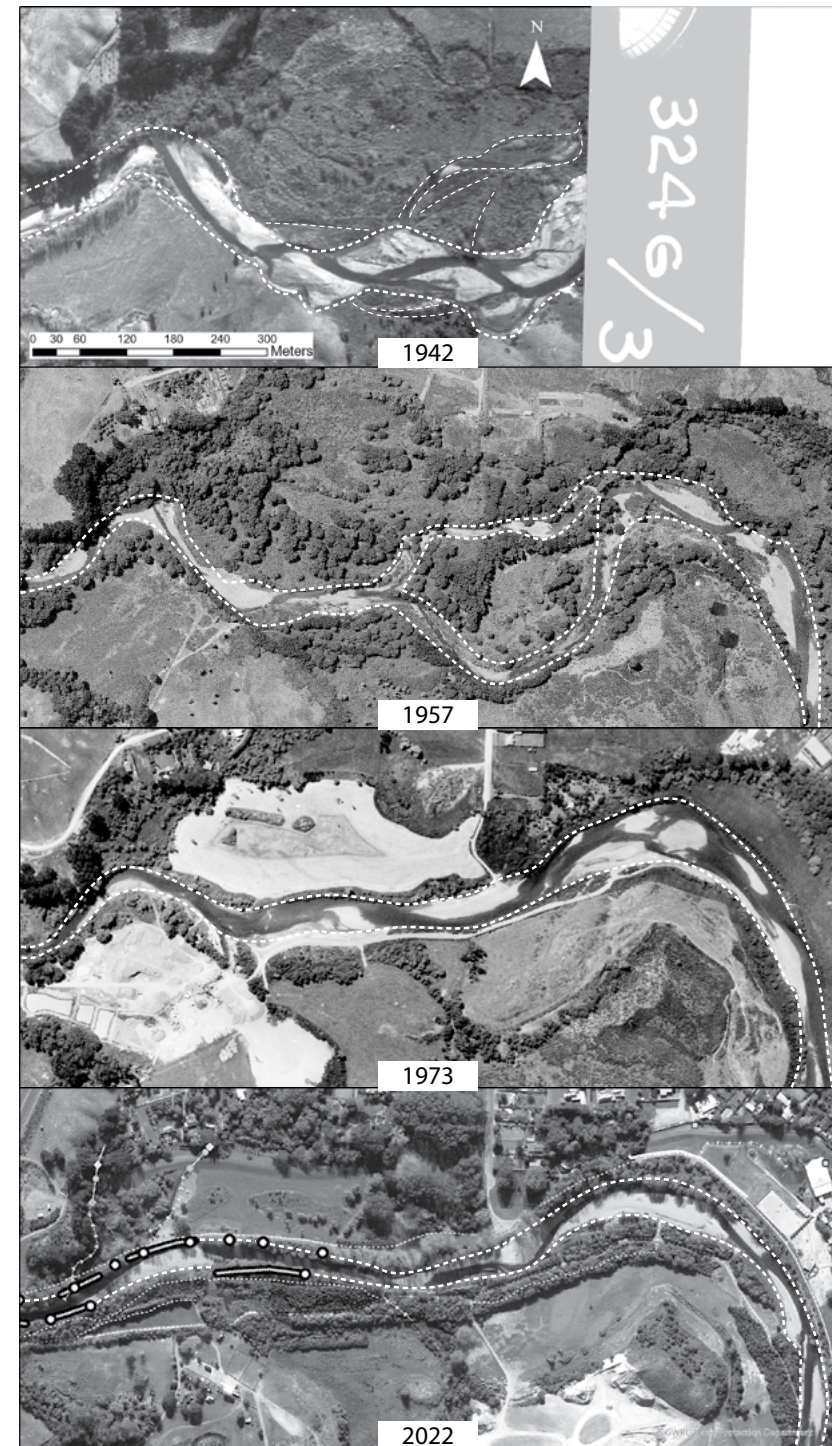
**Figure 2-8 - The same extent near Greenaway Road (XS 200) in 1942, 1957, 1973 and 2022 (photograph bounds are identical). The 1942 river has a broad floodplain with anabranching channels; dashed lines show the approximate bounds of the bed and the active alluvial surface. A gravel extraction operation (lower left) is visible in the 1973 photograph and in 1968 imagery (not shown). The managed channel is now held in a static alignment by riprap and rock lining.**

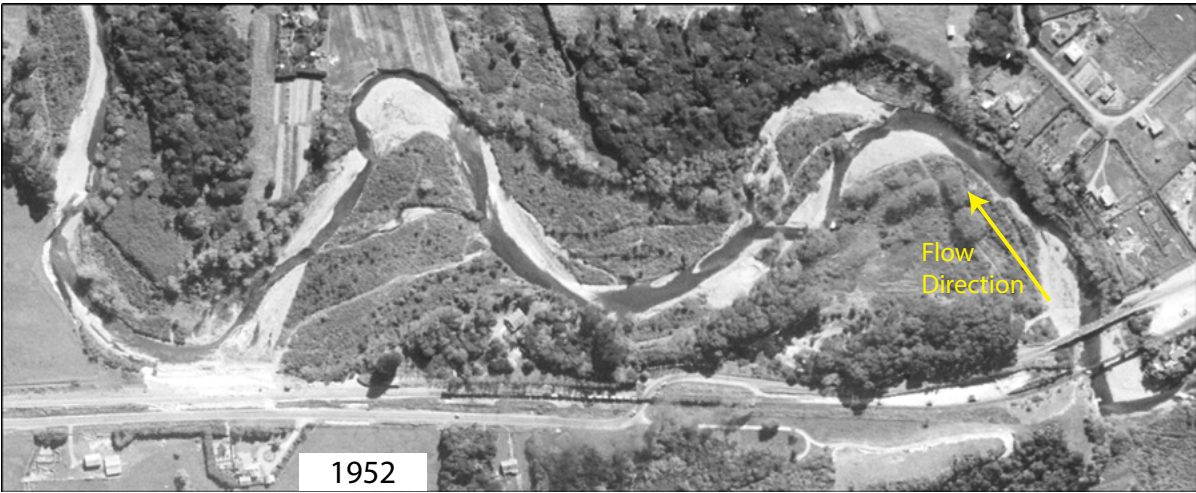
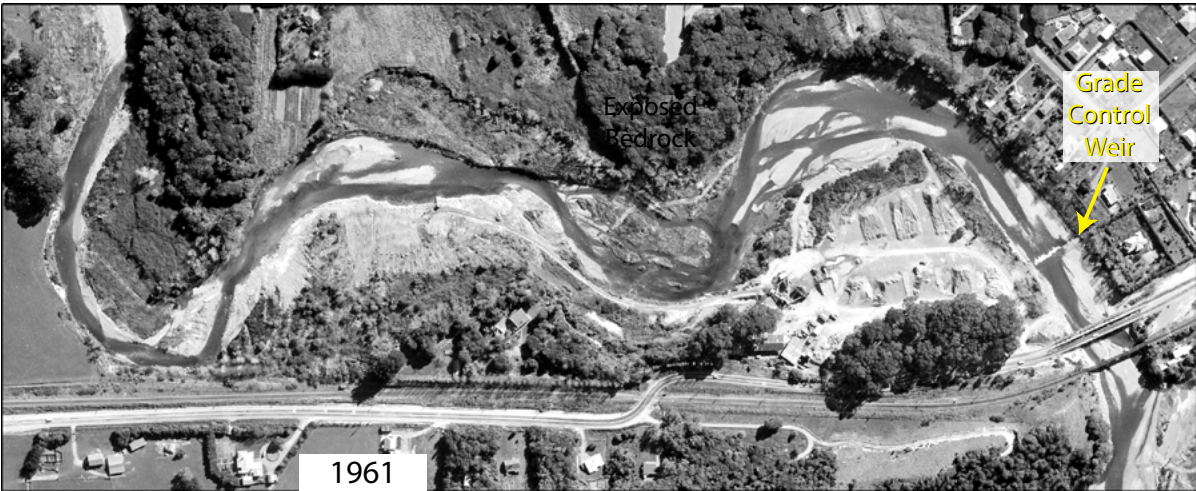
Figure 2-9 - The reach near Edgewater Park (old SH1 and rail bridges at lower right). (A) In 1952 the valley floor holds wetlands, oxbows and low-lying riparian terrain. (B) In 1961, during intensive gravel extraction, bedrock is exposed in the middle point bar and stockpiles are visible on the left bank. (C) By 2022 the river is set in a straight, simple alignment between grade-control weirs at the upper and lower ends of the photograph.

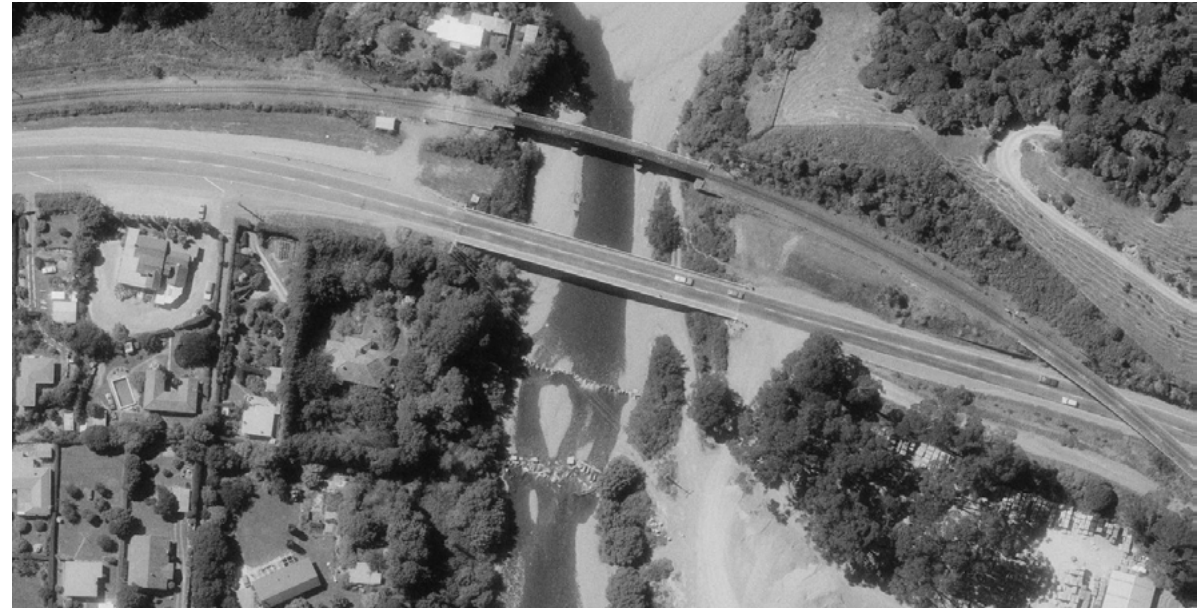
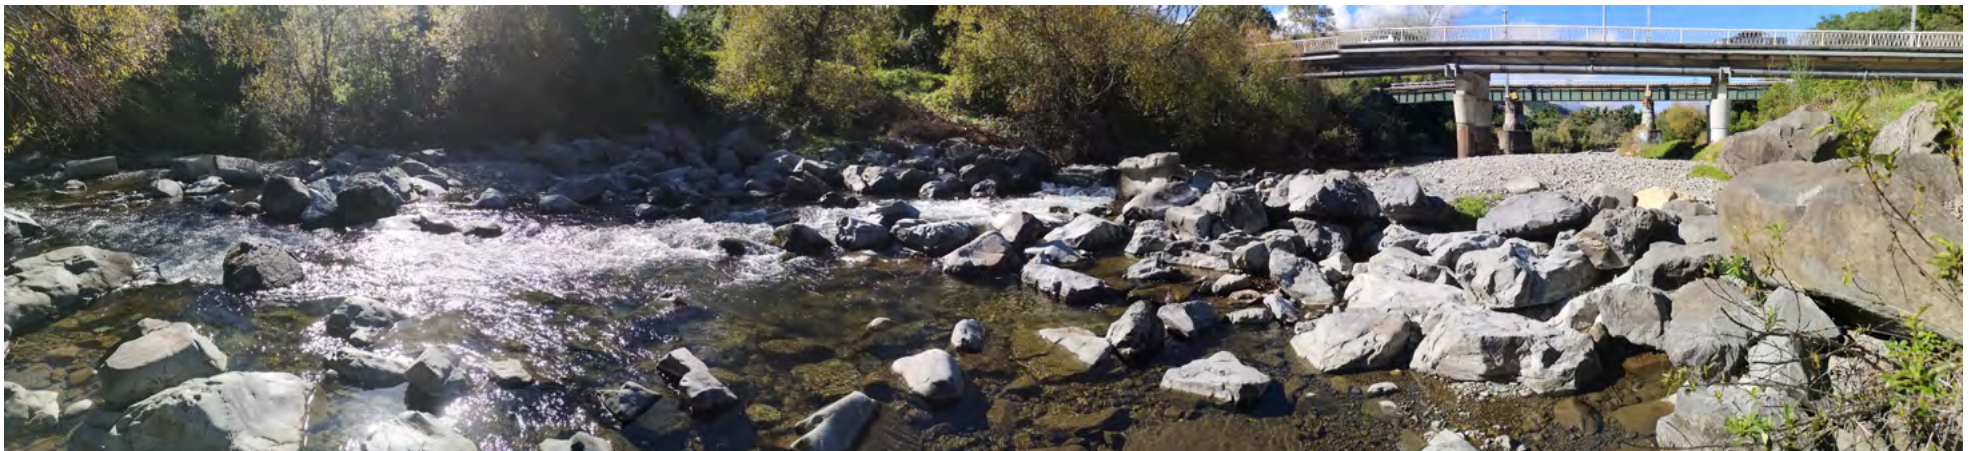
Figure 2-10 (A) The weir below the SH1 and rail bridges in November 1979, then a concrete-block structure; it was replaced by the present rock weir in 1985 (Crown aerial photograph 5614 F 27). (B) The heavy rock ballast of the weir, looking upstream, April 2022.

A sequence of weirs was built to arrest the degradation around the road and rail bridges (Figure 2-10A). Rock was dumped across the river in 1971 to form a sill 200 ft (about 60 m) downstream of the SH1 bridge; it was reinforced with concrete blocks in 1972, partly breached in the 1973 Labour weekend floods and reinstated after flood damage in 1980. In 1985 it was replaced by the rock weir that is largely still in place (Figure 2-10B; Easter 1991). A second weir, the Kebbels grade-control structure near XS 350, lies about 1 km downstream (GWRC 2010; Flanagan 2021). Further bank protection and bed-level controls were installed after the October 1998 floods, and these reduced the supply of gravel from the upper reaches (WRC 2005).

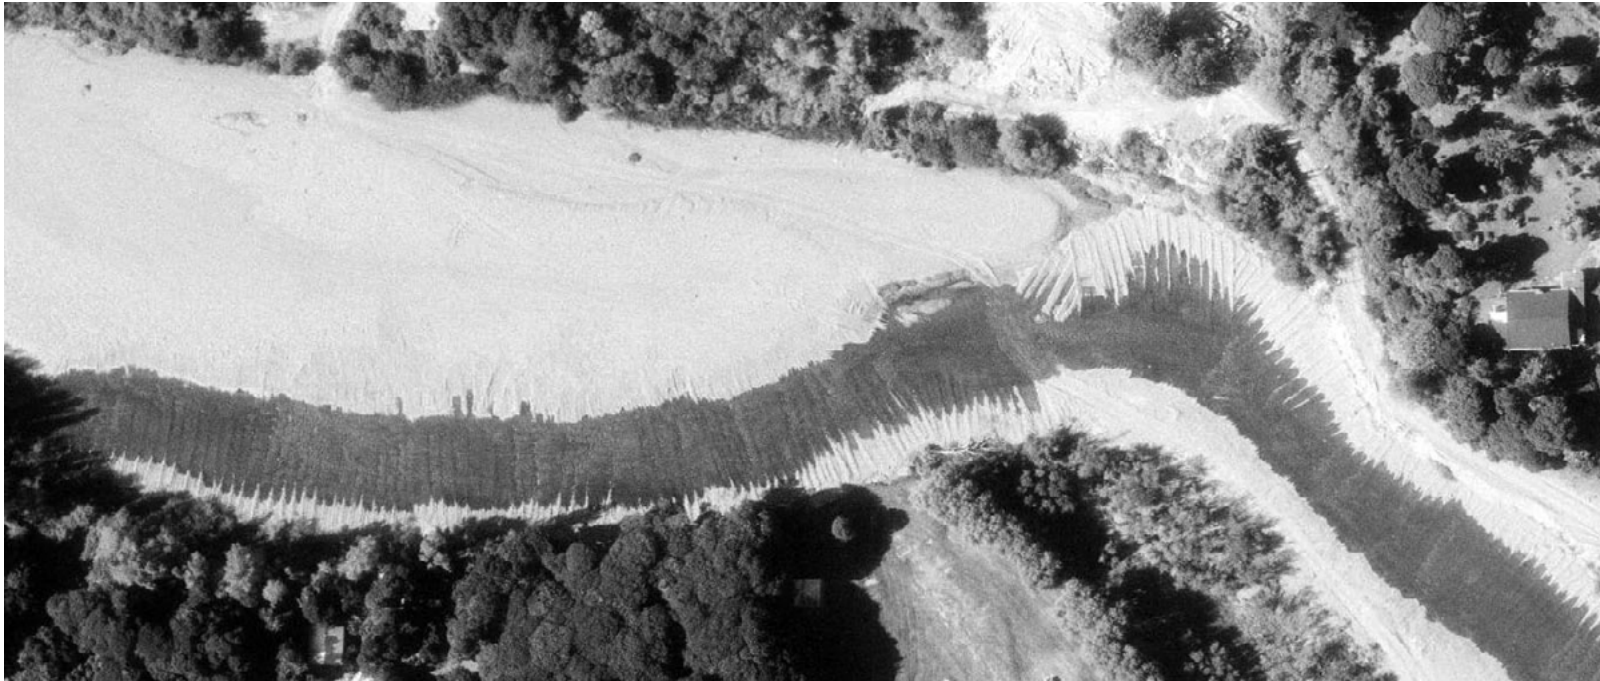
*Figure 2-11 Bulldozer tracks where material has been pushed back and forth across the bed to set the river's course, 1986, near XS 370, about 800 m downstream of the old SH1 bridge.*

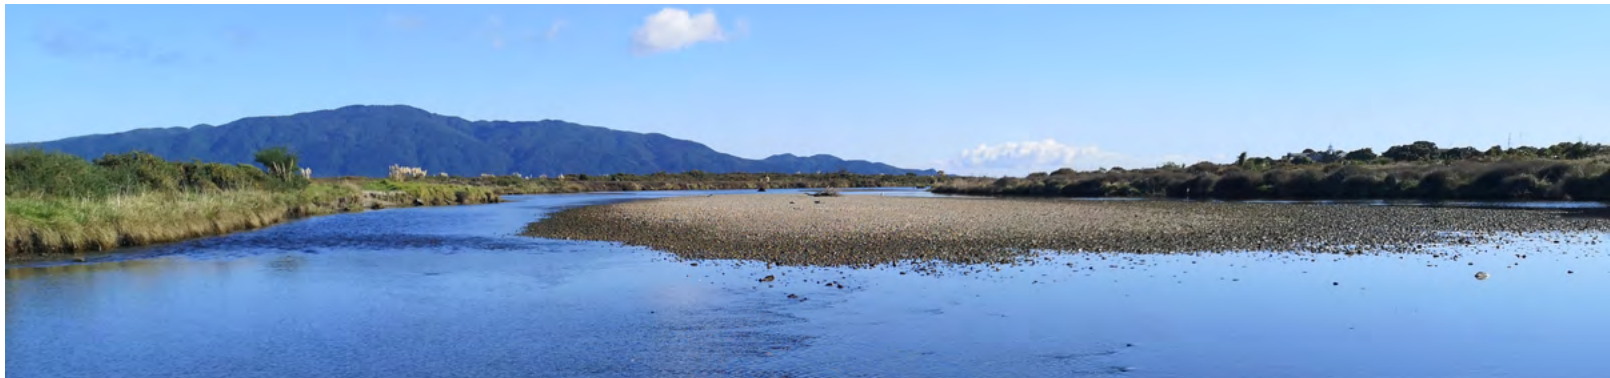
Figure 2-13 View of the sediment accumulation between GWRC cross-sections 60 and 70, looking downstream.

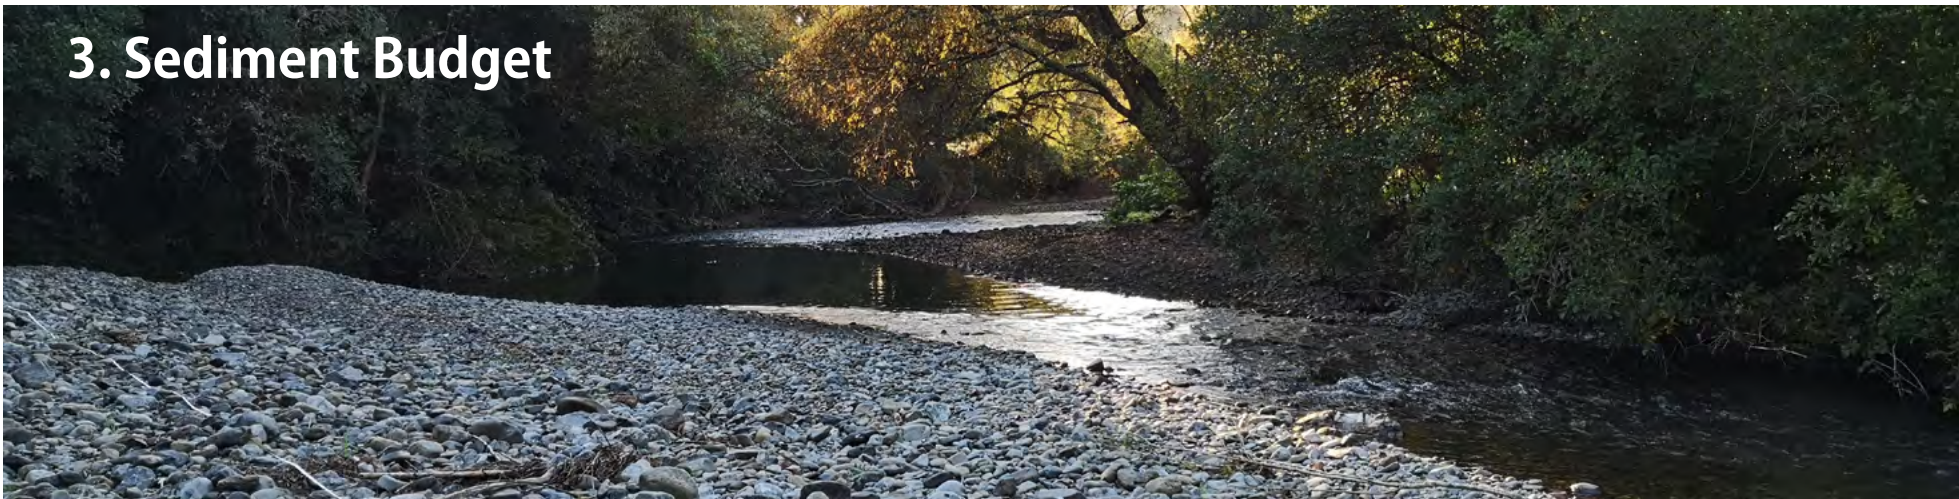
Figure 3-1 Upstream-most gravel sampling site, upstream of Reikorangri Rd bridge.

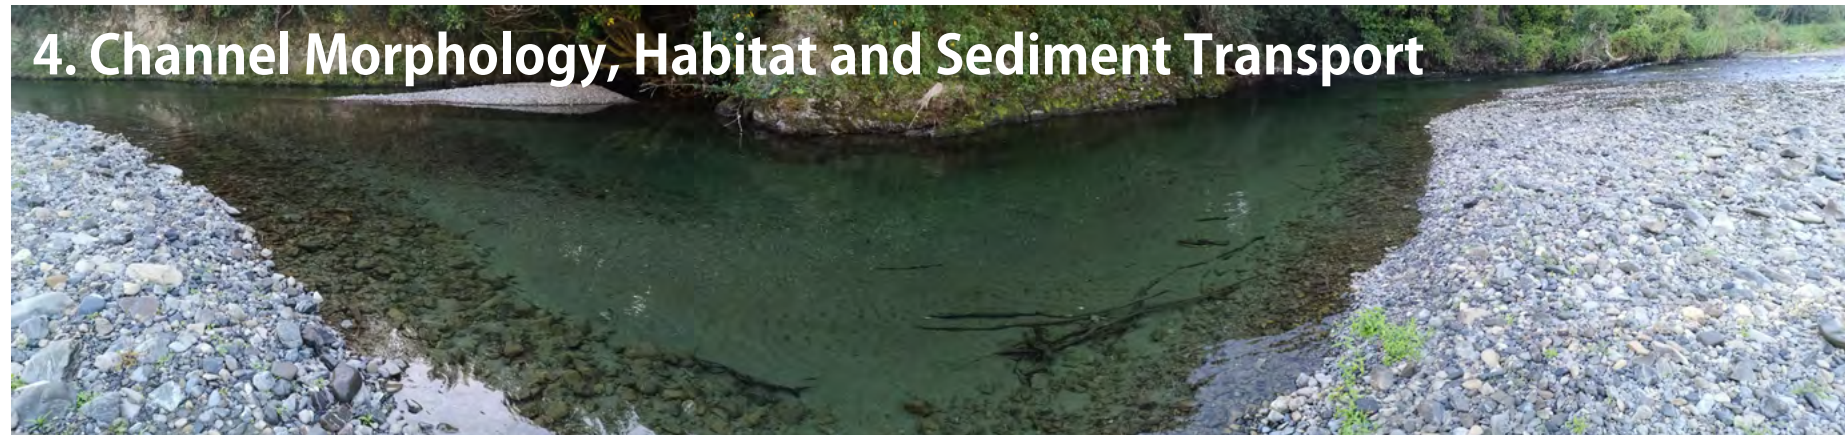
*Figure 4-1 The reach in the Reikorangi Gorge shows an abundance of loose gravelly material, and relatively deep pools layered with sandy material.*

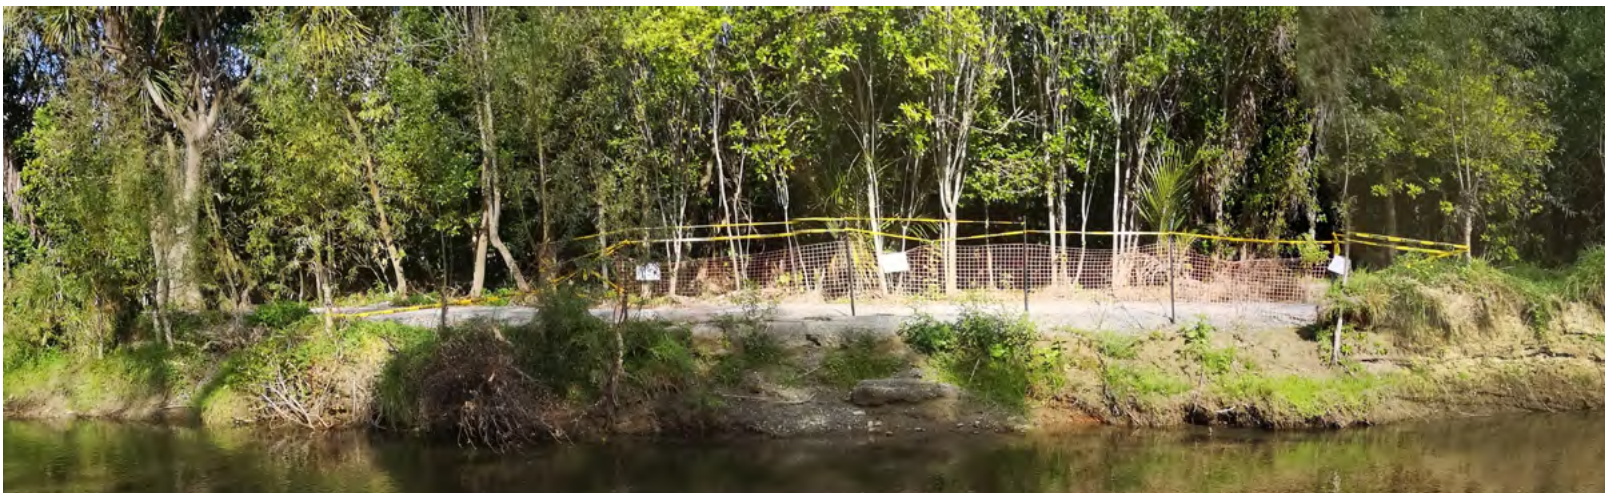
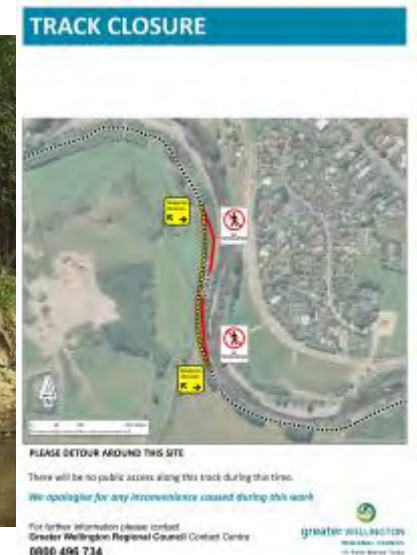
**Figure 4-6** Erosion on the left bank of the Waikanae River near XS250, downstream from Jim Cooke Memorial Park. The erosion is evident in the 2013-2021 LiDAR change map (Figure 3-4).

**Figure 4-7 Forced morphologies.** (A) Three rock groynes near XS 345 anchor pool formation. (B) Woody debris near XS 390 has caused local scour and deposition on the right bank.
