Peria River, Doubtless Bay Restoration

Geomorphic Assessment

Prepared for Department of Conservation

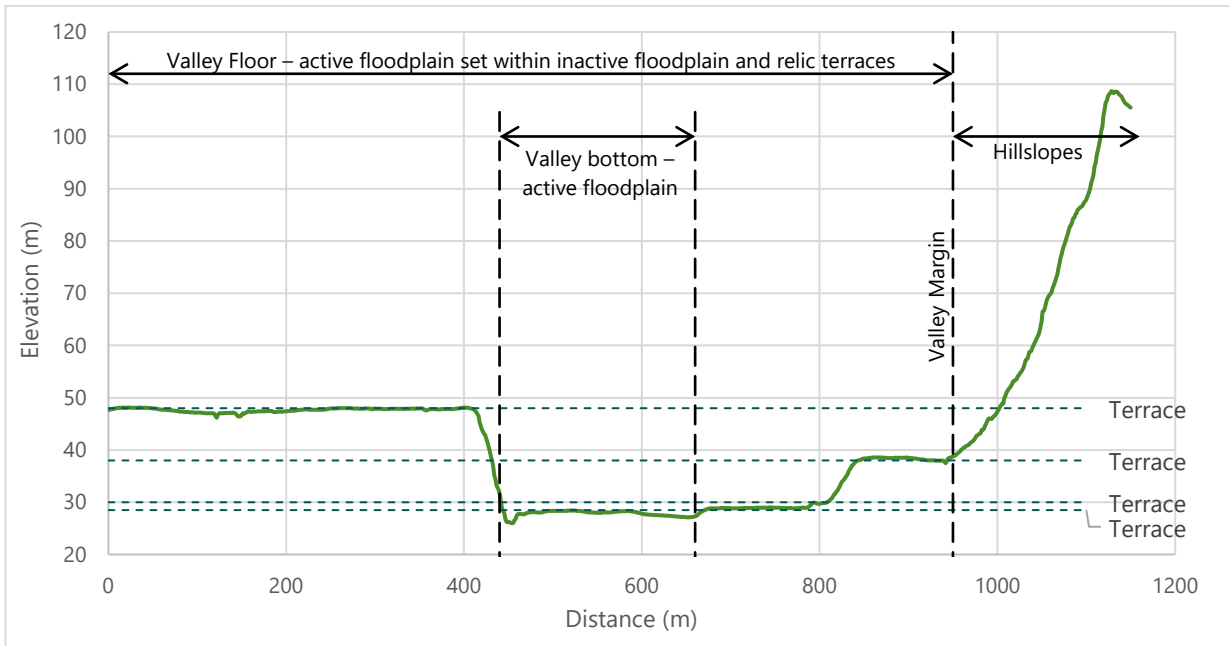
Figure 6: Representative cross section across the valley floor. Terrace levels are indicated. The valley floor includes the active flood plain surfaces (valley bottom) and the terraces. The valley margin represents the boundary between the valley floor and the hillslopes.

There is a suite of up to four terraces in the Peria catchment which were formed as the ancestral Peria River cut down through the valley fill deposits; these flat, past valley floodplains on the valley floor. The active alluvial surface or valley bottom (Fryirs et al., 2016) represents the active floodplain for the contemporary river that is engaged during high flows. Flows within the active floodplain do not inundate the terraces: Terrace 1 is approximately 1 to 2m above the active floodplain elevation. The principal geomorphic features within the restoration site are shown in the Geomorphic Features Map in Appendix 2; a typical cross-section of the valley floor is shown in Figure 6. The features are also shown in Photo 1; for reference of photograph locations, refer to the Geomorphic Features Map.

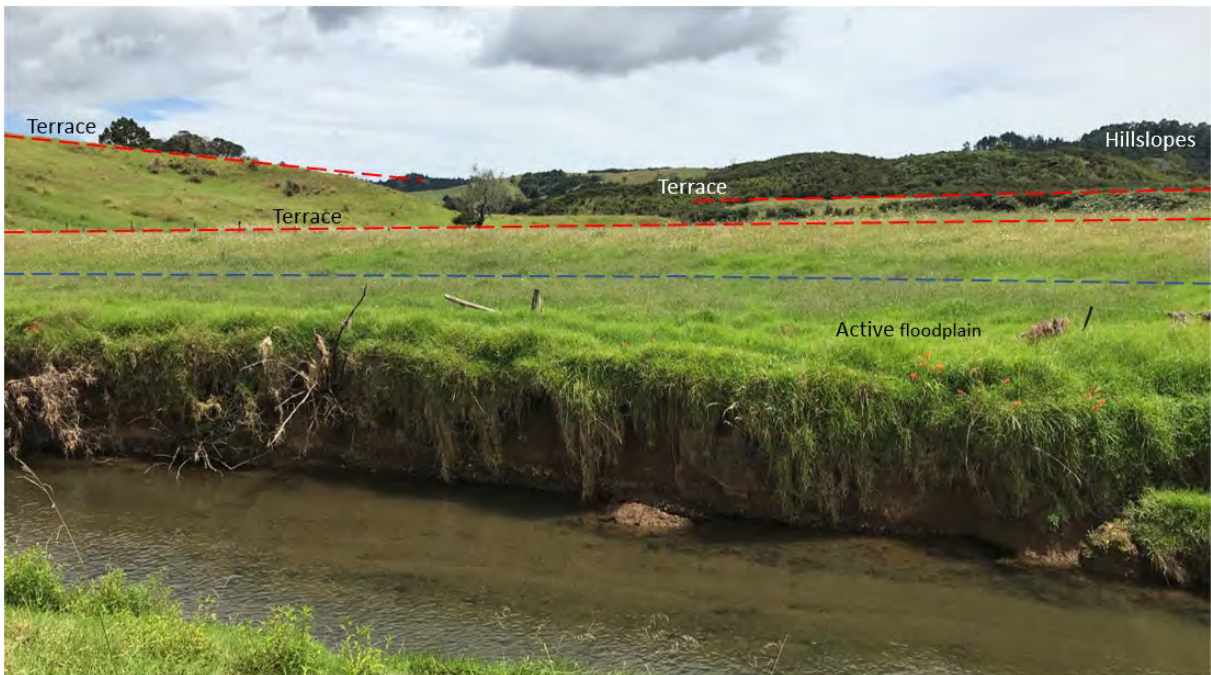
Photo 1: The Peria River with the active floodplain and terraces indicated. Note the bare banks where fluvial entrainment is occurring. The red lines indicate the top of terraces. The blue line indicates the base of terrace 1 and the edge of the valley bottom.

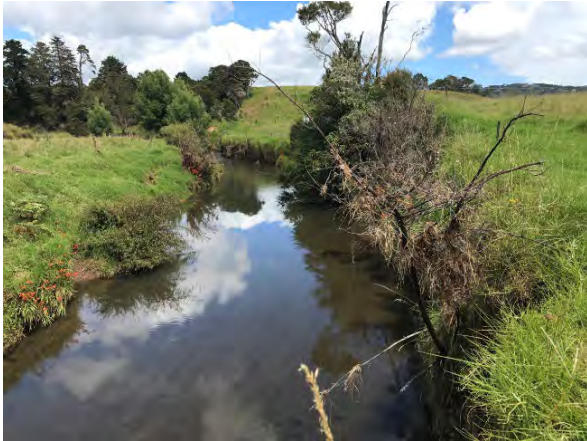
Photo 2: Characteristic run along the Peria River. Note the vertical banks. Looking upstream.

The stream banks are generally between 2 m and 3 m above the active channel, with a profile slope that ranges from about 45° to vertical (Photo 2 and Photo 4). The bank material consists mainly of sand and silt, with bedrock exposed, particularly where the river abuts the terrace margins (refer to Section 3.2 for more detail). The stream banks are generally grassed (dominated by kikuyu), with occasional areas of willow (predominantly crack willow; *Salix x fragilis*), exotic weeds (including cape honey flower; *Melianthus major* and Montbretia; *Crocasmia x crocosmiiflora*) and native vegetation (including tutu; *Coriaria arborea*, which appeared to be recently controlled by herbicide), particularly where the river abuts the terrace margins.

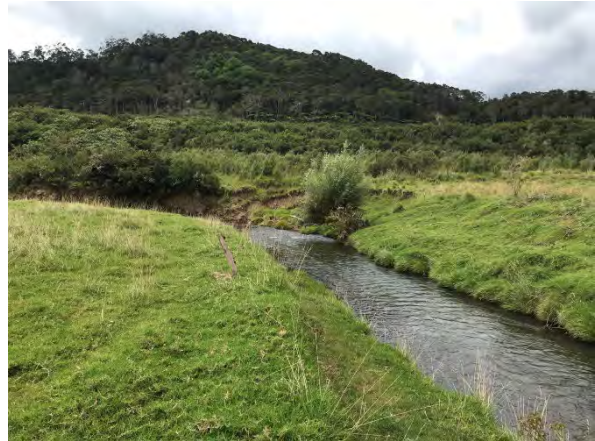
Photo 3: Characteristic run towards a meander bend, looking downstream. Note the graded stream banks and the erosion at the meander bend.

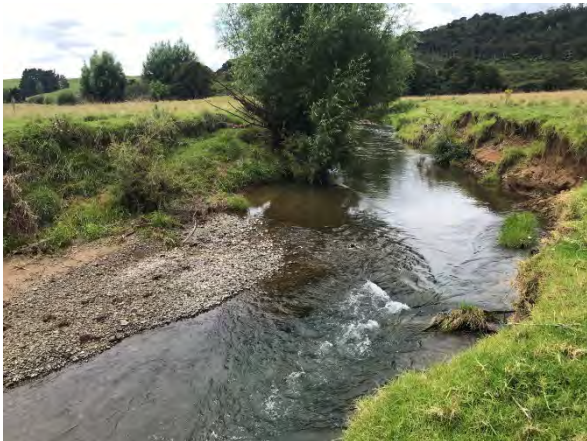
Photo 4: A riffle with upstream pooling behind the riffle and a run. Looking upstream.

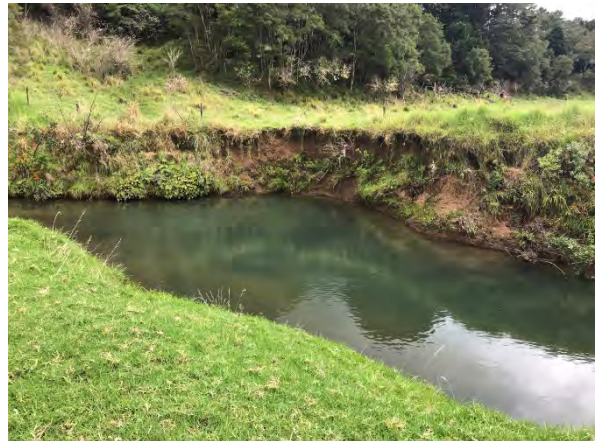
Photo 5: Pool formation and erosion on the outside of a meander bend.

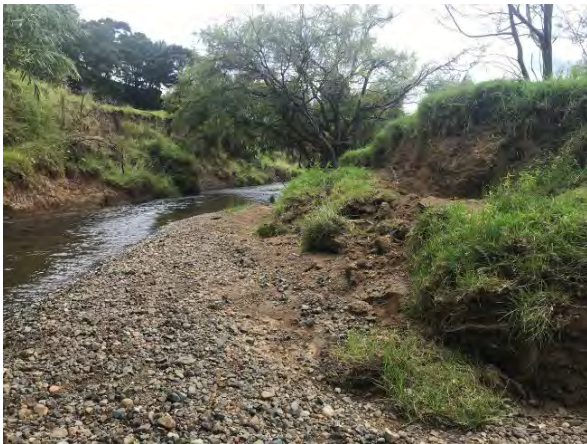
Photo 6: Point bar where sediment is stored on the inside of a meander bend. Erosion is occurring on the inside of the point bar and the banks are slumping. Looking downstream.

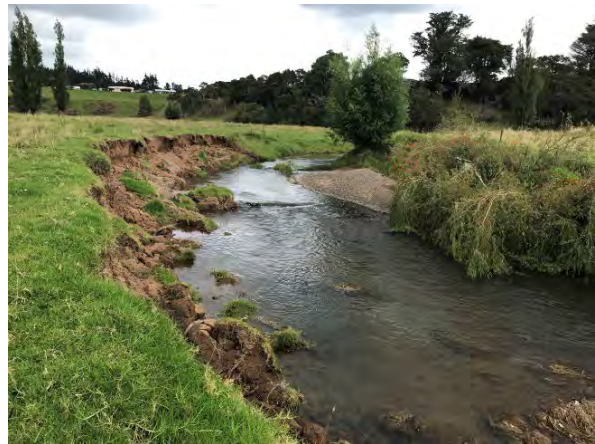
Photo 7: Fluvial and mass slumping of the stream banks in straighter sections of the stream. Looking upstream.

Bank erosion is occurring throughout the Peria River restoration site. The mechanisms for erosion include fluvial entrainment/erosion, where individual grains are dislodged by the flow of water, and mass/bank slumping, whereby sections of the stream banks fall into the channel. Ongoing fluvial erosion can undermine the banks and lead to mass slumping. Erosion is more pronounced on the outside of meander bends (outer bank erosion on the Geomorphic Features Map) as the flow is directed into the banks during high flows. This causes the gradual growth and downstream shift of the meander bends (Photo 3 and Photo 5). Fluvial and mass slumping is also occurring along the gently curving stream banks between the larger meanders (Photo 7, Photo 8 and Photo 9).

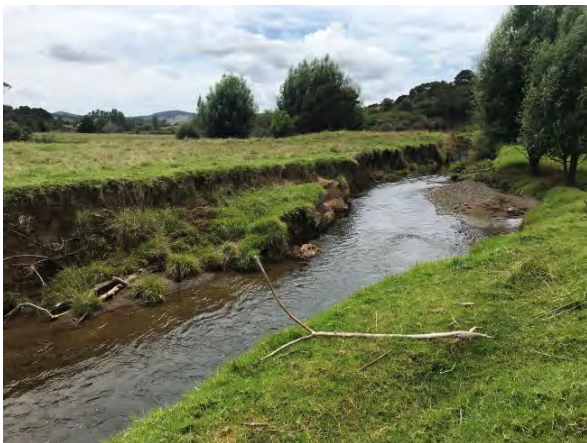
Photo 8: Fluvial entrainment and mass slumping. Looking upstream.

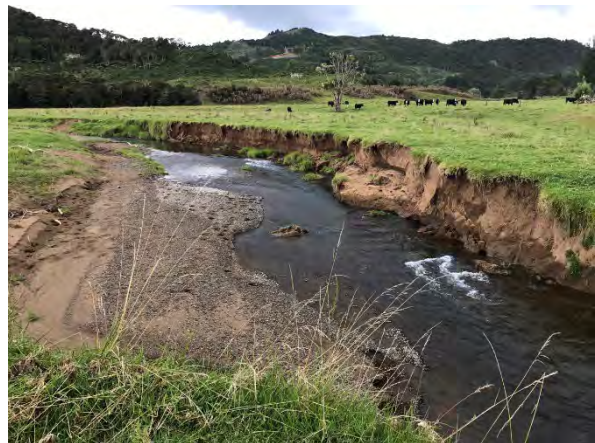
Photo 9: Ford crossing of the stream has likely contributed to localised bank erosion and sediment bar formation. Looking upstream.

Bedload material is deposited on point bars on the inner bend of meanders, and this material is remobilised during high flows. Erosion at these point bars may be accompanied by mass slumping of the exposed edges on the same side of the stream (Photo 6 and Photo 10). Erosion and collapse of the bank material is being exacerbated by stock which trample and loosen sediment on the banks (Photo 11). Farm tracks are also causing localised destabilisation of the stream banks and are also a point of access to the stream for stock (Photo 9).

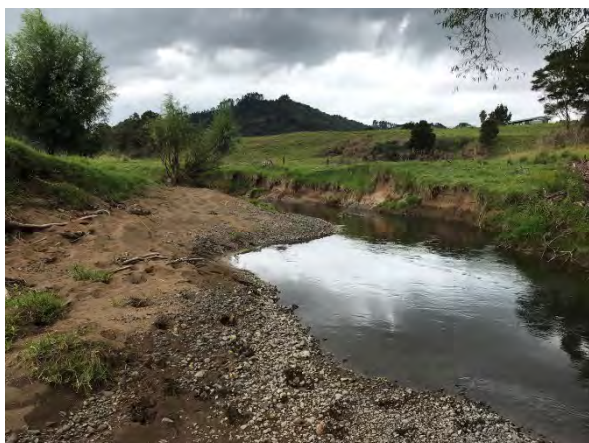
Photo 10: Erosion of material on inside of point bar and slumping. Erosion is likely to have been exacerbated by stock access.

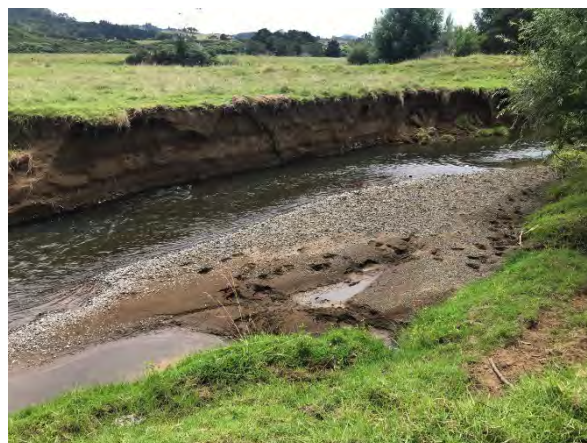
Photo 11: Lateral bar with graded banks where stock can access the stream.

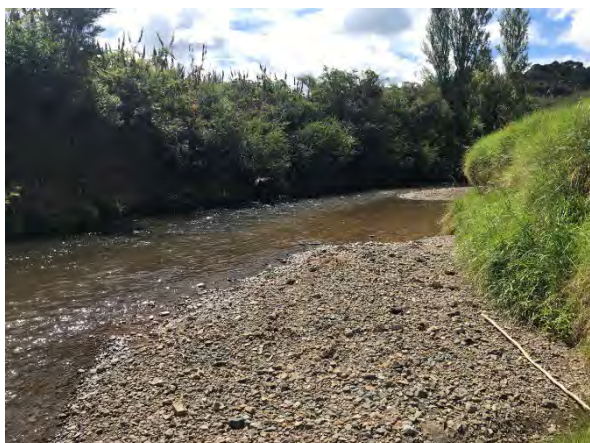
Photo 12: Site 1, lateral bar. Looking upstream.

Sediment sampling for the active alluvial surface was undertaken on bars at the upstream and downstream ends of the study reach (Site 1, Photo 12 and Site 2 Photo 13) to assess the composition of the active surface layer, the gravel fraction that remains on the sediment bar following the removal of the finer portion of material at moderate or waning flow conditions. It gives an indication of the hydraulic roughness in the channel and the calibre of the sediment which is being transported. The material was assessed using the Wolman Pebble Walk methodology (Bunte & Abt, 2001), where a transect was walked across the bar, and a single clast (i.e., a pebble or cobble) was randomly selected at approximately 0.5 m intervals. A total of 100 grains were measured along the b axis (the intermediate axis length), using the modified Udden-Wentworth grain size scale to classify grains at half phi intervals from $\Phi-3$ to $\Phi-7$ (8 to 128 mm) (Blair & McPherson, 1999; Clapcott et al., 2001).

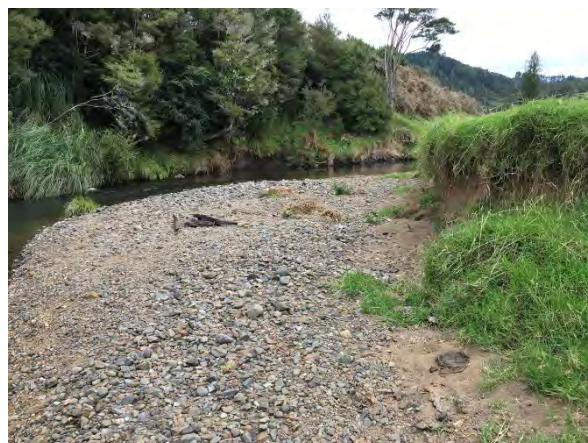
Photo 13: Site 2, point bar. Note erosion of the inside bank. Looking upstream.

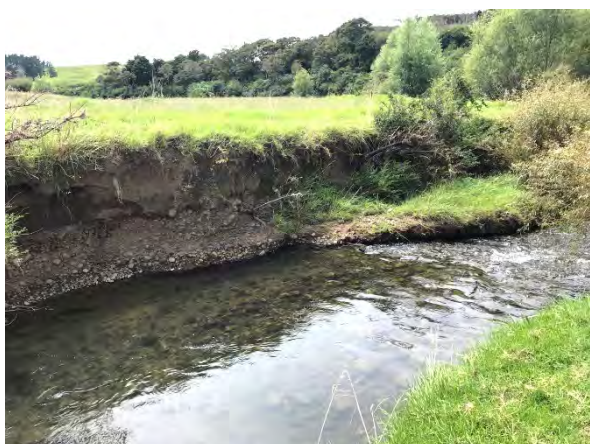
Photo 14: Stream bank exposures with gravel in the base and fine-grained sediment above.

The stream banks provide a cross-section view of the lower terrace material; these typically have a gravel base with fine-grained sediment above (Photo 14). The gravel layer is inferred to be an earlier stream bed at a similar elevation, prior to the deposition of valley fill above. This earlier system was likely filled with material following anthropogenic disturbance. Two samples (Site 3 and 4) (approx. 150 g collected) of the fine-grained bank material were taken. A MasterSizer3000 particle size analyser was used in the University of Auckland laboratory to determine the grain size distribution of the fine-grained samples (approximately 0.25 g of collected sample), refined using the average of four measurements taken from the same sample.

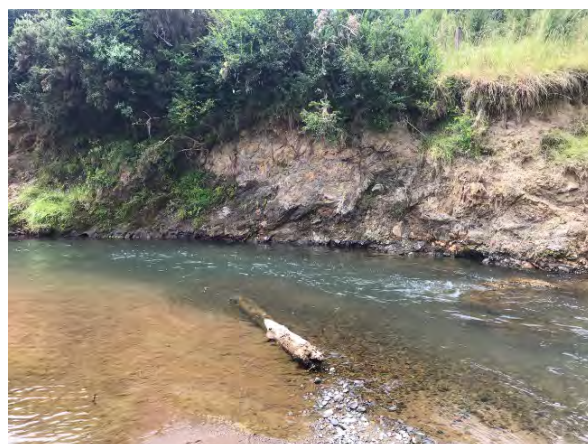
Photo 15: Bedrock exposures in stream banks. Looking downstream. Note the woody debris.

Bedrock was observed in the meander bends where the stream was abutting against the terrace margins (Photo 15), and also at the base of the channel in discrete locations. There was also occasional woody debris in the stream.

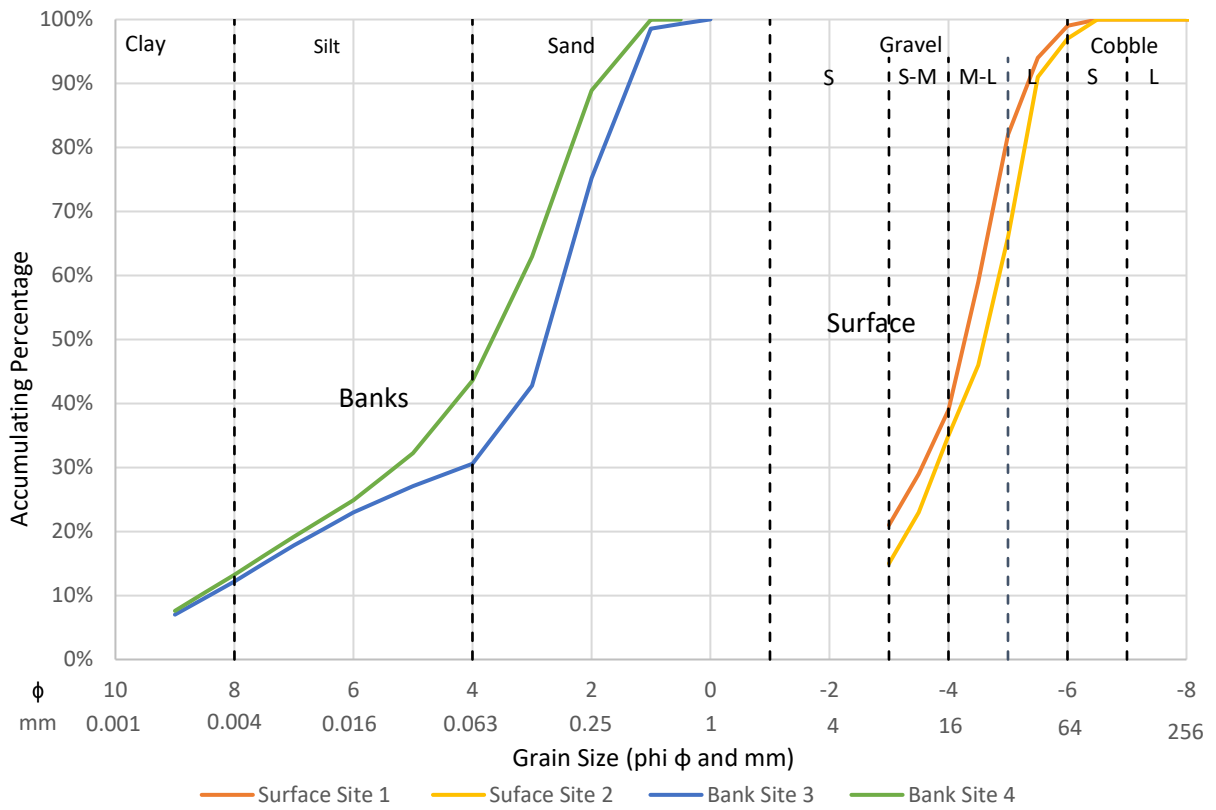
Figure 7: Grain size distribution as accumulating percentage of sediment of the active layer deposits in sediment bars and fine sediment portion of the banks.

The results of the sediment sampling are shown in Figure 7

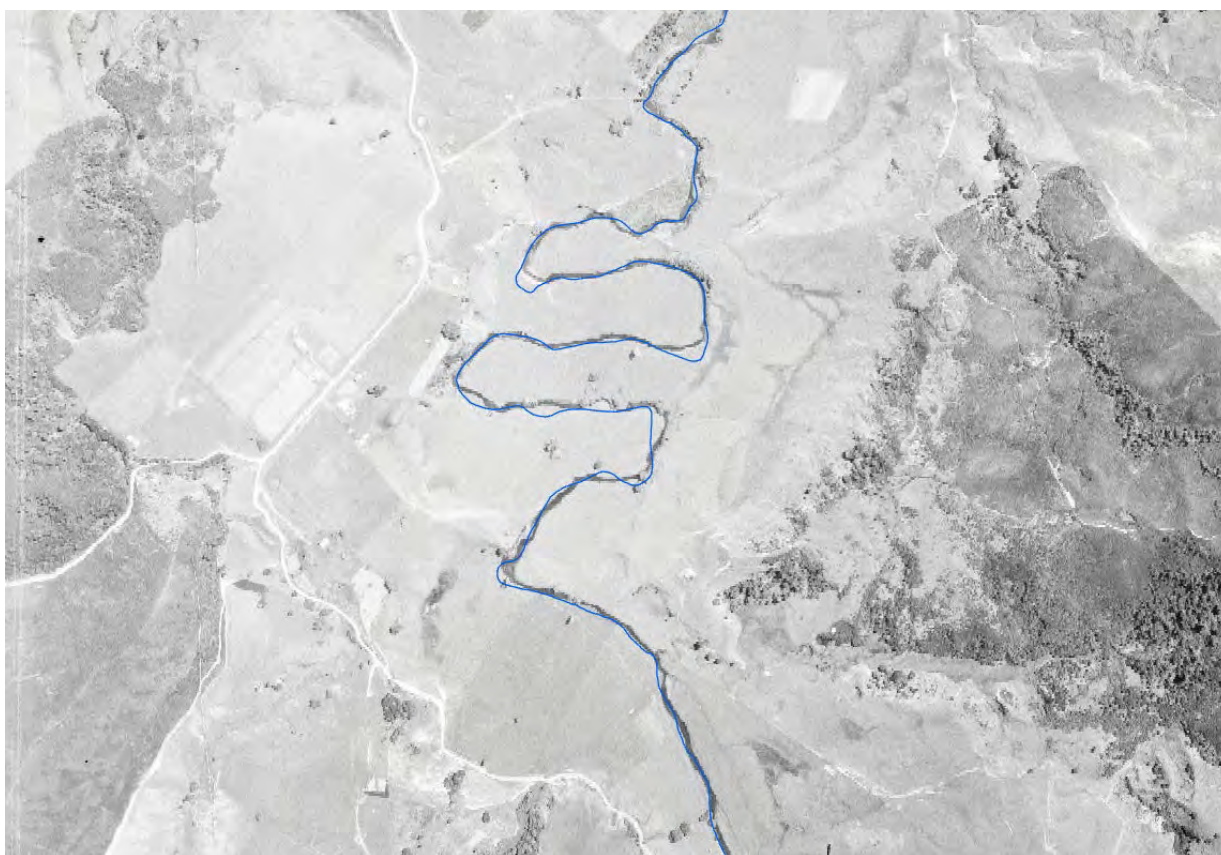
Figure 8: 1950 aerial photo of the Peria River. Current alignment of the Peria River is shown in blue.

Historical aerial photographs reveal how the stream has adjusted over the recent past. Aerial photographs from 1950 (SN1363-30 and SN1363.32) were sourced from Retrolens.nz and the stream alignment was compared to today (Figure 8). This shows that over the last 70 years, there has been a gradual extension (outward growth) of the meander bends with rotation occurring (deflection and shift of the pathway of bend migration) where their growth is restricted by the terrace margins.

The straighter sections of stream between meanders have generally followed the same alignment through this time, however there are some areas of minor adjustment. These could be a result of localised forcing elements such as woody debris or bank slumps which alter stream flow over a decadal timescale, resulting in a localised change in deposition or erosion.

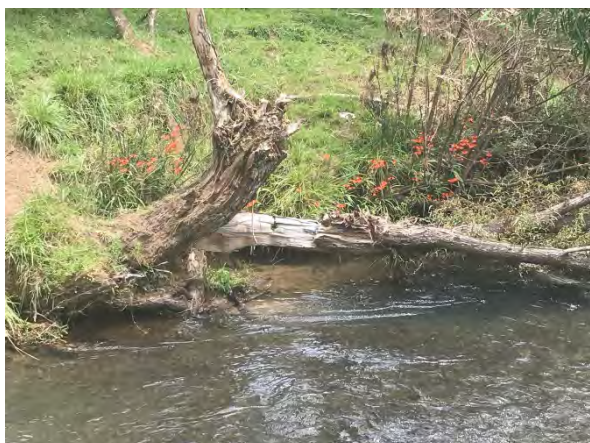
Photo 16: Woody debris at stream edge trapping fine grained sediment on downstream side. A stable undercut has formed below the stump, providing shelter and shade for fish or invertebrates.

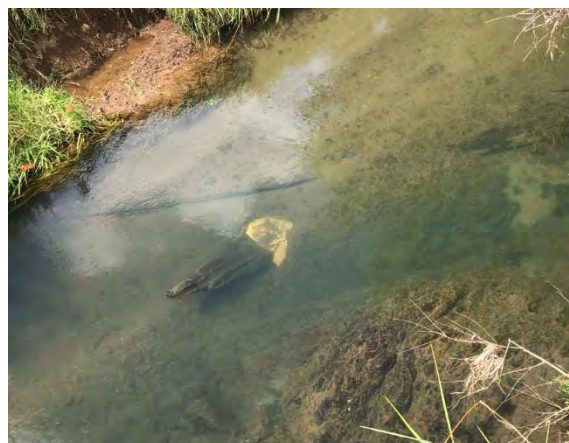
Photo 17: Instream woody debris which facilitates sediment accumulation and scouring to form deeper pools around the wood.

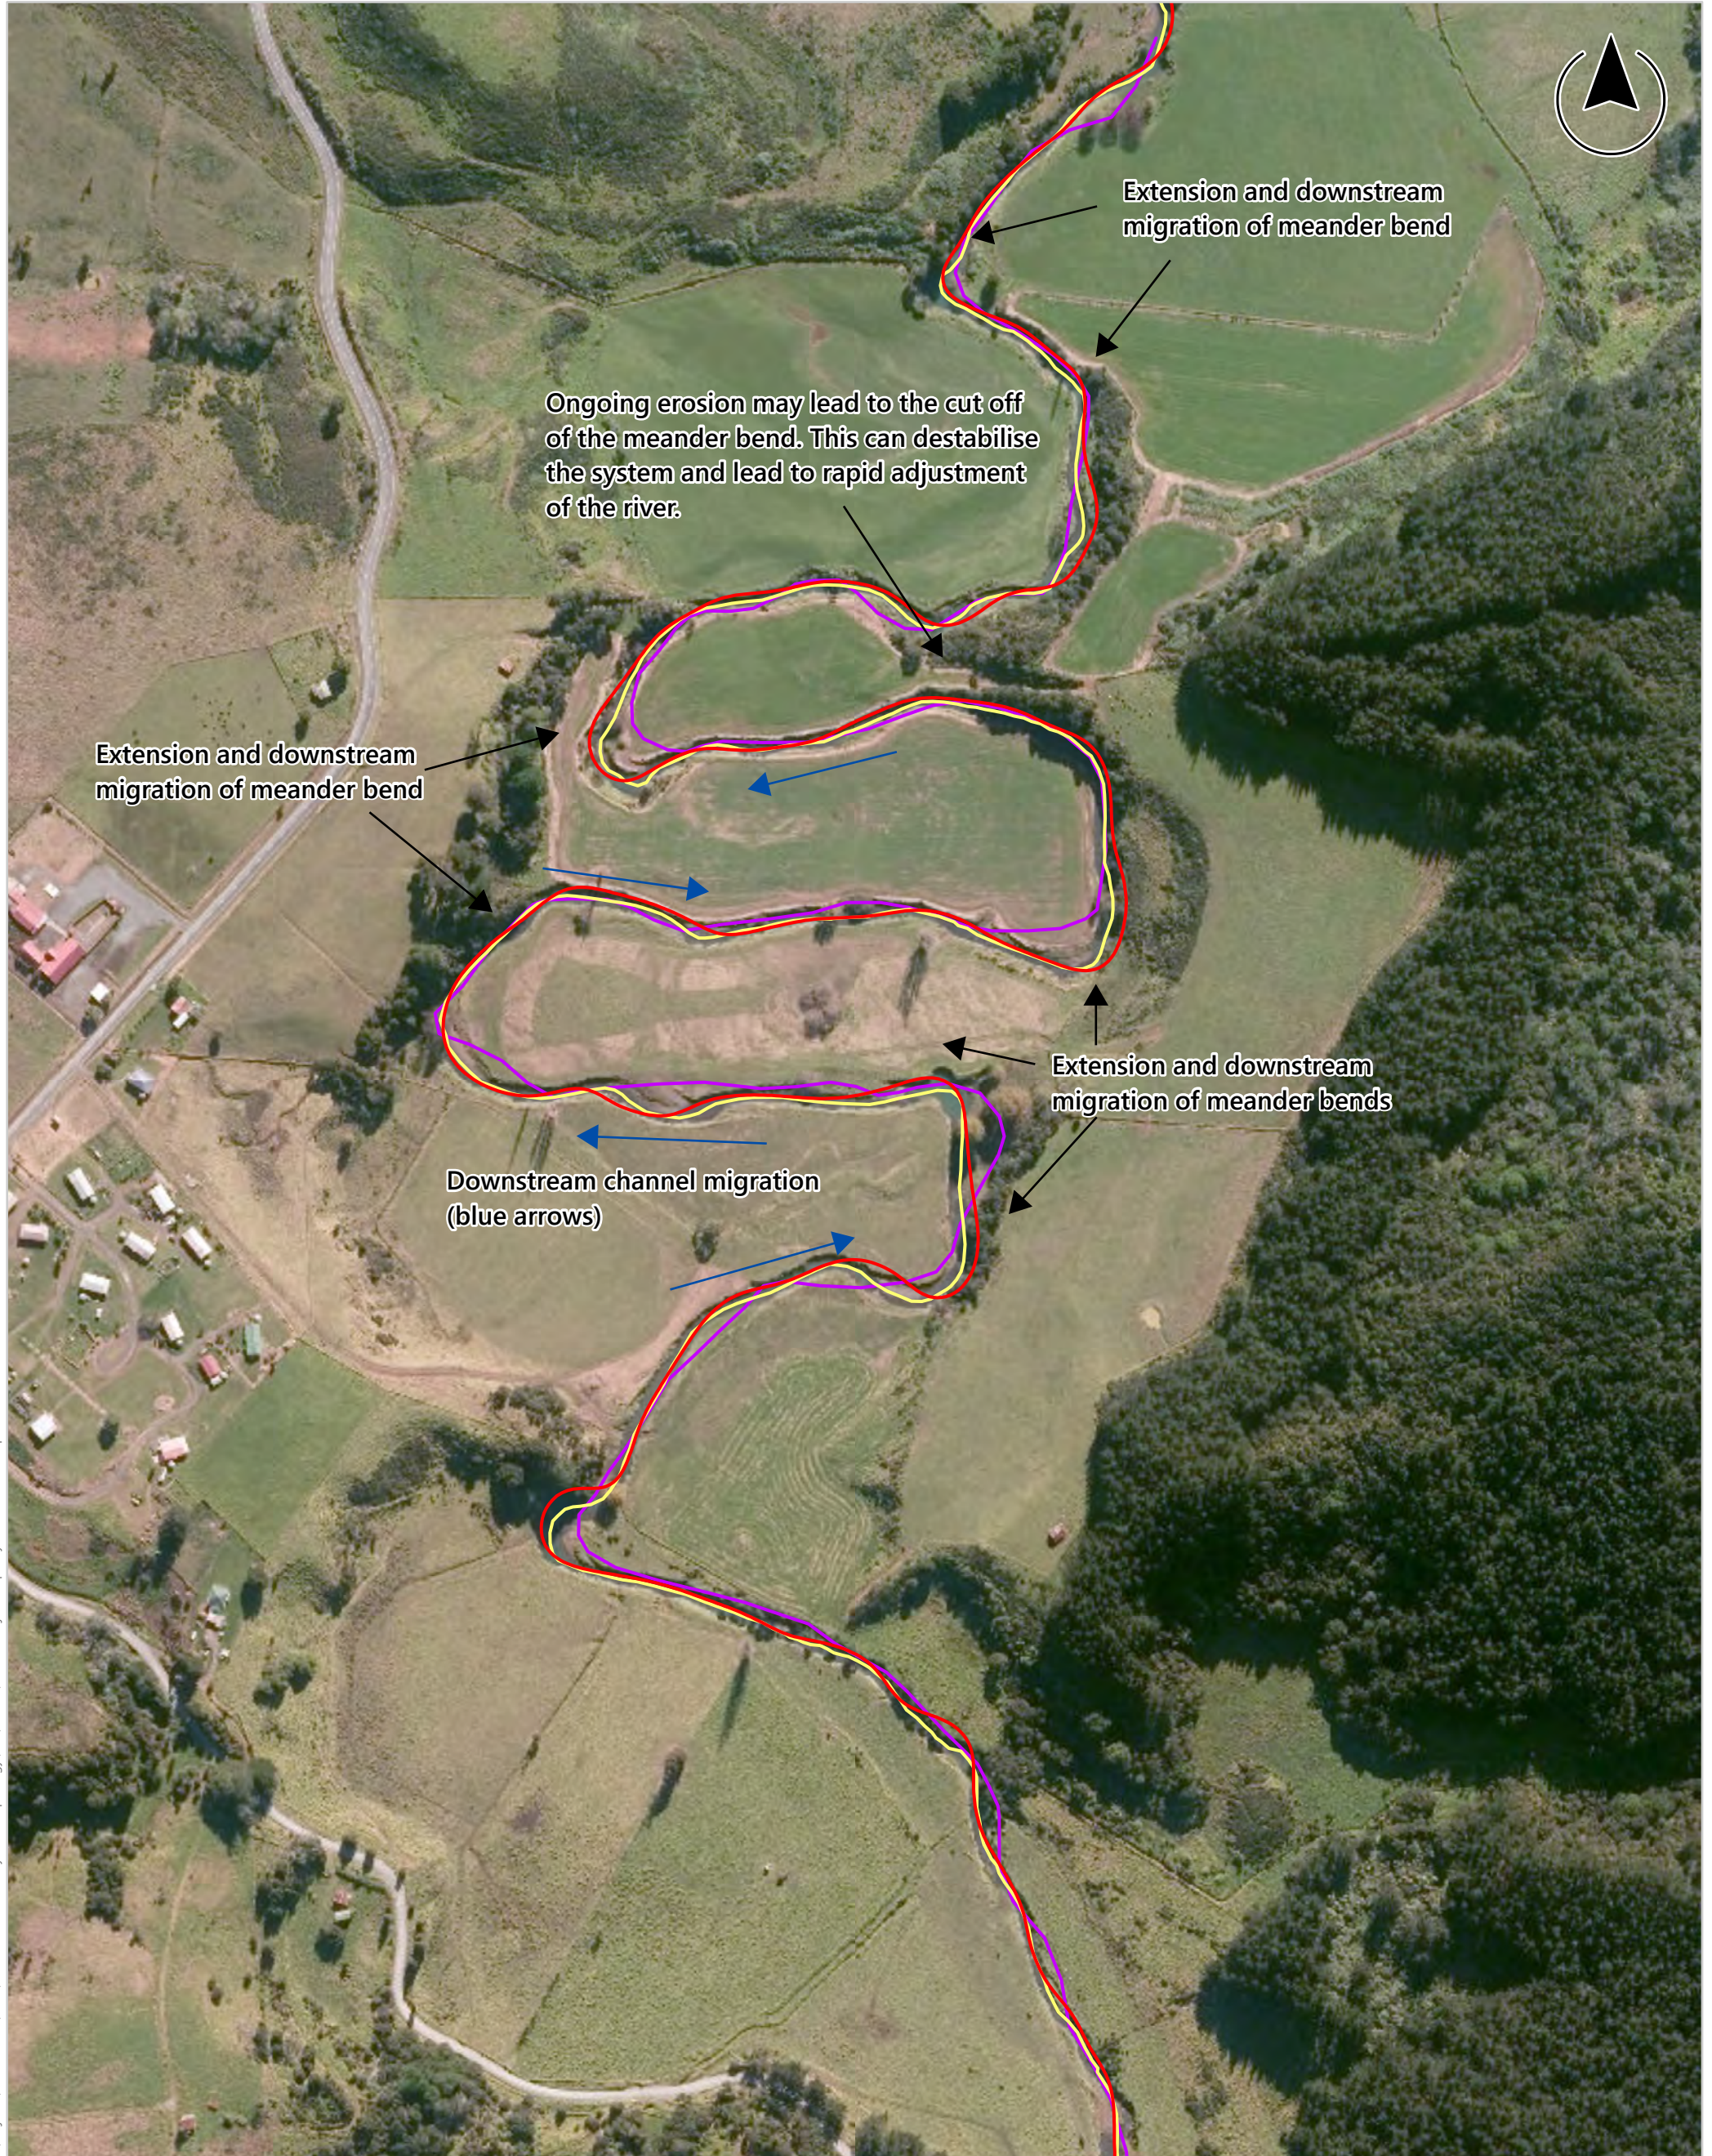
- 2071 Projected Centreline
- 2021 Centreline
- 1950 Centreline

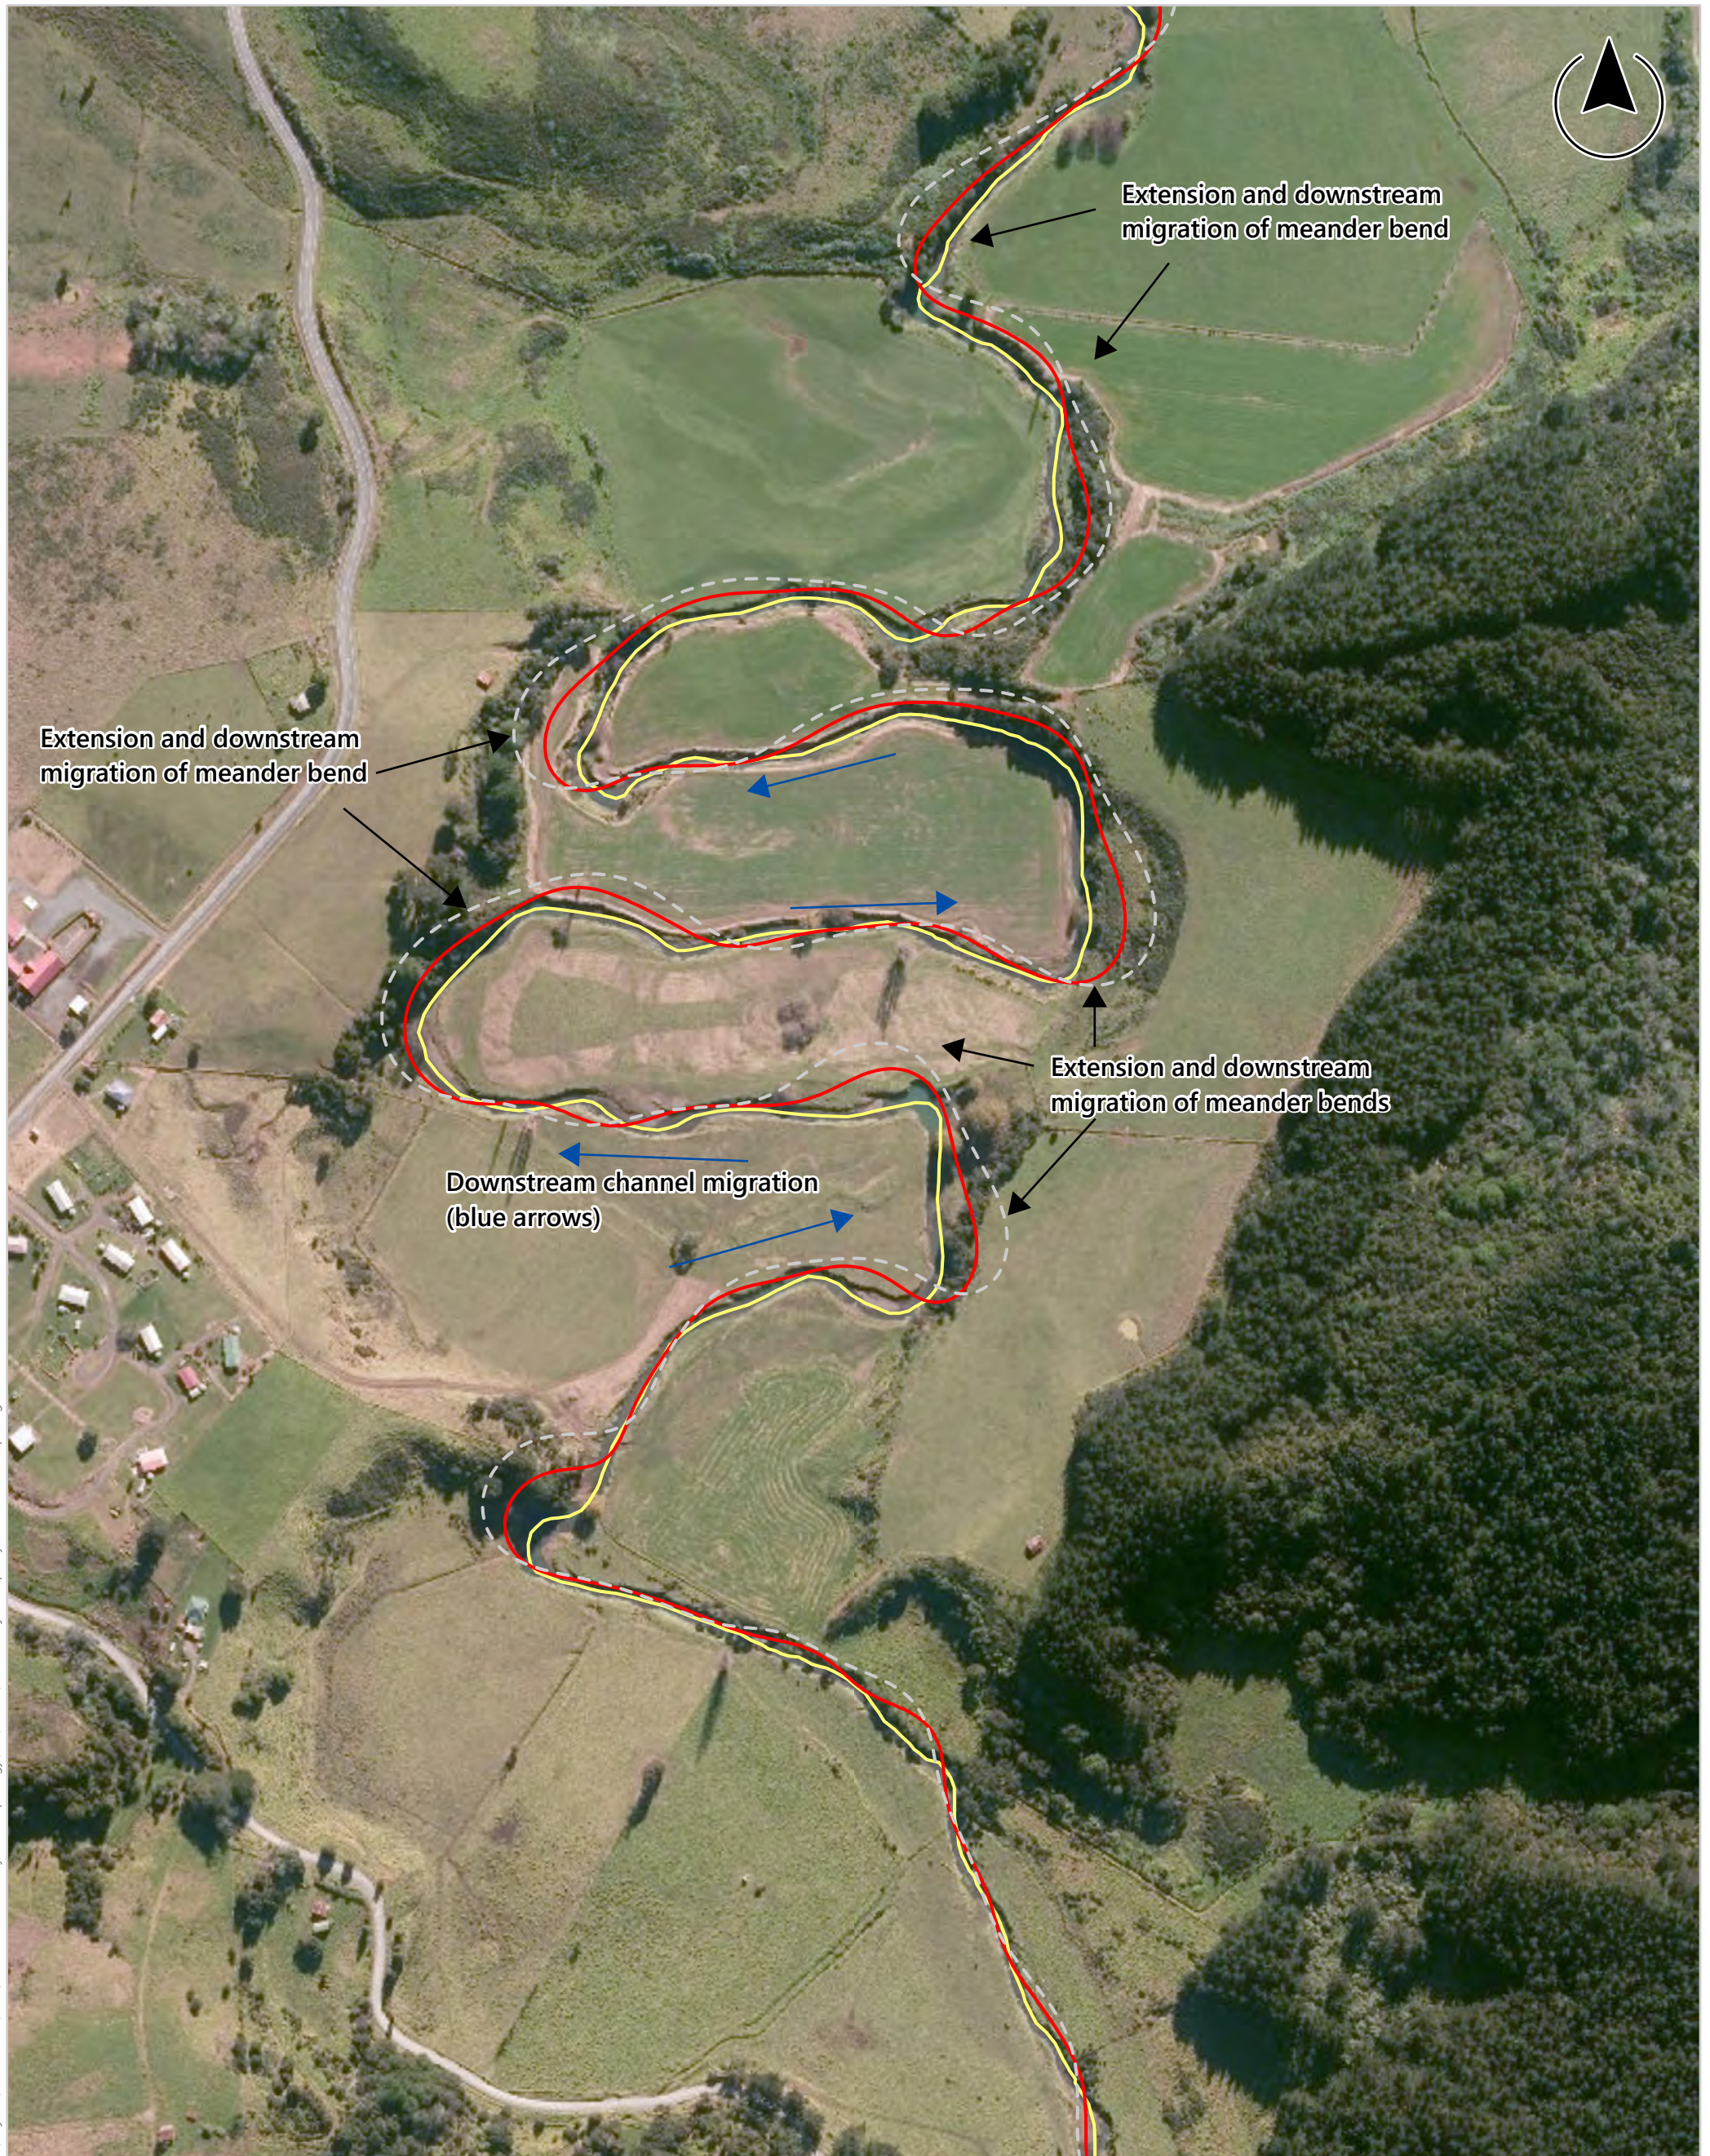
PERIA RIVER - LONG-TERM RIVER EVOLUTIONARY TRAJECTORY

- Long-term evolutionary trajectory
- 2071 Projected Centreline - higher rate of erosion
- 2021 Centreline
