Threats to archaeological features within the redoubt and village area, Opepe Bush Scenic and Historic Reserve, Taupo

SCIENCE & RESEARCH INTERNAL REPORT NO.168

Ann Williams

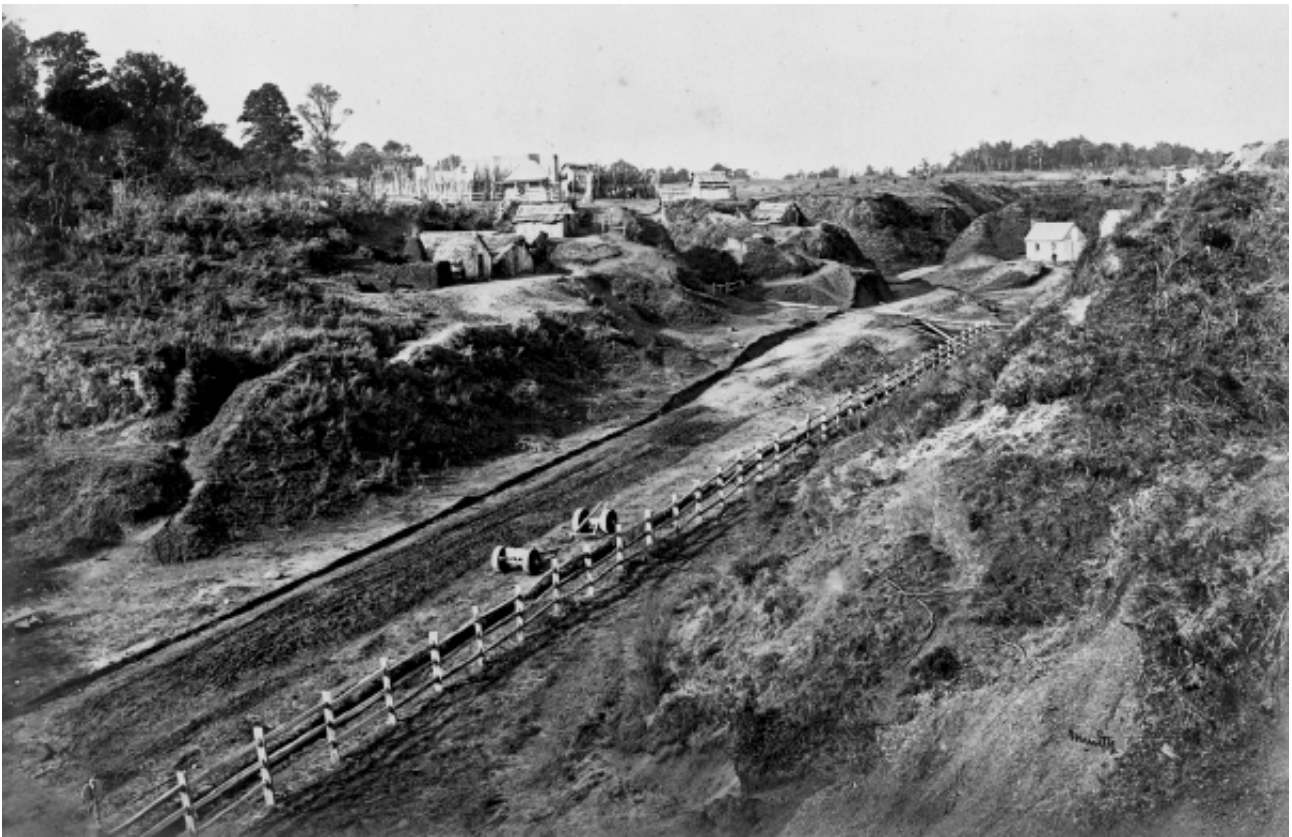
Figure 2. Opepe village and redoubt, c. 1870. (Photographer: Russell James Duncan 1855-1946.) Historic features visible in the photograph include the redoubt stockade, the old Opepe Road, and huts and other structures built on the terraces to the left of and above the road. Courtesy of Alexander Turnbull Library, National Library of New Zealand, Te Puna Matauranga o Aotearoa. F18077_{1/2}.

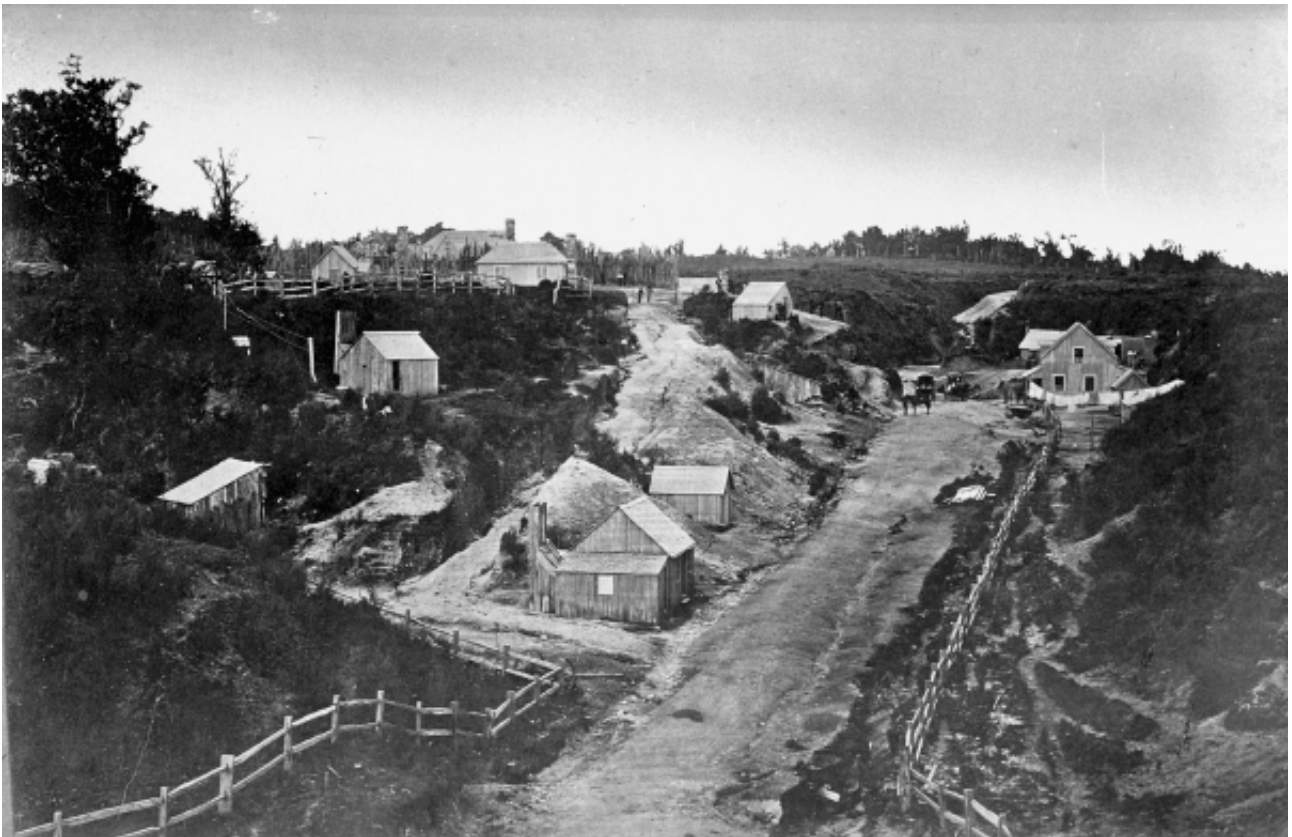
Figure 3. Opepe village and redoubt, c. 1880. (Photographer: possibly Burton Brothers 1868-1898.) Historic features visible in the photograph include the redoubt stockade, the old Opepe Road, and the hotel (with a line of washing in front). Comparison of this photograph with the 1871 photograph shows that considerable modification of the bank to the left of the road has taken place in the intervening decade and that more substantial structures have been built in this area. *Courtesy of Alexander Turnbull Library, National Library of New Zealand, Te Puna Matauranga o Aotearoa. F2673_{1/4}*
