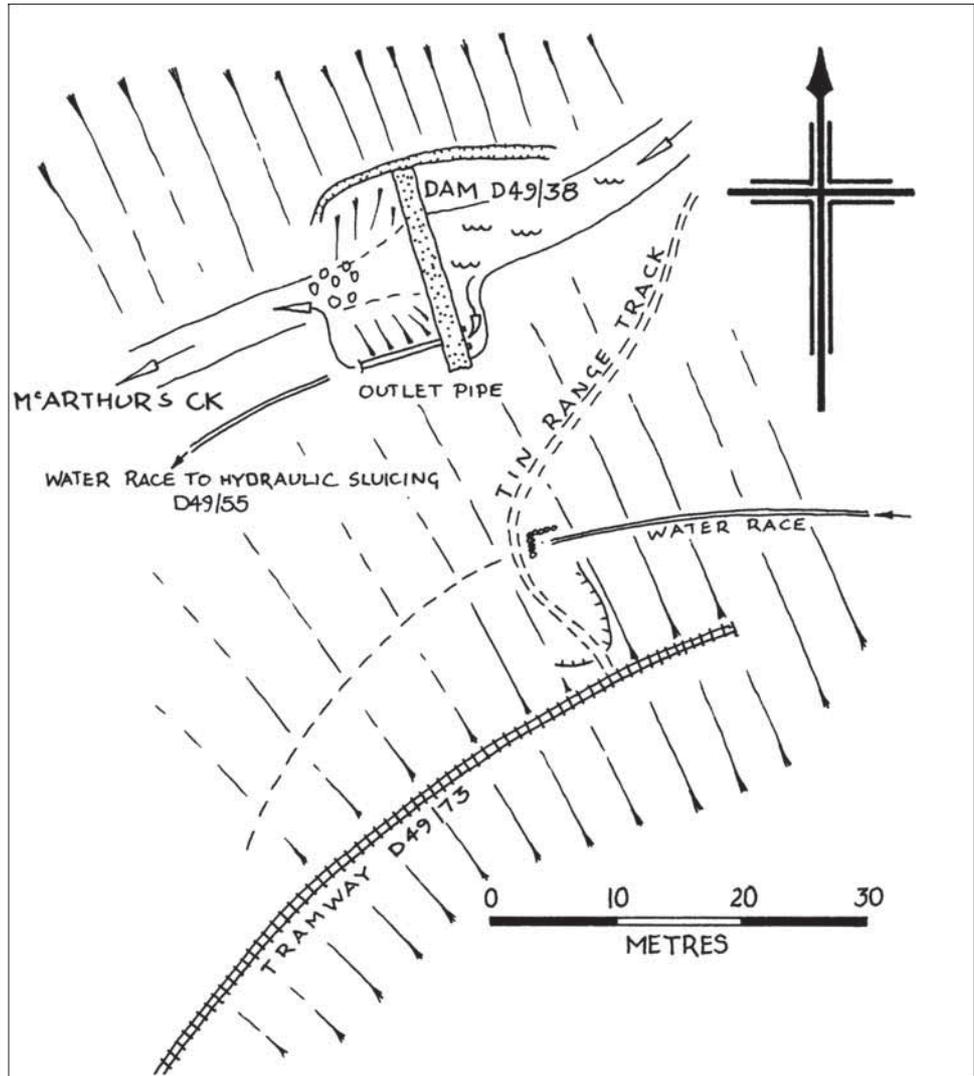
Figure 27. Stone dam (Site D49/38) in headwaters of north branch of McArthurs Creek, with end of tramway (Site D49/73) on hillside above, and start of race (Site D49/55) to hydraulic sluicings (Site D49/41).

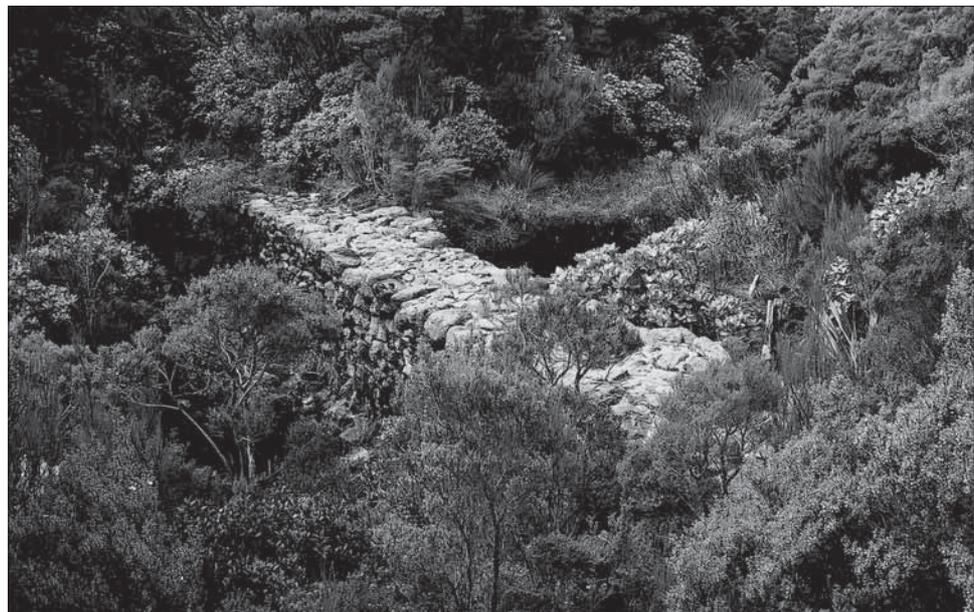
Figure 28. The stone dam (Site D49/38) in the headwaters of McArthurs Creek, built in about 1915 to supply the hydraulic sluicing operation.
Photo: P. Petchey.

and the outflow instead goes back into the creek. The flow from the dam was originally controlled by a vertical iron gate which slid into place on iron guides. The guides are still in place, but the gate is now to be found lying a short distance down the water race.

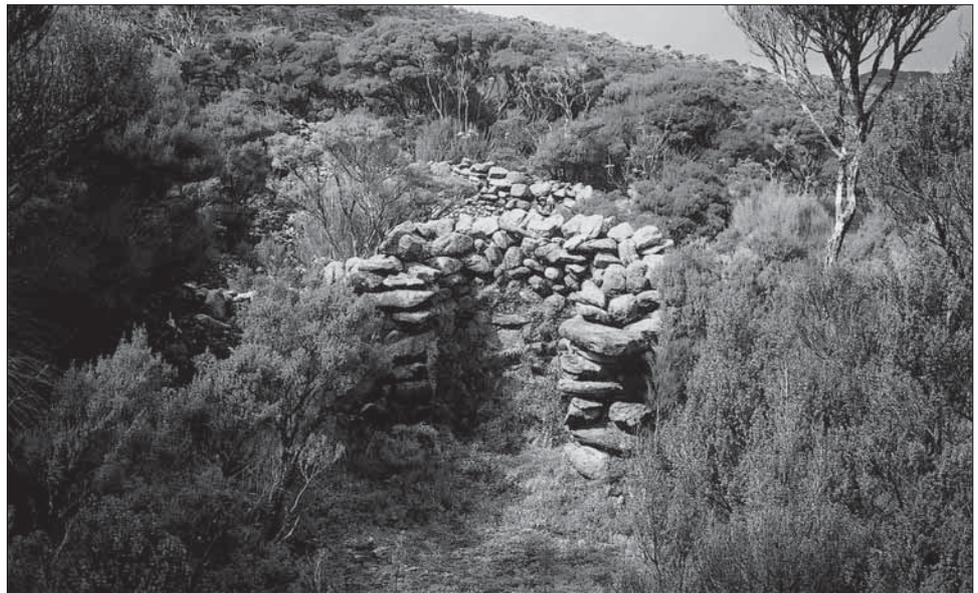
A hut site (Fig. 29) set amongst the alluvial tin workings at D49/69 (Fig. 30). The hut was quite large (6 m × 2.7 m), and its stone chimney extremely substantial. The remaining part of the chimney is 1.9 m tall, 1.8 m deep and 2.5 m wide. The cut terrace that the hut is located on was almost certainly sluiced out (it is not uncommon to find old sluice excavations used as sites for huts).

Figure 29. Stone chimney at hut site (Site D49/68), looking towards the south. *Photo: P. Petchey.*

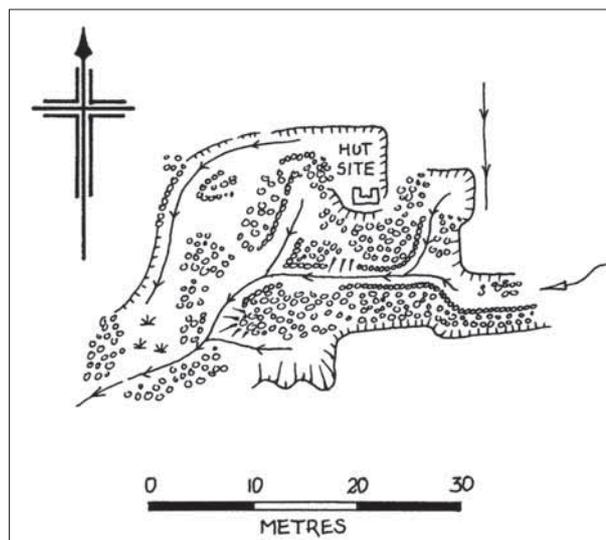
Figure 30. Tin workings (Site D49/69) and hut site (Site D49/68) on western flank of Tin Range.

A set of ground sluicing workings, covering an area of 40 m × 25 m (Figs 30, 31). The hut site D49/68 is set on one side of the workings. There are numerous piles of hand-stacked tailings within the workings, and several of the tailrace branches are revetted.

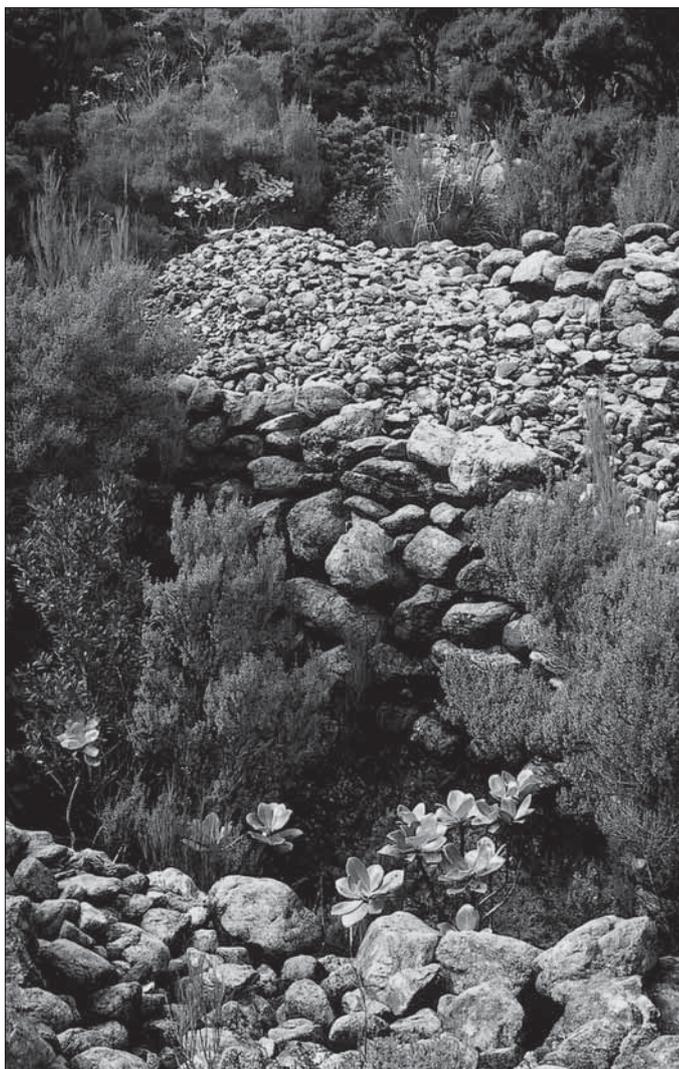
Figure 31. Stacked tailings at Site D49/69. *Photo: P. Petchey.*

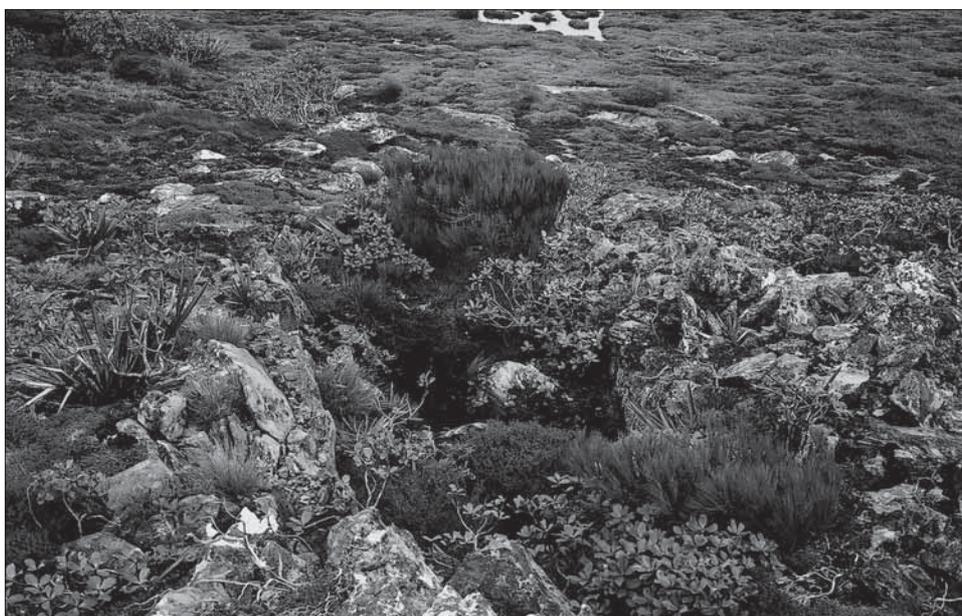
In addition to the sites given individual site record numbers, there are also a number of prospect trenches on the crest of the Tin Range (Fig. 32). Typically, these trenches are shallow (≤ 0.5 m deep, 1-1.5 m wide) and several metres long.

Figure 32. Typical prospect on the summit of the Tin Range. A shallow excavation, with rocks thrown to one side. Looking towards the south.
