6.2.1 Archaeological evidence of the cableway

6.3 MINE SHAFTS

6.4 WINDING HOUSE, NEW MAIN SHAFT

7.1.1 Archaeological evidence of the Phoenix Battery

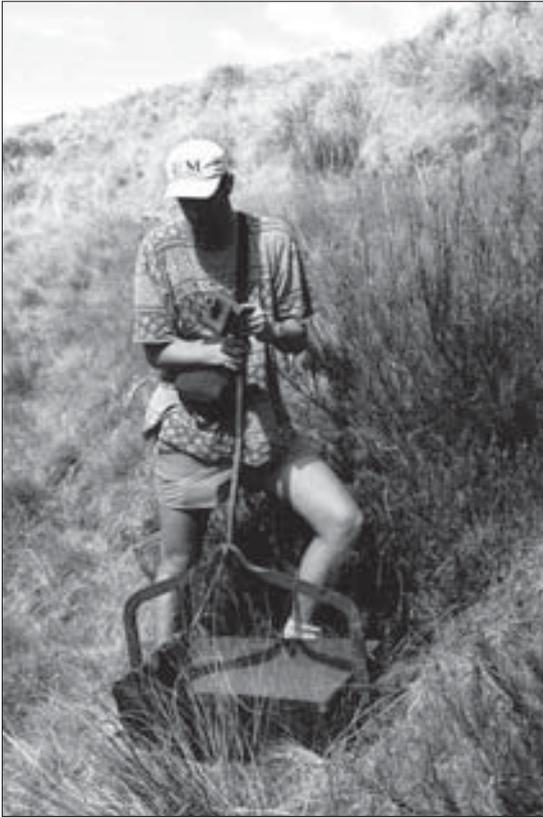
Figure 10. British-American Spur cableway ore bucket and hook assembly (held by A. Braden).
Photo: P. Petchey.

eight ore buckets were found lying in the tussock (Fig. 10). The pylons that supported the cable have also now gone. At the point where the cableway crossed the spur there is a scatter of iron artefacts (bolts, rods etc.), some of which have been wired together.

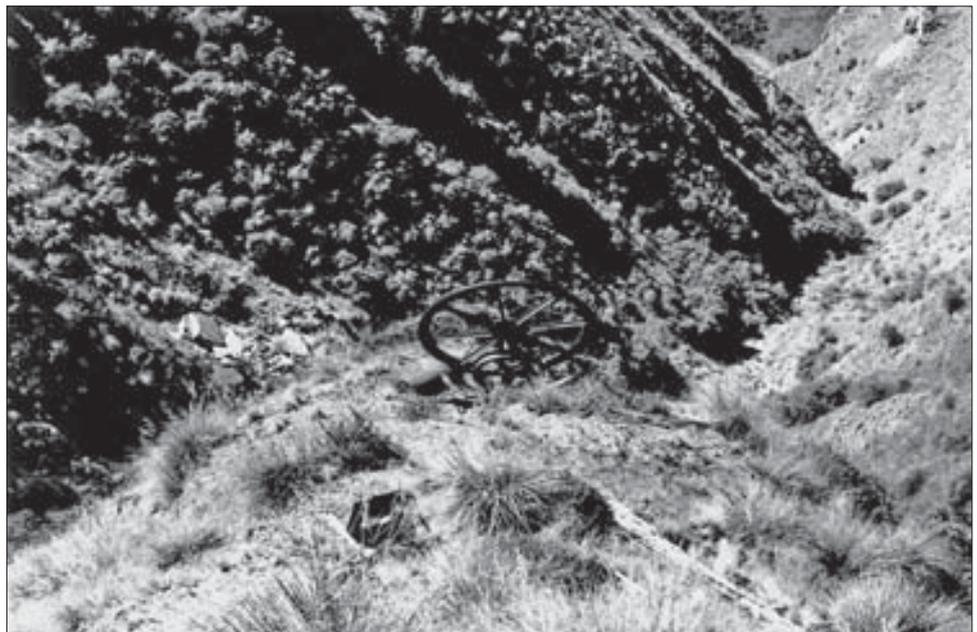
The upper terminal is located on a small spur running into the head of a side gully of Old Man Creek, below the crest of British-American Spur. The upper return wheel is still sitting on the small area of relatively flat ground (Fig. 11), although its timber support frame has long since collapsed. The cast iron wheel itself is in very good condition. It was cast in sections, with the mating faces numbered to aid reassembly. A brake band is attached, to control the speed of the cable as discussed in the contemporary account quoted above. Some other equipment is scattered about, including ore buckets and hangers.

Figure 11. Aerial cableway terminus wheel on British-American Spur, 1996.
Photo: P. Petchey.

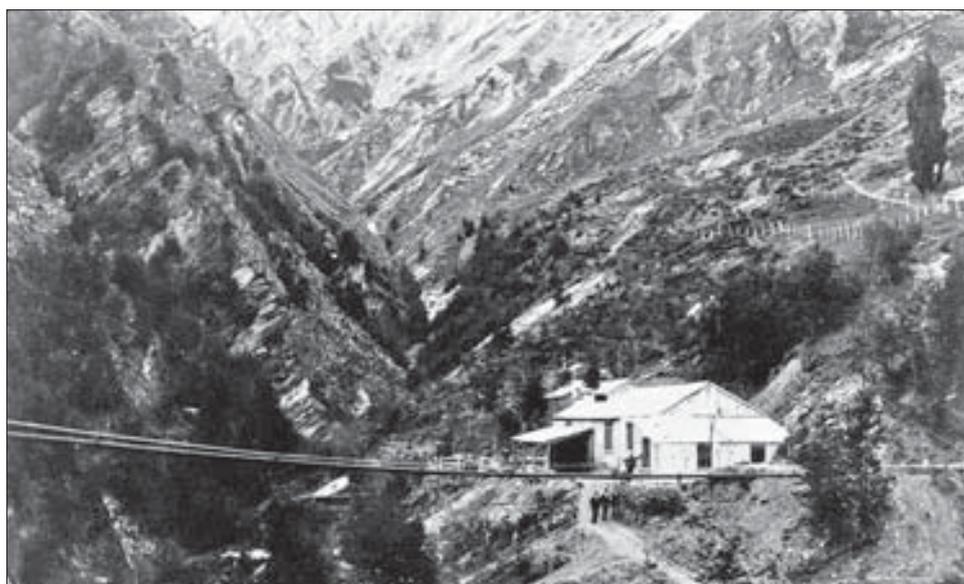
In 1896 the Achilles Company sank a new main incline shaft, dipping north at 45°⁸. It was constructed by sinking from No. 2 Level of the mine to a depth of 117 ft, and then rising from the same level to the surface (AJHR 1896 C3: 108). Double lines of rails were laid, with a stairway down one side. The winding was powered by a Pelton wheel that, presumably, used the same water source as the battery (AJHR 1898 C3A: 61). A corrugated iron shed housed the equipment and covered the shaft mouth (Fig. 12).

Figure 12. New Main Shaft winding house. One of the poplar trees on Bakery Flat is visible to the right.
Photo: Hocken Library.

This site is the best-preserved industrial area at Bullendale, with some major mechanical components remaining in situ (Fig. 13). It consists of a 90 ft × 30 ft (27 m × 9 m) terrace cut into the hillside with a track leading past on the downhill side. To the north the track is level, but only runs for a few hundred metres, and to the south it descends slightly and leads towards the site of the Phoenix Battery. Where the track passed the winding house, contemporary photographs (Fig. 12) show a covered loading area.

above the shaft mouth, as this was an incline shaft. A low lantern-light roof visible in contemporary photographs (see Fig. 12), together with the jumble of surviving timber framing, suggests that a heavy but low timber head frame was constructed on the south side of the incline shaft.

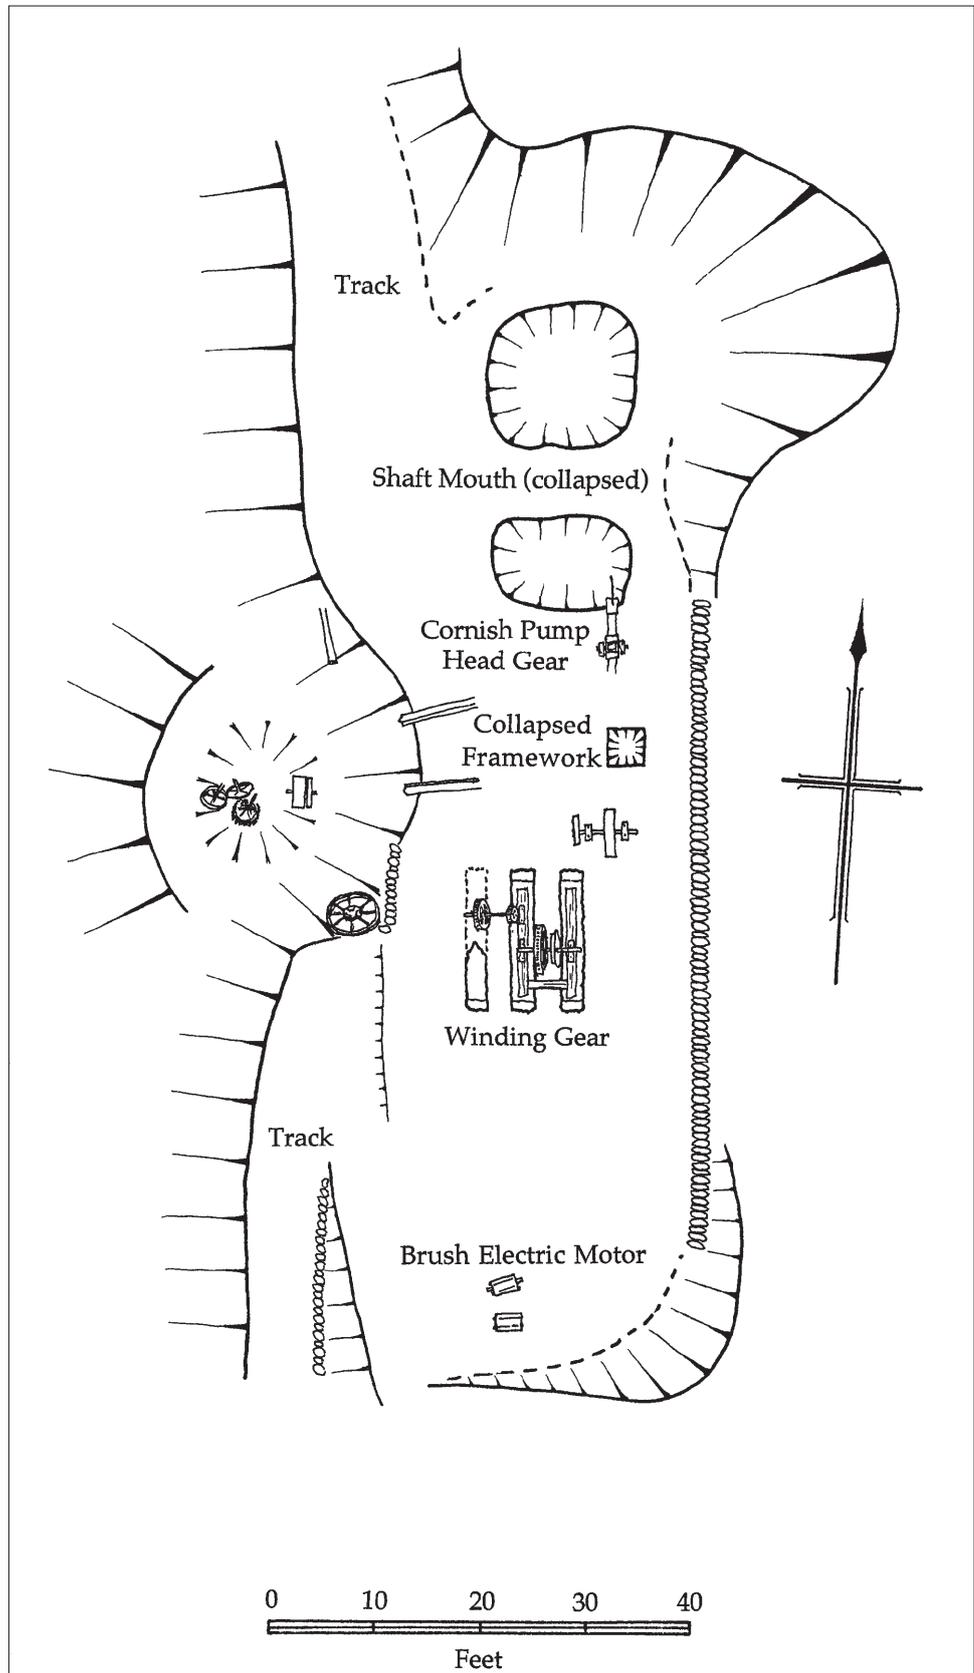
The mouth of the main shaft (now collapsed and blocked) is at the northern end of the terrace. Two large shallow depressions 2 m in diameter probably mark the shaft entrance. In the middle of the terrace, in line with the shaft depression, are the stone foundations for the main winding gear (Fig. 14). These foundations consist of three parallel supporting walls, each 12 ft 6 in long and 3 ft 9 in high (3.8 m long, 1.1 m high). On these walls is a cast iron winding drum and an intermediate drive shaft. These were originally mounted in bearings bolted to timber members along the tops of the support walls, but the timbers are now rotten and the bearings have been stripped to recover the bearing metal. The main winding drum is 6 ft 1 in (1.85 m) in diameter, and is embossed with its maker's name 'Cossens & Black, Dunedin'. No heavy winding cable is to be seen at the site, and it is likely that this was released down the shaft at some time.

Figure 13. Plan of New Main Shaft winding house site, 1996.

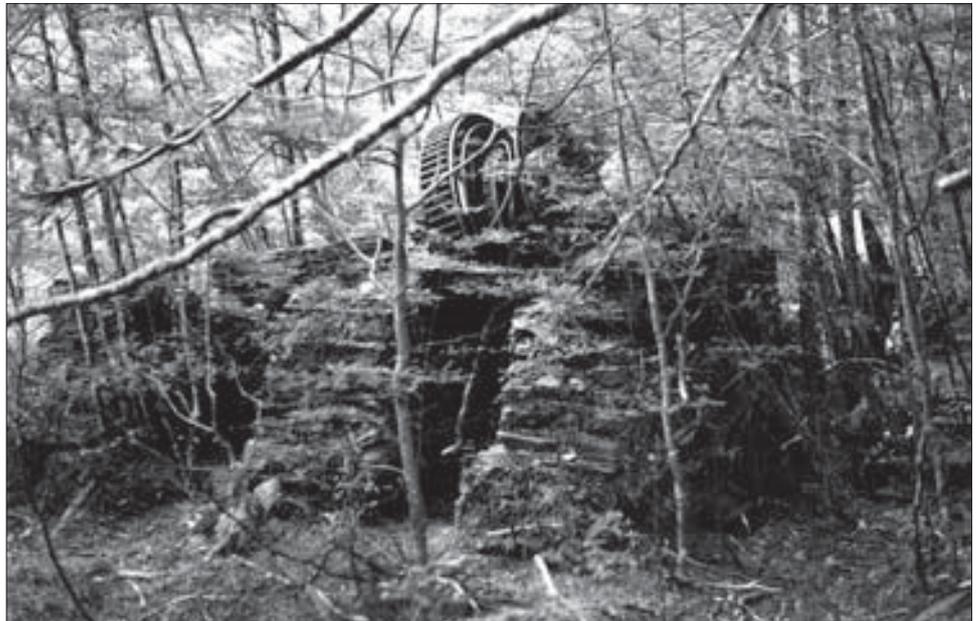
Figure 14. New Main Shaft, 1996. Cossons & Black winding drum and foundations.

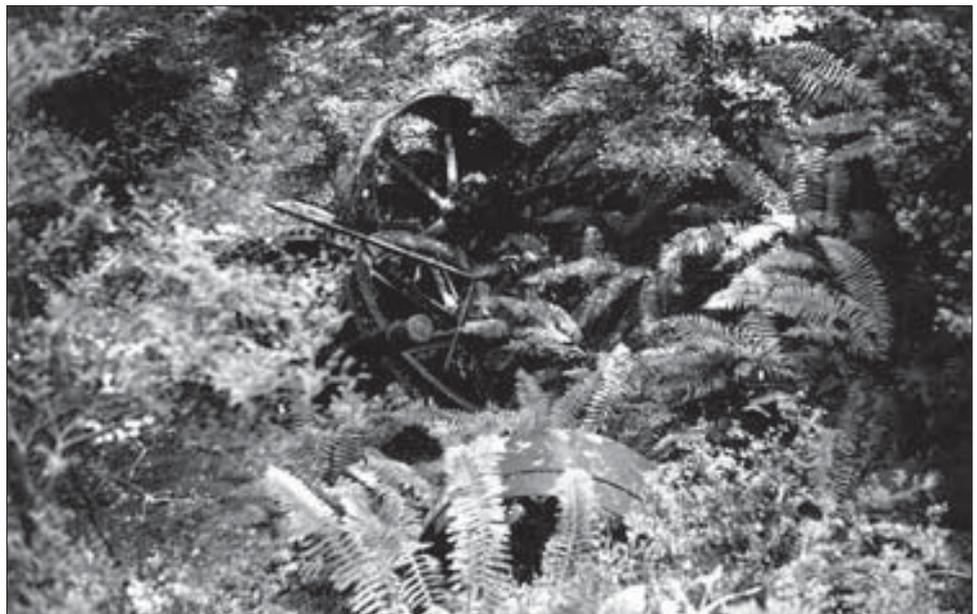
There is also a sizeable depression on the west side of the terrace, into which some winding gear had either collapsed or been dumped (Fig. 15). Subsidence into this depression has damaged some of the stone foundations of the winding gear. This depression was recorded as a collapsed shaft in 1979, but no evidence for such a feature is shown on mine plans found to date. The closest likely feature is 'Neill's Winze' on the Otago Level of the mine (Achilles Mine plan 1900).

Figure 15. New Main Shaft site, 1996. Collapsed winding equipment on west side of terrace.

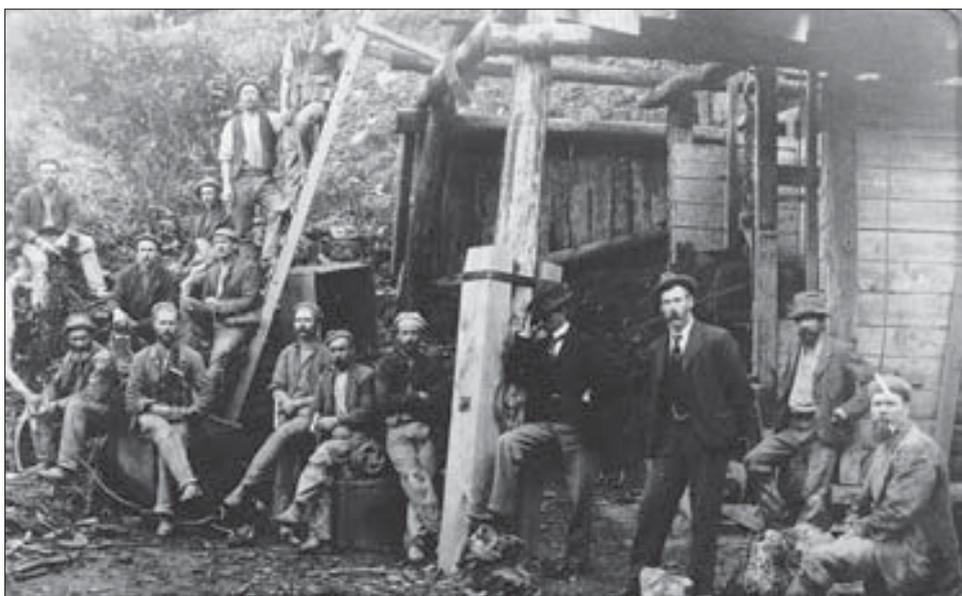
The history of this shaft is hard to determine accurately. It is probably the shaft sunk in 1886 or 1887 by the Phoenix Extended Company after they bought the ground from the Otago Company. The shaft was dug to a depth of 150 ft (46 m), and measured 10 ft 3 in × 3 ft 6 in (3.12 m × 1.07 m). It was divided into three compartments, two for winding and one for ladder access (AJHR 1890 C3: 61). A crosscut dug to the south for 100 ft (30.5 m) was not successful, and the ground was sold to the Phoenix Company, who drove to the north, cutting the lode. Mining operations were then carried on for a period using both this shaft and the New Main Shaft (discussed above, section 6.4). An inclined hauling winze connected the north cross-cut to the lower levels of the mine (Levels 2, 3, 4 and 5). A contemporary photograph of a shaft head at Bullendale (Fig. 16) is possibly of this site.

Figure 16. Murdochs Creek shaft head and mine workers.
Photo: Hocken Library.

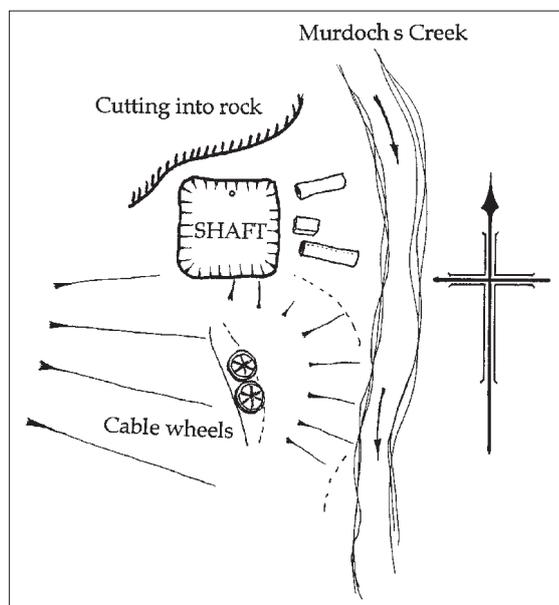
The site of this shaft is on the true right bank of Murdochs Creek, immediately below the site of the New Main Shaft winding house on the hillside opposite (see Figs 8 and 17). A cutting has been made into the side of the creek bank to accommodate the head frame. The shaft is now blocked at a depth of about 2 m. A pipe (possibly a compressed air line) protrudes from the blockage. Two 64-in (1.63-m) diameter cable pulleys are sitting beside the shaft. These would have been mounted on the top of the head frame to guide the main winding cables going down the shaft. A scatter of iron artefacts in the streambed downstream from the site at the time of the survey included the remains of several shaft cages.

Figure 17. Site plan of Murdochs Creek Shaft.

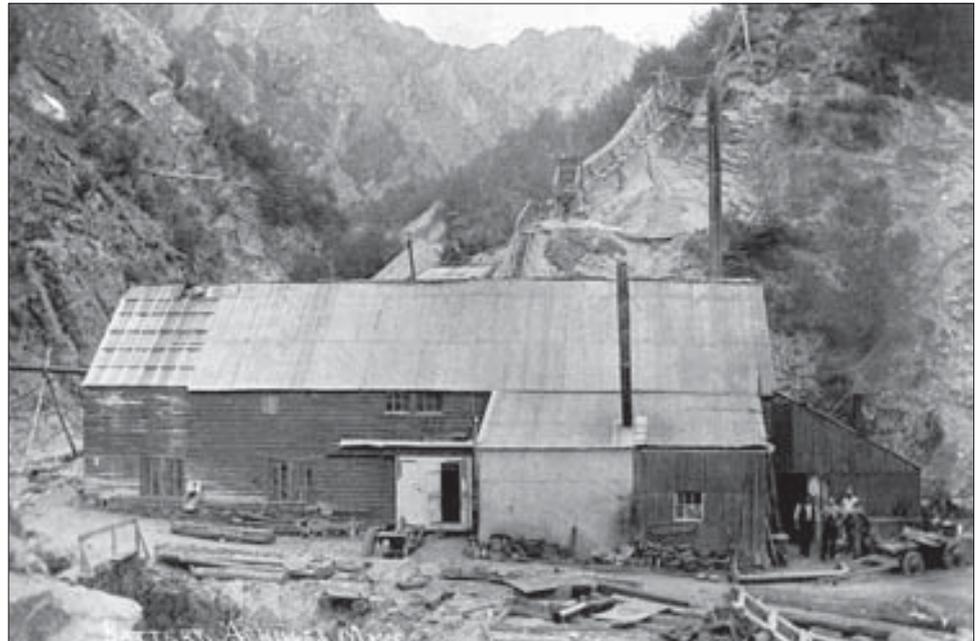
Figure 18. Phoenix (Achilles) Battery, c. 1887.
Photo: Hocken Library.

The Phoenix Battery site is at the confluence of the Right Branch of Skippers Creek and Murdochs Creek. It was recorded as Site S123/140 in 1979 by N. Ritchie. Figure 20 shows the site as it was in 1996, and can be compared with Fig. 18 that shows the battery house in c. 1887. Figure 21 is the site plan as recorded in 1996. As these views show, the site has been badly disturbed. While some of this is due to human agency, most damage to this site has been caused by flooding of Murdochs Creek. A schist spur shields the site from the force of the flood waters from Skippers Creek, but also serves to turn the Murdochs Creek waters across the site. As a result, a channel has been scoured through the

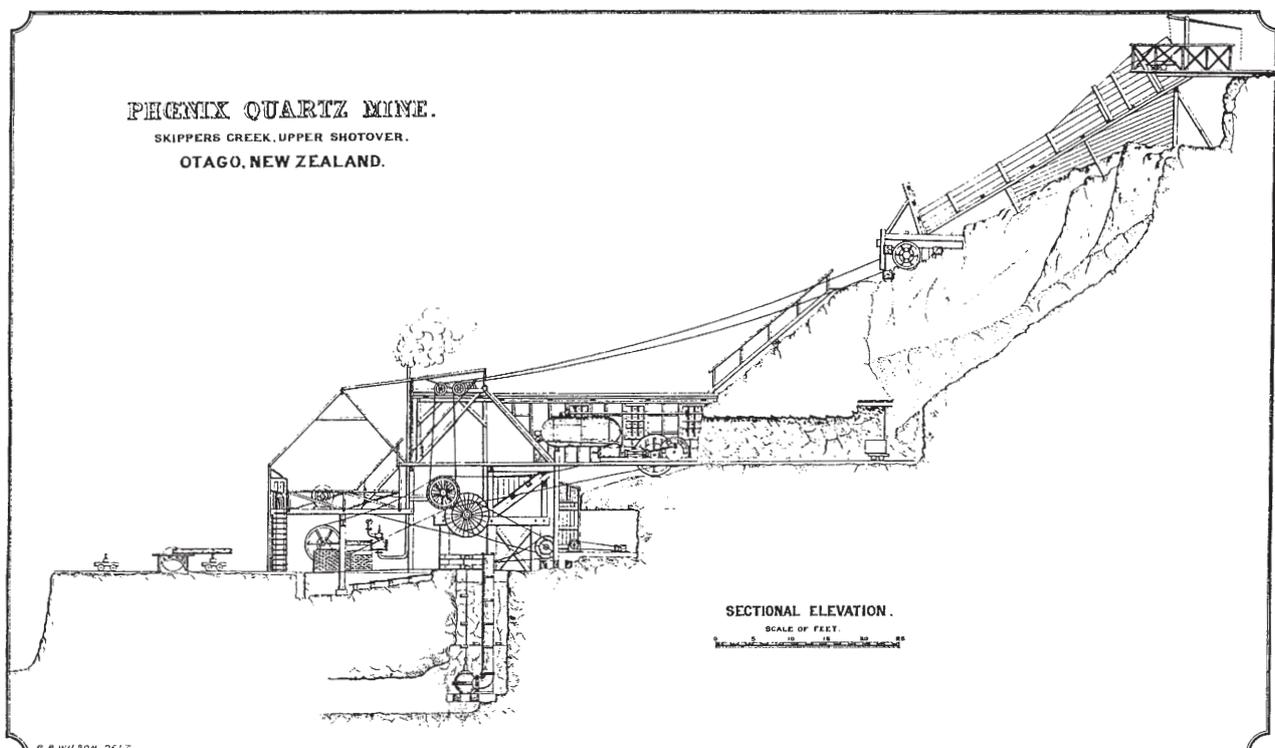
A description of the battery in 1886 reproduced in De La Mare (1993: 26-27) stated that the battery house measured 45 ft × 85 ft (13.7 m × 26 m), with the turbine sunk 20 ft (6 m) below the floor. The 1887 cross-section of the building (Fig. 19) shows that the electric motor and the water turbine were in place at the same time. It also shows a steam engine in use, powering the rock crusher and air compressor (see also Handbook of New Zealand Mines 1887: 54). Contemporary photographs (Fig. 18) show the building as a large timber structure built on a revetted terrace at the junction of Murdochs and Skippers Creeks. A curious roof line and gable end suggests that the building was originally a slightly smaller double-gable structure that was modified and enlarged at least once, with the valley between the original twin ridges being roofed over to increase the internal space.

Figure 19. 1887 elevation of Phoenix Battery.
Illustration: *Handbook of New Zealand mines, 1887.*

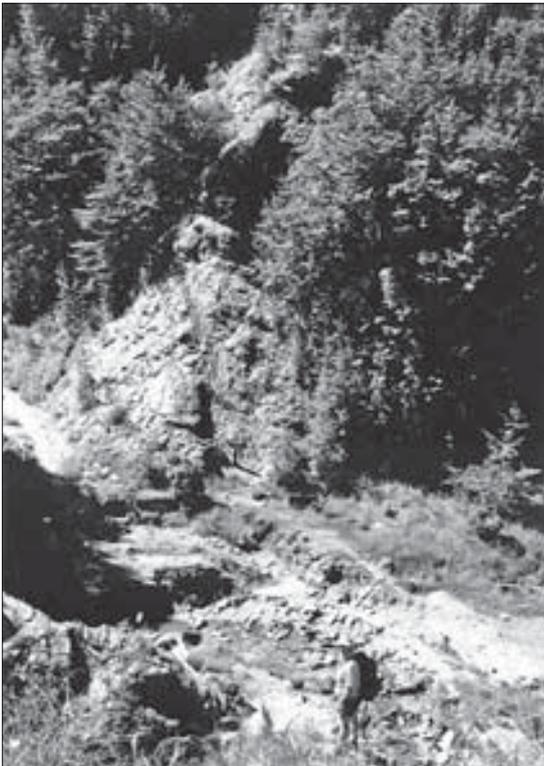
Figure 20. Phoenix Battery Site. Rockcrusher is on knob in upper centre of view. Fallen stampers and flood damage visible on flat. Note items of machinery lying in creek. (B. Ahern, now deceased, but formerly with DOC Queenstown, in foreground.)
Photo: P. Petchey.

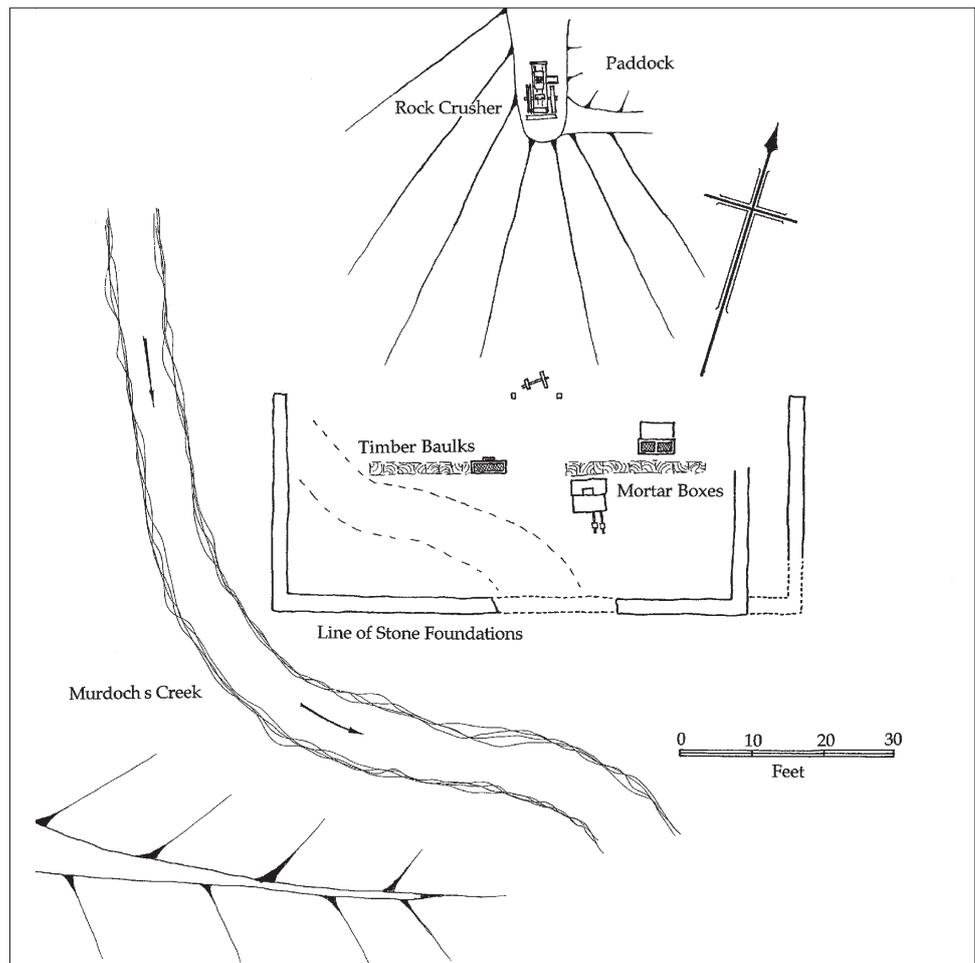
site of the battery house, although the schist foundations for the building remain relatively intact. They measure 65 ft 6 in × 31 ft (20 m × 9.5 m), and are 28 in (0.7 m) wide. While this is smaller than the 85 ft × 45 ft quoted in De La Mare, this may be due to the full extent of the foundations no longer being visible, particularly at the back of the site where material has slipped from the slope above. Alternatively, the figures given by De La Mare may refer to an enlarged battery house that extended beyond the original foundations. The wall foundations only just stand proud of the present ground surface, but a section exposed where the stream has cut through shows them to be some 4 ft (1.2 m) in depth.

At the back of the battery house, against the foot of the hillside, there are the decayed timber baulks for a 30-stamp mill. Only one iron mortar box is still standing on these, while two others lie fallen, one containing two stamper shafts. One mortar box measured 62 in × 16 in × 53 in high (1.57 m × 0.40 m × 1.35 m). They were constructed with cast iron bases, and sheet iron upper halves, so they could be dismantled for the haul into Bullendale¹². In the centre of the stamper foundations is a gap, behind which are two charred posts standing in the schist scree from above. Between these posts lie (partially buried) two belt pulleys on a shaft. The well for the water turbine that was located in the gap between the two banks of stamps has filled with debris and is not apparent. Several turbine rotors

Figure 21. Plan of Phoenix Battery site.

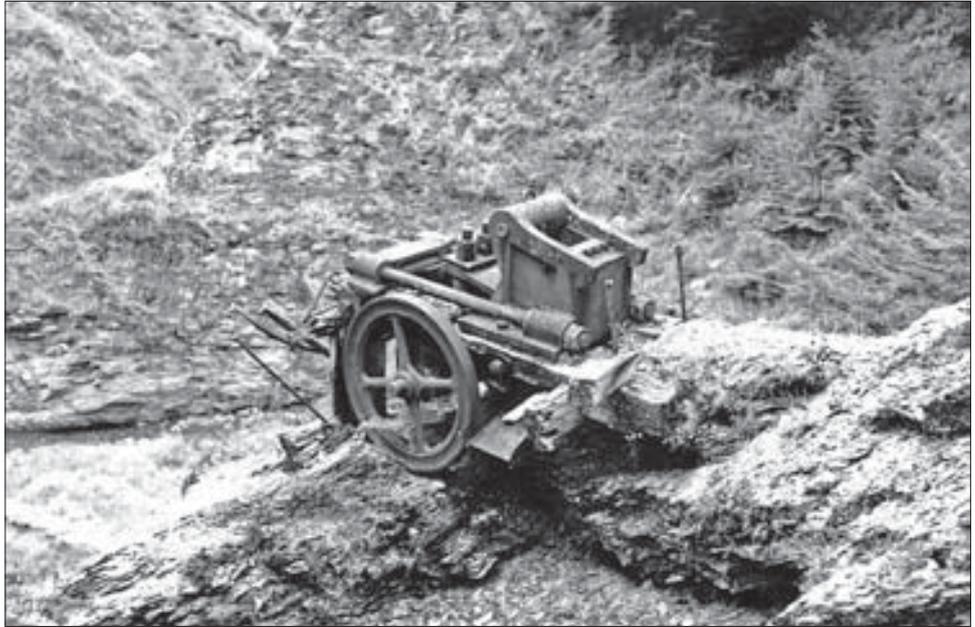
On a schist knob above the battery, sits the Kincaid & McQueen rockcrusher that was installed in 1886 (Fig. 22)¹³. It is still in good condition and reasonably intact, although several pieces have gone missing in recent years. However, its timber supporting frame has decayed, and the unit is sitting at an angle, supported on one side by its flywheel resting on the schist spur. Between the crusher and the battery site was the paddock for the ore, from which material was fed to the stampers via an ore pass (see Fig. 19). This ore pass has either collapsed or is full of loose material, and cannot now be located. The end of the tramway that supplied the crusher has largely slipped away. Nothing remains of the ore chute or tipper mechanism for the ore carts.

Figure 22. Kincaid & McQueen rockcrusher. Note decayed support timbers.
Photo: P. Petchey.
