# FULL INCIDENT INVESTIGATION SUBJECT TO LEGAL PRIVILEGE

1. PARTICULARS OF INCIDENT / NEAR MISS		
Title of Incident: ICAM 1187943 Whanganui River Boat Incident		Risk Manager Incident No. 1187943
Reporting Line: Operations		
Accountable Manager: [REDACTED]		Safety Plan No. (Whanganui Vessels 7877)
Date of Incident 18/11/2020	Time: 10am (approx.)	Location Whanganui River, Pipiriki

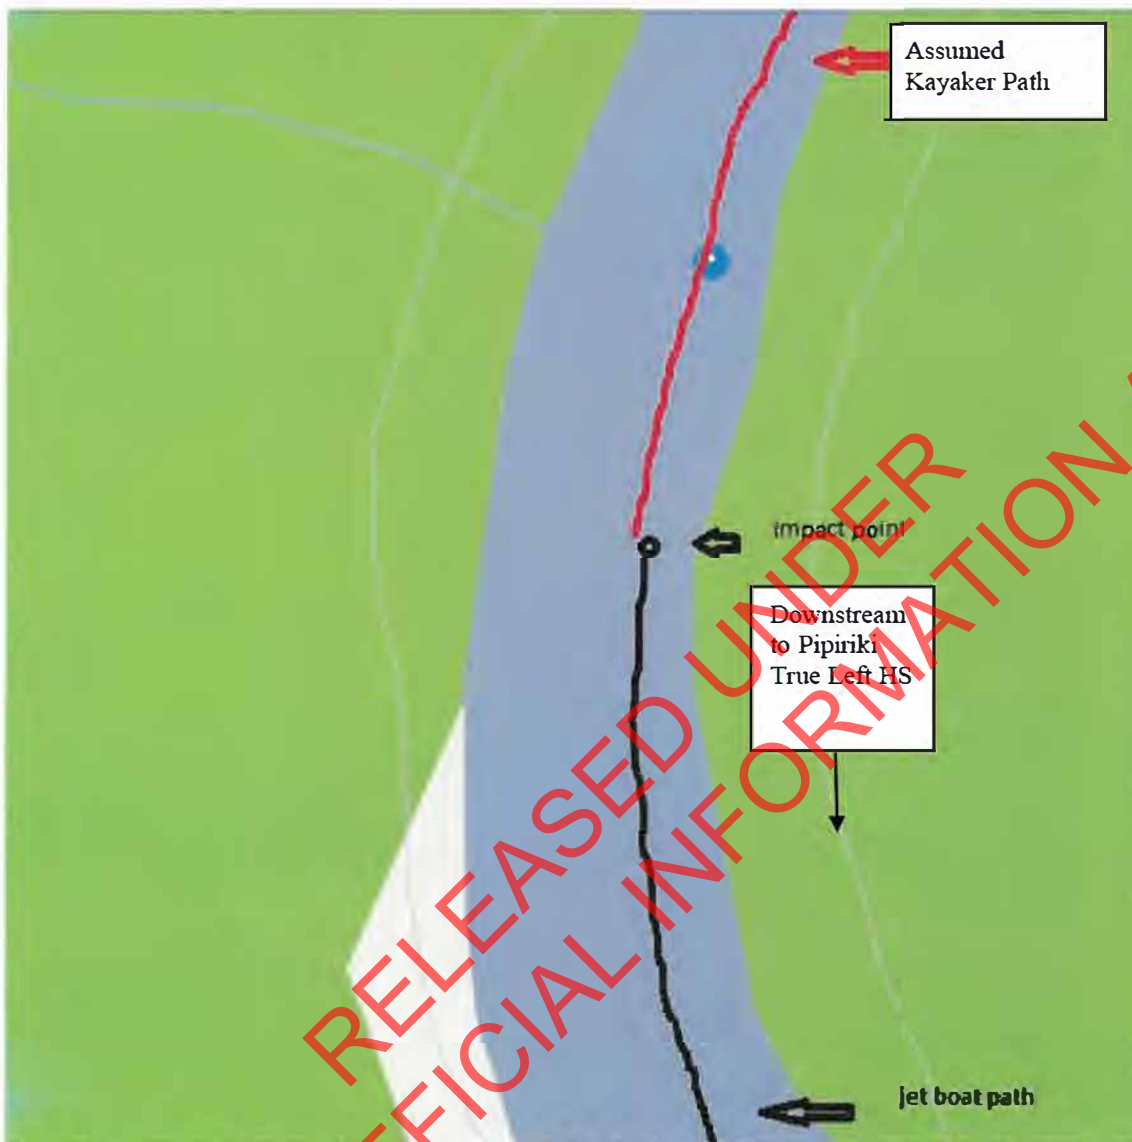
Figure 1: Skipper drawing showing jet boat path on the Whanganui river and the location of impact. The kayak Path is shown in red and is an assumption of the Skipper.

At the same time the skipper on the DOC jet boat was travelling upstream and was wearing tinted safety glasses that had fogged up in the heavy rain. The skipper momentarily removed his glasses to clear them with his fingers to improve his visibility on the river and looked down. The DOC non-passenger member sitting next the skipper was hunched over sheltering from the rain. The skipper returned his vision to the helm of the vessel and it was at this point that the skipper and non-passenger member both heard a thump on the starboard (right) side of the jet boat. They turned around to see the kayaker swimming towards his kayak in the river. The skipper stated that he did not expect to see another kayaker on true left-hand side of the river at that location and at that early time of day.

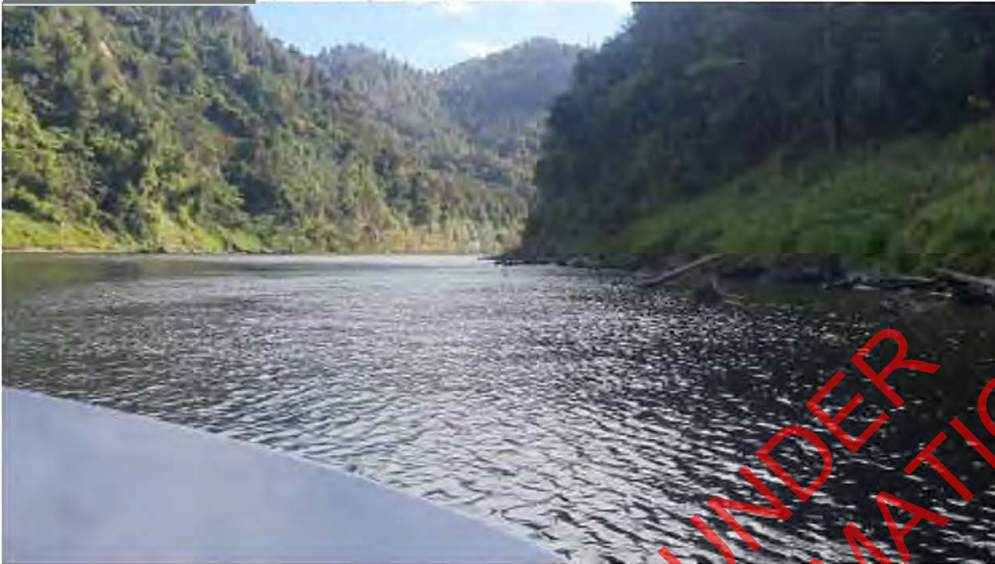
Photo 1: Photo showing the approach to the river corner on the true left-hand side of the bank during fine weather (January 2021)

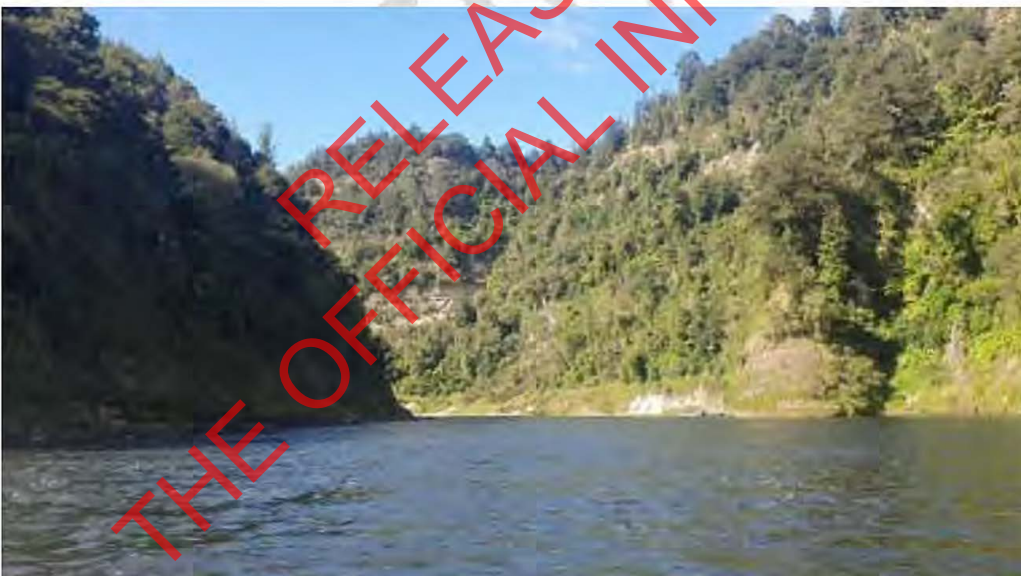
Photo 2: The accident site on the river. (Note weather conditions clear in the photos and not representative of the rain on 18 November 2020) Looking downstream. Accident site to left of photo.

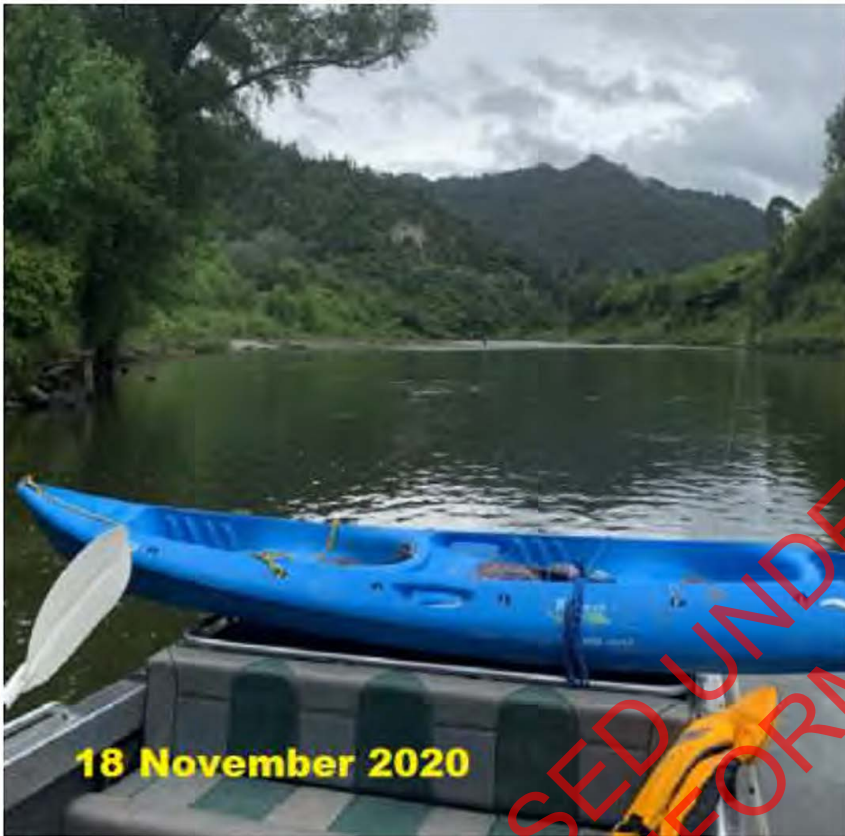
18 November 2020

Photo 3: River flow and overcast weather on the day of the incident: approximately 1.5 hours after the incident occurred.

Whanganui District operates vessels on the river often in variable weather conditions. River flows can change within this large catchment but were relatively low on the day of the incident with sporadic heavy rainfall. This is a common weather pattern for the river.

There are currently no limited operating limits regarding flow (cumecs or metres) or weather with too much discretion on the Skipper to determine safe operating limits. (See Appendix A which shows weather conditions and flow height)

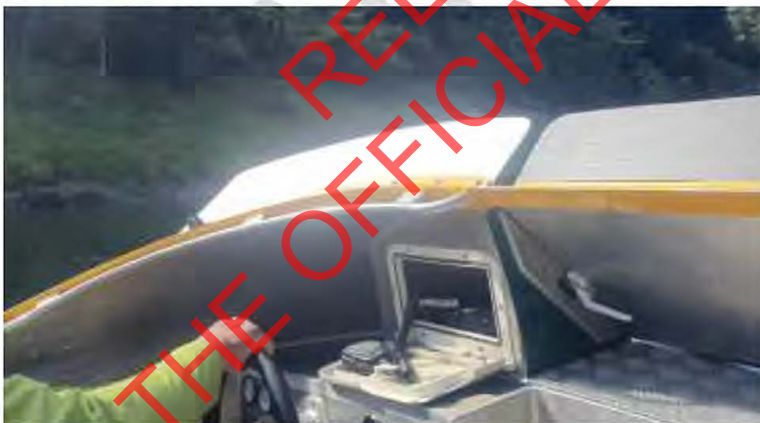
All jet boats for the District including Wawahia are regularly serviced and were modified approximately 12 months before the incident. The wind deflectors that the boat came with from factory were originally made from clear perspex. These were removed after being damaged and replaced by deflectors made of aluminium to deflect sand from the bow. These performed in a similar manner and were more robust but unfortunately restricted the drivers forward visibility over the front windscreen and bow of the boat as they were not see-through (see Appendix A, photograph 4).

Photo 4: Modified metal wind deflectors to replace see through Perspex ones.

- Boat modification to the seat of Wawahia and Paparoa to improve visibility across the bow of the boat.
- Active Supervision of staff and vessels at Pipiriki.
