Heritage Assessment Puhipuhi Mercury Mine

Maria Butcher
January 2011

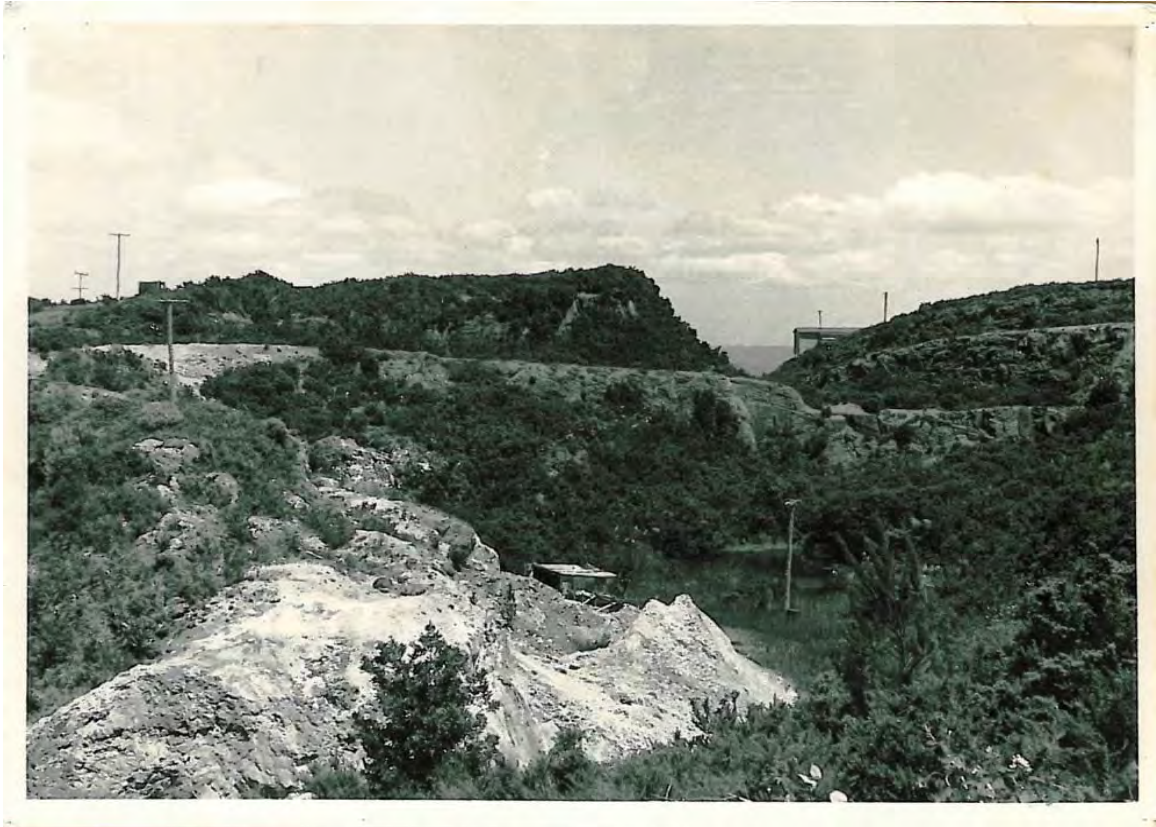
Figure 1: The quarry in the 1970s. Photo courtesy of the Whangarei Library.

To state the obvious, the first stage of the process was to extract the mercury ore from the quarry (figure 1). A photo from the *Northern Advocate*²⁷ shows a digger, a bulldozer, two trucks and a tram in operation. The trucks were used to transport the ore to the processing plant, and the tram was used to transport the overburden to the tip site (see figure 3). The tip area was a natural gully, and the landscape has been altered by tram loads of overburden. The quarry today is more overgrown than it appears in figure 1, although the power poll at the bottom is still visible. The roads on the property are covered in regenerating natives and in gorse, although the benching is clearly apparent. The route of the railway line can be followed as it ran alongside the lake, and to the east of the dam the railway tracks are still in place. Towards the end of the line there are two parallel sets of tracks which connect to each other via a pair of railway switches. This may have been in the vicinity of the engine shed (see figure 3) although no traces of this building were noted.

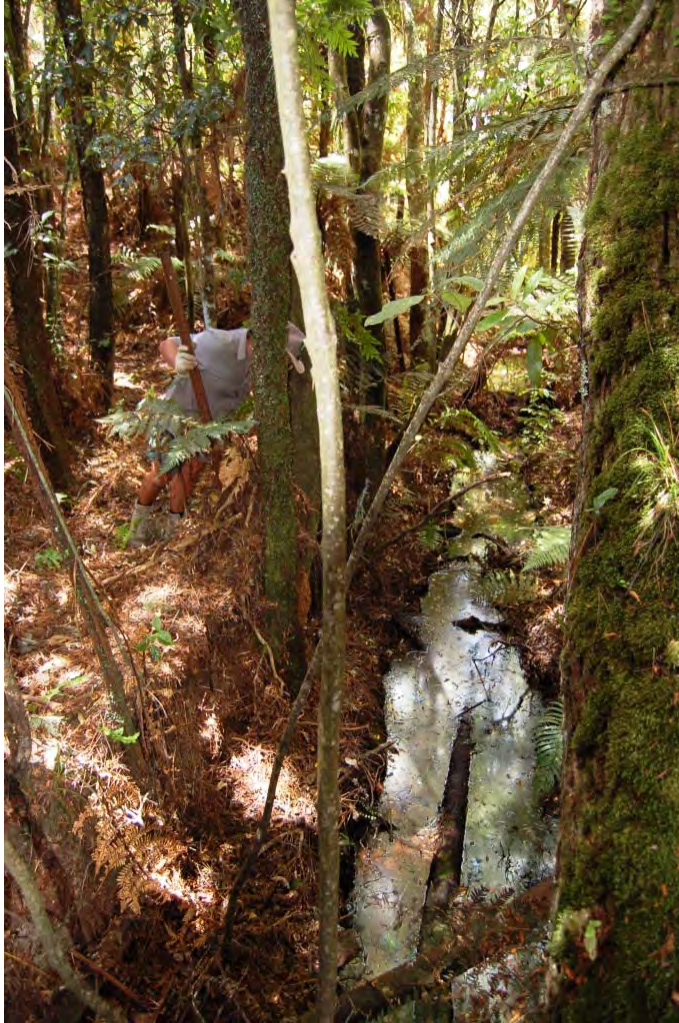
Figure 2: Looking down the channel below the dam, note that the iron pipe continues for some distance down the stream (left); the culvert and pipe set into the bottom of the dam (below).

Water was of utmost importance for extracting elemental mercury from its ore, as explained below. Messrs Miller and Armstead spent £2 000 constructing a dam in the Waikiore Stream to secure a water supply for their venture²⁸. The dam, approximately four metres high on the down stream side, is a constructed of earth and stone. An iron culvert is set into the base of the dam, and through it runs a narrow iron pipe (figure 2). Below the dam the natural stream bed has been altered to form a channel with a regular rectangular cross section.

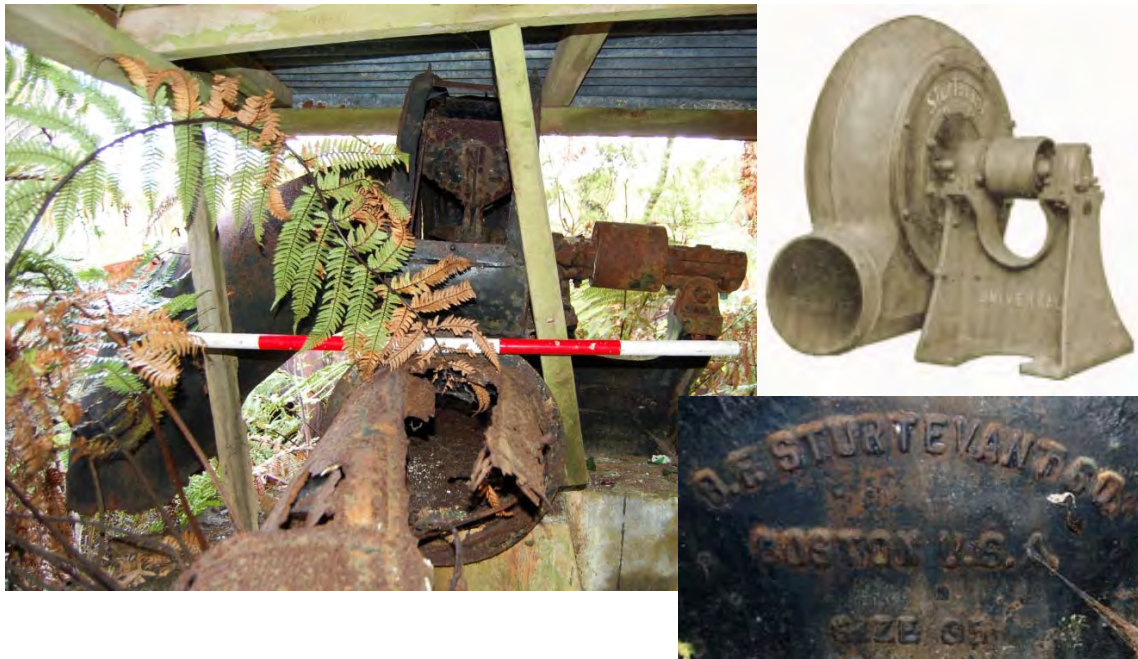
Figure 5: cast iron Sturtevant fan under rough corrugated iron roof. “Monogram” model, manufactured in the 1920s – 1940s. A large volume fan, adapted for exhausting smoke fumes and gasses from engine-rooms, laboratories and kitchens (see B. F. Sturtevant, n.d., and also www.sturtevantfan.com).

A. Exhauster/fan. An electric belt-driven exhaust fan, manufactured by B. F. Sturtevant Co. of Boston, “America’s first and most innovative fan company³²”. The fan is mounted on a concrete platform, with a roughly constructed wooden and corrugated iron roof. It connects to a vertical “chimney” c. 0.6m diameter and c. 5 metres high. A canvas belt (8 cm wide) is present. The fan connected to the pair of tanks below (B), apparently to vent gaseous bi-products of the mercury extraction process (?).

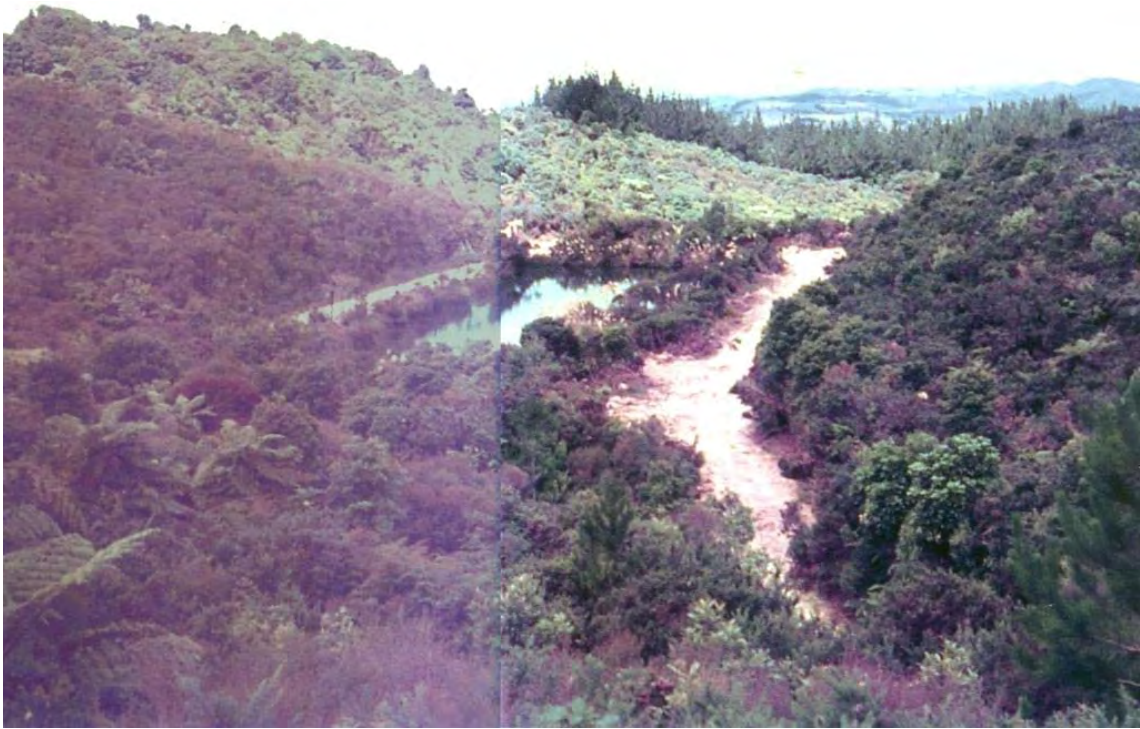
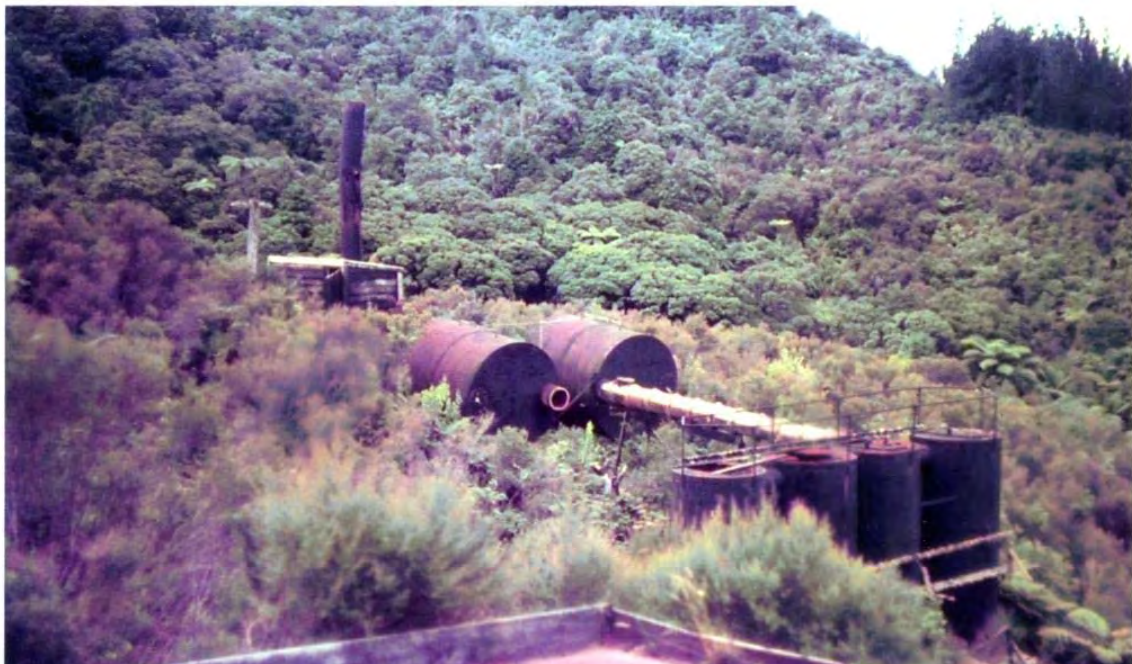
B. Tanks. A pair of drum-shaped metal tanks, mounted on their sides; 3 m diameter and 3 m long. Footed on wooden sleepers. Internal baffle made of bricks with small “window”. Intake pipes (c. 60 cm diameter) connected to the towers (C), and outlets connected to exhauster (A). Apparently used for containing gaseous bi-products of mercury extraction process.

Figure 6: Above: Looking east across the lake in 1968; the dam is in the middle ground, and the roads flanking the lake are clearly visible (see figure 3). Below: Looking north at the towers (bottom right), the tanks, and the building which housed the fan/exhauster.

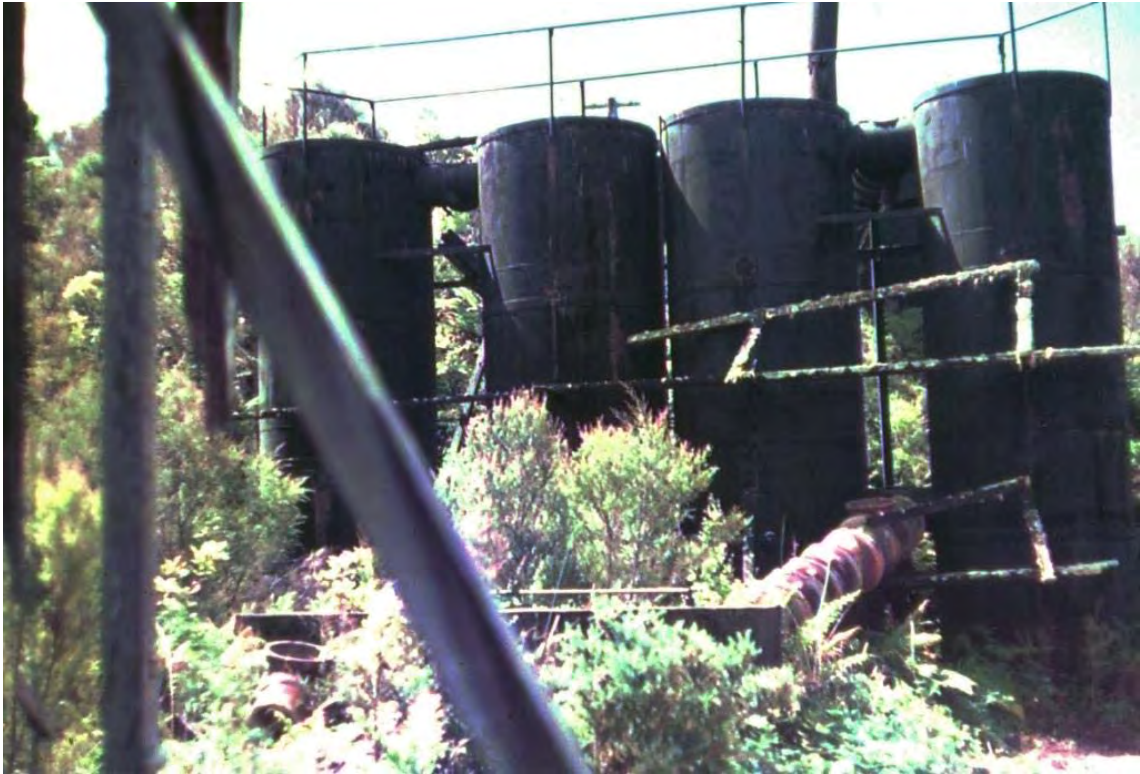
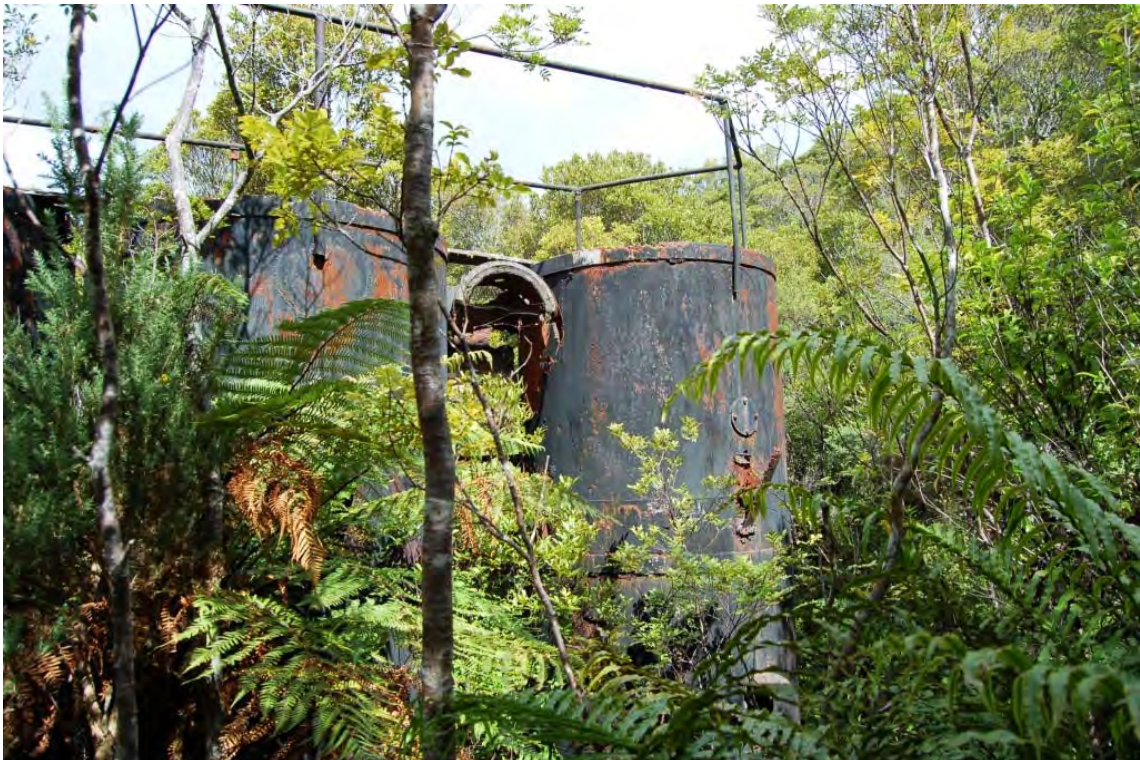
C. Towers. Four metal “towers” approximately 12 metres high, with round cross-sections, approx. 3m diameter. Each tower has an internal “funnel” structure. The funnels feed into a system of narrow pipes at the bottom of the tower structures. The towers are paired, each pair connected with a shared input pipe and shared output pipe (c. 60 – 80 cm diameter). Due to the sloping topography, the output pipes are at the same level as the input pipes of the tanks above (B). The pipes which fed the towers were connected with the cooling system by way of a concrete structure (D) described below. Function: final stage of separating the liquid mercury from waste gasses (?)

Figure 7: Towers. Above: Southern aspect of towers in 1968. Note handrail around the top and large inlet pipes connected to the “exchange” by way of terracotta pipes. Photo from the collection of Anne and Brian Reed. Below: Northern aspect of towers inn April 2010. Note the large “outlet” pipe.

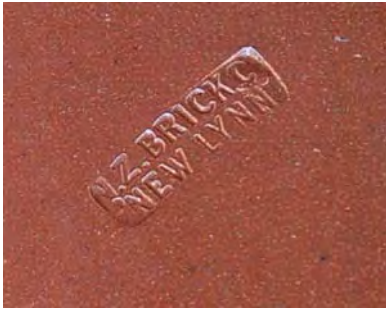
Figure 8a: Pipe Battery. Above: the stamp on the side of a fragment of pipe remaining on the site today. Below: The pipe battery in 1968. The structure is evidence today by a series of low concrete troughs, visible below.

E. Pipe battery (remains). Ten low concrete troughs, each 1.2 x 3.6 m, and 0.7 m apart. Height: 0.5 m. The base of the “pipe battery”, a complex vertical arrangement of terracotta pipes set into cooling troughs of water. Broken terracotta pipes present on the site, some stamped with the name of the manufacturer (figure 8a and 8b).

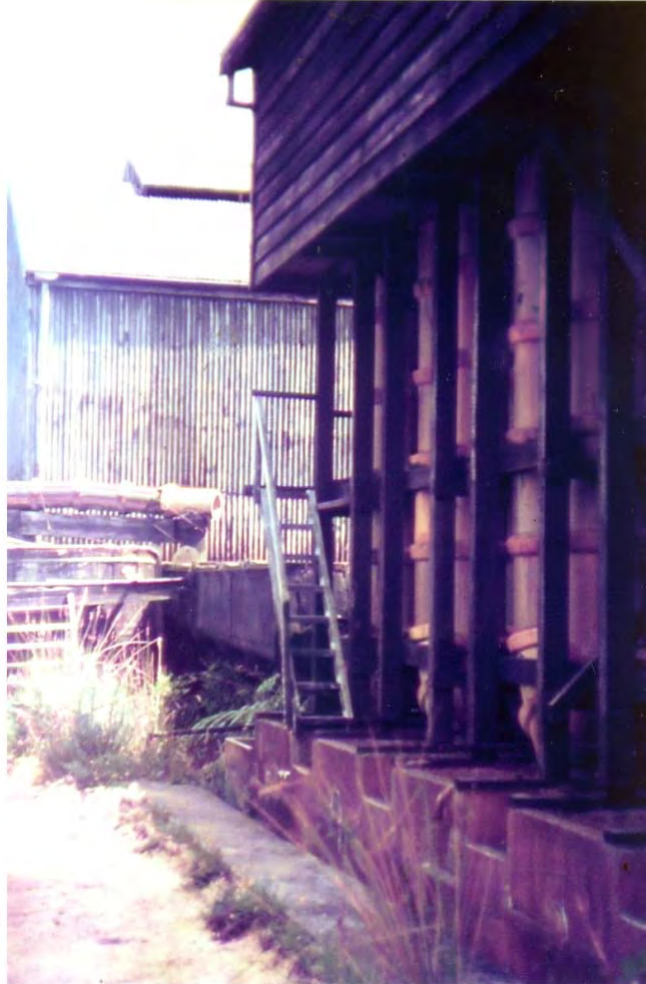
Figure 8b: The Pipe Battery in 1968. Evidenced today by a series of low concrete troughs, visible at the bottom of this photo. This photo was taken facing the south, looking back at the corrugated iron building which housed the furnace. The “cooling trough” (G) is visible behind the ladder.

G. Cooling trough and pipes. Re-enforced metal trough, rectangular, 5.4 m wide by about 10 m long. Supported underneath by substantial concrete and timber structure. Trough contains five horizontal metal pipes, which fed directly into terracotta pipes of the pipe battery. Sturdy nature of trough and evidence of plumbing underneath indicates it was filled with water. The initial stage of the cooling process, whereby the mercury vapour passed through the horizontal pipes set in water and fed into the pipe battery.

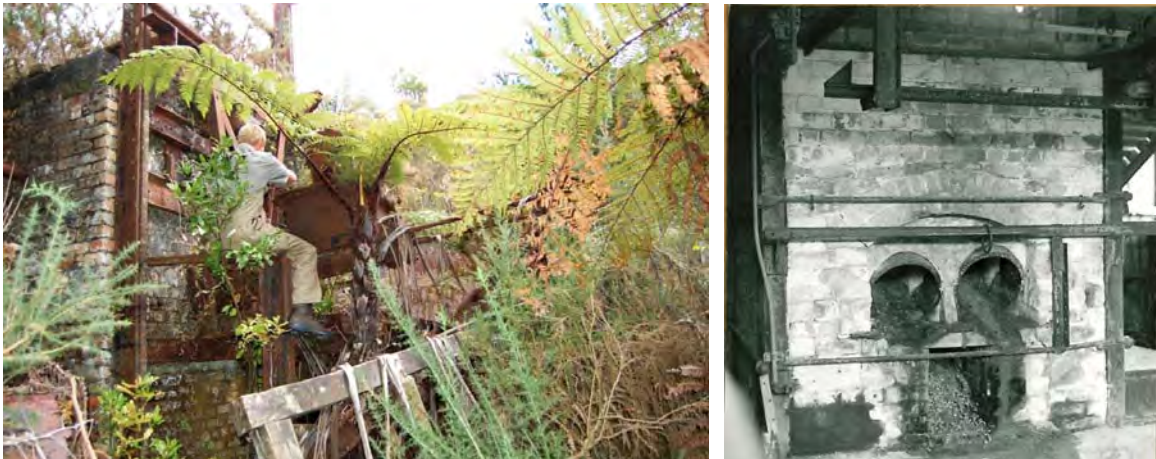
H. Furnace (part of). Brick furnace, approx. 3 m x 2.5 m x 4 m high. Façade shown in figure 9b is missing.

J. Mechanical structure. Complex metal structure attached to back of furnace (figure 9a). (Part of machinery to rotate inner chamber of furnace?)

Figure 9a: Left: rear view of the furnace and associated metal structures. Right: front of furnace as it appeared in the 1970s; the façade and associated building no longer exist. Photo courtesy of the Whangarei Library.

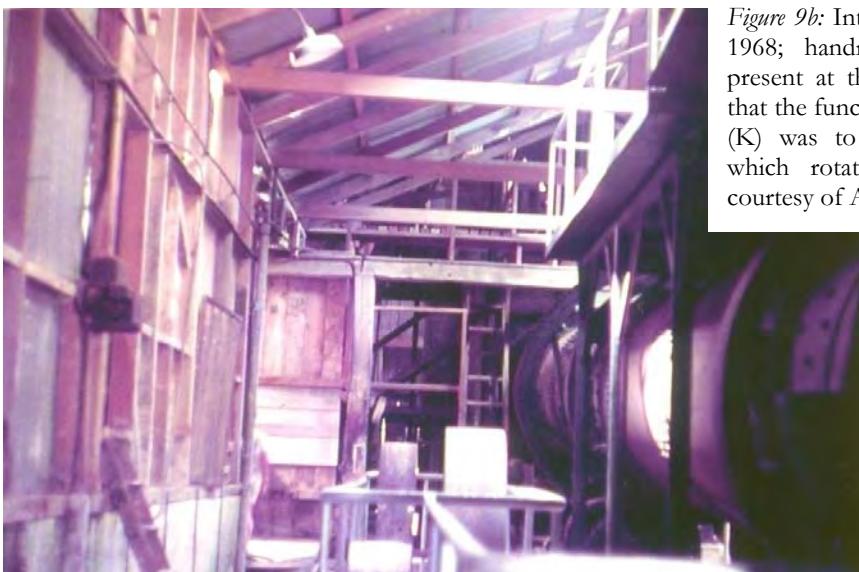
K. Channel. Concrete channel set into ground, c. 1 m wide and 6 m long. Based upon a historic photograph, the channel accommodated the wheels relating to the rotating function of the furnace.

L. Handrail. Metal handrail, related to concrete channel (K.).

Figure 9b: Interior of furnace building in 1968; handrail visible in foreground present at the site today; photo shows that the function of the concrete channel (K) was to accommodate the wheels which rotated the furnace. Photo: courtesy of Anne and Brian Reed.

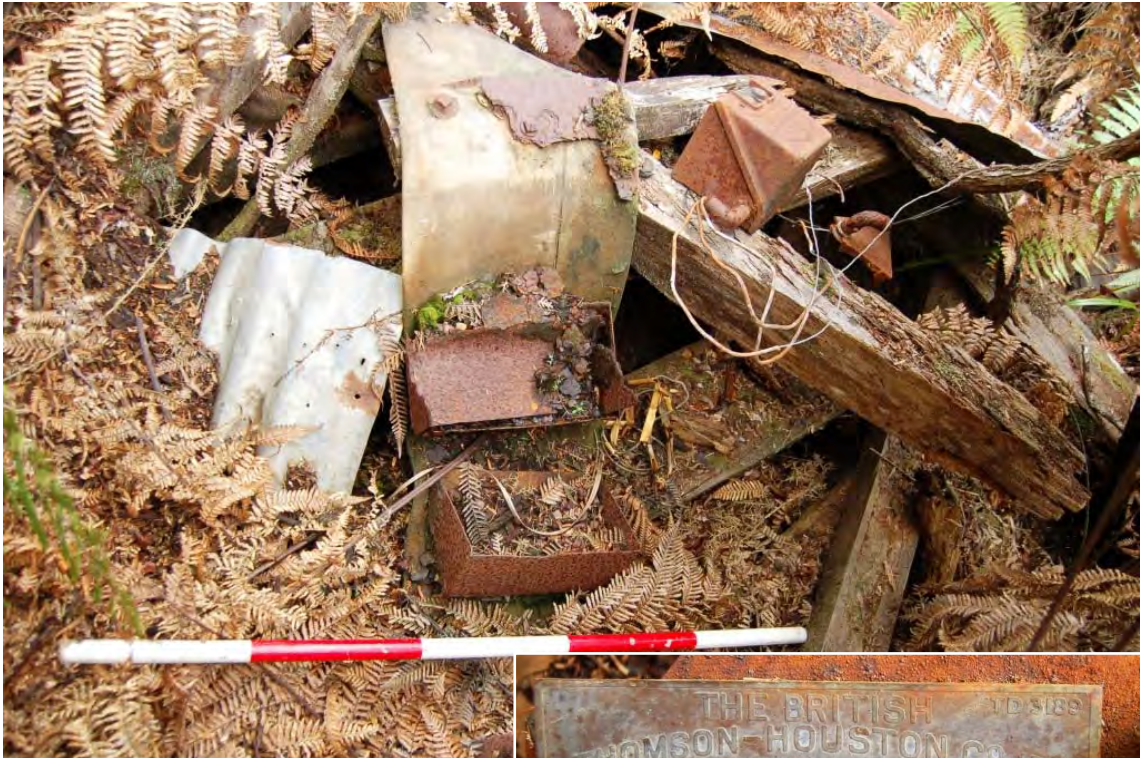
I. Conveyor belt system. For lifting crushed ore to the top of the furnace. Steeply angled wooden tracks, and wide canvas belt with metal scoops attached (see figure 10).

Figure 10: Above: debris in the vicinity of the furnace including canvas conveyor belt with metal scoops attached, for lifting ore to top of furnace. Left: plaque attached to electrical component in the same vicinity.

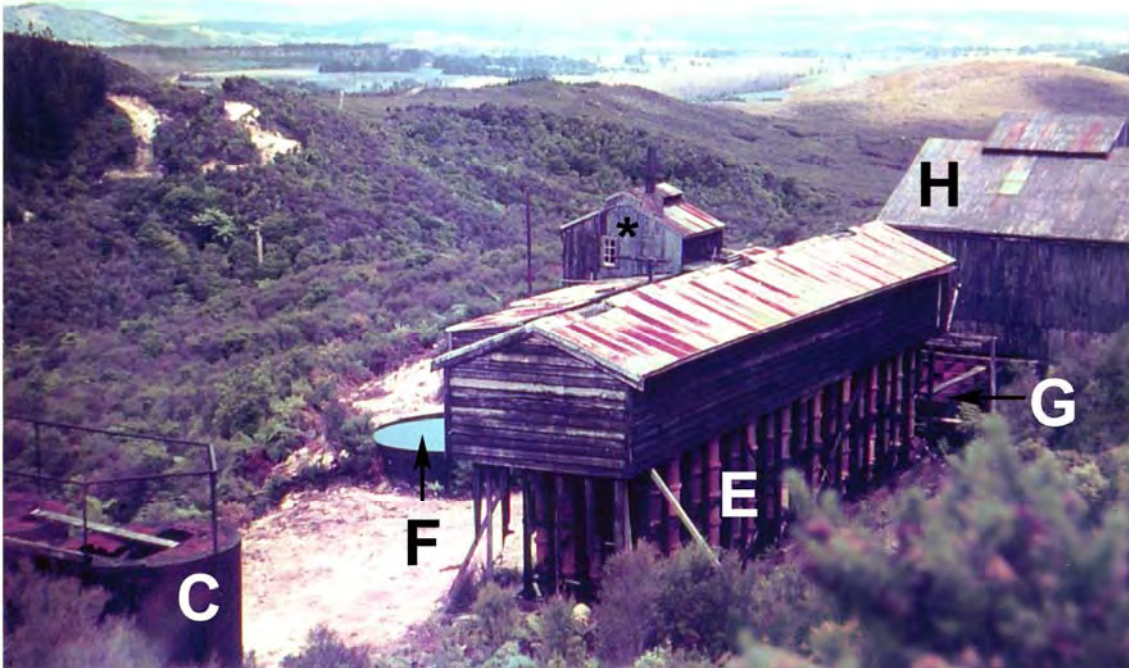
Figure 11: Photo of the processing plant taken in the 1968, with main components labelled. Letters relate to sketch plan of site (figure 4). None of the buildings are still standing. No trace of the building marked with an asterisk is evident at the site today. Photo from the collection of Brian and Anne Reed.

NZMM Ltd did a poor job of cleaning up the site when it was finally abandoned. Therefore, the fabric of the processing plant is more complete than one might expect. The ore-crushing equipment is notably absent, but it is clear that it was positioned between the chute (M.) and the conveyor belt (I.). The crusher may have been worth salvaging, since, unlike the bulk of the equipment, it would be of use for other applications. It is clear from historic photos that the furnace and all the associated equipment was housed in a large shed, which would have accommodated the crushing and drying of the ore. Rubble from this structure, including corrugated iron and timber, is present. The same is true of the other buildings, seen standing in figure 11.

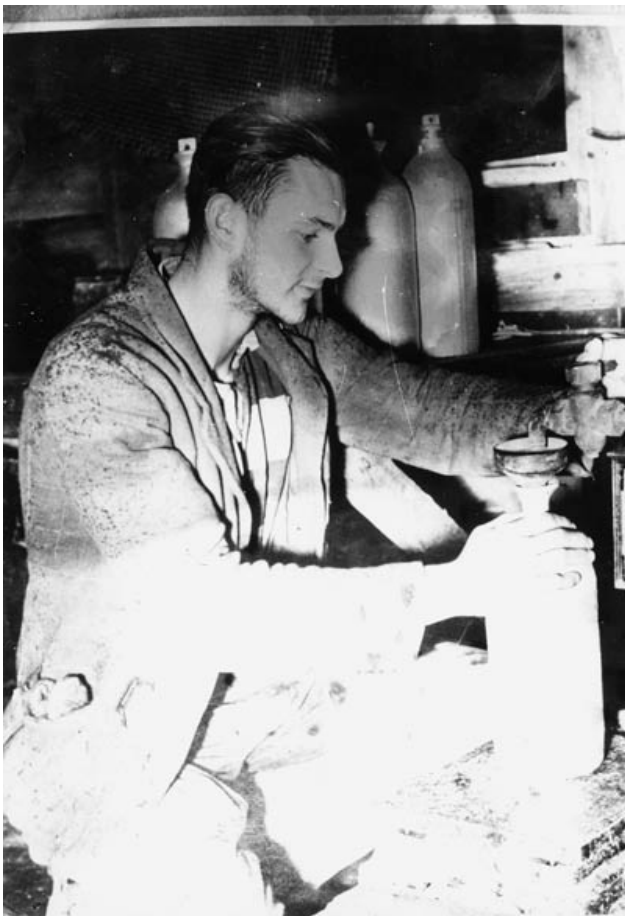
Figure 12: Dusty Miller filling cast-iron mercury flask.

Most of the mercury extraction process is evidenced by the historic fabric present at the site today. The final stage of the process – the collection and bottling of the liquid mercury product – is not. According to Brian Reed, this was a manual process: the liquid mercury was collected in a bucket from a series of valves at the base of the pipe battery, and taken to the building marked with an asterisk in figure 11. The bottling process is evidenced by a photograph which appeared in the *Northern Advocate* in 1979 (figure 12). The newspaper identifies the man as Dusty Miller, filling cast iron mercury flasks. It is interesting to note the complete absence of protective clothing.
