# Heritage Assessment Waro Horse Tramline Track

**Maria Butcher**  
**January 2011**

Heritage Assessment: Waro Horse Tramline Track  
Maria Butcher, Department of Conservation, Whangarei Area Office  
2011

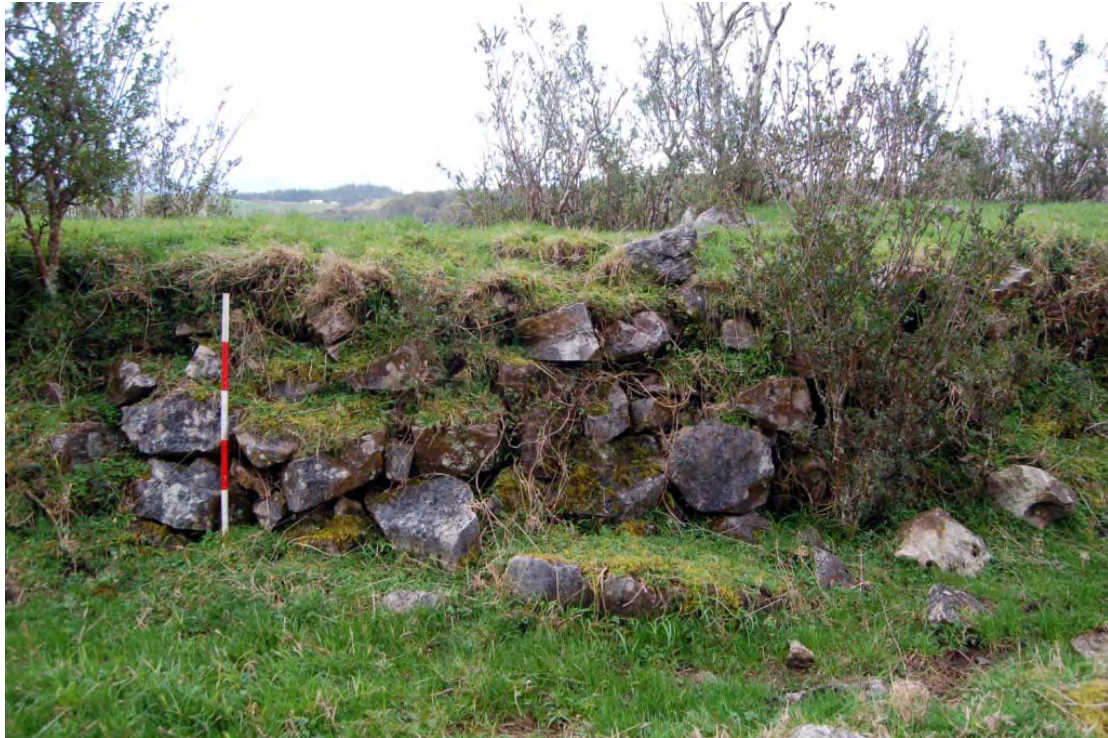
About 30 metres of the eastern tramline platform is faced with limestone blocks. In some places, the facing resembles dry stone walling; in others it is much more haphazard. The limestone was sourced from the local environment.

Figure 3: Close-up of a section of the tramline, showing the rough construction of the stone facing

The stone facing of the eastern tramline has suffered damage caused by cattle knocking individual stones out of place. It is hoped that the rebuilding of the worst-affected section will direct cattle along particular routes, thus protecting the stonework.

Privet is having a detrimental effect upon the stone facing of the horse tramline. The species has been taking root in the gaps, pushing the stones out of place as it grows. The privet was most likely introduced in the 19<sup>th</sup> century as a hedge plant, but it is impossible to discern any of the original hedgerows. Therefore the privet growing in the Waro Limestone Scenic Reserve has no historic value.

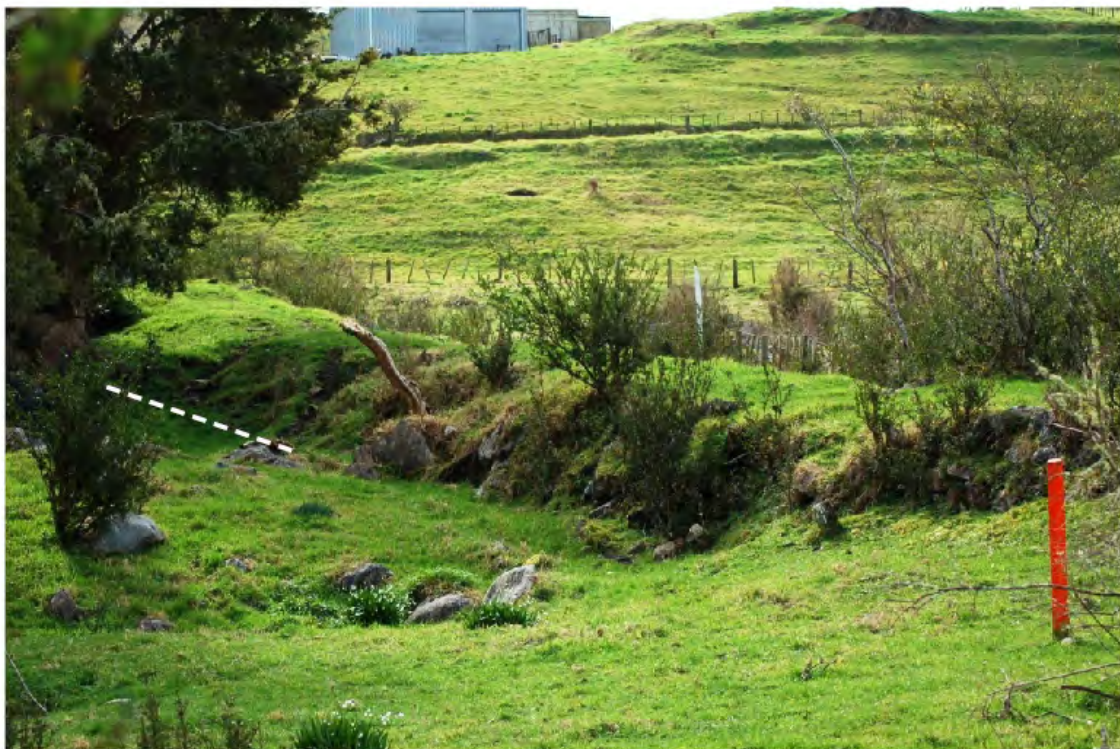
*Figure 5:* Section of tramline platform prior to reassembly and weed control; the dashed line indicates the length of stone facing which was reassembled

In late 2010, a section of stone-facing approximately 12 metres long was repaired under an Archaeological Authority issued by the New Zealand Historic Places Trust. The stonework in this area was in poor condition largely due to the effects of cattle. The cattle had progressively knocked limestone blocks out of place, and displaced fill from the interior of the platform. The stone-work was repaired using a combination of reassembly and reconstruction. First, the fill which had accumulated along the edge of the platform was removed using a small digger. Many of the original limestone rocks were recovered during this process, and re-assembled in the same rough style as the adjacent section of stonework. More limestone blocks were required to finish the repairs, and these were obtained from a quarry less than 1 kilometre away. Figure 6 shows the repaired section of stonework immediately after completion.

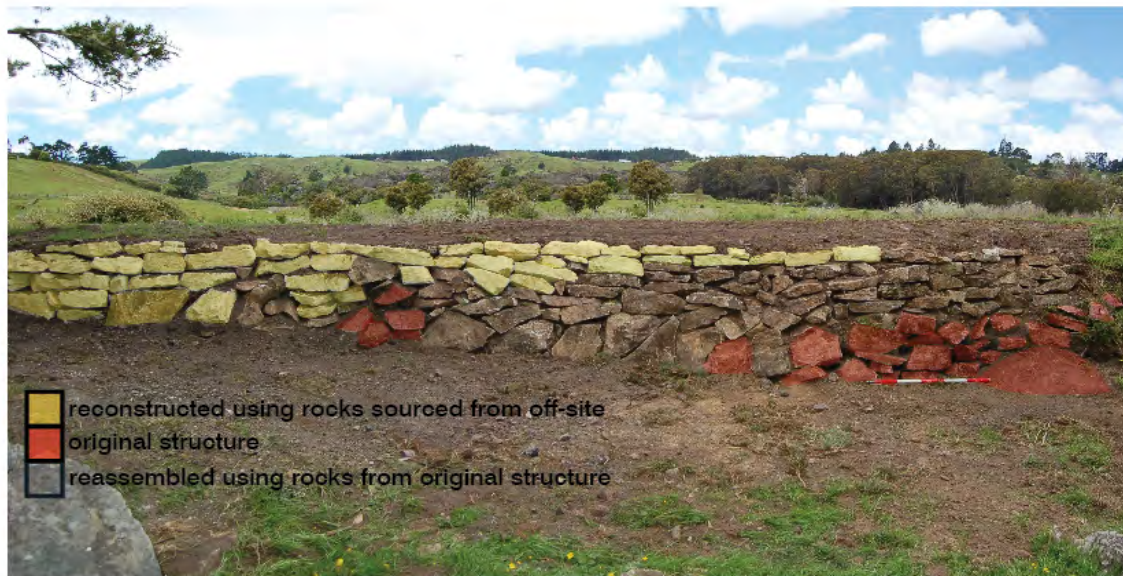
Figure 6: The repaired section of stone facing
