Archaeology of the Antipodes Islands

Peter Petchey, Rowley Taylor, Kath Walker and Graeme Elliott

This paper may be cited as: Petchey, P.; Taylor, R.; Walker, K.; Elliott, G. 2023: Archaeology of the Antipodes Islands. Department of Conservation Te Papa Atawhai, Wellington, New Zealand. 101 p.

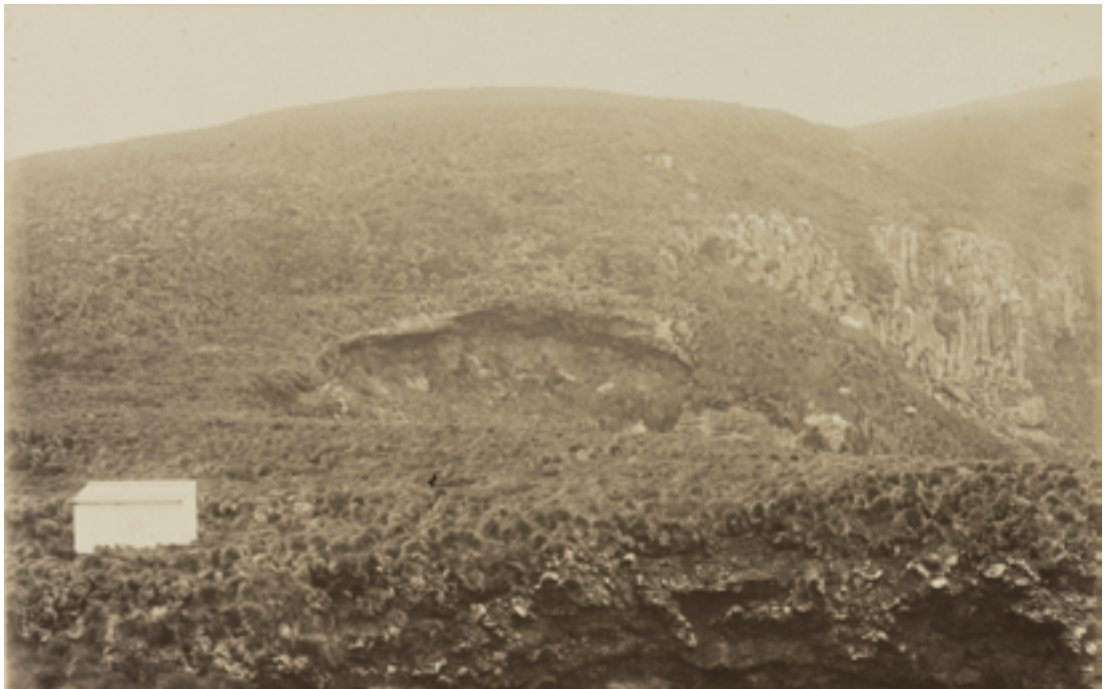
Figure 5. The Antipodes Island castaway depot hut in 1888, when it was only 2 years old. It was painted white to make it easily visible. *Photo: William Dougall; Hocken Archives.*

Servicing of these depots was initially infrequent (and often inspection trips did not even include the Antipodes and Bounty Islands). However, from about 1876 the government steamer *Stella* became available, and the depots' inspection and maintenance began to improve, with new depot huts established. In 1881 the situation was further improved when the *Hinemoa* and *Kekeno* were also provided for official visits. One of the observations made by the visiting ships was the ongoing damage to the depots and theft of supplies, probably by illegal sealers (Kerr 1976: 52). After another official search of the islands, this time for the *North American* which disappeared in early 1885 (no sign of the ship or any survivors were ever found), the New Zealand Government decided to establish more formal castaway depots on the Antipodes and Bounty Islands (Taylor 2006: 114–115). In 1886 Captain Fairchild of the SS *Hinemoa* was despatched to construct castaway depot huts there, and his report describes the island and the location and construction of the hut on Antipodes Island (AJHR 1886 H24: 6; Figs 5 & 6):

We reached the Antipodes at 10 a.m. on the 16th March, and, after steaming round the island, found fairly good anchorage on the north-east side, in fifteen fathoms of water, with black sandy bottom. We at once proceeded to land the material and erect the house, which was finished at 5 pm on the 17th, and all the stores etc deposited therein. I travelled up to the highest part of the island, which I found to be 1,320 ft. high, and which I named Mount Galloway, after our chief engineer, who accompanied me. Nearly the whole of the island is covered with coarse grass, and there are over 2,000 acres of land comparatively level, on which albatrosses sit in thousands. There are also two streams of water, taking their source from the mount; one empties into the sea on the north-east side of the island, and the other on the north-west side. Each of these streams discharges about five gallons of excellent water per minute. There is no bush or wood of any kind on the island.

The house is erected on the north-east end of the island, in the best-sheltered place we could find, about 100 ft. above sea-level, and about 300 ft. in from shore, and can be seen a good distance off from a vessel approaching from the north-east. Enclosed is a rough sketch of the island. A peculiar incident happened whilst sinking the holes for the posts for the house. When down about 2 ft. we unearthed a piece of an earthenware bowl, which I forward to you, also samples of grasses, fern, and rock of volcanic origin. I also found some pieces of timber, which had been the remains of an old hut; but, as it was New Zealand wood, it had, no doubt, been a sealer's hut.

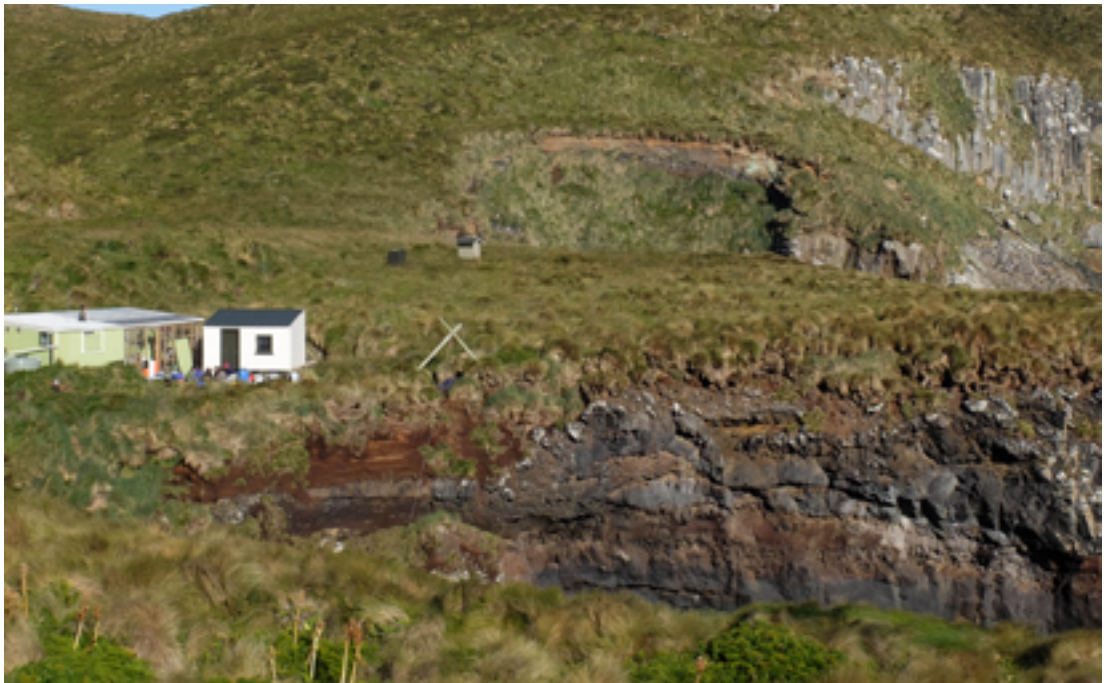
Figure 6. The same view as photographed by Dougall in 1888, taken 130 years later in March 2018. *Photo: Peter Petchey.*

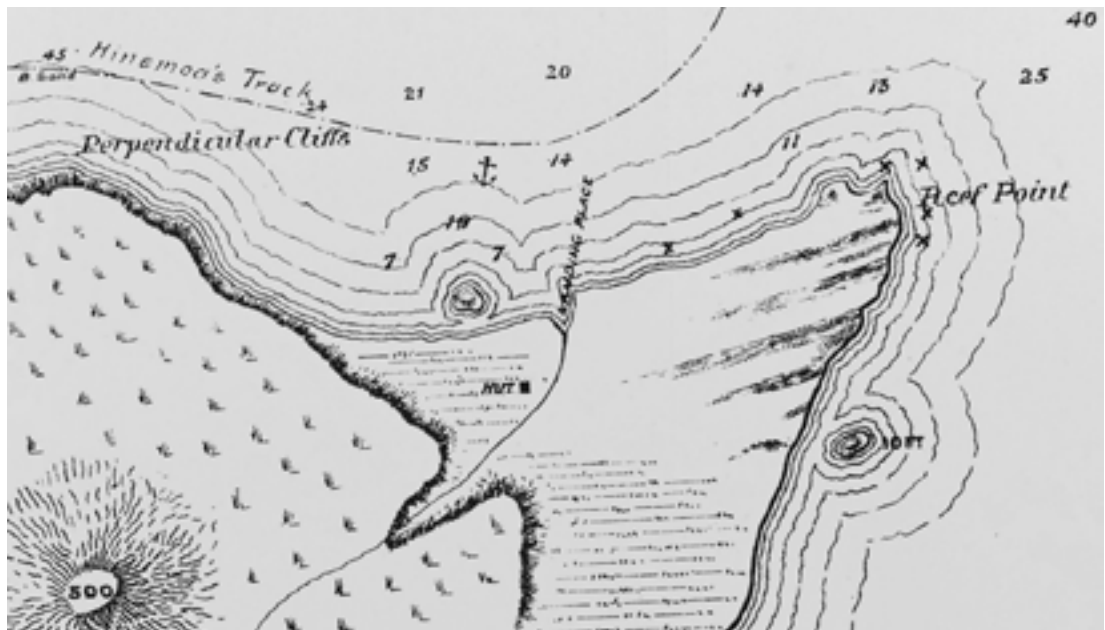
Figure 8. Detail of Captain Fairchild's map of Antipodes Island, showing the castaway depot hut and landing. *AJHR 1886 H24*.

Fairchild's comments about the earthenware bowl and timber are interesting, as they confirm that the new castaway depot hut was built in the same place as sealers had camped some 80 years earlier. Fairchild also drew a sketch map of Antipodes Island (Fig. 7), which was the basis for maps used in official documents regarding the place until a more accurate survey was carried out by HMS *Ringdove* in 1896.

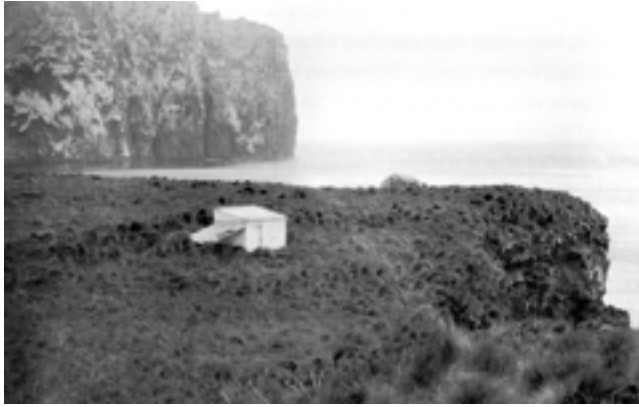
Figure 14. The Antipodes Island castaway depot hut in 1926, photographed by Rollo Beck of the Whitney South Seas Expedition. The shelter on the side of the depot that had been built by the *Président Félix Faure* castaways can be seen clearly. Reproduced in Taylor 2006, from which this version was obtained.

The major in-service modification to the castaway depot hut was carried out in 1908 by the shipwrecked crew of the *Président Félix Faure*, who constructed two makeshift shelters up against the hut and used ship-wrecked timbers to build wooden benches around the inside walls to give extra sleeping space. While these benches were still present in 1978, they were subsequently removed (although their shadows can still be seen on the inside walls). One of the cabins erected in 1908 was a lean-to structure along the full length of the southern wall. It was roofed with sheets of zinc lining from provision boxes supported by four oars lashed to other boat wreckage, and had walls of peat, tussock and other vegetation (see Fig. 5 above). Many buried small pieces of the zinc lining and the remains of two oars were recovered in the summer of 2014/15. This was when the area just south of the depot hut was cleared of vegetation to make a space to add a covered porch to the 1978 BAAS hut during the repairs carried out after the 2014 slip (Fig. 47). These items are discussed in more detail below.

Figure 82. Timber and iron items found buried in 2014 under tussocks below the low ridge just south of the castaway depot hut, 2015. These are presumed to be the remains of the oars and other salvaged timber from the *Président Félix Faure* lifeboat and the metal lining from the castaway depot hut's provision boxes which were used to make the lean-to cabin shown in Fig. 14. Some of this material is now stored under the south end of the hut. *Photo: Kath Walker.*

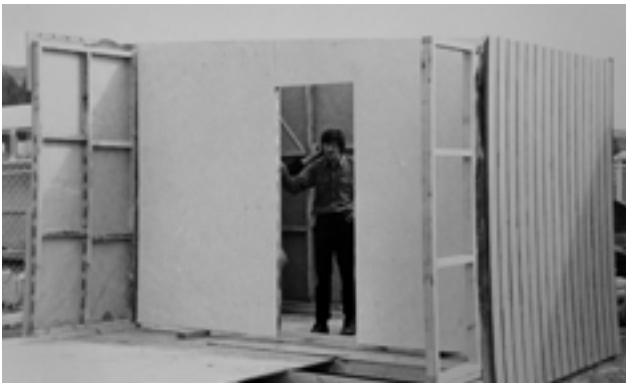
Figure 17. Trial construction of the 1978 BAAS hut at Tūrangi, prior to it being broken down for transport. *Photo: Newton 1979; Archives New Zealand Te Rua Mahara o te Kawanatanga, Dunedin Regional Office.*

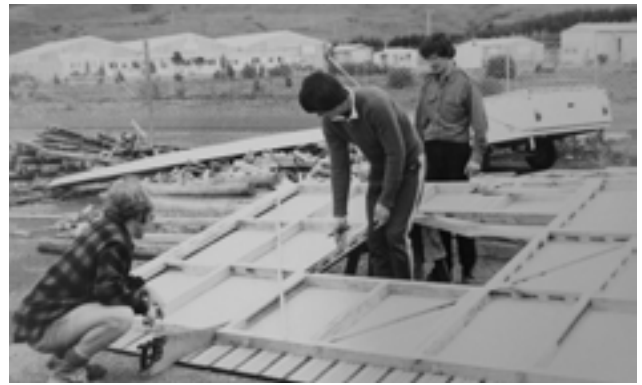
Figure 18. Cutting up the BAAS hut into units for transportation at Tūrangi in 1978. *Photo: Newton 1979; Archives New Zealand Te Rua Mahara o te Kawanatanga, Dunedin Regional Office.*

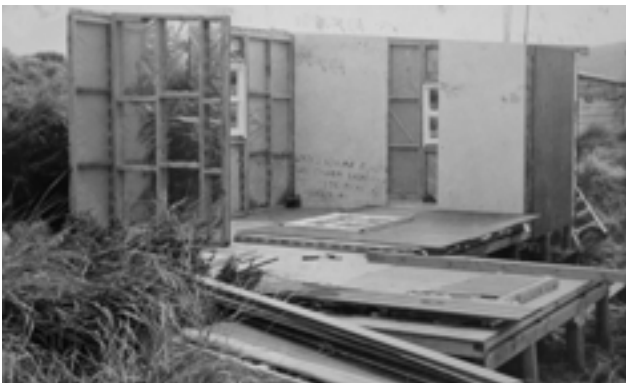
Figure 19. The new BAAS hut during construction on Antipodes Island in 1978. *Photo: Newton 1979; Archives New Zealand Te Rua Mahara o te Kawanatanga, Dunedin Regional Office.*

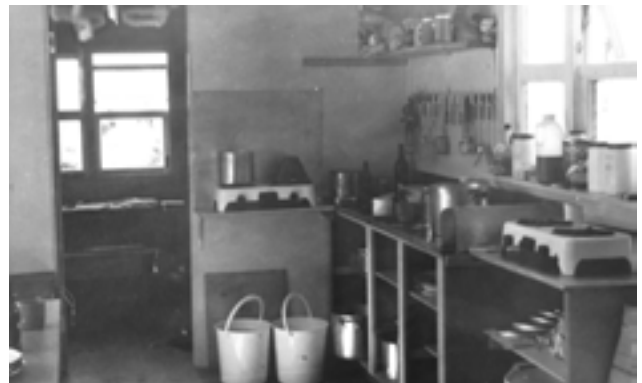
Figure 20. Inside the new BAAS hut in 1978. *Photo: Newton 1979; Archives New Zealand Te Rua Mahara o te Kawanatanga, Dunedin Regional Office.*

Figure 93. The kitchen corner inside the 1978 BAAS hut in 2018 (see also Fig. 20, 1978). Many of the original features remain – including some of the kitchen utensils! *Photo: Peter Petchey.*

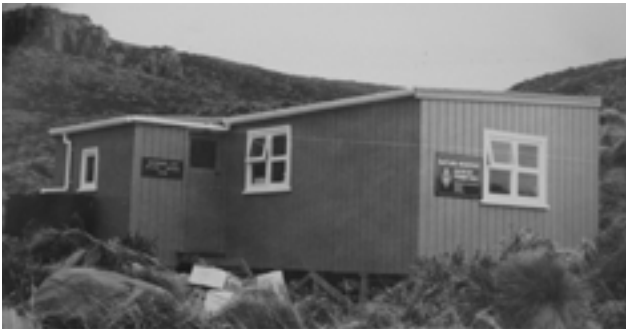
Figure 21. The new eight-bunk BAAS hut in 1978. *Photo: Newton 1979; Archives New Zealand Te Rua Mahara o te Kawanatanga, Dunedin Regional Office.*

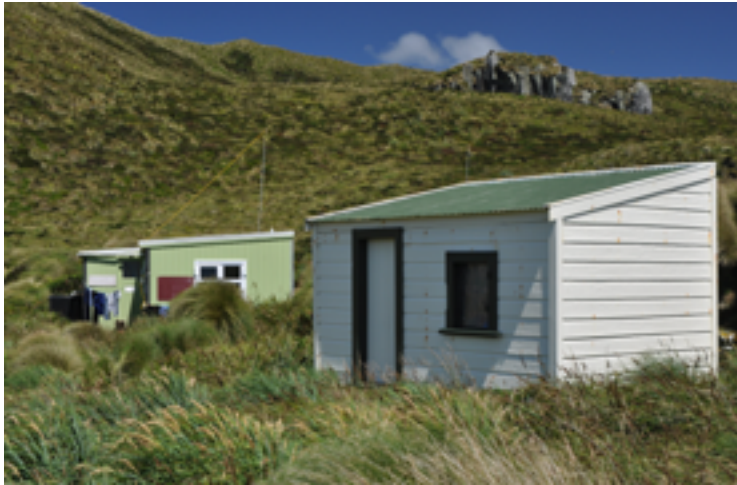
Figure 22. The 1978 BAAS hut and castaway depot hut in 2012, in their original locations. *Photo: Kath Walker.*

On 6 January 2014 after a sustained period of heavy rain, landslides occurred over nearly 20% of Antipodes and Bollons Islands. One large landslip flowed down towards Hut Cove, sweeping the 1978 BAAS hut off its foundations, shunting it 20 m northwards and swivelling it around by 90 degrees. The hut came to rest close to the castaway depot hut, which fortunately was missed by the landslide and not damaged. Kath Walker and Graeme Elliott arrived 2 weeks later expecting to use the 1978 hut during an albatross research visit, but instead had to occupy the castaway depot hut for 2 months. They dug out the 1978 hut and when they were picked up in February, a team led by builder John Henderson had just a few hours to jack the hut up and make it watertight. Supplies to repair the hut were shipped to the island during the winter expedition, but bad weather precluded any major work being undertaken. The work was done in November 2014 when a team repiled and repaired the hut where it stood, close to the castaway depot hut. The finishing-off work, including plumbing, jibbing, window installation, re-painting the interior, sealing the floors and building interior fittings was carried out by Kath Walker and Graeme Elliott with help from engineer Andrew Troup and carpenters Greg Martin and Joe Hayes over subsequent summers (Figs 22–24).

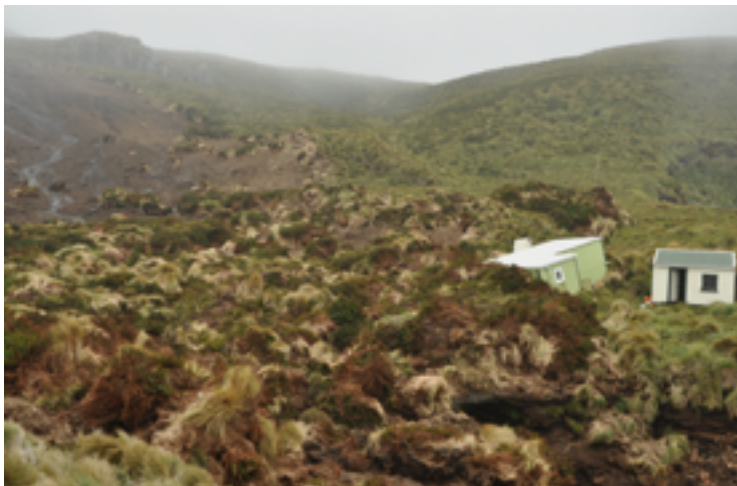
Figure 23. The aftermath of the 2014 landslip, with the 1978 BAAS hut pushed towards the castaway depot hut, 2014. *Photo: Kath Walker.*

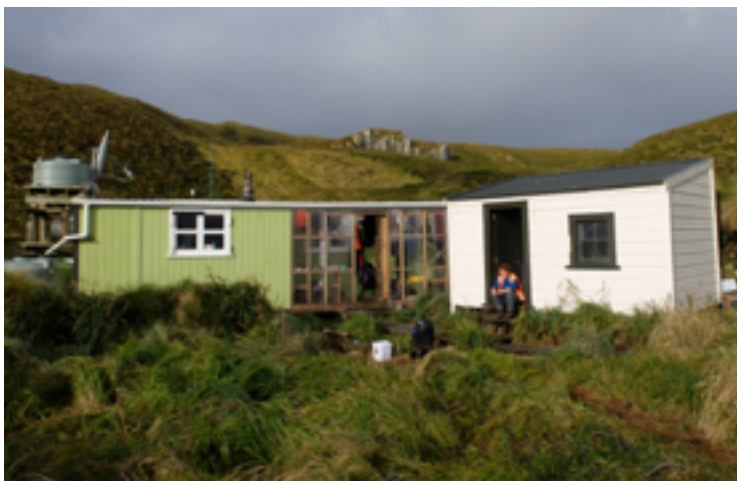
Figure 24. The Antipodes Island huts in 2018, after the 2015 rebuild of the old BAAS hut (Hayley Ricardo on the castaway depot hut steps). *Photo: Peter Petchey.*

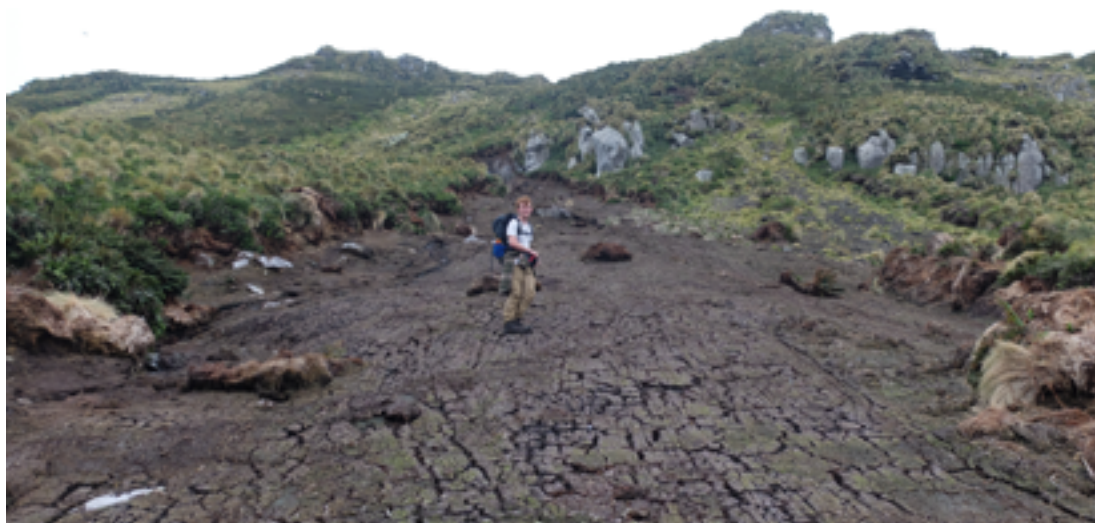
Figure 27. Theo Van Noort on a slip on the south coast of Antipodes Island in 2018. The upper layers of vegetation and peat regularly slough off the island's steeper slopes, sweeping away or covering with debris any archaeological material in their way. The 2014 Hut Cove slip probably destroyed sealing camp evidence there, and the toe of a slip debris field has come within 6 m of one south coast sealers' hut site. *Photo: Peter Petchey.*

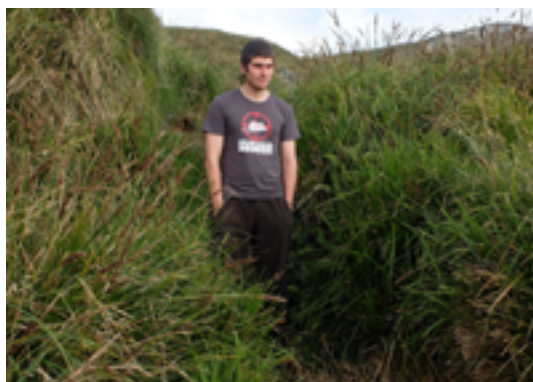
Figure 25. Finlay Cox standing on boardwalk cut through the grass near the Hut Cove huts in 2018, showing coastal vegetation that can be up to 2 m high, creating a dense and almost impenetrable mat. Archaeological sites under this are invisible. *Photo: Peter Petchey.*

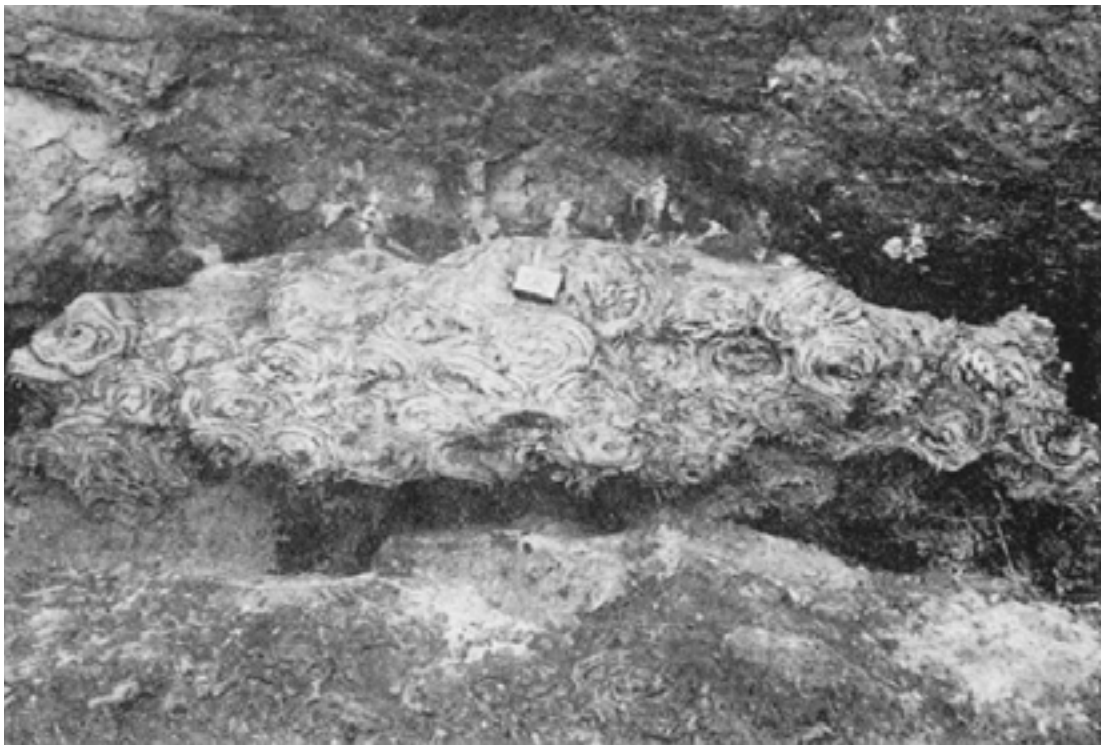
Figure 32. The penguin skin cache at Anchorage Bay as photographed during the 1969 University of Canterbury Antipodes Expedition. The pile of skins has been consolidated by guano. Matchbox for scale = 5 cm. *Photo: R.J. Stanley, published in Warham & Johns 1975.*

The BAAS expedition in 1978 found that the penguin skins had changed little since they were photographed by the 1969 expedition (Newton 1979), and a photograph in Fraser (1986: 87) shows them again in a similar condition. At this stage it was still obvious that the upper, most visible, bale of rolled skins was sitting upon a lower (and larger) layer of rolled skins. Based on the 1969 photograph and the rough scale given, the main upper layer was approximately 12 inches / 300 mm high. However, since that date the cache has been progressively trampled and buried by fur seals and penguins and in 2014 a small slip brought down earth and tussock in front of the rock shelter. Figures 33–38 show the condition of the cache over the years from the mid-1980s to 2018. There is no longer any sign of the barrel staves that Warham observed in 1969. The state of preservation of the buried skins is unknown; but overall, the cache has deteriorated significantly.

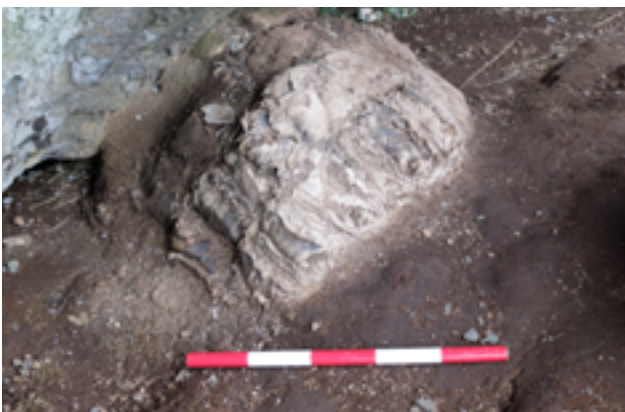
Figure 36. The penguin skin cache (lower right) in January 2015 with the front of the rock shelter now covered by landslide debris that slipped down in January 2014.
Photo: Kath Walker.

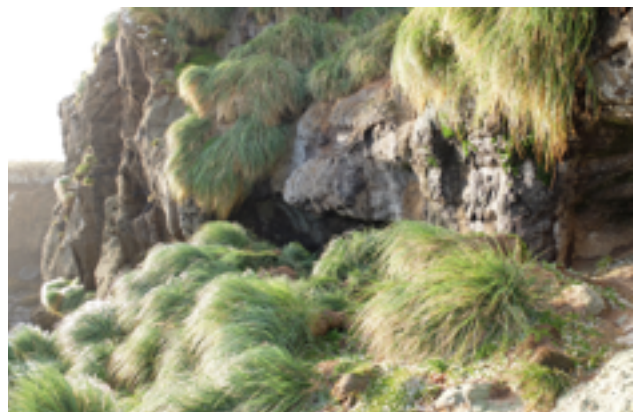
Figure 37. The remaining penguin skins in March 2018.
The scale is 0.5m long. *Photo: Peter Petchey.*

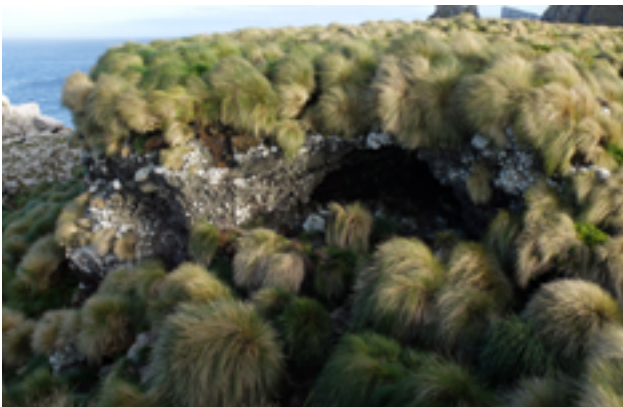
Figure 41. Cave at Reef Point in 2018. *Photo: Peter Petchey.*

It is likely that this cave was used to store seal skins under the care of Wild and Hoef until shipped to Canton on the *Favorite* in 1807, as it is the only large shelter close to the main ship anchorage. Two other small caves exist nearby, which could have provided some shelter for sleeping, but otherwise contained no evidence that they had been utilised. A large sea cave exists under the point on the west side of Hut Cove, but this is regularly swept by the tide. Figures 41 and 42 show the cave in 2018. Figure 43 shows a plan of the cave in 2018.

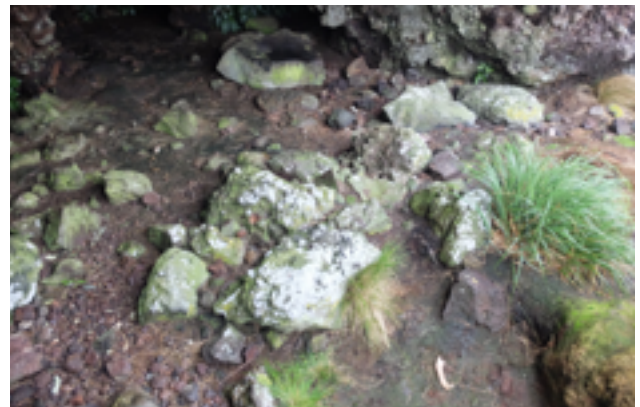
Figure 42. Looking into the Reef Point cave 2018, with the possible collapsed stone wall running from the centre of the image up to the right (see also Fig. 43). *Photo: Peter Petchey.*

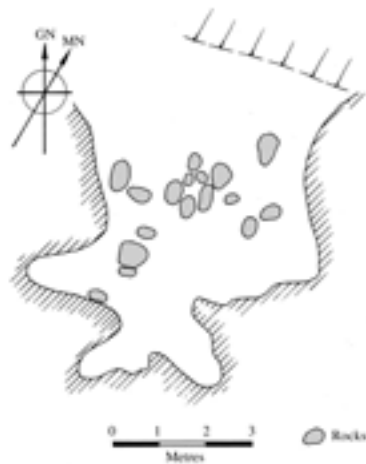
Figure 43. Plan of the Reef Point cave, showing the remains of the possible rough stone wall across the entrance. *Baseline offset plan, Peter Petchey and Bea Ayling.*

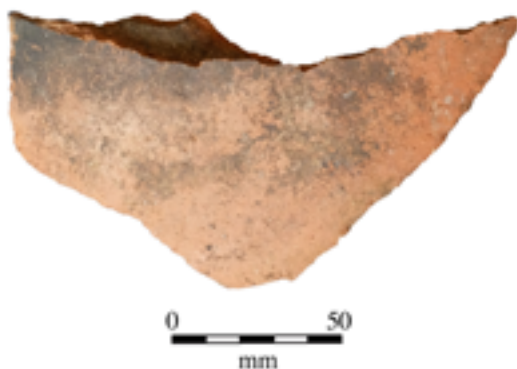
Figure 44. The fragment of earthenware pottery (140 × 70 × 18 mm thick) found in front of the castaway depot in 2017, photographed in 2018. The area where it was found had been cleared and dug during the mouse eradication project. *Photo: Peter Petchey.*

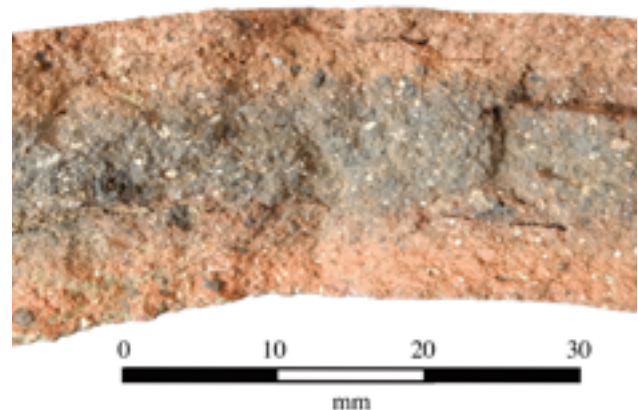
Figure 45. Cross-section of the earthenware fragment found in 2017, photographed in 2018. *Photo: Peter Petchey.*

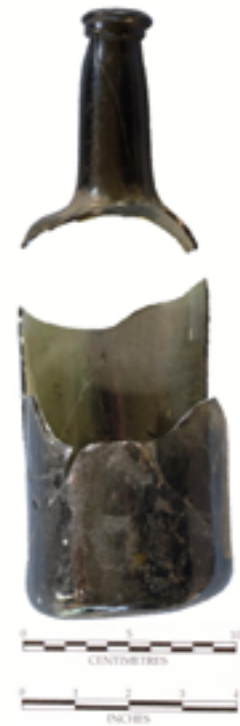
Figure 46. The broken bottle found near the castaway depot hut by Kath Walker and Graeme Elliott in 1998, photographed in 2018. This bottle is of a late 18th / early 19th century form and was probably discarded by sealers. It is now in the collection of the Southland Museum and Art Gallery. Photo: Peter Petchey.

In February 1998 a broken bottle was found by Kath Walker and Graeme Elliott when they were putting in the first boardwalk around the huts, between the castaway depot hut and the 1978 BAAS hut (in its old position). It was about 7–8 m west of the huts along the track to the toilet (in its then location; it has been moved since) and Anchorage Bay, behind the small ridge sheltering the huts. The free-blown bottle (Fig. 46) is consistent with an early 19th-century date, particularly in the hand-formed neck and top details. It is likely to have been discarded by sealers; it is much too early in its form to be associated with the *Président Félix Faure* castaways or the stocking of the castaway depot.

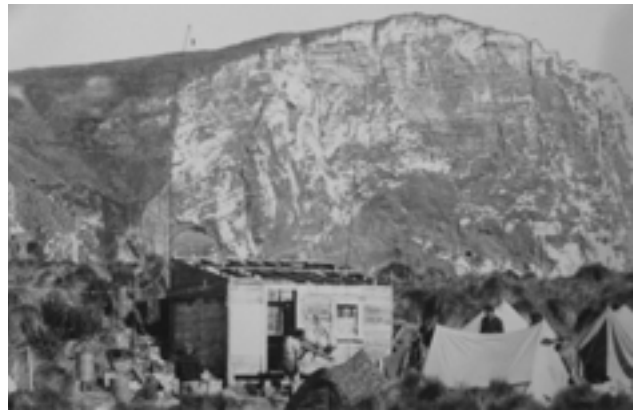
Figure 49. The castaway depot hut soon after the 1978 BAAS Expedition arrived, before any repairs were carried out. *Photo: Newton 1979; Archives New Zealand Te Rua Mahara o te Kawanatanga, Dunedin Regional Office.*

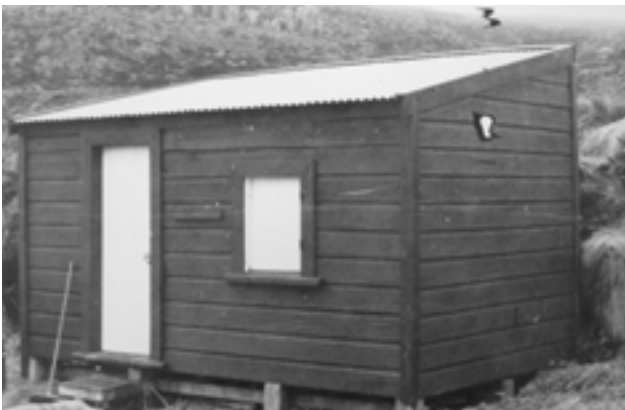
Figure 50. The castaway depot hut after repairs and repainting by the BAAS Expedition in 1978. *Photo: Newton 1979; Archives New Zealand Te Rua Mahara o te Kawanatanga, Dunedin Regional Office.*

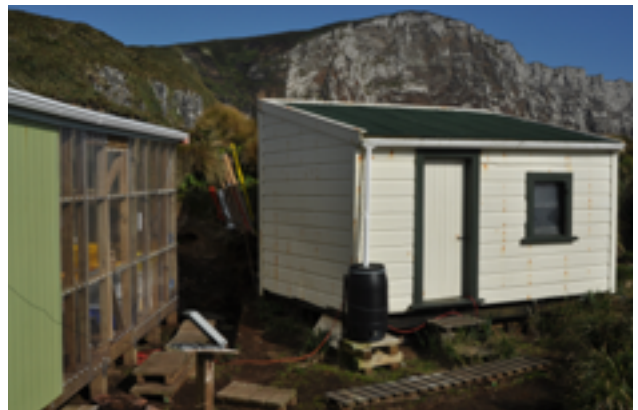
Figure 51. The castaway depot hut adjacent to the 1978 BAAS hut after the repair works on the latter were completed in 2015. The castaway hut is in good condition, but the staining from rusting nails is evident. *Photo: Kath Walker.*

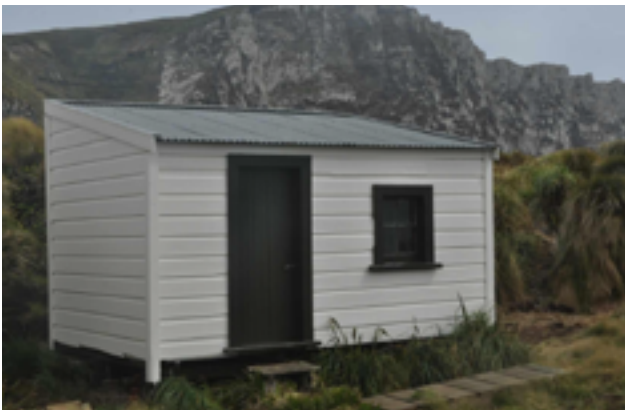
Figure 52. The castaway depot hut after it was repainted in early 2017 by Kath Walker and Graeme Elliott. *Photo: Kath Walker.*

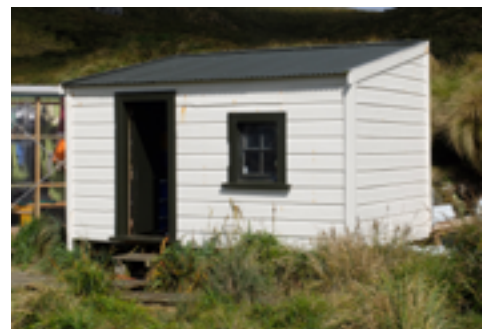
Figure 54. East (front) and north walls of the castaway depot hut in 2018.
Photo: Peter Petchey.

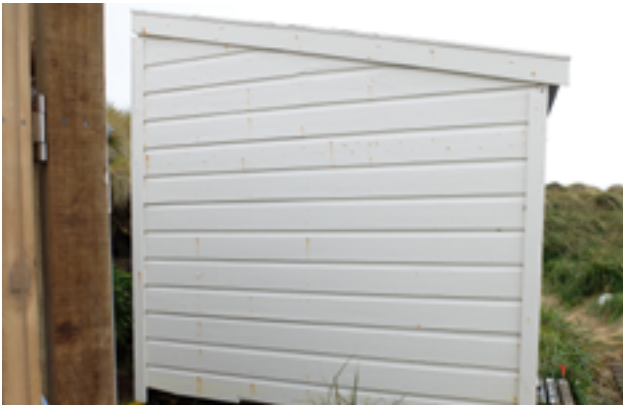
Figure 55. South wall of the castaway depot hut, 2018, showing the nails in the fifth weatherboard from the top that fixed the lean-to roof constructed by the *Président Félix Faure* castaways. Photo: Peter Petchey.

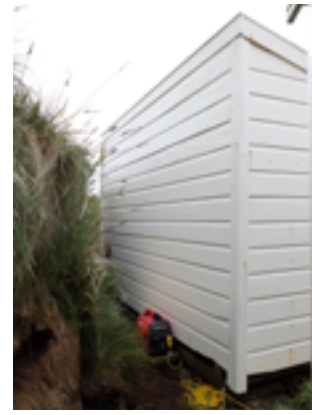
Figure 56. West (rear) wall of the castaway depot hut, 2018. This was originally closer to the bank, until the depot shifted slightly when it was being repiled in 1998. Photo: Peter Petchey.

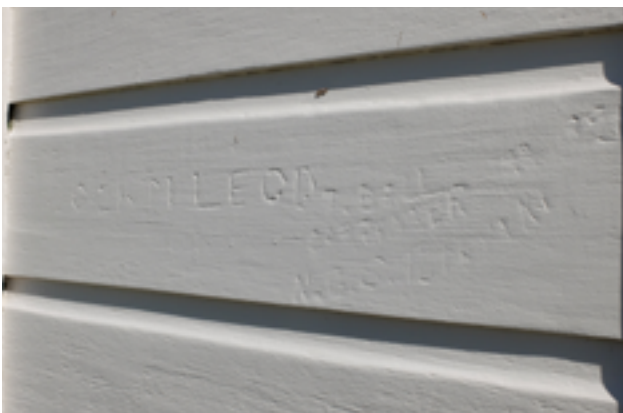
Figure 57. Carved names on the front external wall of the castaway depot hut (to the left of the door), 2018. Photo: Peter Petchey.

The exterior of the castaway depot hut is clad in rusticated weatherboards (9½ inches wide and 1½ inch overlap), with plain architraves and plain vertical corner closure boards and barge boards. Rust bleeding from the nails used to fix the weatherboards is visible even after the recent repaint. Old nails hammered into the weatherboards on the south wall show where the *Président Félix Faure* castaways built their lean-to (Figs 55, 56). There are traces of several inscriptions to the left of the door (Figs 57, 58). These complement the inscriptions inside the depot, which are described below.

As discussed above, there are further inscriptions on the front exterior wall of the depot, to the left of the door (Fig. 57). These are now partially obscured, but were more clearly visible in the past:

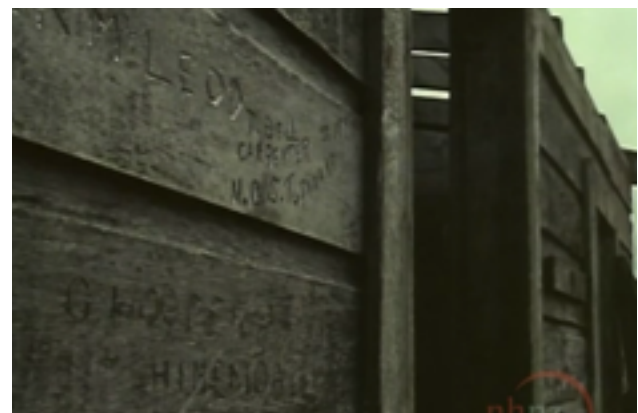
Figure 58. The same carved names recorded in the 1981 TVNZ Wild South documentary episode *Island of Strange Noises*. 'G. Hooper' and 'Hinemoa' are also visible; but are not visible in Fig. 57 (2018). Image: TVNZ.

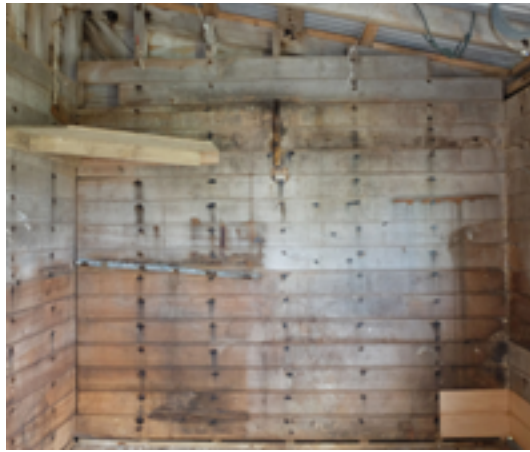
Figure 59. The inside north wall of the castaway depot hut, 2018. The line where the *Président Félix Faure* castaways' bunks were built is clearly visible half-way up the wall. *Photo: Peter Petchey.*

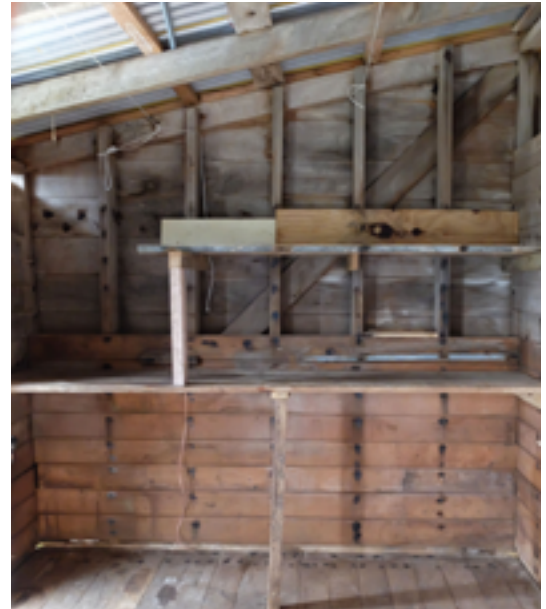
Figure 60. The inside south wall interior of the castaway depot hut in 2018 showing the modern shelving which is constructed partly of wall lining boards taken from the wall. The wall framing, including the brace, is also clearly visible in this view. *Photo: Peter Petchey.*

protected the lower wall linings from the weather when the roof failed in the 1960s (Fig. 59). An old army wooden case has been nailed to the rear wall to act as a small shelf or cupboard (Fig. 60). Presumably this held supplies during the 1969 or 1978 expeditions.

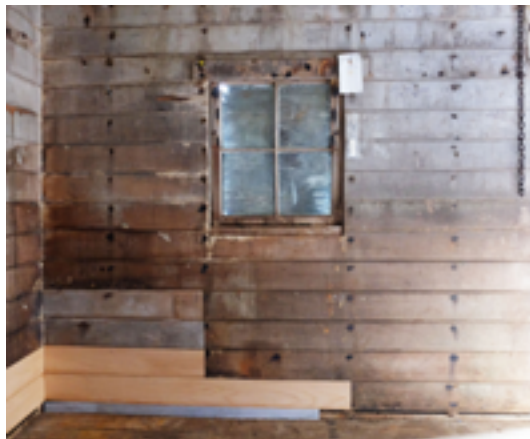
Figure 61. The inside east (front) wall of the castaway depot hut in 2018 showing the hut's one window (north side of the door). Replacement tongue and groove lining boards are visible in the lower left (northeast) corner. *Photo: Peter Petchey.*

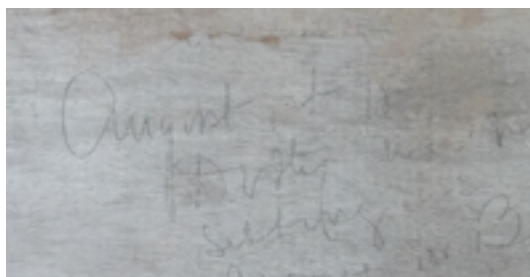
Figure 64. The Fig. 63 inscription in 2018, showing significant deterioration over 40 years, probably as a result of abrasion from items hung on the wall. Photo: Peter Petchey.

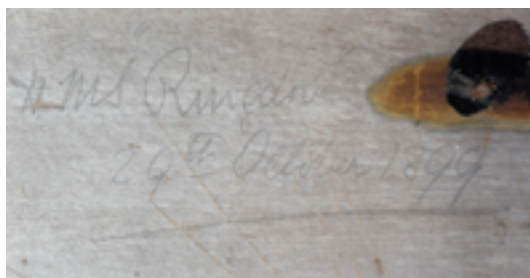
Figure 66. HMS *Ringdove* inscription recorded in 2018. Consolidant has been added to the nearby nail head since 2004. Photo: Peter Petchey.

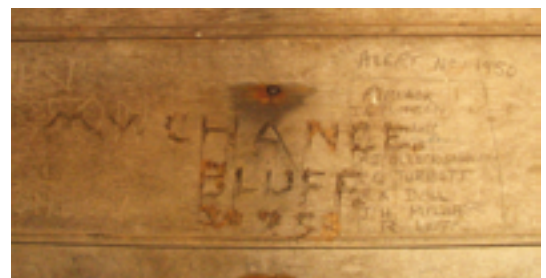
Figure 67. Inscription by the crew of the MV *Chance* from Bluff, recorded in January 2004. Taylor (2006) is of the opinion that it was the *Chance* crew that vandalised the castaway depot hut contents, and the fact that this inscription has been hacked out over the top of the 1950 *Alert* inscription speaks of a lack of respect for the place. Photo: Kath Walker.

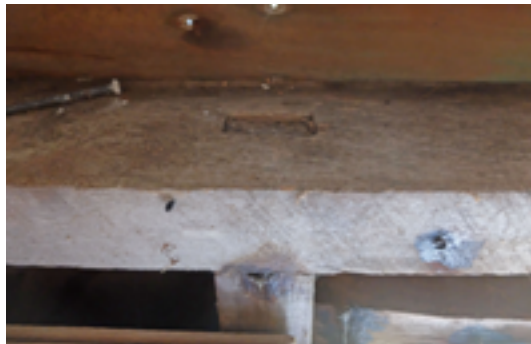
Figure 68. Top plate and stud in the east (front) wall of the castaway depot hut, showing the mortise and tenon joint, 2018. *Photo: Peter Petchev.*

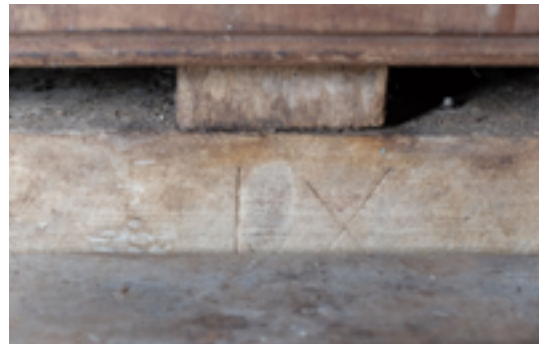
Figure 69. Bottom plate and base of stud in the west (rear) wall of the castaway depot hut, 2018, showing one of the Roman numerals that the timbers were marked with to aid reassembly of the prefabricated structure. *Photo: Peter Petchev.*

The castaway depot hut is built with a timber frame that is notably robust, which accounts for its survival in the harsh subantarctic environment. It is of conventional design, using top and bottom plates and vertical studs and diagonal bracing, but the studs are 5 × 2 inches (125 × 50 mm) rather than the standard 4 × 2 inches (100 × 50 mm), and they are mounted into the top and bottom plates using mortise and tenon joints (Fig. 68). This was a standard construction technique during the 19th century but was phased out at the end of the century in favour of simpler (and cheaper) rebated joints or simple butted and nailed joints. However, it is a very strong joint, which does not rely on the strength of an iron nail, so is ideally suited to the Antipodes Island situation where a robust building was necessary. The studs were also closely spaced, at centres that varied from 13 inches to 18½ inches (330 mm to 470 mm) (but were typically about 16½ inches (420 mm)). Many of the joints were marked with Roman numerals, evidence that this was a prefabricated kitset that was made in New Zealand and then marked for easy reassembly on the island (Figs 69, 70).

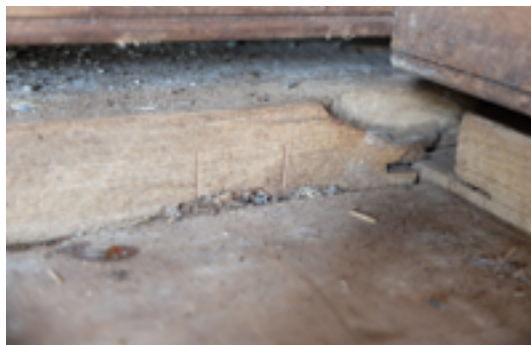
Figure 70. Scarf joint in the bottom plate of the west (rear) and north side wall of the castaway depot hut, 2018, with Roman numerals to aid reassembly. *Photo: Peter Petchev.*

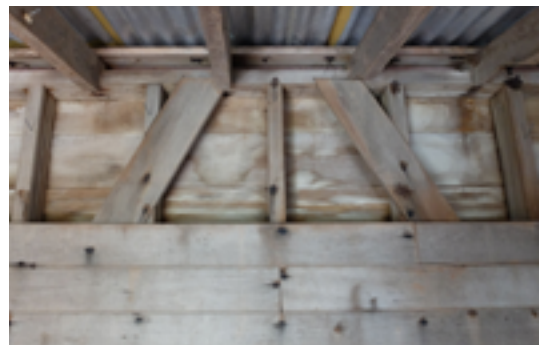
Figure 71. Top middle of the west (rear) wall of the castaway depot hut, showing the studs, top plate and bracing in the wall, with the rafters attached to the top plate, 2018. *Photo: Peter Petchev.*

The roof framing consists of the original 5 × 2 inch (125 × 50 mm) rafters, with modern tanalised pine purlins. The corrugated aluminium roof cladding is nailed to the purlins (Figs 71, 72).

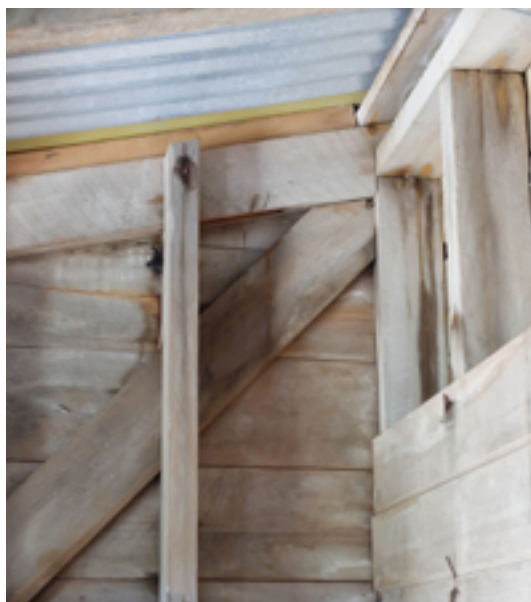
Figure 72. Top left hand (southwest) corner of the castaway depot hut, 2018, showing the side wall studs and bracing. Note the lack of a top plate on the side wall, with the studs fixed to the end rafter instead. *Photo: Peter Petchey.*

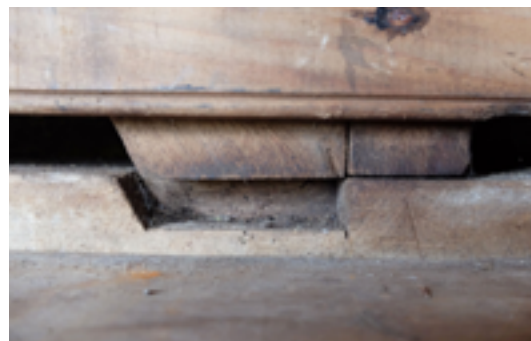
Figure 73. Bottom plate of the west (rear) wall of the depot, 2018, showing the rebate cut for the bottom end of one of the wall braces. The brace has pulled out of the rebate, suggesting that the building has moved slightly over time. *Photo: Peter Petchey.*

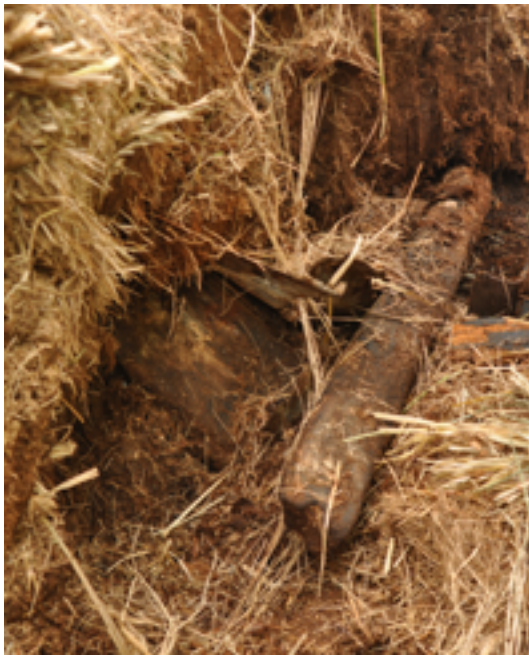
Figure 74. Southernmost fireplace, which included a large wooden lintel with burn marks, found as shown with both horizontal and vertical flat iron near its middle section, and many limpet shells nearby, 2015. This material was unearthed when tussock and peat was removed from the front of the low bank about 3 m south of the castaway depot hut to clear space around the 1978 BAAS hut which had just been shunted against the bank by a landslide. *Photo: Kath Walker.*

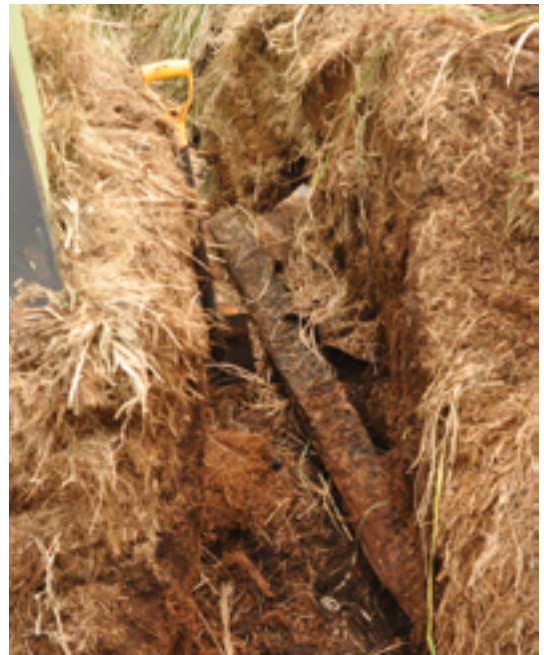
Figure 75. Large wooden lintel with burn marks, found as shown with both horizontal and vertical flat iron near its middle section, and many limpet shells nearby, 2015. This material was unearthed when tussock and peat was removed from the front of the low bank about 3 m south of the castaway depot hut during excavation of the 1978 BAAS hut. *Photo: Kath Walker.*

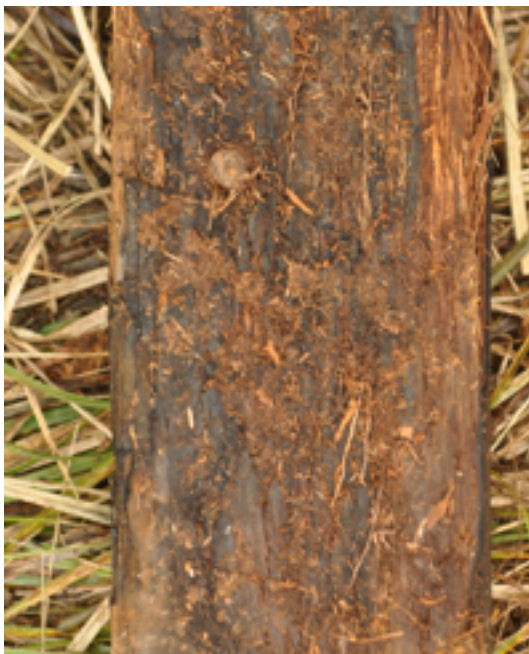
Figure 76. Close-up of the timber lintel showing one of several tacks which may have held sailcloth to it to shelter the fire from rain, 2015. *Photo: Kath Walker.*

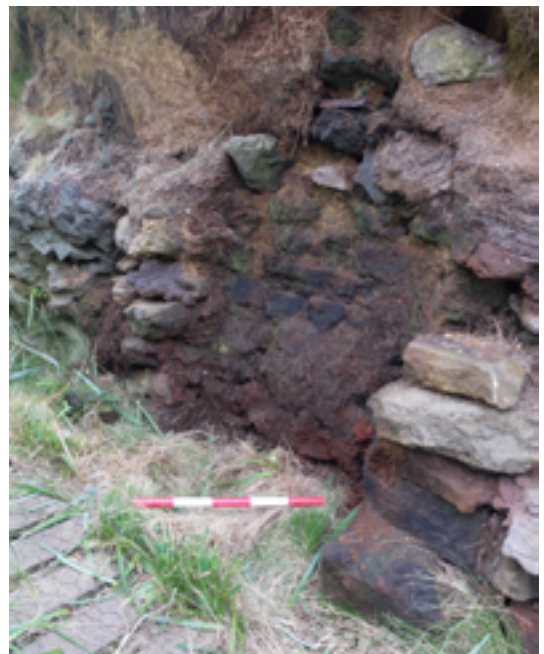
Figure 77. The stacked rock fireplace uncovered just south of the castaway depot hut in November 2014 when vegetation and peat were removed to make space for a porch on the landslide-shunted 1978 BAAS hut. The lean-to cabin roof built by *Président Félix Faure* castaways would have covered this area, keeping this fire dry. The scale is 0.5 m long. *Photo: Peter Petchey.*

Two old fireplaces were uncovered while digging away tussock and peat from the bank behind the castaway depot hut and the 1978 BAAS hut in 2014 during the repair work after the landslip. These fireplaces were 2 m and 4 m respectively south of the southwest corner of the castaway depot hut, and now immediately west of the main bunkroom window of the 1978 BAAS hut. At least one of the fireplaces is presumed to have been built by the shipwrecked crew of the *Président Félix Faure*, as they were known to have tended a fire for much of the time they were on the island.

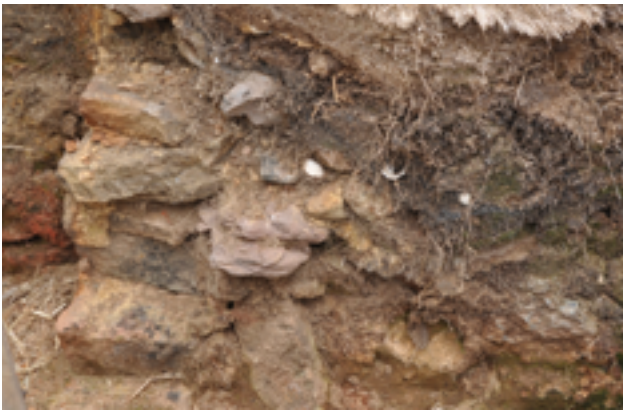
Figure 78. Detail of the right-hand side of the stacked rock fireplace showing the stonework and limpet shells, overlain by peaty soil, 2015. *Photo: Kath Walker.*

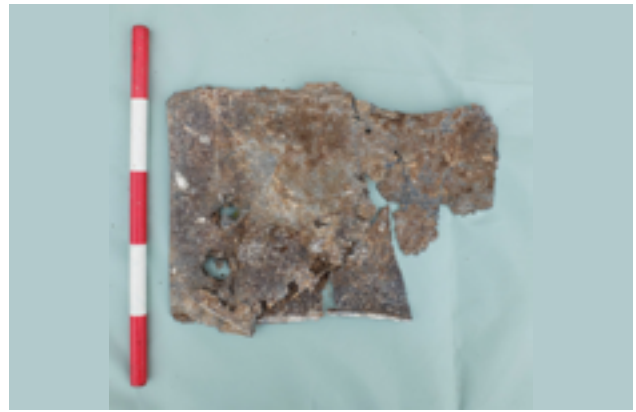
Figure 83. Section of zinc sheeting with a corner seam, 2018. *Photo: Peter Petchey.*

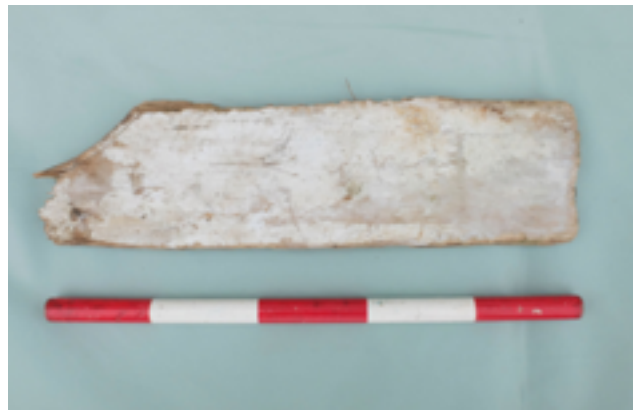
Figure 85. A section of white-painted timber with a shaped end, 2018. *Photo: Peter Petchey.*

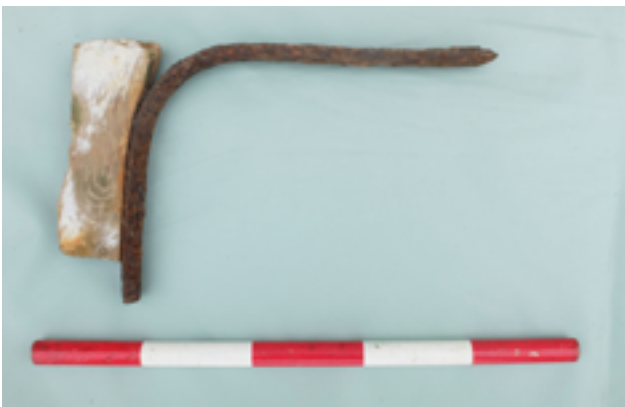
Figure 86. A light rib or stud with an iron bracket attached, 2018. *Photo: Peter Petchey.*

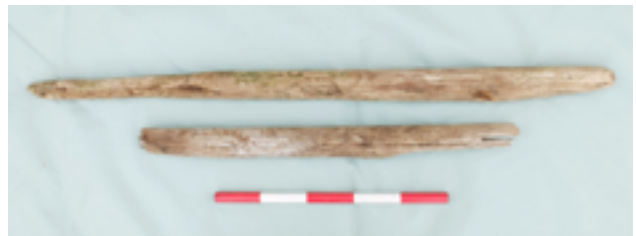
Figure 87. Two sections of oars, 2018. *Photo: Peter Petchey.*

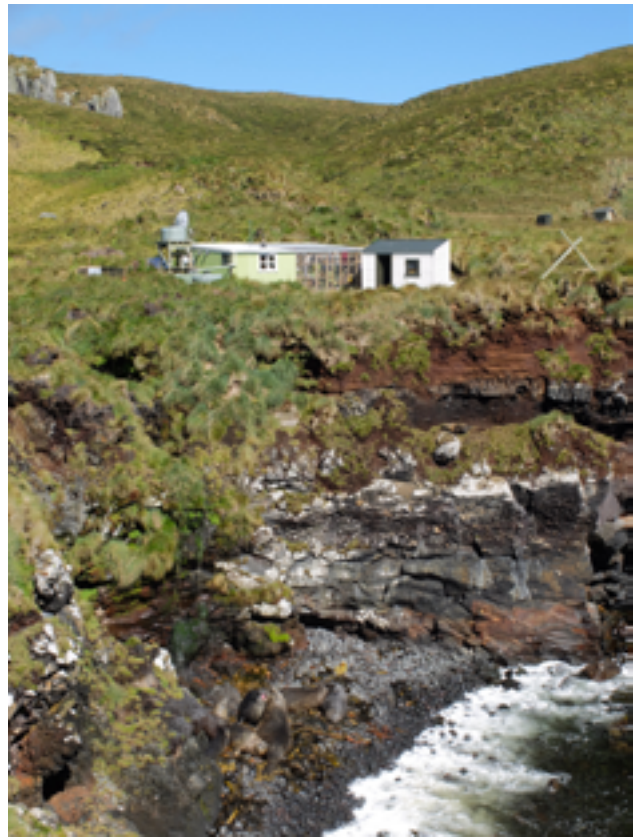
The 1978 BAAS Hut had been partly prefabricated at the former New Zealand Department of Lands & Survey's training centre at Tūrangi and was L-shaped, with two bunkrooms, a main central room, a storeroom and an enclosed porch. It was originally 7.2 m long × 3.6 m wide at one end × 5.4 m wide at the storeroom end (Newton 1979) (note that Newton's report was in a mixture of imperial and metric measurements, reflecting the transition between the two systems that was then occurring). When the hut was rebuilt in 2016 after the 2014 landslip, the east end was extended, and it is now 9.65 m long (with the other main dimensions remaining unchanged). At this time, the inside corner of the 'L' shape of the building was also enclosed with timber framing and transparent sheeting to provide an enclosed north-facing verandah area with clotheslines for drying gear (Fig. 89). The internal layout was altered slightly at the extended end to incorporate a shower, larder and diesel stove, which necessitated reducing the size of the eastern bunkroom from four to two bunks. The window in the unaffected western bunkroom was replaced by a larger replica to provide an emergency exit (Fig. 90). A modern aluminium-framed window was placed in the new eastern wall during the 2016 hut extension (Fig. 91) and the (now smaller) bunkroom was fitted with one of the surplus original windows (Fig. 90), with the second window being placed in what was the old storeroom, which formerly only had an un-opening pane of glass (Fig. 90). Two new plastic water tanks fed by roof water, and a header tank for water and diesel (for the stove)

Figure 88. The 1978 BAAS Hut (left) and castaway depot hut above Hut Cove in 2018. *Photo: Peter Petchey.*
