Archaeology of the Antipodes Islands

Peter Petchey, Rowley Taylor, Kath Walker and Graeme Elliott

This paper may be cited as: Petchey, P.; Taylor, R.; Walker, K.; Elliott, G. 2023: Archaeology of the Antipodes Islands. Department of Conservation Te Papa Atawhai, Wellington, New Zealand. 101 p.

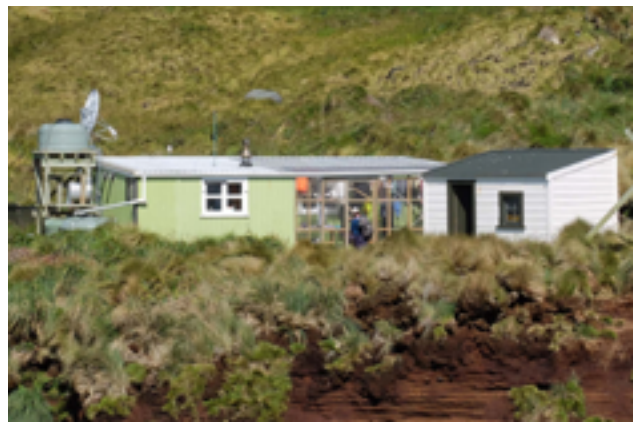
Figure 89. The northern side (front) of the BAAS hut in 2018, with the castaway depot hut to the right. *Photo: Peter Petchey.*

the inside corner of the 'L' shape of the building was also enclosed with timber framing and transparent sheeting to provide an enclosed north-facing verandah area with clotheslines for drying gear (Fig. 89). The internal layout was altered slightly at the extended end to incorporate a shower, larder and diesel stove, which necessitated reducing the size of the eastern bunkroom from four to two bunks. The window in the unaffected western bunkroom was replaced by a larger replica to provide an emergency exit (Fig. 90). A modern aluminium-framed window was placed in the new eastern wall during the 2016 hut extension (Fig. 91) and the (now smaller) bunkroom was fitted with one of the surplus original windows (Fig. 90), with the second window being placed in what was the old storeroom, which formerly only had an un-opening pane of glass (Fig. 90). Two new plastic water tanks fed by roof water, and a header tank for water and diesel (for the stove)

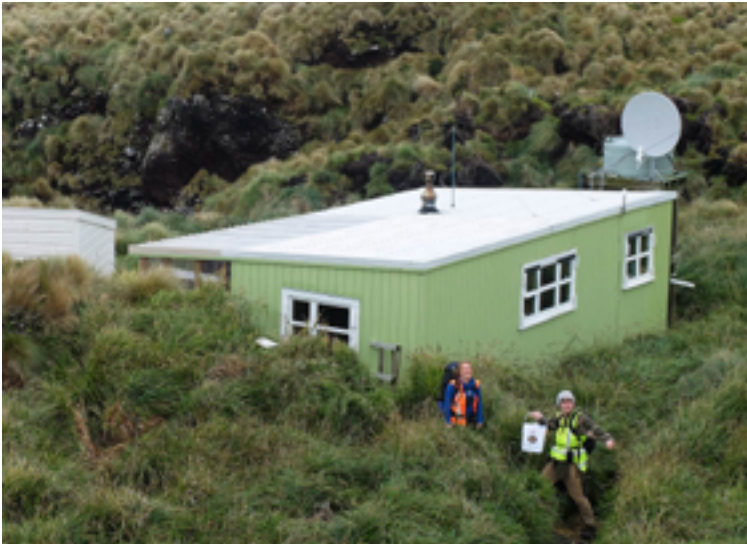
Figure 90. The west and south (rear) sides of the BAAS hut in 2018, with Hayley Ricardo and Theo Van Noort. *Photo: Peter Petchey.*

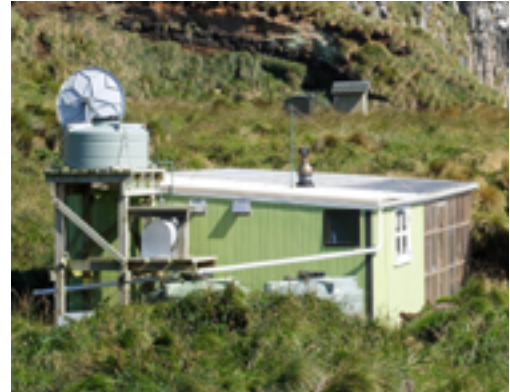
were mounted at the eastern end of the hut (Fig. 91). A satellite dish is now also mounted on the header tank frame (it is dismantled when the hut is unoccupied), giving a level of communications that could only be dreamt of in previous decades. During this rebuilding work an annotated board was found that records the original hut construction (Fig. 92). Figures 21 and 93 show the original 1978 kitchen corner of the hut and the same corner in 2018. The main living area of the hut in use is shown in Figure 94.

Figure 91. The eastern (extended) end of the BAAS hut in 2018, showing the header tank stand, satellite dish, water tanks and the modern aluminium window. *Photo: Peter Petchey.*

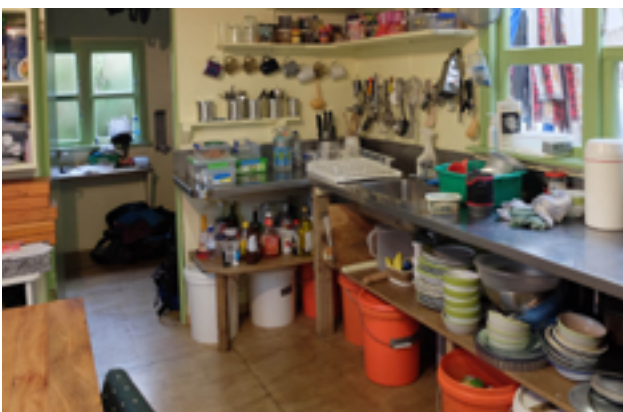
Figure 93. The kitchen corner inside the 1978 BAAS hut in 2018 (see also Fig. 20, 1978). Many of the original features remain – including some of the kitchen utensils! *Photo: Peter Petchey.*

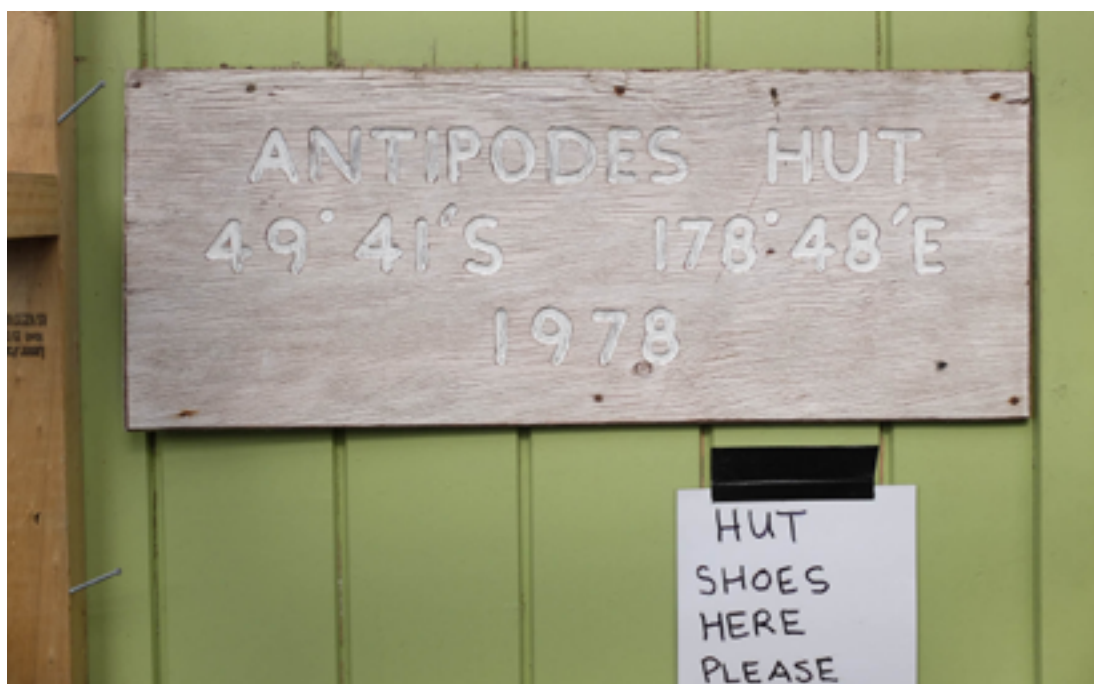
Figure 95. The original wooden hut sign (now protected by the covered veranda) on the wall beside the outside door of the 1978 BAAS hut, 2018. *Photo: Peter Petchey.*

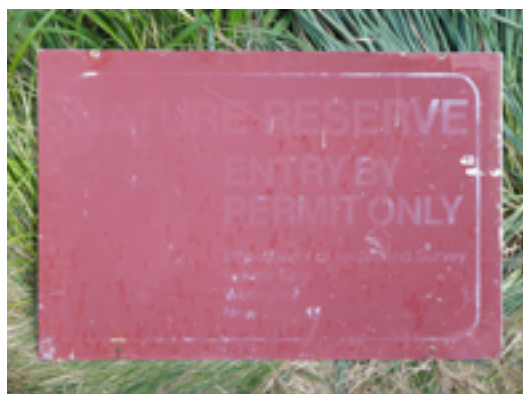
Figure 96. The now very faded nature reserve sign, that was originally mounted on the end wall of the 1978 BAAS hut, in 2018. It is now unmounted inside the covered veranda. *Photo: Peter Petchey.*

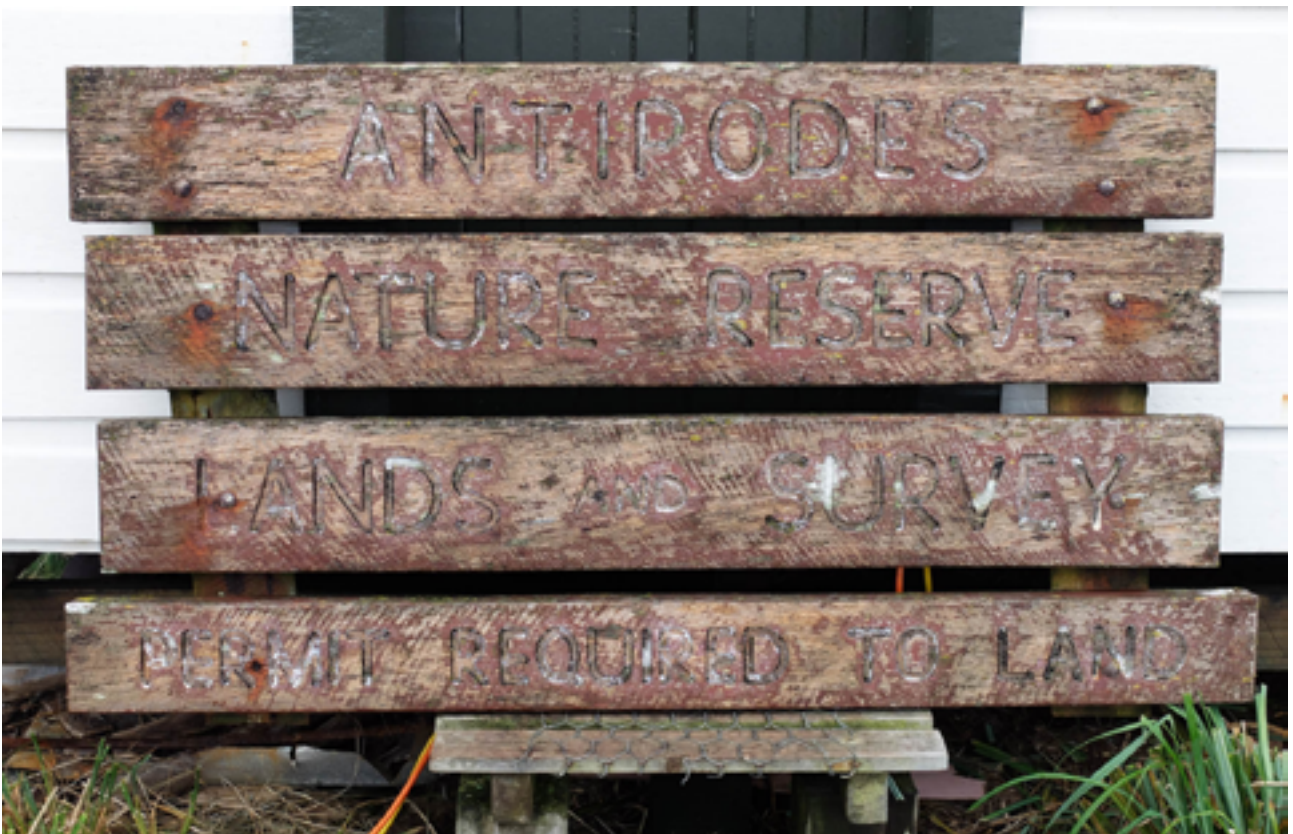
Figure 99. The Lands & Survey sign after cleaning at the 1978 BAAS hut, 2018. *Photo: Peter Petchey.*

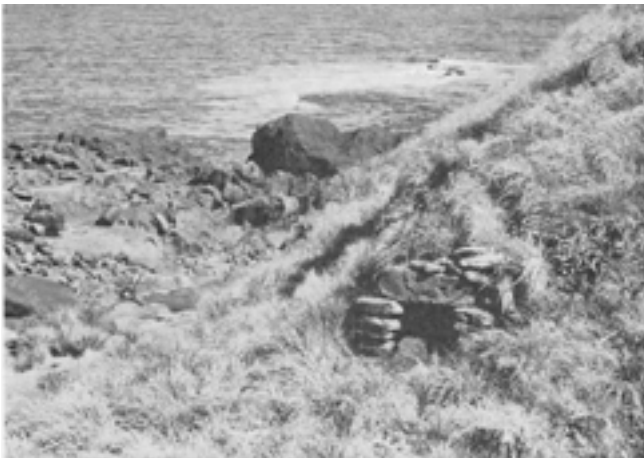
A low tent-shaped ridge of rock runs out towards the sea in the coast of South Bay about 1000 m west of a wide stream bed, dry during our visit, that provides the easiest route down from the plateau in this area. At the landward edge of this ridge, and about 20 m from the sea, a fire place-like structure made from slabs of stone was found, half-hidden among tussock grass [now identified as Hut 1]. This structure was about 1 m high and 1 m wide with a 'lintel' of a heavier slab some 80 cm wide. Nearby was a second similar structure, but less well preserved [Hut 2], and in the grass a glass bottle, now in the Canterbury Museum.

Fig. 13.—Fireplace-like structure on shore of South Bay (see "X" on Fig. 6). (Photo: R. J. Stanley.)

Figure 102. The southernmost South Bay fireplace (Hut 1) found and described by members of the 1969 University of Canterbury Expedition. *Reproduced from Warham & Johns 1975.*

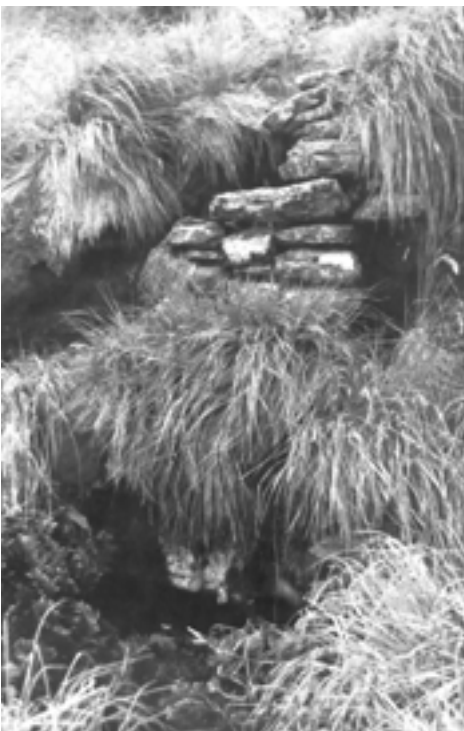
Figure 104. Fireplace and chimney of the western South Bay hut site (Hut 2) in 1978. *Newton 1979, courtesy of Rowley Taylor.*

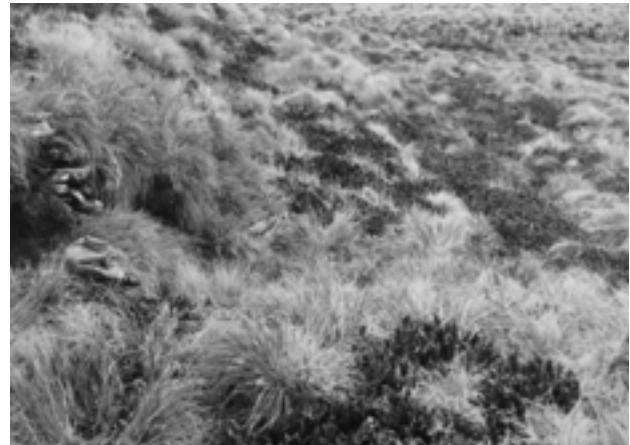
Figure 103. The western South Bay hut site (Hut 2) photographed during the 1978 BAAS Expedition. The original caption reads 'A castaway's camp site with chimney cut into the bank area of site between chimney, packs and Brian Bell.' However, it is certainly a sealers' not a castaways' camp site, as the *Spirit of the Dawn* castaways had no fire. *Newton 1979; Archives New Zealand.*

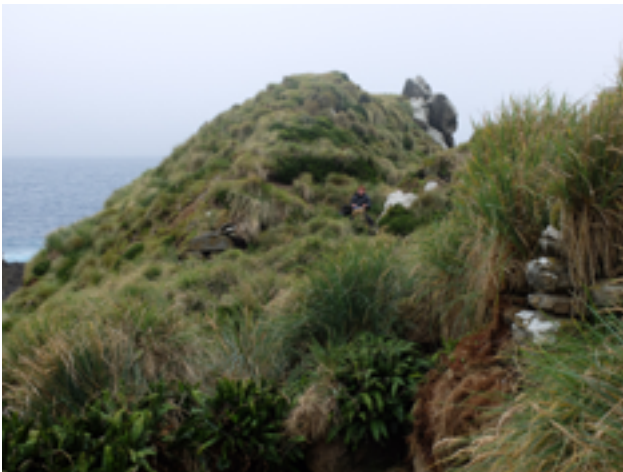
In 2018, the southernmost hut site consisted of a stone fireplace with the large stone lintel that Warham and Johns (1975) commented on. The fireplace faces due north and is set into the bank at the inland end of one of the distinctive ridges that runs perpendicular to the shore (Fig. 105). The lintel is 1040 mm long × 330 mm high, capping a fireplace 700 mm wide × 500 mm high (although this latter dimension has probably been reduced by soil build up) (Fig. 106). The hut site was covered with tussock grass and the original outline of the hut was not visible (but might survive as subsurface archaeological evidence).

Figure 105. South Bay hut sites. Hut 1 (left midground) and Hut 2 (chimney in right foreground) in 2018, with one of the rocky ridges that provided shelter for the camp in the upper centre of the view. *Photo: Peter Petchey.*

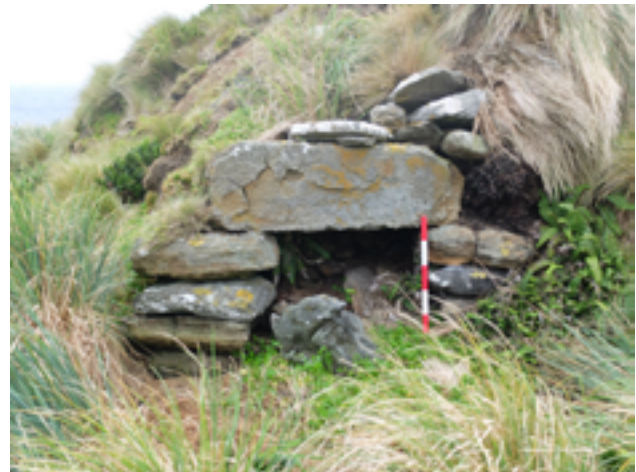
Figure 106. The stone fireplace of South Bay Hut 1 in 2018. The scale is 0.5 m long. *Photo: Peter Petchey.*

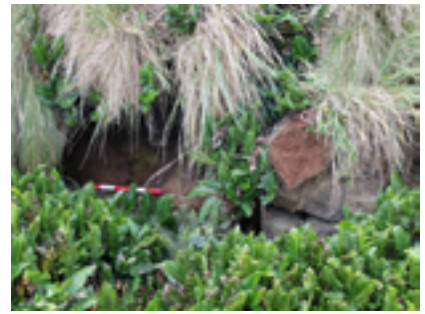
Hut 3 was found on the side of a level area set slightly above and between Huts 1 and 2 during the 2018 survey. The form of Hut 3 is less obvious than the very clear fireplaces of the other two huts, with the visible evidence consisting of a stacked stone wall or structure at the end of a cut section of bank (Figs 111, 112). The stone structure is 660 mm tall × 400 mm wide, but projects only 360 mm from the bank. The cut section of bank is 2.36 m long. Obtaining further detail of this hut would require the area to be cleared of vegetation (it is presently covered in thigh-high fern).

Figure 111. Hut 3 site, with the stone wall section to the right, and the cut bank (with the 0.5m scale) to the left, 2018. *Photo: Peter Petchey.*

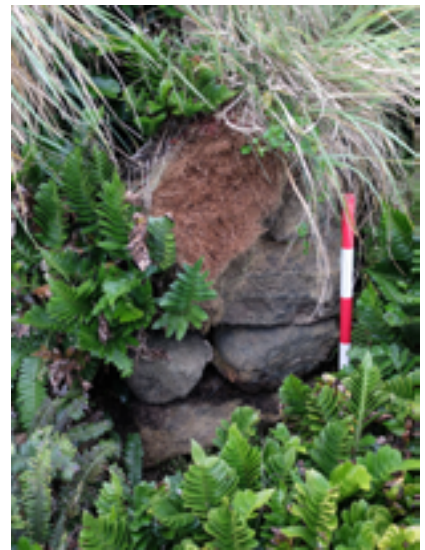
Figure 112. The stonework of Hut 3 (0.5m scale in 100mm units), 2018. *Photo: Peter Petchey.*

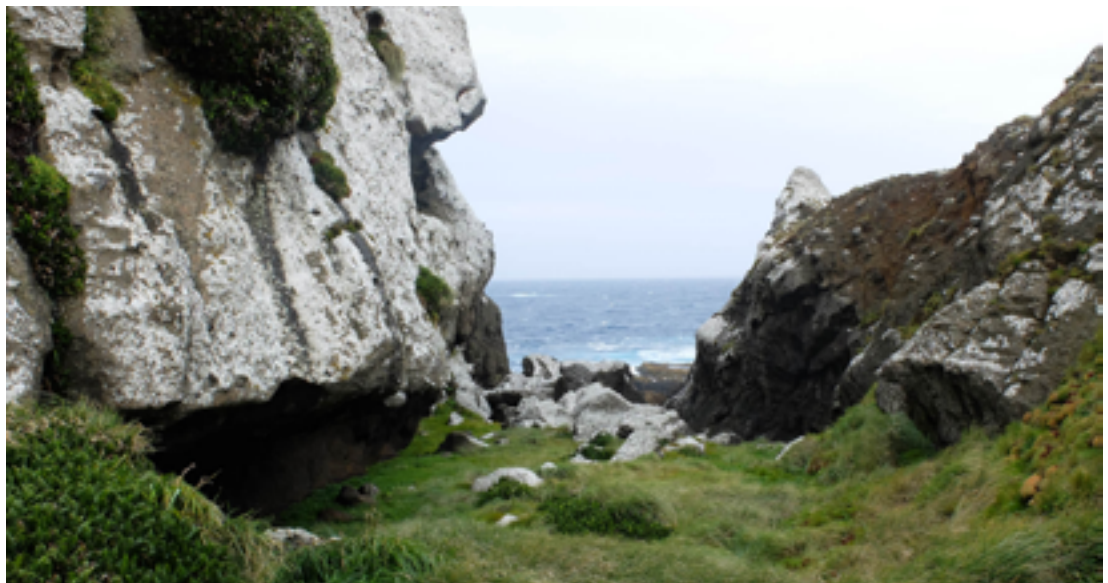
As discussed above, the identified features of the sealers' camp are set against the base of several distinctive rocky spurs that sit perpendicular to the shoreline and would have provided good shelter for the camp. Although no other artefacts or obvious structures were observed in 2018, it is quite likely that the sealers did make use of this wider area, which consists of long narrow sheltered flats and a natural rock shelter (Fig. 113). The penguin skin cache at Anchorage Bay (site Antipodes Is. 1) was in a less prepossessing shelter than this one, so it is highly likely that the sealers used this shelter to store seal skins and/or other supplies.

Figure 113. Natural rock shelter (left) in one of the narrow gullies between the ridges that shelter the sealers' camp, 2018. *Photo: Peter Petchey.*

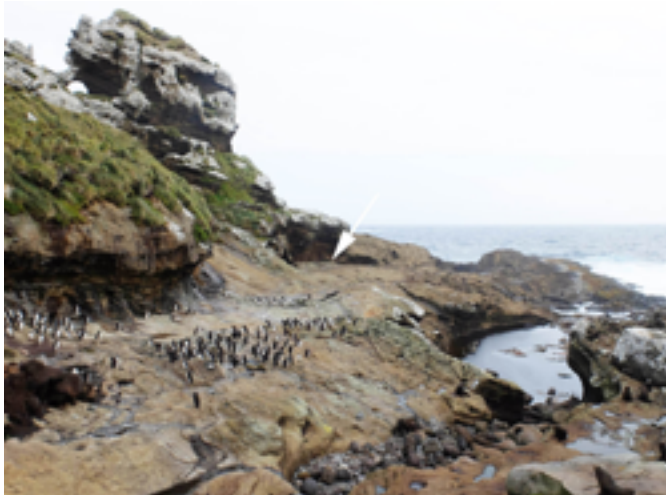
Along the coast to the west of the main sealers' campsite an old fireplace that contained charcoal and burnt penguin bones was found under a rock by Jane Forsyth and Ian Turnbull in October 1990 (Taylor 2006: 54). At the time of discovery, the rock formation sheltering the fireplace was being eroded by storm waves. The fireplace had not been observed since its discovery in 1990, so it was uncertain whether it still survived. However, the 2018 survey did relocate it under an overhang on the west side of a rocky ridge running perpendicular to the shoreline (Fig. 114). The fireplace overlooks a large rock platform that is used by both seals and penguins, which is in turn above a large, sheltered pool that is replenished every high tide.

Figure 114. The location of the sealers' fireplace (arrow) under a rock overhang, overlooking a smooth rock platform and sheltered tidal pool, 2018. *Photo: Peter Petchey.*

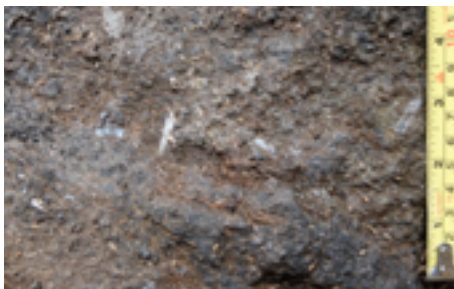
Figure 116. Close-up of the hard ashy hearth matrix of the south coast fireplace, containing fragments of burnt bone, 2018. The seal hairs are due to modern seals occupying the area. The scale is in inches (top) and centimetres (bottom). *Photo: Peter Petchey.*

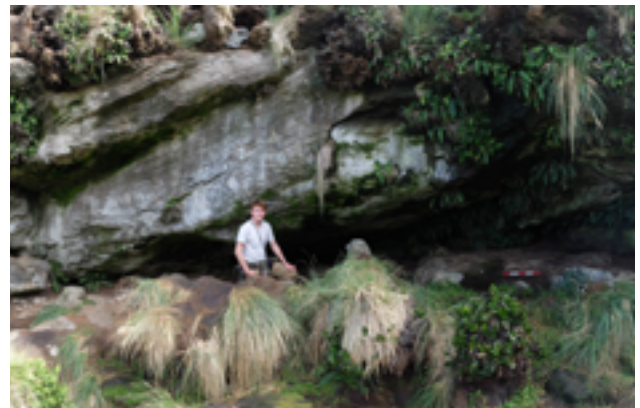
The castaway cave was inspected in 2018. It is approximately 7 m long, with upper and lower areas as described above. The upper platform is 4 m wide, extends back a maximum of 2.8 m, with a maximum headroom of 1.6 m. The lower area has only 1 m of headroom. The cave is now being occupied by seals, so the remains of the walls are slowly being degraded. No artefactual material was observed during the visit. The two nearby volcanic plugs (Fig. 118) were also searched for any evidence of the castaways' mast, but nothing was found (Figs 119–123).

Figure 121. Front view of the castaway cave in 2018, with Theo Van Noort in the lower section, and the photo scale (0.5 m long) to the right on the upper platform. *Photo: Peter Petchey.*

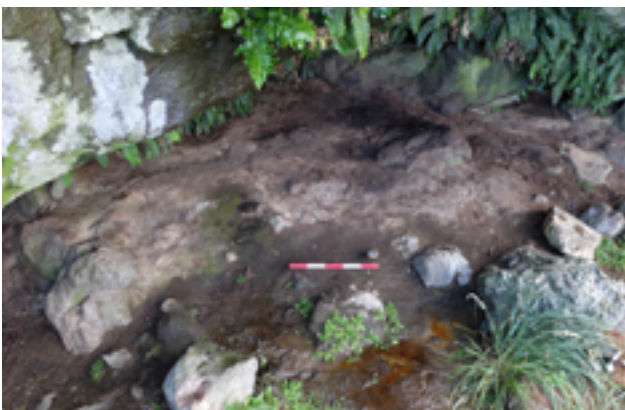
Figure 122. The upper platform inside the cave in 2018. The scale is 0.5 m long. *Photo: Peter Petchey.*

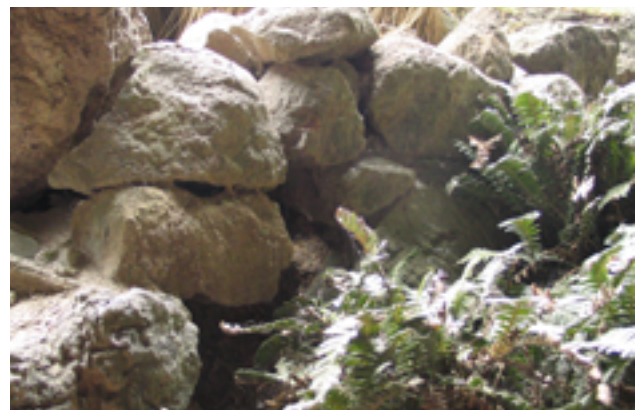
Figure 123. Remains of the low rock wall that the castaways built in front of the cave, January 2004. *Photo: Kath Walker.*

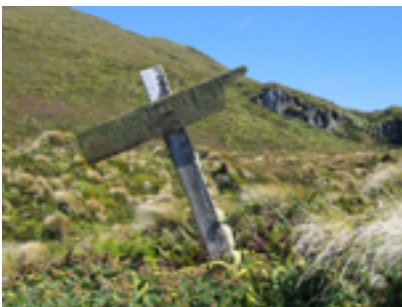
The fingerpost consists of a timber upright with a timber fingerboard attached at the top. The lettering and pointing hand on the board are slightly raised because of the extra protection afforded by the original paintwork (now weathered away). The post is 3½ inches (90 mm) square and 8 feet (2.45 m) tall (including the below-ground section). The fingerboard is 30 inches (760 mm) long, 5½ inches (140 mm) wide and 1 inch (25 mm) thick and is set 5 inches (130 mm) down from the top of the post (it has been set slightly higher in the past, as evidenced by old bolt holes). The base of the post was sawn squarely off, unlike other posts in the island that had axed points, and a circular saw had been used for this cut, indicating that the post was cut to length in a sawmill, rather than being hand sawn by the ship's carpenter. Some features of this post differ from the other surviving Antipodes Island posts, notably the dimensions of the timber and this evidence of sawing.

Figure 126. The Alert Bay fingerpost in January 2004. The light angle shows that the lettering stands proud of the rest of the board: this is due to the paint of the letters providing some protection from weathering for the underlying timber. Photo: Kath Walker.

When the fingerpost was recorded by Kath Walker and Graeme Elliott in January 2004, the board was still attached using two bolts and the post was leaning. Before leaving at the end of their trip, the board was refixed by DOC-staffer Jeremy Carroll using stainless steel screws, the post righted, and the timber treated with preservative. Although the stainless screws are somewhat intrusive, they have undoubtedly saved the fingerboard from falling from the post (as has happened with the other boards on the island). Iron nails have also been used to fix the board at some time, and the rusty remains of these are present. Figures 125–128 show the Alert Bay fingerpost at different times, along with a diagram based on a 2004 tracing of the raised post lettering (Fig. 129).

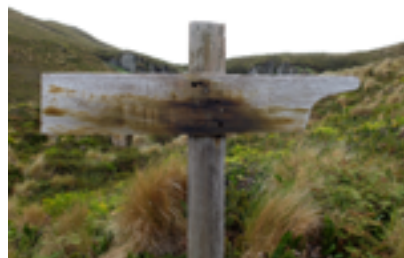
Figure 127. The Alert Bay fingerpost in 2018, with the slightly raised lettering visible. The stainless-steel screws were added by DOC staff in 2004. While incongruous, they are effective and durable. Photo: Peter Petchey.

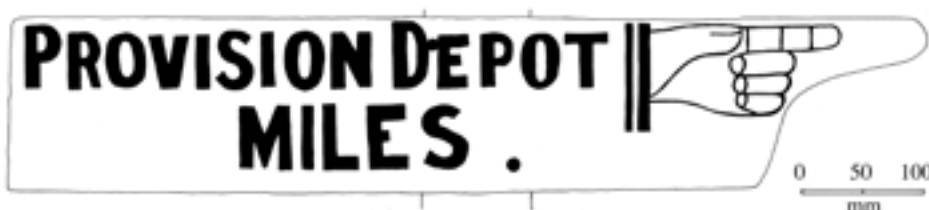
Figure 129. Tracing of the raised Alert Bay fingerpost 2018. Note that the actual number of miles to the depot would have been added in a different paint when the post was erected, and eroded away more quickly than the other signwriting, thus providing less protection to the wood beneath.

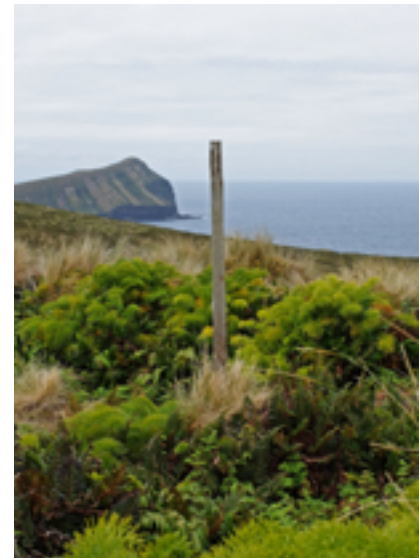
The post is 5 feet 11 inches (1.8 m) tall (including the below-ground section) and is leaning eastward at about 15° from the vertical. Although wind-worn and slender, it is in reasonable condition. The in-ground end is broken to a point, and it appears likely that the post was originally longer, has been broken off and then replaced in the ground by someone. The post tapers slightly, from $2\frac{1}{4} \times 2\frac{1}{8}$ inches (57×54 mm) near the base to $1\frac{1}{2}$ inches (38 mm) square at the top.

Figure 132. The Conical Hill fingerpost with Bollons Island in the background, 2018. *Photo: Peter Petchey.*

All of the fingerposts that were inspected in 2018 were coated with copper naphthenate (CN) emulsion timber preservative. Most posts were withdrawn from the ground so the subsurface section could also be treated; only the Cave Point post was too firmly embedded for this to be carried out. The treatment conditions were not ideal, as the posts were not fully dry and could not be wrapped after the application of preservative, but a good thick coverage was obtained. The Alert Bay post was given two coats (the last of the emulsion was used up on the post).

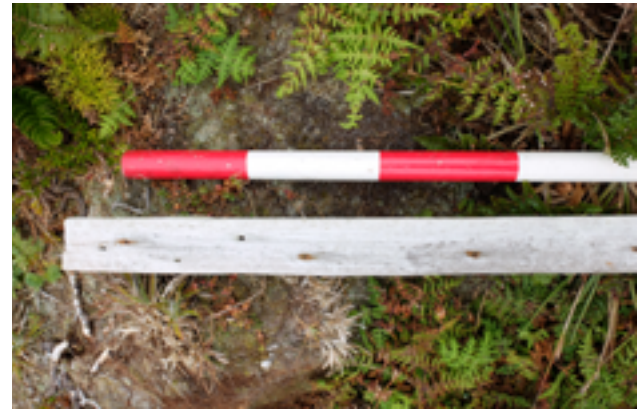
There are six nail holes in the southern side of the top of the post that show where the fingerboard was mounted. On the northern side of the post there is a row of nine flat-headed tacks/tack holes stretching from the top to the bottom of the post. Some of the holes contain the rusted remains of iron tacks, and three copper tacks remain in place, with small fragments of a light canvas held beneath the heads. The location is very conspicuous, and a flag may have been tacked to the post either when it was erected or later (possibly for mapping purposes).

Figure 134. The tack holes on the Conical Hill fingerpost, on the opposite side to the fingerboard nail holes, 2018. Post removed from hole for examination. Scale has 100mm divisions. *Photo: Peter Petchey.*

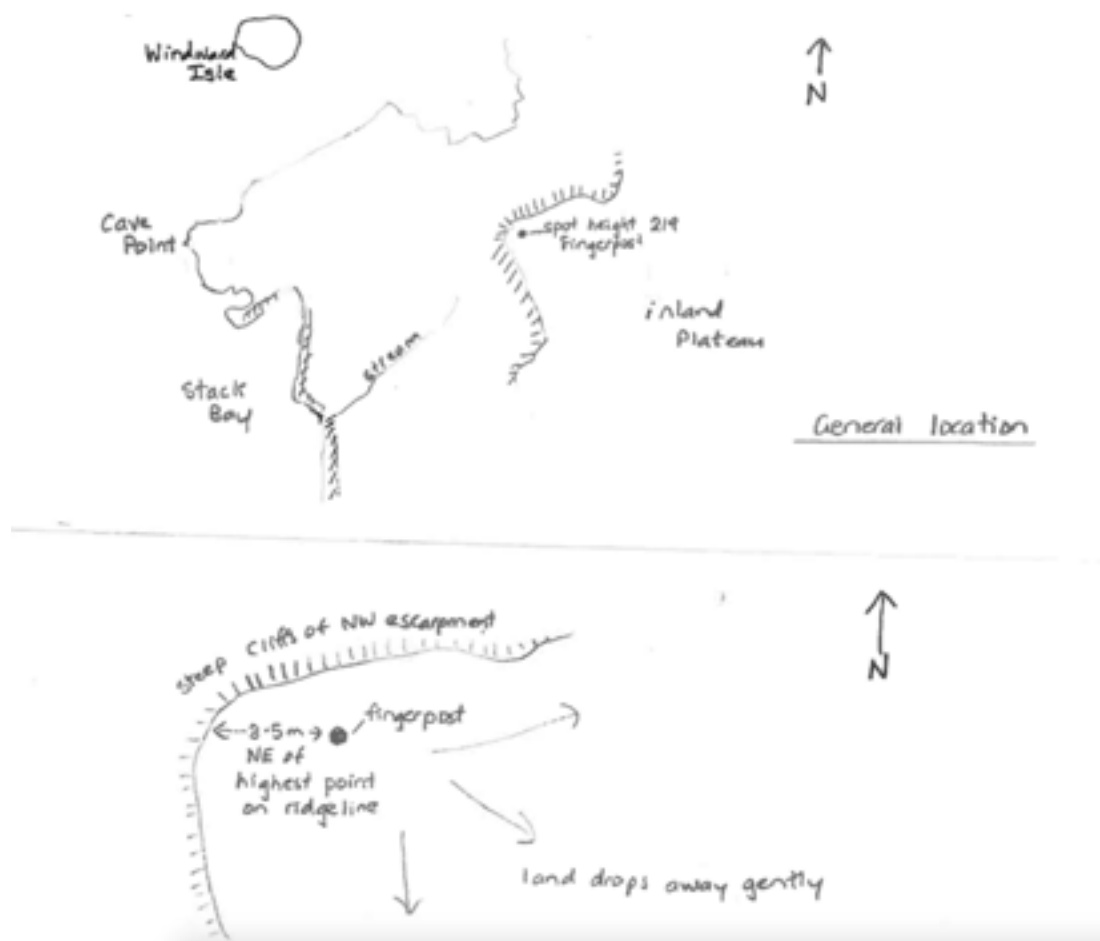
Figure 135. Location of Cave Point (spot height 219) fingerpost. *Sketch map by Kath Walker.*

This fingerpost is located on a point of high ground about 1.2 km east of Cave Point on the west side of Antipodes Island (Figs 1, 135–137). It was found during the 1969 University of Canterbury Expedition: ‘later that morning we headed for higher ground to the west and found the remains of an old castaway signpost dating from 1894 on top of a 219-metre high peak’ (Taylor 2006: 236). This was just the standing post, missing the fingerboard. The fingerboard was found by Kath Walker and Graeme Elliott in January 2015 in a hole between the tussocks about 2 m NE of the post, buried about 500 mm deep under tussock and soil. It had been nailed to the post with six iron nails, but these had corroded away. The fingerboard is of a simple design, with the point formed by straight cuts rather than the more curved design of the Alert Bay finger post. The fingerboard was too decayed and fragile to remount on the post and was returned to New Zealand for conservation treatment. It is now held at the Southland Museum and Art Gallery in Invercargill.

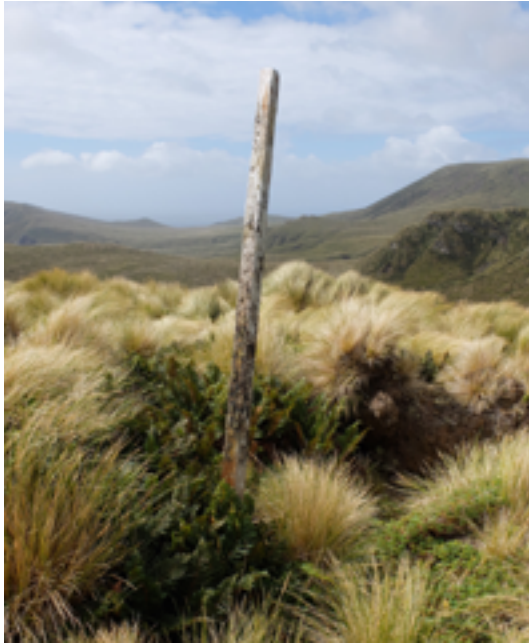
The Cave Point (spot height 219) fingerpost is the only one on the island that is firmly set in its hole, so it could not be removed for measurement or preservative treatment of the below-ground section. The above-ground post is 5 feet 4 inches (1.63 m) tall, and tapers from 25/8 × 2 inches (67 × 51 mm) to 1 3/4 inches (44 mm) square at the top. It is partly covered with a white lichen, which has been mistaken for surviving paint. The fingerboard was mounted 1/2 inch (13 mm) below the top of the post and was attached by four iron nails (Figs 138–141).

Figure 137. The Cave Point (spot height 219) fingerpost in 2018. *Photo: Peter Petchey.*

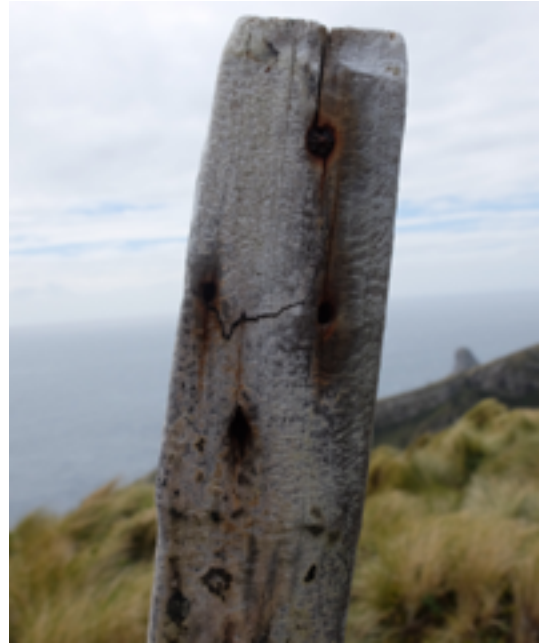
Figure 138. The southern face of the Cave Point (spot height 219) fingerpost in 2018, showing the nail holes that held the fingerboard in place. *Photo: Peter Petchey.*

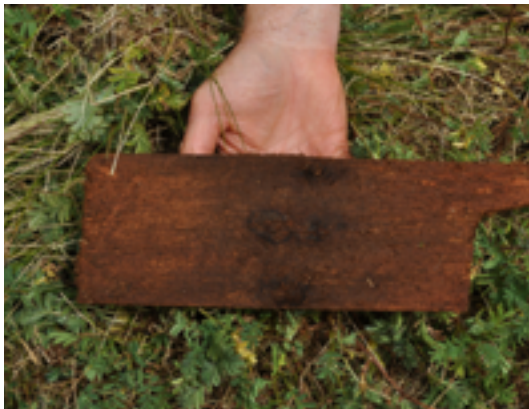
Figure 139. The front face of the fingerboard from the Cave Point (spot height 219) fingerpost, found by Kath Walker and Graeme Elliott on 26 January 2015 buried a short distance from the standing post. *Photo: Kath Walker.*

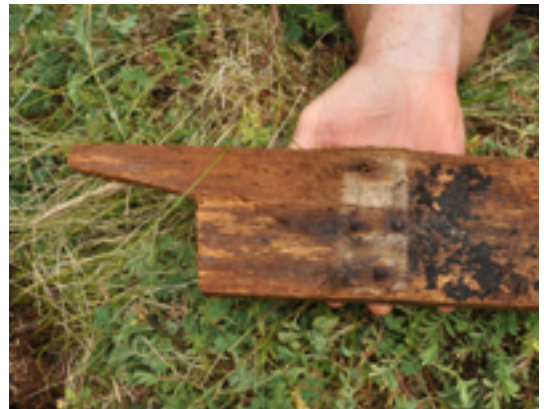
Figure 140. The rear face of the Cave Point (spot height 219) fingerboard as found in January 2015. *Photo: Kath Walker.*

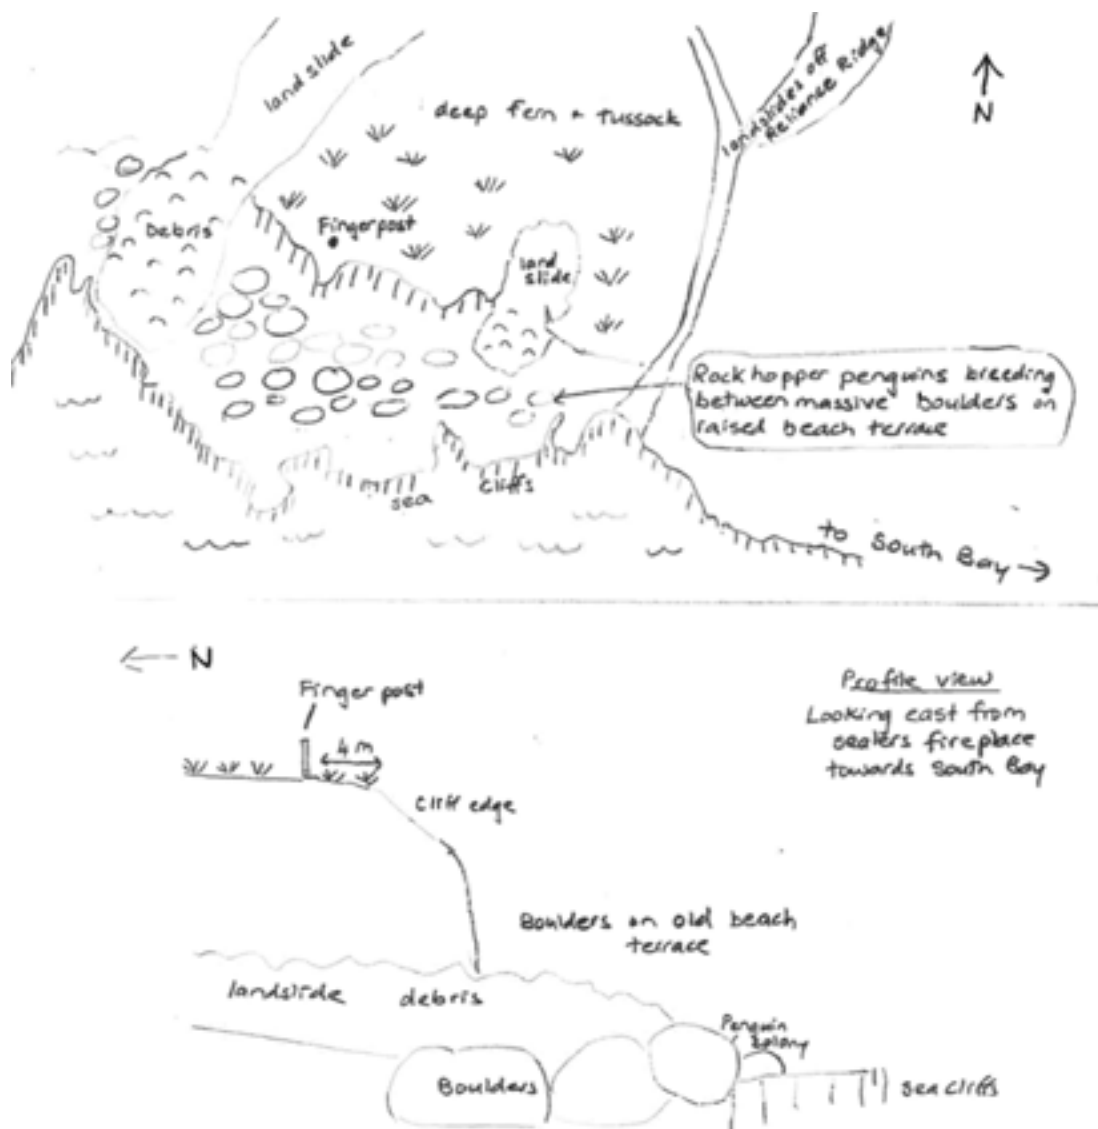
Figure 141. Plan and profile of south coast fingerpost location. Sketch map by Kath Walker.

The south coast fingerpost is located at the top of a cliff above a raised boulder beach terrace (which is occupied by a penguin colony), about 130 m southeast from the south coast sealers' camp site (Figs 28, 141). It is in a conspicuous location, set about 4 m back from the cliff edge (Fig. 142). The post is still standing (Fig. 143), but the fingerboard is missing (Fig. 144) and has not been found. In common with most of the other Antipodes Island fingerposts it is loose in the ground and was pulled out for measuring and preservative application in 2018.

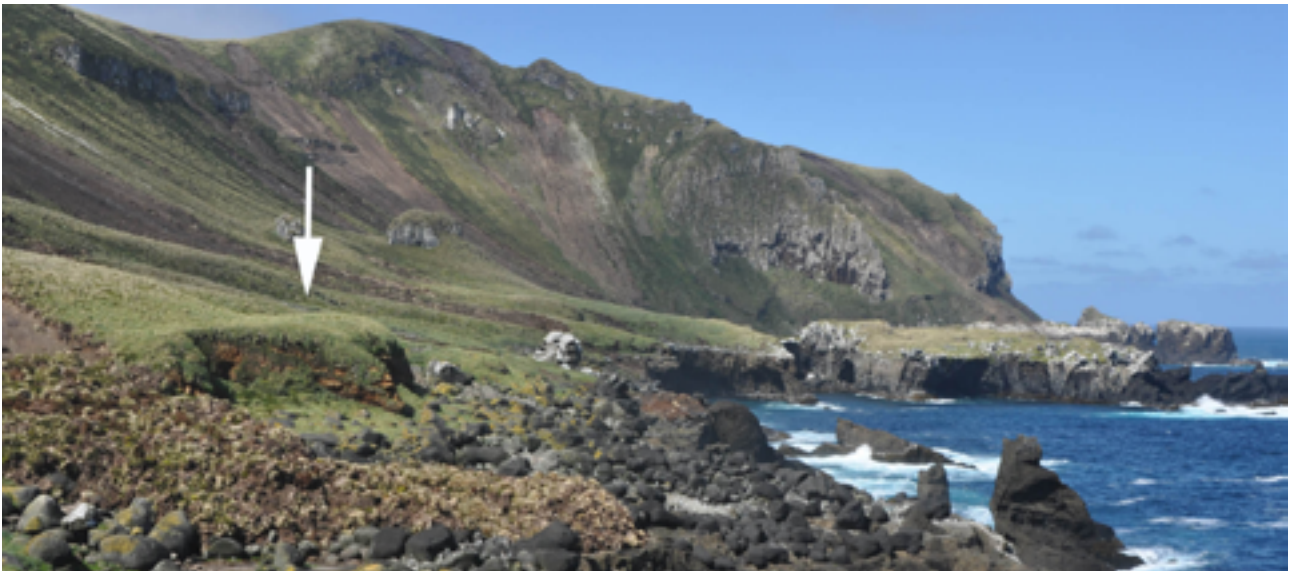
Figure 142. Looking east towards South Bay from the sealers' camp promontory, January 2015. The south coast fingerpost is located on the small hillock (arrowed). *Photo: Kath Walker.*

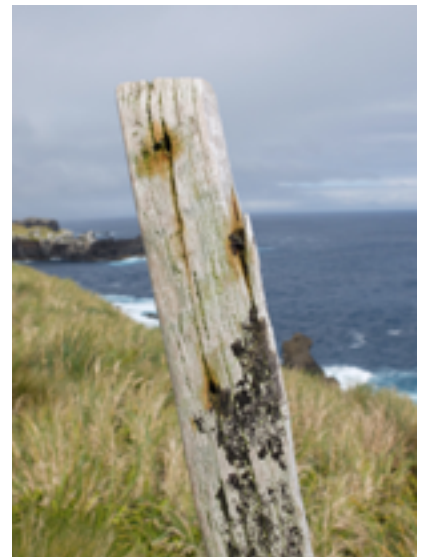
The post is 9 feet 6 inches (2.9 m) long, of which 6 feet 3 inches (1.9 m) stands above ground. The post tapers and measures $2\frac{1}{8} \times 2\frac{3}{4}$ inches (54×70 mm) at ground level, and $2\frac{1}{8} \times 1\frac{3}{4}$ inches (54×44 mm) at the top. The roughly parallel faces have circular saw marks (Fig. 145) while the tapering faces have hand saw marks (Fig. 146). This indicates that a heavy machine-milled board was cut lengthways to produce the post, which was also how the South Bay fingerpost nearby was produced. The bottom end of the post has an axe-cut point (Fig. 147). The rusted nails that once fixed the board are still visible in the top of the post (Fig. 144).

Figure 144. The top of the south coast fingerpost (2018) showing the nail holes where the fingerboard was attached. *Photo: Peter Petchey.*

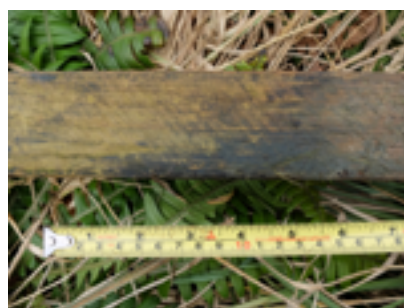
Figure 146. Hand-cut saw marks on the south coast fingerpost, 2018. *Photo: Peter Petchey.*

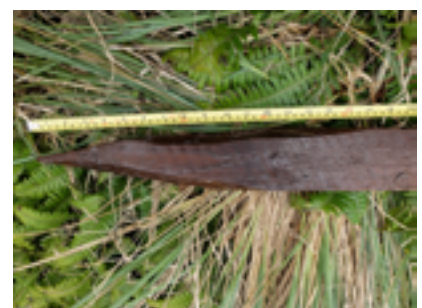
Figure 147. The axe-cut end of the south coast fingerpost, 2018. *Photo: Peter Petchey.*

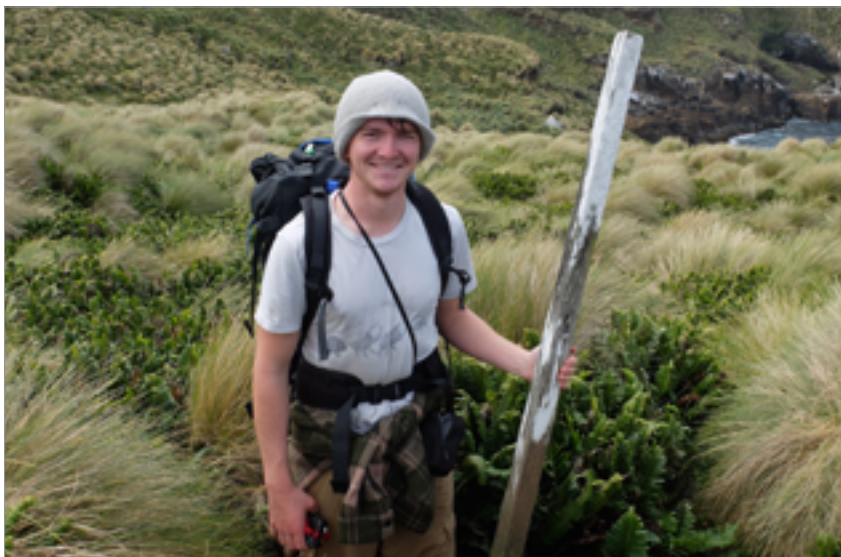
The South Bay fingerpost is located on the western side of the neck of the isthmus that defines the western side of South Bay (Figs 29, 117, 148–49), 100 m to the west of the *Spirit of the Dawn* castaway cave, and 150 m SW of the volcanic plug on which the castaways placed a flagpole. It is located about 10 m above sea level, and about 5 m back from the seaward cliff edge (Fig. 148). Only the post remains, with the fingerboard missing. The post is partially covered with white lichen, which has been mistaken for paint (Fig. 150).

Figure 150. Theo Van Noort and the South Bay fingerpost in March 2018. *Photo: Peter Petchey.*

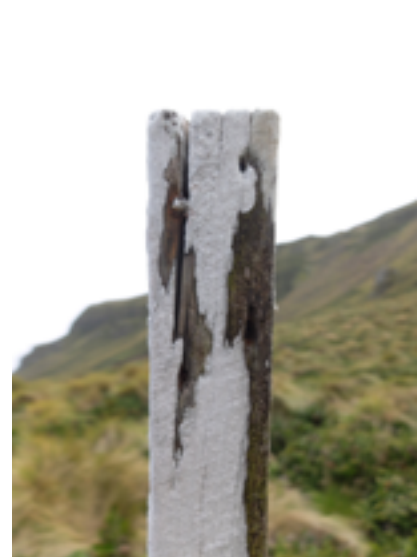
The post is 9 feet 3½ inches (2.83 m) long, of which 6 feet 6½ inches (2 m) stands above ground. The post tapers, measuring 2⅞ × 2 inches (73 × 51 mm) at ground level, and 2 × 1⅞ inches (51 × 46 mm) at the top (Fig. 151). The roughly parallel faces have circular saw marks (Fig. 152) while the tapering faces have hand saw marks (Fig. 153). This indicates that a heavy machine-milled board was cut lengthways to produce the post, which was also seen on the south coast fingerpost nearby. The bottom end of the post has an axe-cut point (Fig. 154). The rusted nails that once fixed the board are still visible in the top of the post (Fig. 151).

Figure 151. The top of the South Bay fingerpost (2018), showing the white lichen and nail holes where the fingerboard was attached. *Photo: Peter Petchey.*

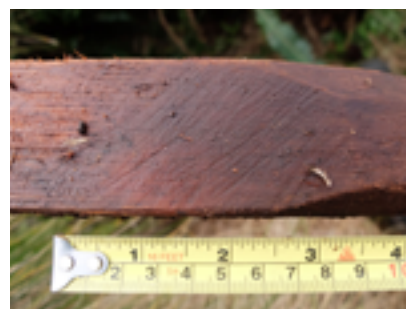
Figure 153. Hand saw marks on one face of the South Bay fingerpost, 2018. *Photo: Peter Petchey.*

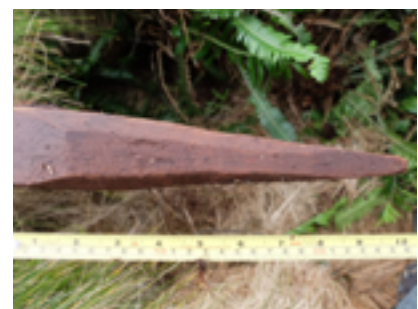
Figure 154. The axe-cut point of the South Bay fingerpost, 2018. *Photo: Peter Petchey.*

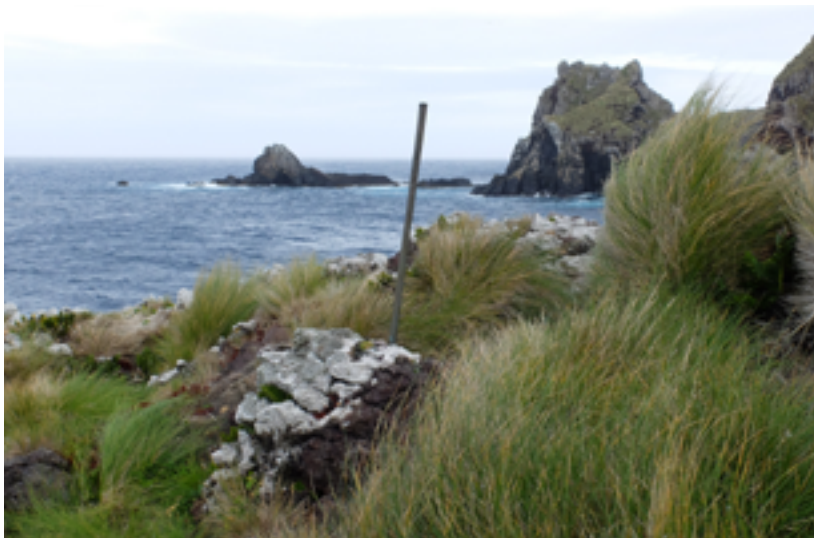
A Department of Scientific & Industrial Research (DSIR) magnetic survey mark is indicated by a copper or brass pipe mounted vertically over a natural rock arch at Reef Point, at a point that looks down into Stella Bay (Figs 1, 155). This pipe is stamped 'MAG SURVEY DSIR NZ' (Fig. 156). The geophysics function of the former DSIR is now with GNS.

Figure 155. The DSIR Magnetic Survey mark on Reef Point, with Stella Bay in the background, 2018. *Photo: Peter Petchey.*

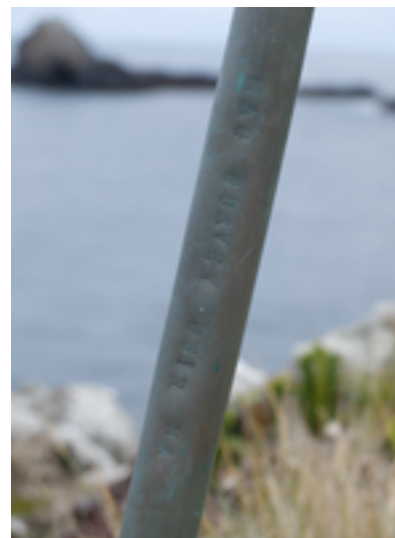
Figure 156. The stamped legend on the DSIR magnetic survey mark, 2018. *Photo: Peter Petchey.*

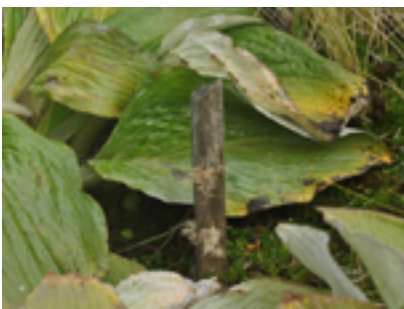
The remains of pegs and/or temporary survey marks were observed on the summits of Mount Galloway, Mount Melville and Albatross Point (Fig. 1). Mount Galloway has a small wooden peg, only one inch (25 mm) square and standing 10 inches (260 mm) high (Fig. 158). Mount Melville and Albatross Point both have galvanised iron pipes set vertically into the ground (Fig. 159), while Mount Melville also has some timber remnants near the pipe (Fig. 160). From the locations and nature of these items it seems most likely that they are survey marks set out for surveying and aerial photograph control; a plan of photo control points dated November 1972 (Southland SO 8564) shows points on all of these locations.

Figure 158. Broken peg or post on the summit of Mount Galloway in 2017. *Photo: Kath Walker.*

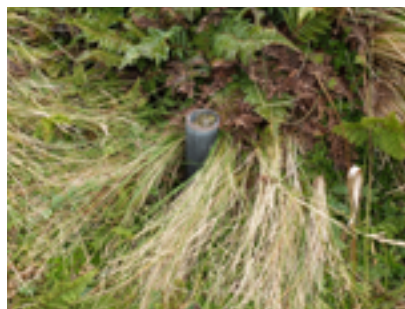
Figure 159. 1¼ inch diameter galvanised water pipe at the summit of Mt. Melville, close to several old timbers, 2018. This is probably a survey point from the 1969 (or a subsequent) expedition. *Photo: Peter Petchey.*

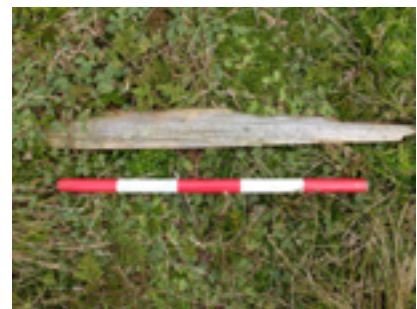
Figure 160. Timber at the summit of Mt. Melville, probably associated with the iron pipe survey mark (Fig. 159). A 7/8-inch-square timber is buried beneath this one. *Photo: Peter Petchey.*

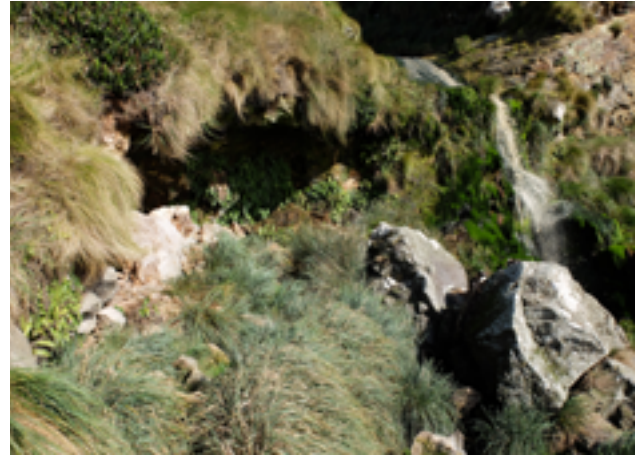
inlet) showed evidence of recent natural changes (a roof fall covered the cave floor and a large landslide covered the flat area) (Fig. 163). This reflects the situation found all over the island: the dynamic nature of the land, especially the regular slips and landslides, mean that archaeological sites can be ephemeral and easily swept away.

Figure 163. A cave beside a stream in Ringdove Bay in 2018; a recent roof fall in the cave covered the floor. While it is possible that this cave could have been used by people, natural processes on Antipodes Island are such that archaeological evidence is likely to be rapidly buried or swept away. *Photo: Peter Petchey.*

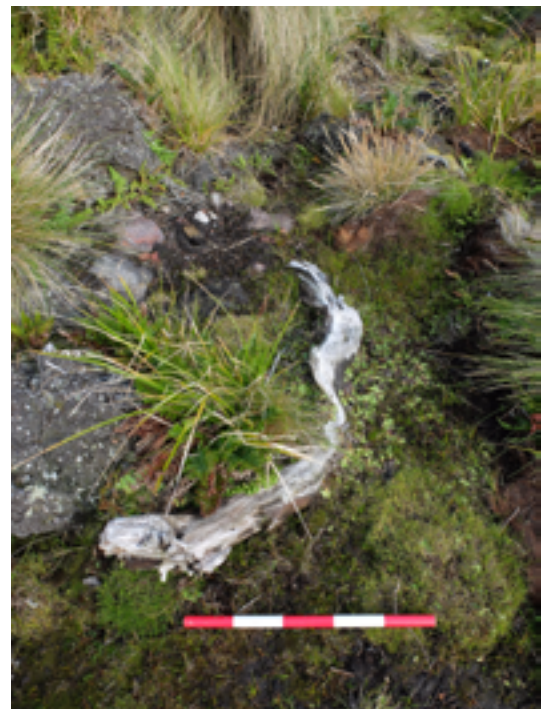
The Antipodes Islands are devoid of woody vegetation apart from shrubby *Coprosma rugosa*. Although some individual stems (both in living plants and dead wood) up to 100 mm diameter were observed in 2018 (Fig. 164), and Rowley Taylor measured examples up to 140 mm in diameter, nowhere on Antipodes Island is this vegetation abundant enough to supply a reliable fuel source for a semi-permanent encampment. This raises the question of what did the men living on the island during the sealing era (when a maximum population of 86 people ashore was estimated by Taylor (2006: 59)) burn to cook food and keep warm?

Figure 164. Long-dead *Coprosma rugosa* timber in Sectoides Stream on the western side of Antipodes Island, 2018. The scale is in 100 mm units. Photo: Peter Petchey.

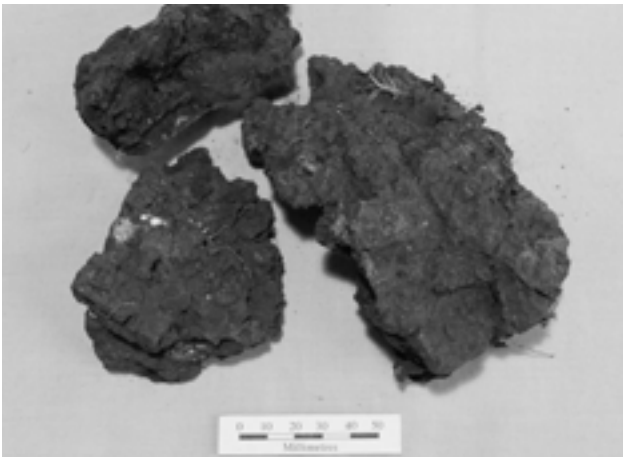
This peat is constantly being laid down as vegetation and animals (principally birds) die and (as has already been observed earlier in this report), is also constantly slipping away in landslides (Fig. 27). Many of these peat deposits are dense and some have become lignite (Scott et al. 2013). To test the possibility that this was used as fuel by the sealers, a 2.5 kg sample was taken, mixed from four sites: the slip beside the South Coast sealers' camp (Fig. 166), Dougall Stream, Ringdove Stream and Sectoides Stream. This sample was returned to New Zealand and air-dried for several months before being burnt in an open grate using dry timber as a starter (Fig. 167). The sample did burn reasonably well once ignited and would have been a viable fuel if it could be dried out. Combined with the sealers' suspected use of animal fats for fuel (at the South Coast fireplace), this suggests that they could have used a mixture of locally available fuels on Antipodes Island. However, confident answers to this question await the opportunity to analyse the ash of the known historic fireplaces on the island.

Figure 165. Compressed peat (lignite) sample from the slip beside the south coast sealers' camp, 2018. *Photo: Peter Petchey.*
