Archaeology of the Antipodes Islands

Peter Petchey, Rowley Taylor, Kath Walker and Graeme Elliott

This paper may be cited as: Petchey, P.; Taylor, R.; Walker, K.; Elliott, G. 2023: Archaeology of the Antipodes Islands. Department of Conservation Te Papa Atawhai, Wellington, New Zealand. 101 p.

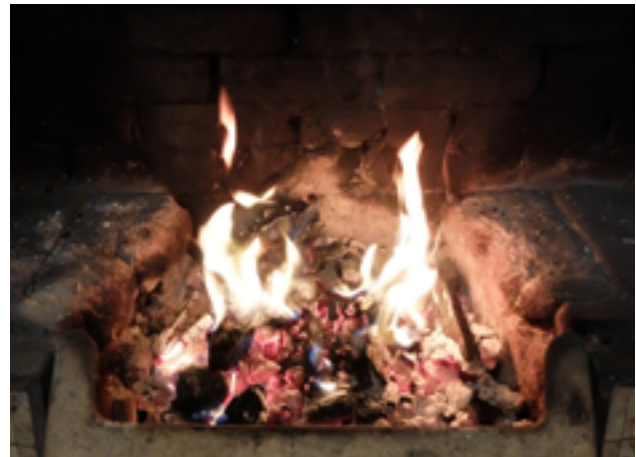
This peat is constantly being laid down as vegetation and animals (principally birds) die and (as has already been observed earlier in this report), is also constantly slipping away in landslides (Fig. 27). Many of these peat deposits are dense and some have become lignite (Scott et al. 2013). To test the possibility that this was used as fuel by the sealers, a 2.5 kg sample was taken, mixed from four sites: the slip beside the South Coast sealers' camp (Fig. 166), Dougall Stream, Ringdove Stream and Sectoides Stream. This sample was returned to New Zealand and air-dried for several months before being burnt in an open grate using dry timber as a starter (Fig. 167). The sample did burn reasonably well once ignited and would have been a viable fuel if it could be dried out. Combined with the sealers' suspected use of animal fats for fuel (at the South Coast fireplace), this suggests that they could have used a mixture of locally available fuels on Antipodes Island. However, confident answers to this question await the opportunity to analyse the ash of the known historic fireplaces on the island.

Figure 166. Burning the dried peat/lignite sample in an open hearth in Dunedin, 2018. *Photo: Peter Petchey.*
