DENNISTON AT WORK

THE DENNISTON BRAKEHEAD

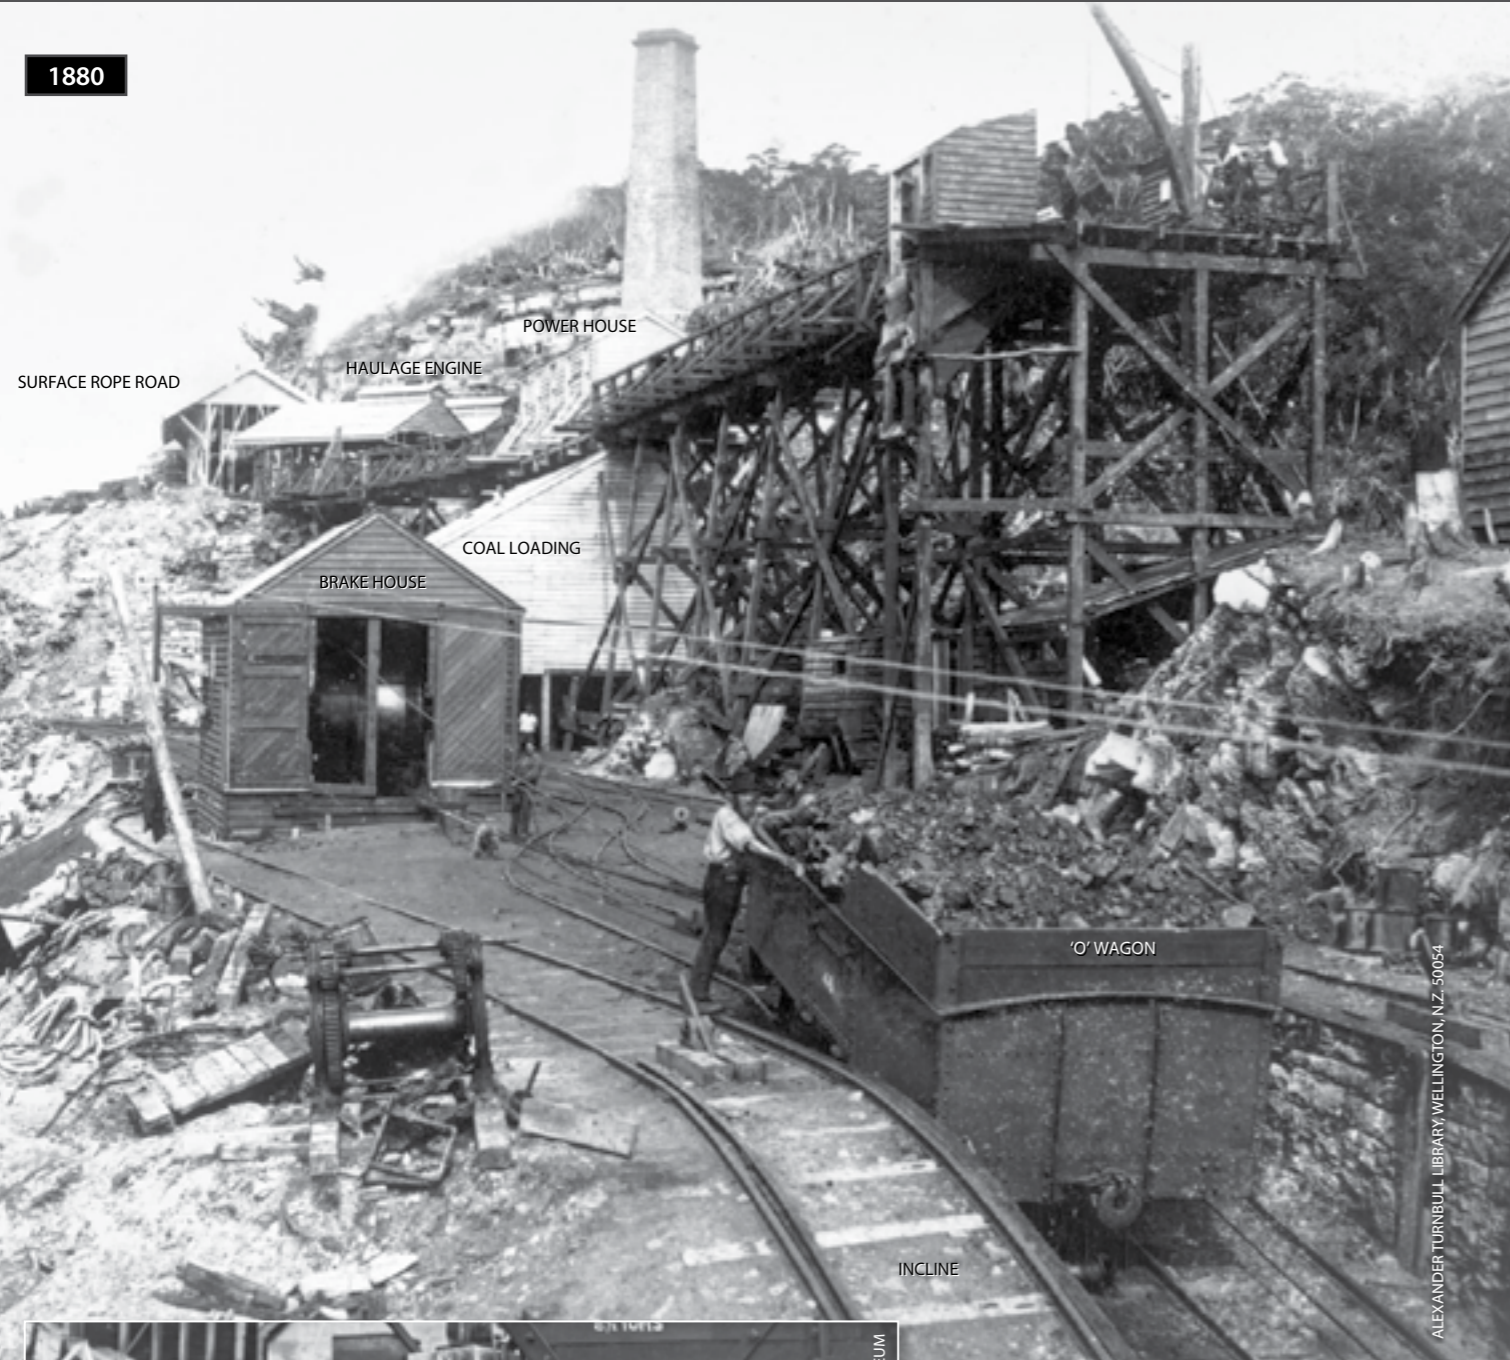
1880

Coal arrived along the rope road at the upper level of the Brakehead where tubs were unclipped, weighed and emptied into the bins. Coal was fed into railway wagons located on the lower level of the Brakehead – in this case early 'O' wagons.

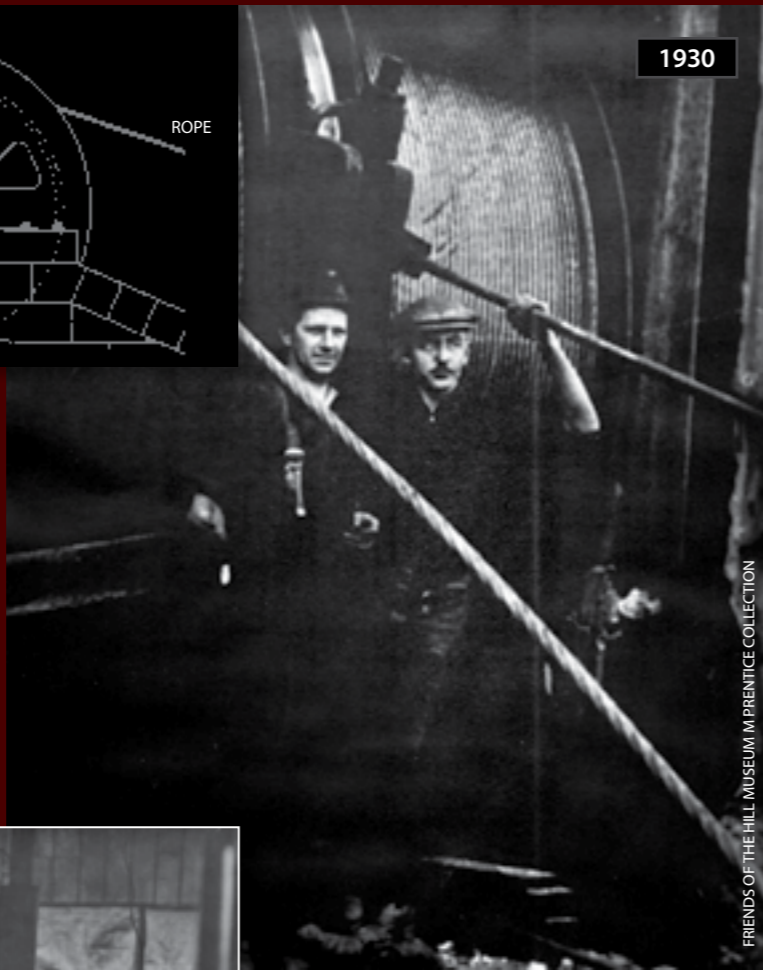
1930

For the first few years of Incline operations, the 3.2 metre diameter drum had a “strap friction” brake which consisted of a single brake band on the drum. The cable band broke frequently, causing delays and reducing output – not to mention the danger – as the brakeman and others in the vicinity had to flee for their lives.

Hydraulic braking was installed about the same time as the mining of the thicker seams of the Coalbrookdale mines increased output.

A pair of 3.2 metre diameter drums were fixed side by side on a horizontal shaft. As it turned, a 20mm diameter steel cable or ‘rope’ wound onto one drum while another rope wound off the other. The weight of a loaded wagon descending the Incline and unwinding the rope from one drum, provided more than enough power to haul up an empty wagon attached to the rope that was being wound onto the other drum.

The brakeman controlled the speed of the wagons by regulating water flow to the brake cylinders. The brake unit resembled a direct acting horizontal winding engine, but instead of steam driving the pistons, water was run into the cylinders to slow the pistons down. That made the drums turn more slowly, checking the speed of the descending wagon.

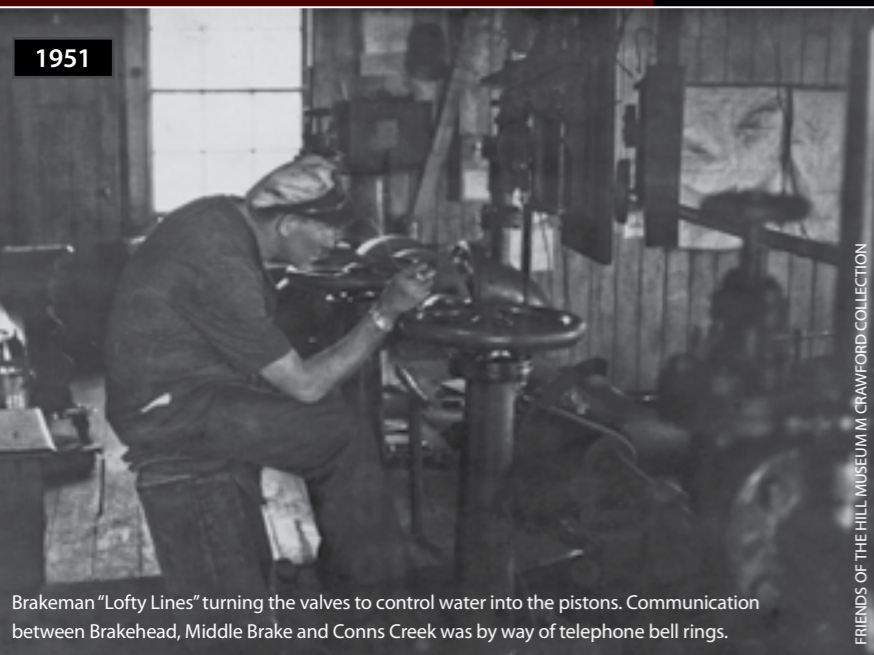
1951

Brakeman “Lofty Lines” turning the valves to control water into the pistons. Communication between Brakehead, Middle Brake and Conns Creek was by way of telephone bell rings.

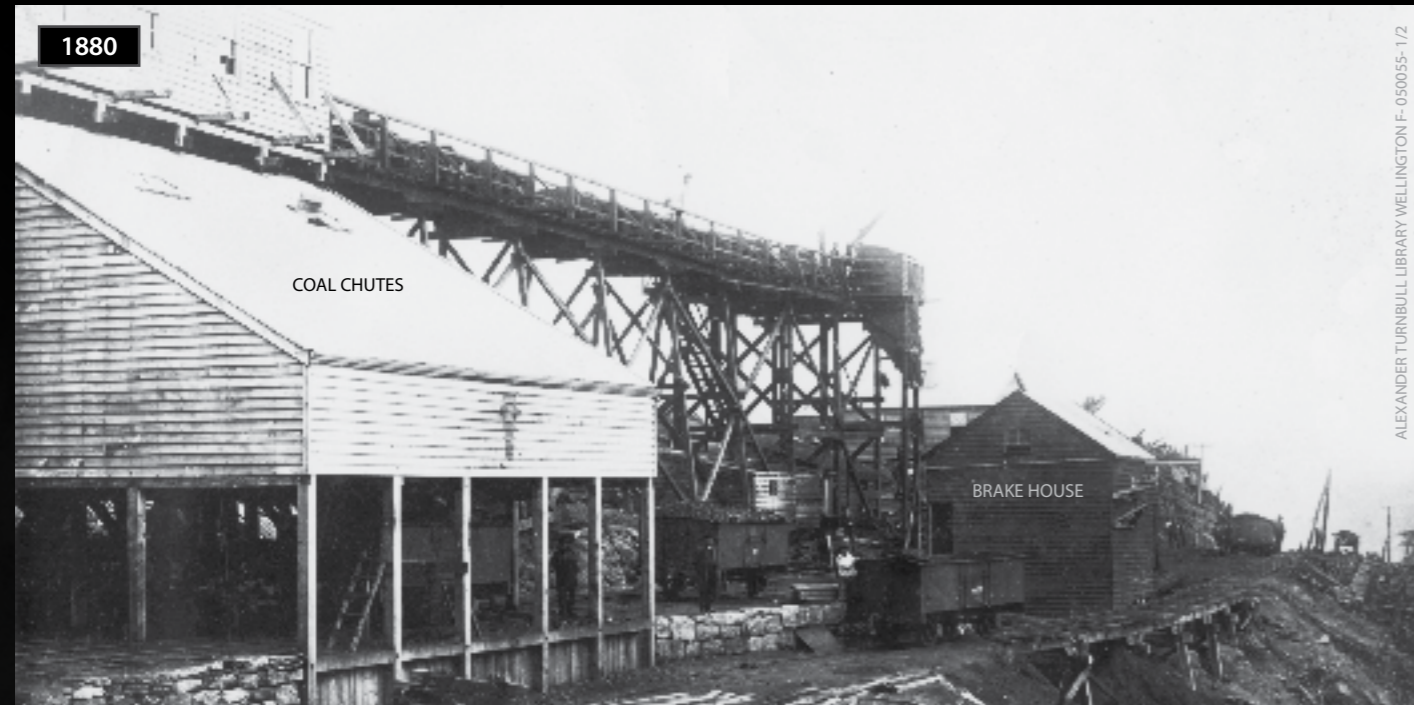
VIEW FROM THE BACK 1880

Coal was loaded down chutes into waiting railway wagons. Early O wagons – 4 wheel iron box hopper wagons – are in use in the above photograph. Slack dumped over the side of the hill conveniently built up flat land to the right of the brakehouse, making space for an additional line to marshal the wagons with the donkey winch to the elevated backshunt before filling.

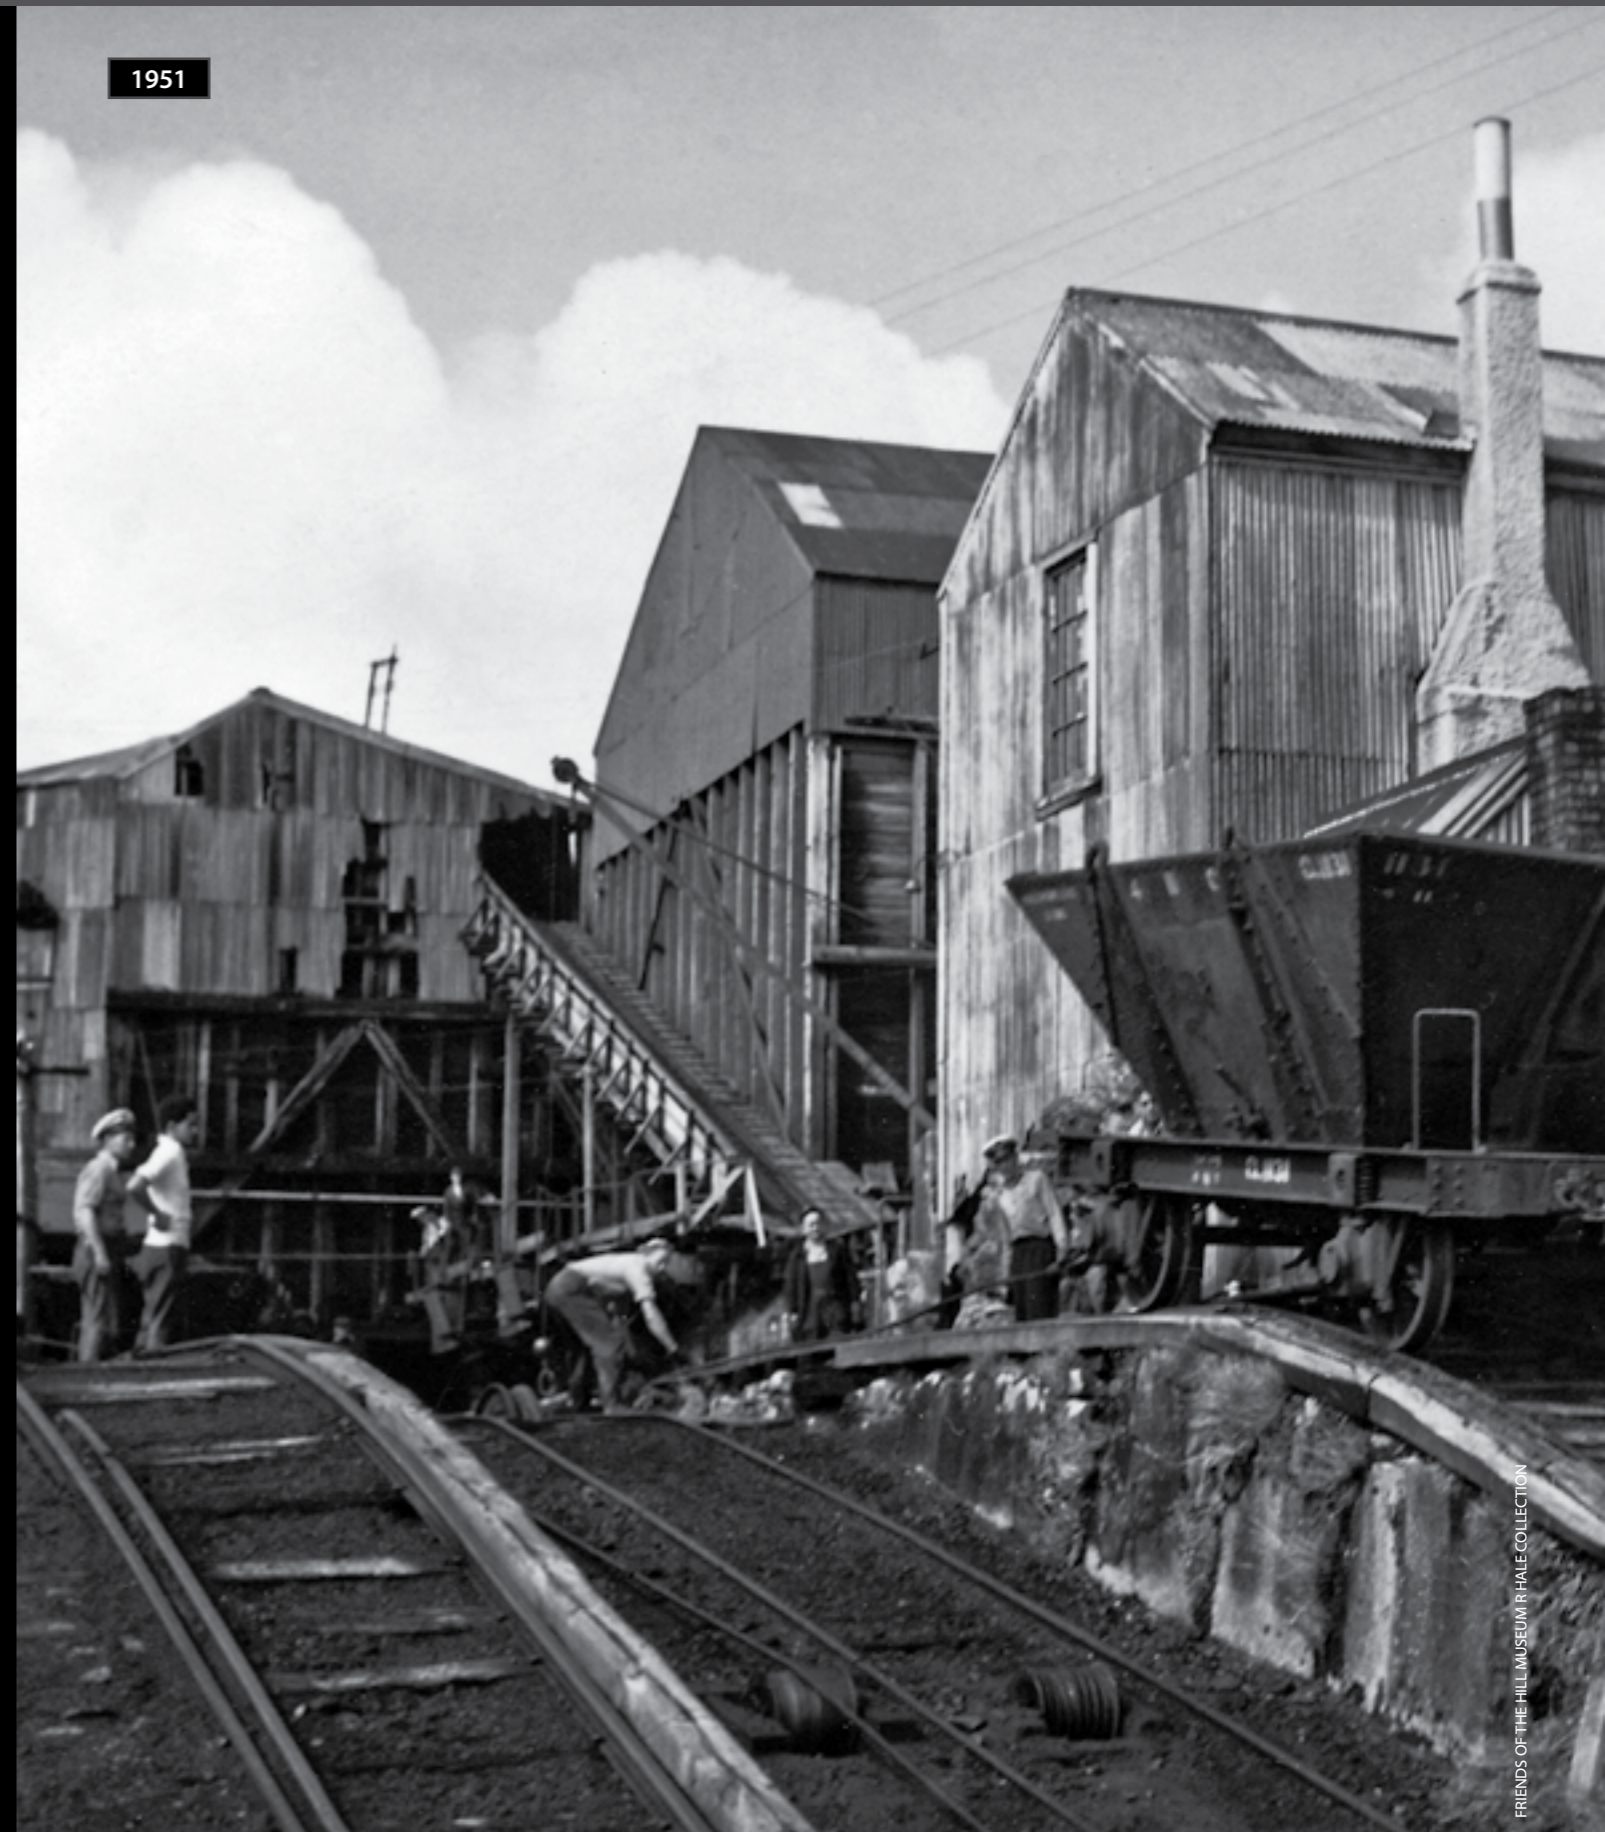
VIEW FROM THE BACK 1966

The view in the image to the left is from a similar position to the 1880 photograph but taken much later. The donkey winch cable (left foreground) has winched empty Q wagons into a waiting position near the loading conveyors (sited in the corrugated iron clad structure between the brake house and the bins). The utilisation of gravity was cunningly engineered into Brakehead operations, as demonstrated with the use of the elevated backshunt area.
