# Jack's Mill School

Kotuku

## CONSERVATION REPORT

31 July 2006

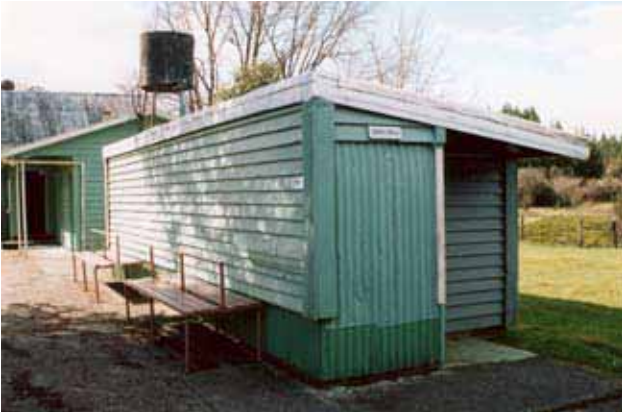
Toilet block, from the south.

Have a plumber check the pipework and fittings in the toilet block, and carry out any repair work needed to have the facility working efficiently.

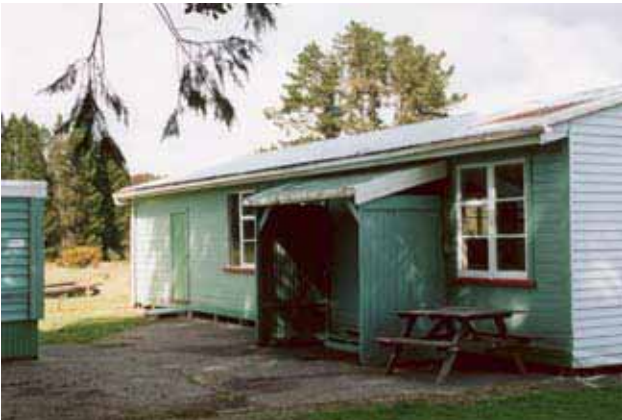
Classroom, north elevation.

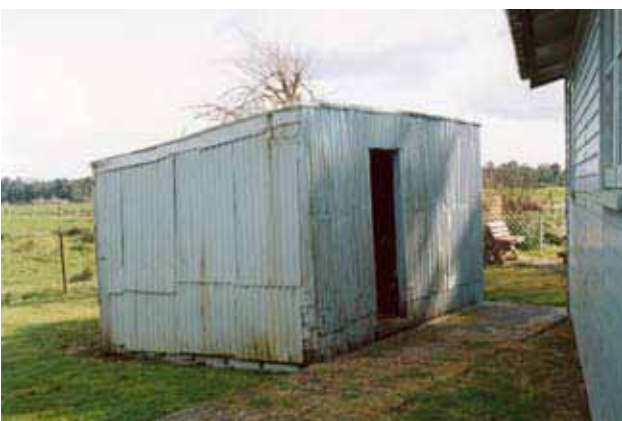
Corrugated iron shed, from the east.

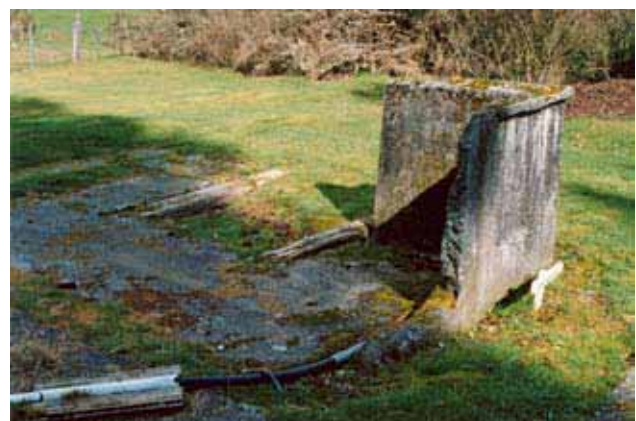
Remains of the original boys' toilet.

This is now just a relic, a part of a concrete wall, near the shed on the south side of the grounds. It is recommended that this be retained exactly as it is, and be kept weeded.
