Backwater habitat creation on Cobden Island in the Grey River

Following a survey of īnanga (*Galaxias maculatus*) spawning sites on the West Coast in 2007, Cobden Island in the lower Grey River was identified by the Department of Conservation (DOC) as a candidate site for spawning habitat restoration.

This case study is part of a series providing information about techniques used to restore native freshwater fish habitat in New Zealand rivers and streams.

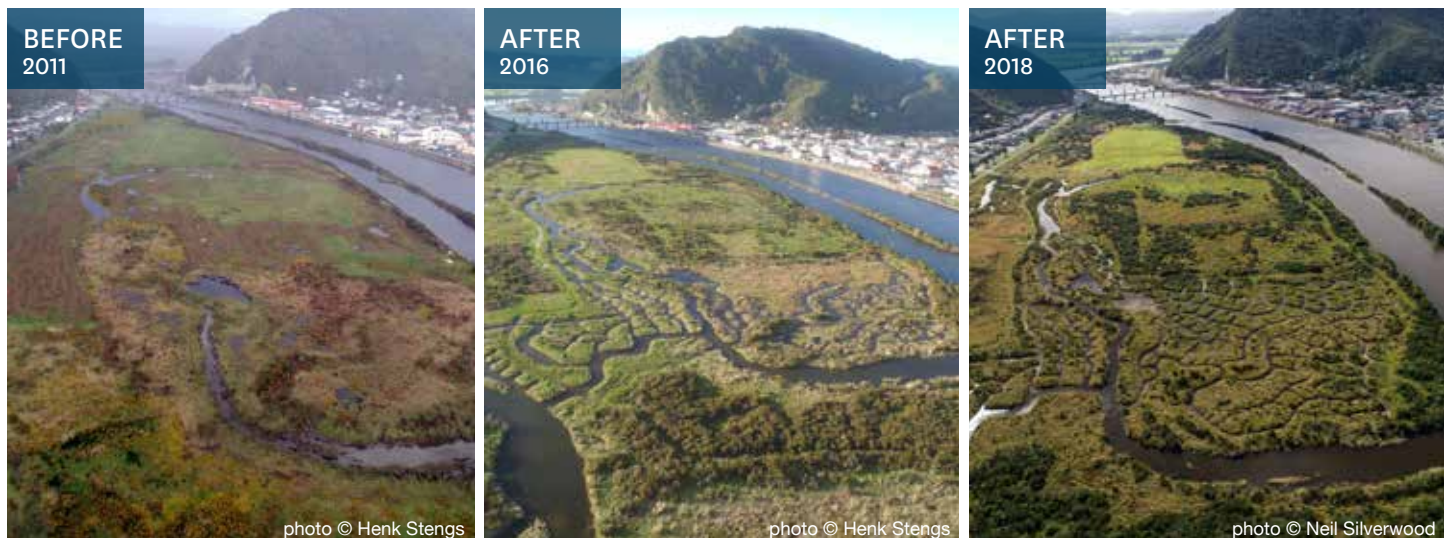
Approximately 6 km of new riparian margin and backwater habitat has been created by excavating a series of convoluted channels over an area of about 6 ha on Cobden Island. The fifth annual (and last) stage of channel excavation was completed in 2017, and in 2018 the project is now nearing completion.

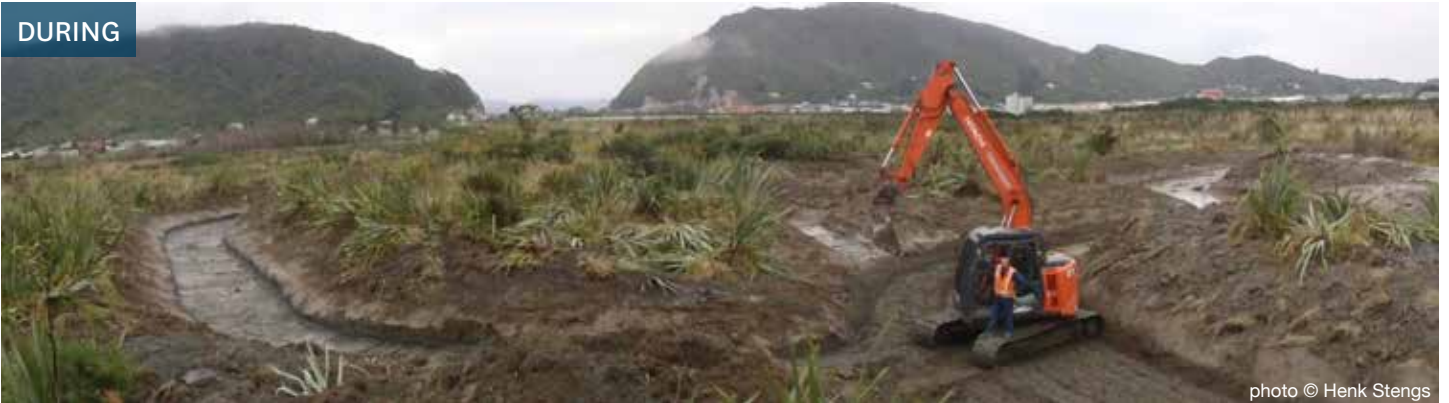
DURING

- numerous broad channels with gently-sloping banks excavated in the dry
- low-level weirs to retain water in the channels at low tide.

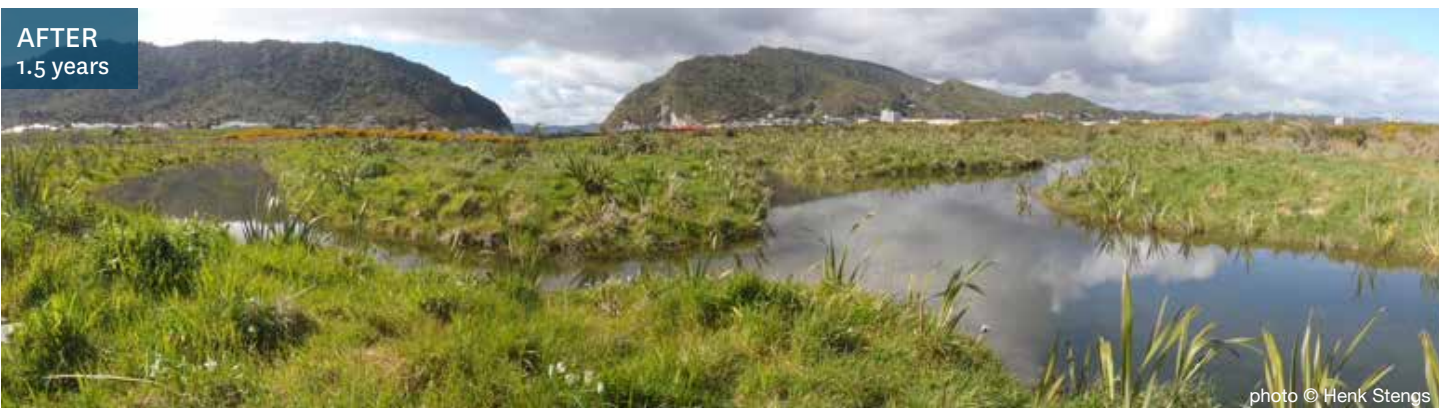
**AFTER
1.5 years**

- Riparian plants established very quickly and there was generally a high survival rate.
- In 2018, around 11,000 flax plants – 95% of the plantings – had been planted.
- Regular weed control was required for around three years after the excavation of each channel, until sufficient ground cover established to shade out the weed species.
- Residual weeding will be required for another 12–18 months, but the time and effort required for this is declining as native vegetation cover becomes established. After this, only a small amount of ongoing maintenance will be necessary to prevent weeds (e.g., invasive willow cuttings that are washed onto the island during floods) from re-establishing.
