## Salt water influence and riparian habitat condition in the Arahura river mouth lagoon system

### MEMORANDUM

**Arahura River Restoration Project**  
Department of Conservation  
West Coast Tai Poutini Conservancy  
10 Sewell Street  
Hokitika

Date:  
25 March 2020

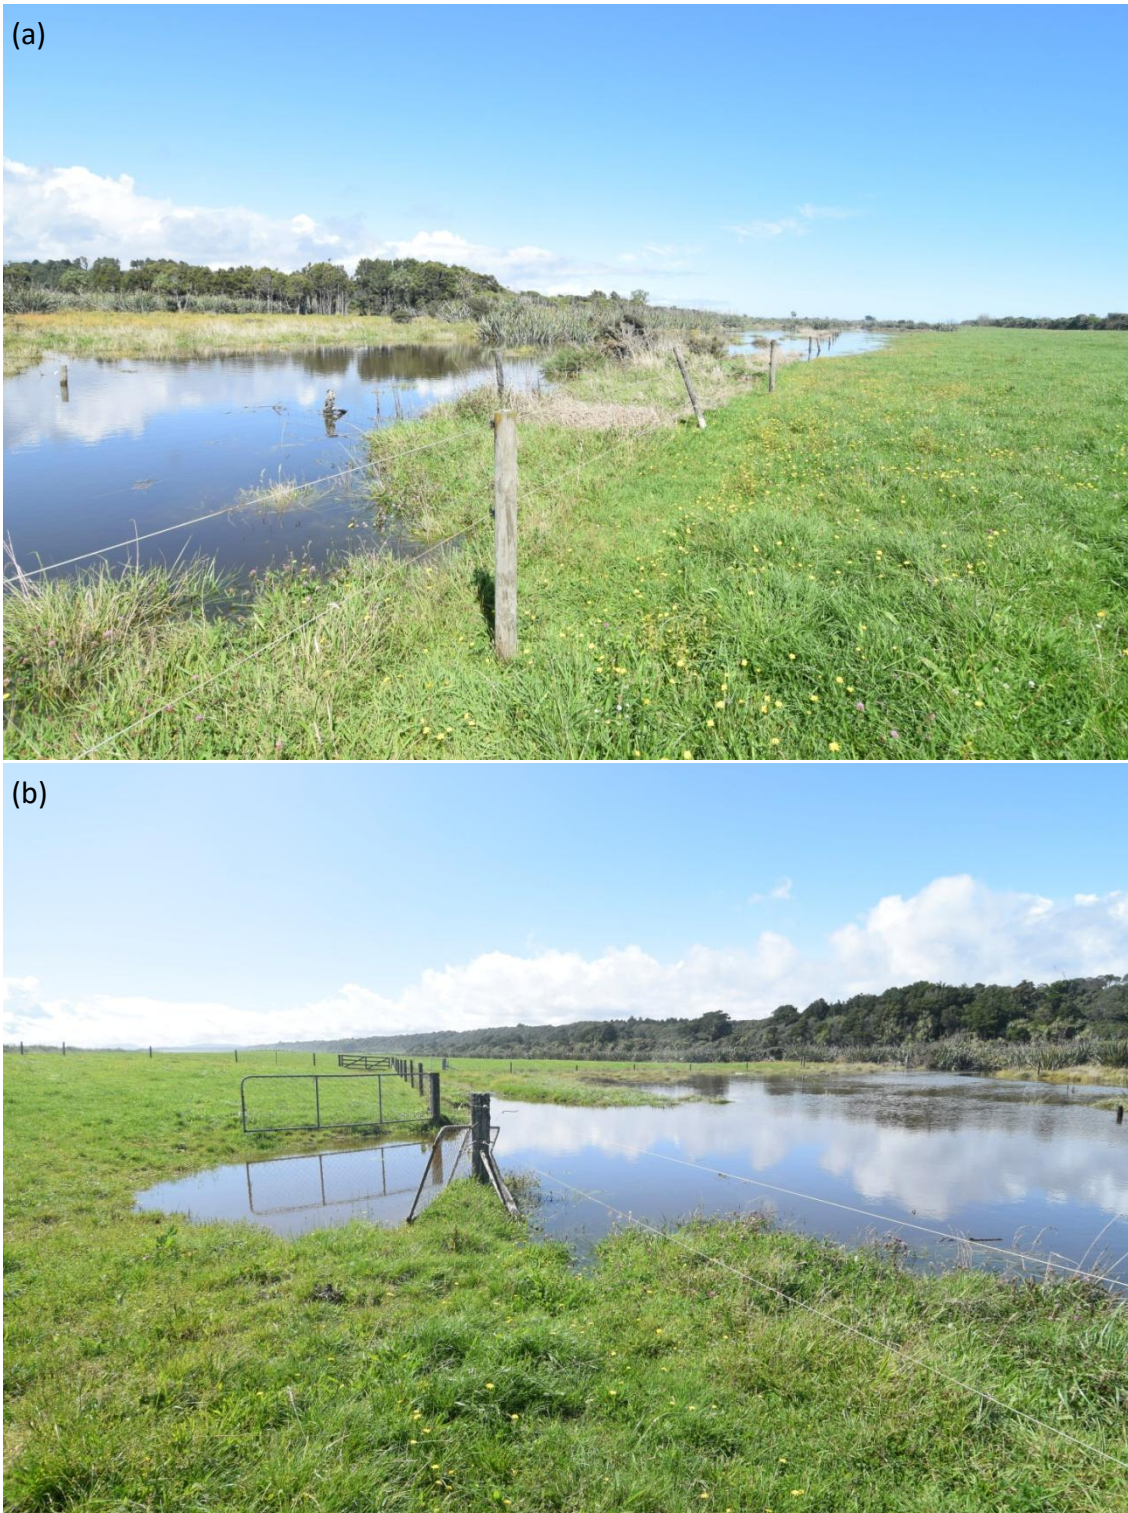
**Figure 1** Spring tide water levels in the tidal waterway north of Flowery Creek (a) and (b) Riparian margins bordering the grazed area of DOC land. Although tidal inundation of pasture was observed, water levels were considered to be relatively high due to a combination of the spring high tide and moderate river flows.

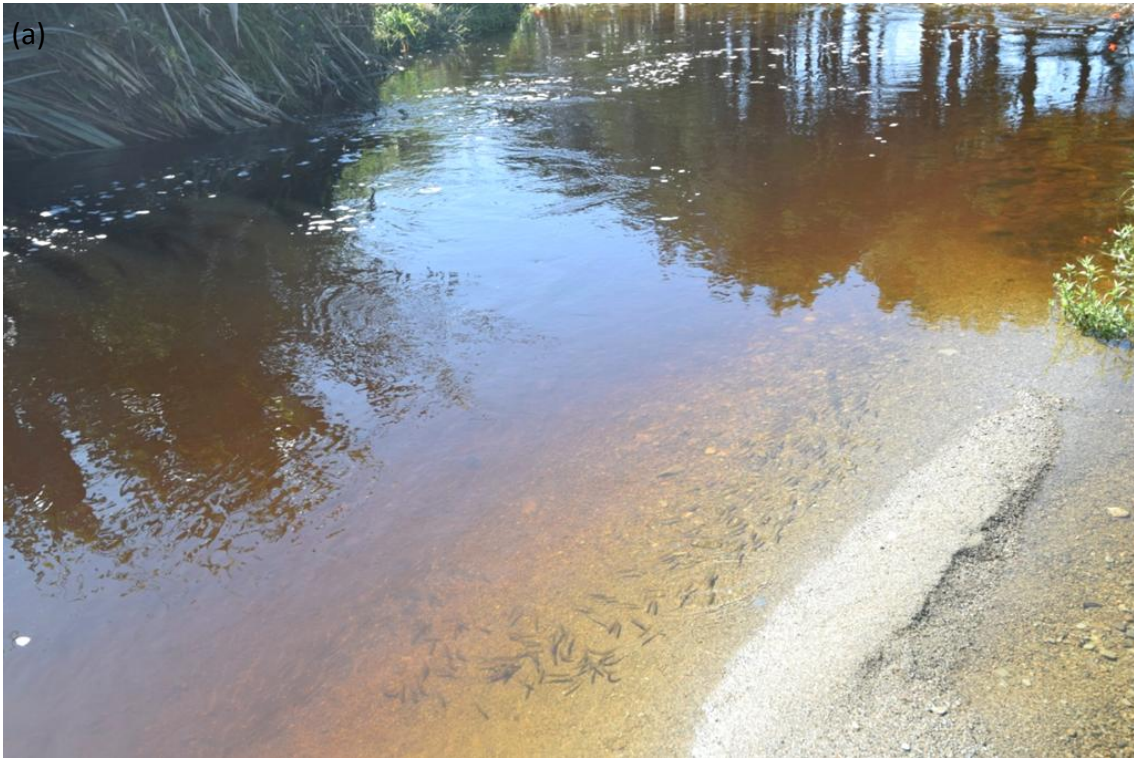
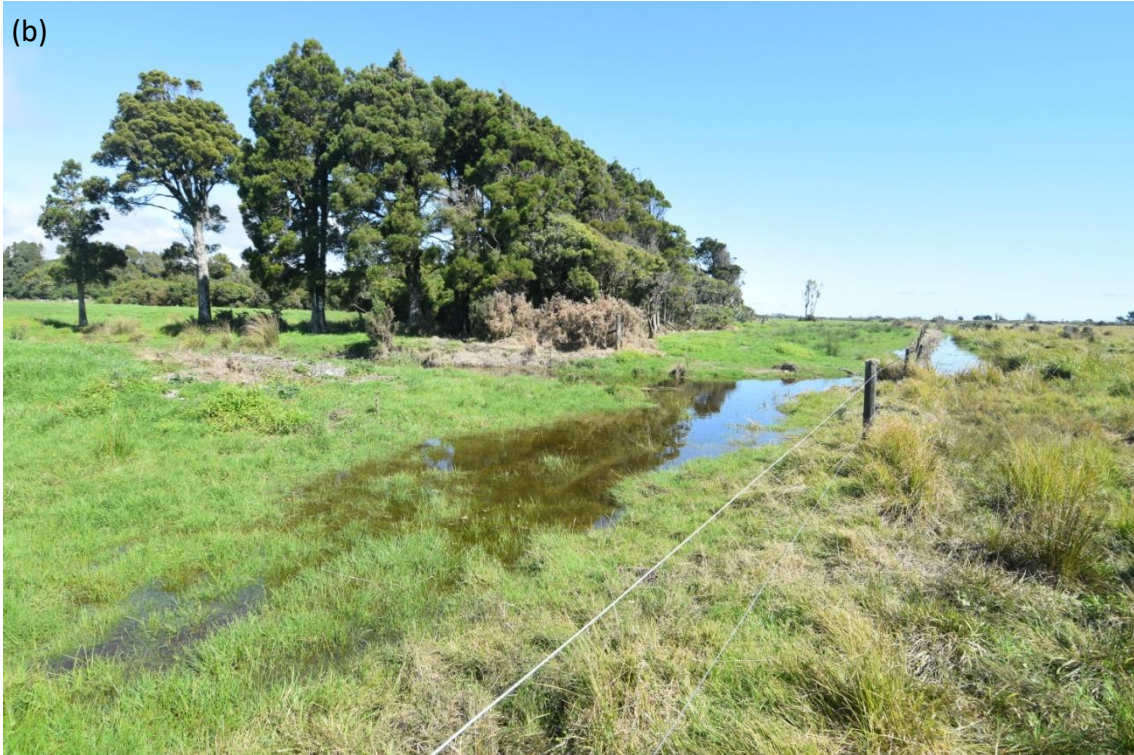
**Figure 2** (a) Adult Inanga observed in the lower reaches of Flowery Creek. (b) Tidal inundation in the wetland areas north of Flowery Creek confluence. Several small tributaries and ephemeral waterways occur in this area.

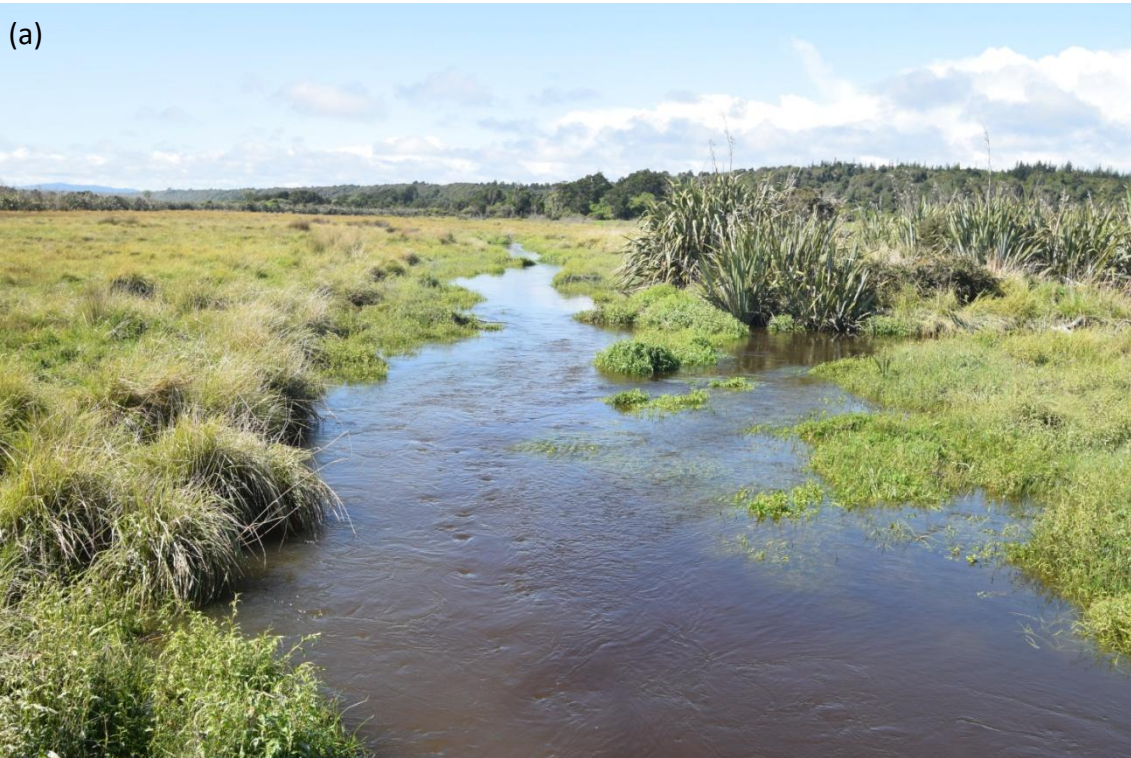
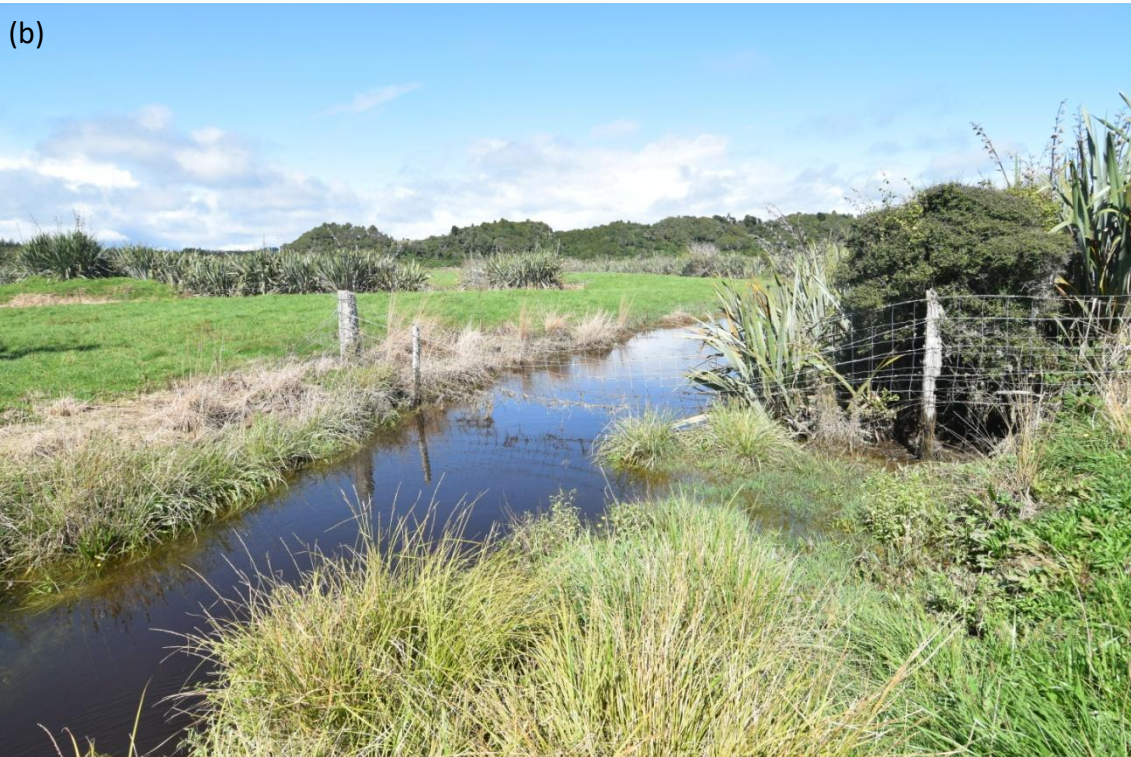
**Figure 3** (a) and (b). Two views of the tributary north of Flowery Creek showing suitable riparian vegetation for *Inanga* spawning.

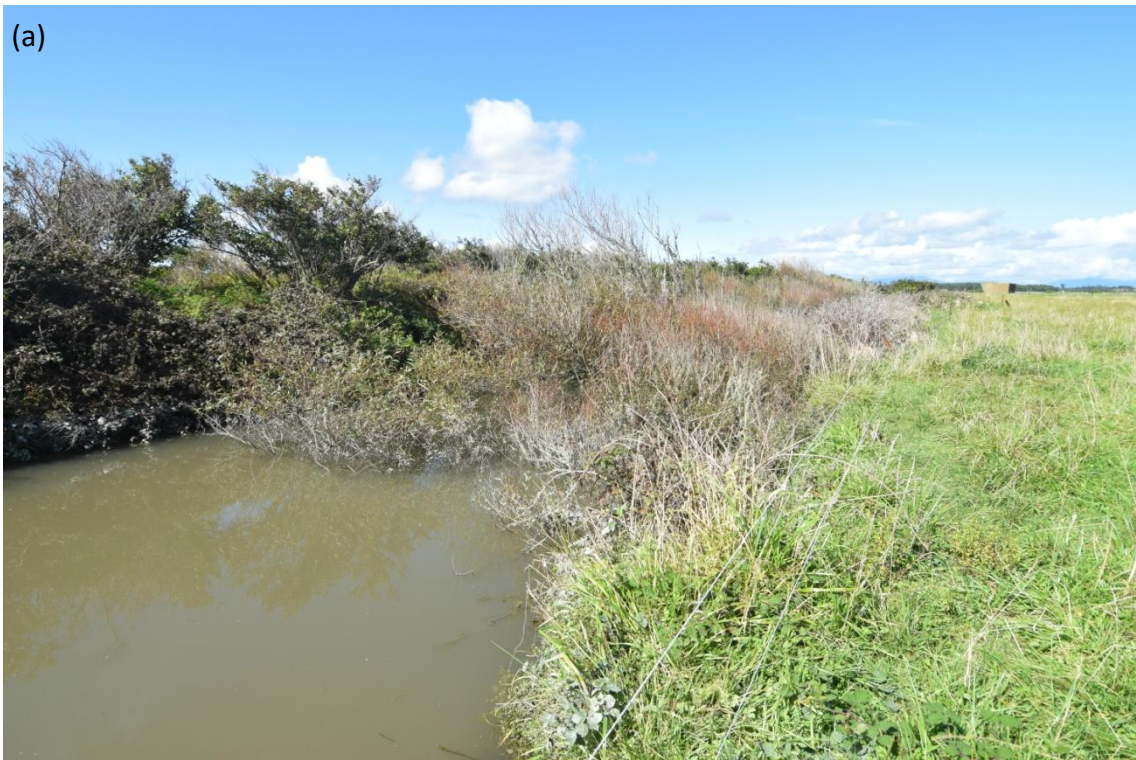
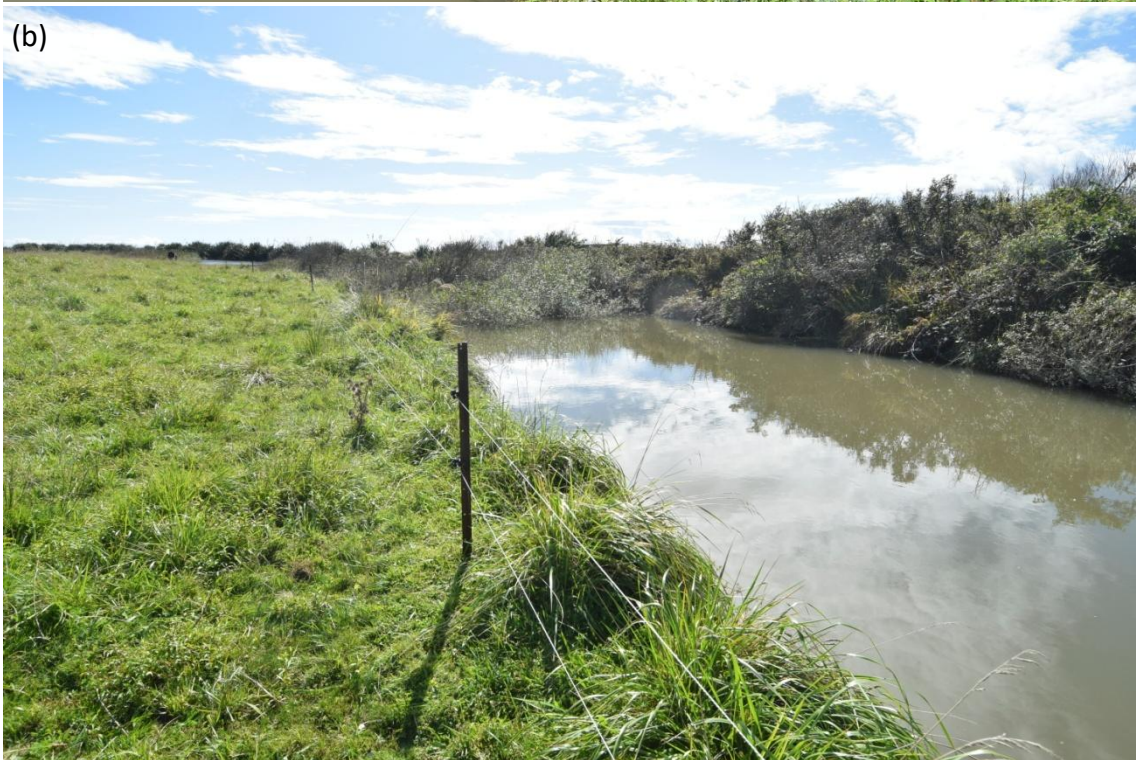
**Figure 4** (a) and (b). Two views of the small lake that occupies an old flood channel on the south bank. Strong tidal flows were observed entering the lake system on the spring high tide of March 11<sup>th</sup>.

Strong tidal pushes into the south bank tributaries were observed during the incoming tide that included significant in-flow to the small lake in this vicinity. Bottom salinity in the lake (2.7 ppt) was initially higher than in the tributary channels, which are shallower, indicating that higher salinity waters had entered the lake on previous tides. Salinity levels peaked around 1300 as expected, and by this time they were higher than measured in the lake (5.5 ppt). The upstream limit of salt water in the Greyhound Road

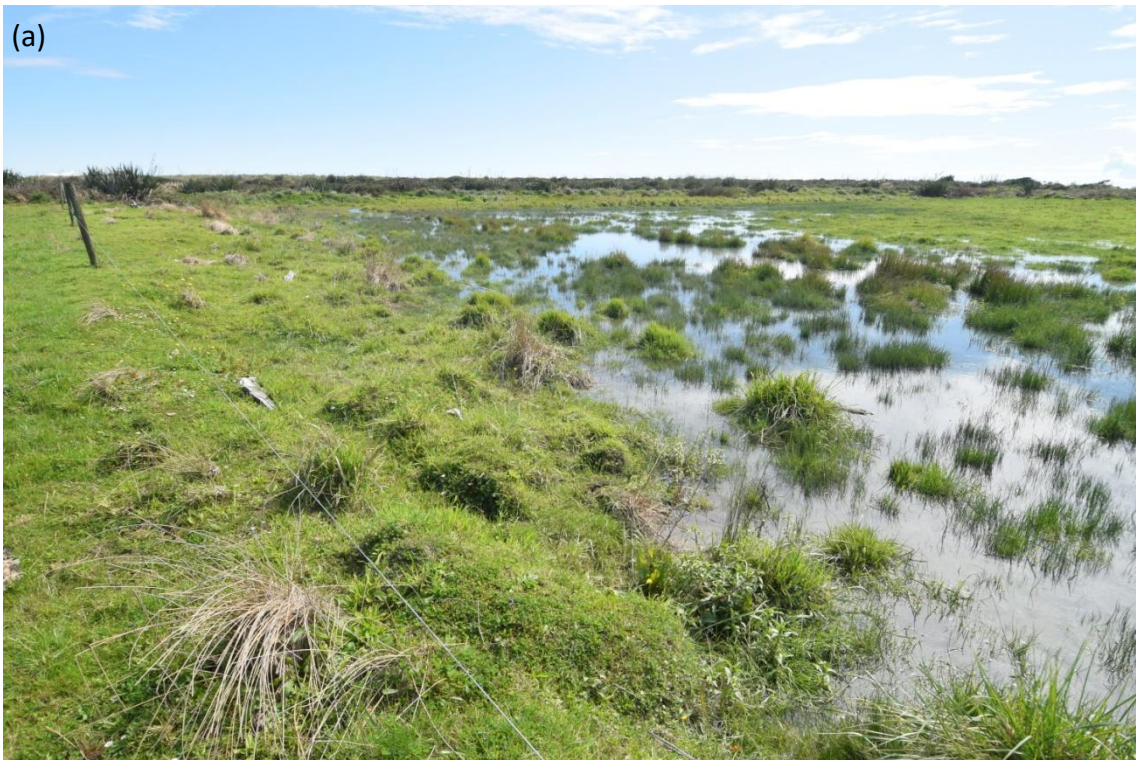
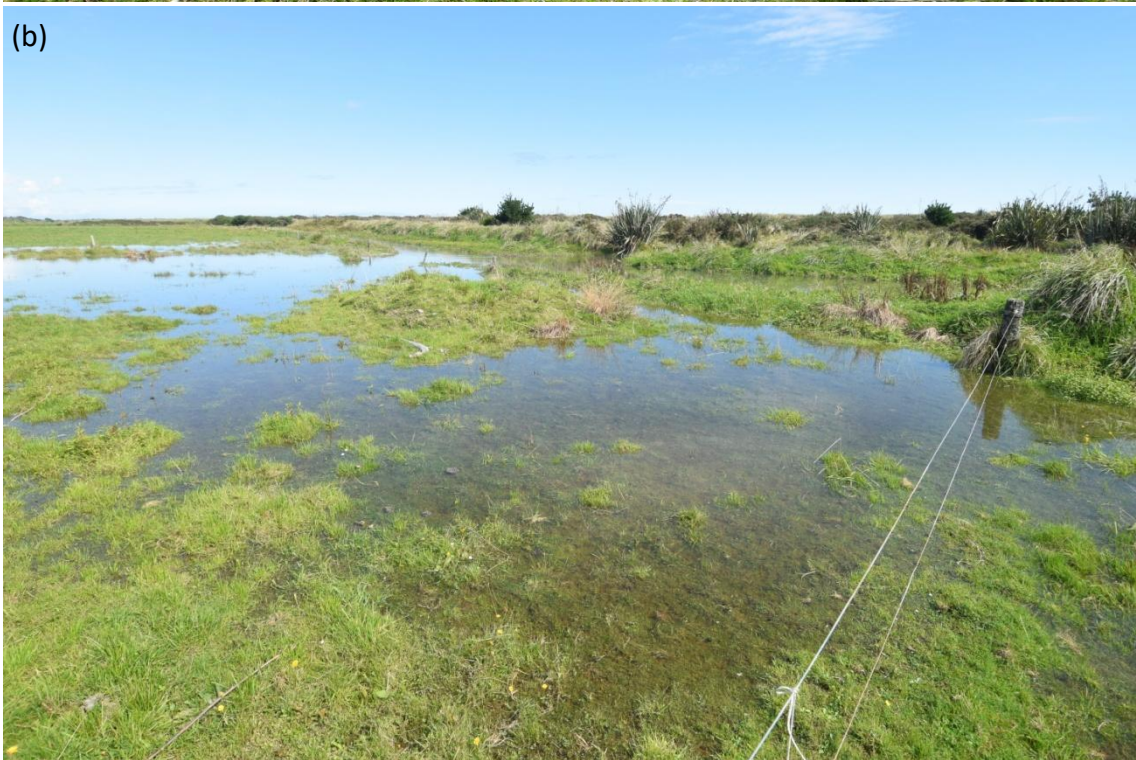
**Figure 5** (a) and (b). Tidal flooding into low-lying areas of pasture adjacent to the Greyhound Road.

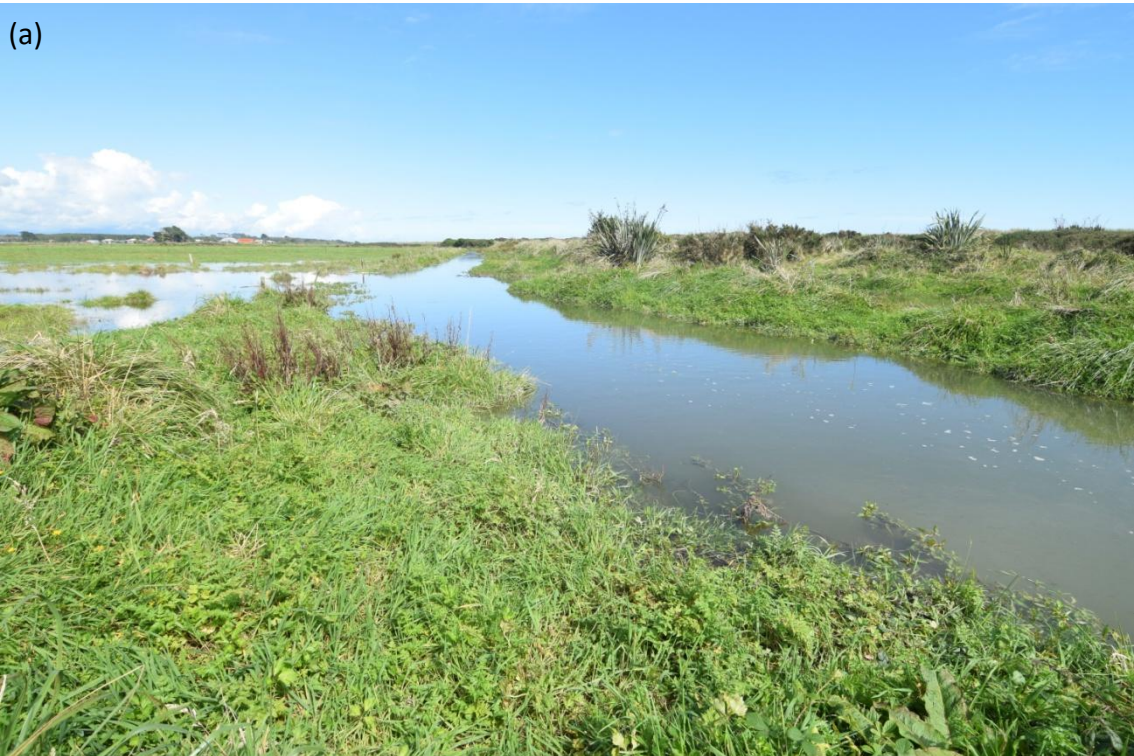
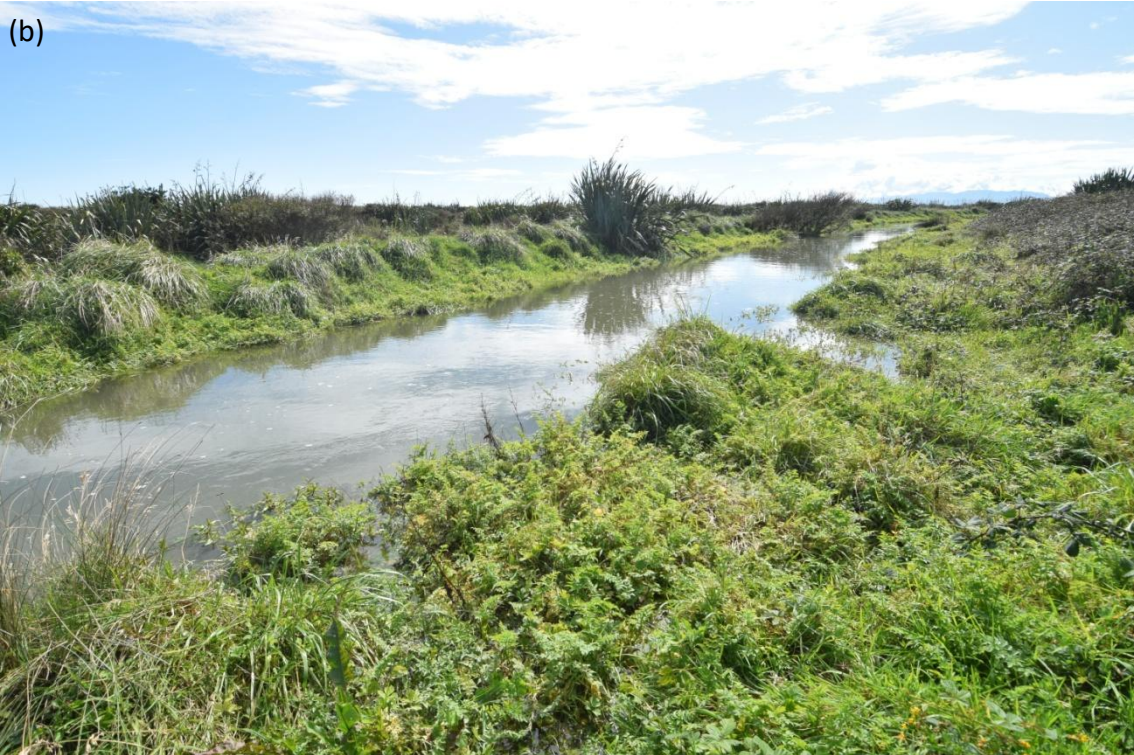
**Figure 6** (a) and (b). Riparian margins of the Greyhound Road tributary on the March 11<sup>th</sup> spring high tide.

- lower reach of the stream running parallel with Greyhound Road.
- margins and entrance channels of the small lake on the floodplain adjacent to the main channel.

The majority of potential spawning habitat in the above locations is provided by tall fescue and lotus in association with buttercup (*Ranunculus repens*), burr chervil (*Anthriscus caucalis*), water cress (*Nasturtium officinale*), rushes (*Juncus* spp.) and sedges (*Carex* spp.).
