BUILDING CONDITION APPRAISAL.

Chateau Tongariro Hotel - State Highway 48,
Whakapapa Village, Mount Ruapehu

Prepared for: Department of Conservation

Date: April 2023

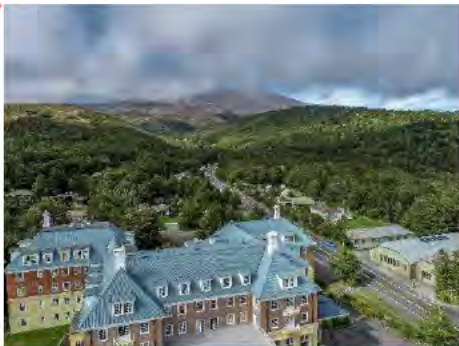
Ref.	Element	Description	Comments on condition/recommended works	Priority	Photograph
1.0	MAIN ROOF (ORIGINAL)				
1.1	Main roof	Aerial overview of the main roof to the original 1929 Chateau building.	<p>The main roof is constructed from a timber frame with corrugated metal roof sheets to the main pitches and trapezoidal roof sheets to the top section. Dormer windows are provided to all pitches which also have metal roof sheet finish.</p> <p>The main roof was inspected using a drone and limited visual inspection from the roof access hatch.</p>

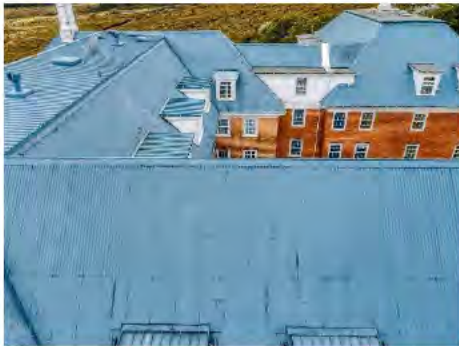
1.2	Main roof	Corrugated roof sheets	<p>Condition: The corrugated roof sheets are considered to have approached the end of their effective life and are suffering from corrosion and failing paint finish.</p> <p>Recommended works: Given the extremely exposed location the roof sheets should be replaced in the medium term if immediate and necessary repairs and overhauling works are undertaken.</p>	●

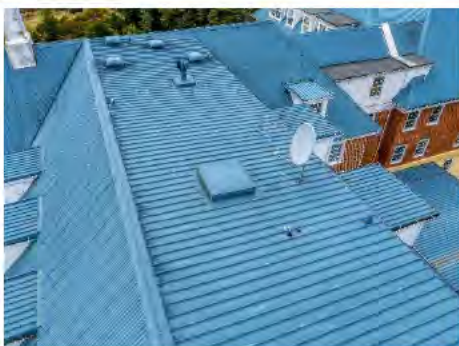
1.3	Main roof	Trapezoidal roof sheets to top section	<p>Condition: The trapezoidal roof sheets have approached the end of their effective life and are suffering from localised water ingress, corrosion and failing paint finish.</p> <p>Recommended works: The roof sheets will need replacement in the short term, or medium term if immediate repairs and overhauling works are undertaken.</p>	●

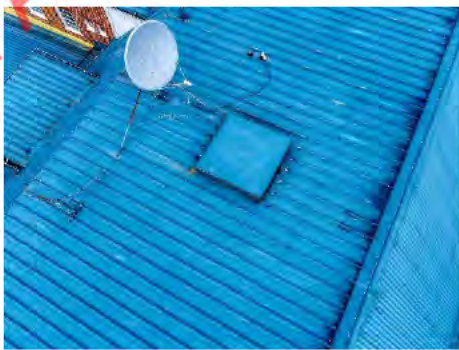
Ref.	Element	Description	Comments on condition/recommended works	Priority	Photograph
1.4	Main roof	Service penetrations and access hatch	<p>Condition: Water ingress and stained timber framing was noted at the roof access hatch with corrosion and previous repairs noted externally.</p> <p>Recommended works: The roof hatch should be replaced when the roof sheets are being replaced. In the immediate term allow for temporary repairs to prevent water ingress.</p>	●

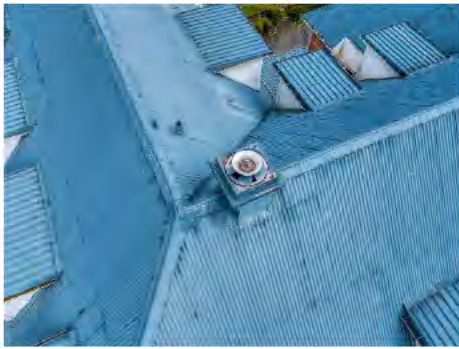
1.6	Main roof	Service penetrations	<p>Condition: The cowl to the roof vent is missing and will be prone to water ingress.</p> <p>Recommended works: The roof vent to be replaced when the roof sheets are being replaced. In the immediate term a cowl should be provided to eliminate the risk of water ingress.</p>	●

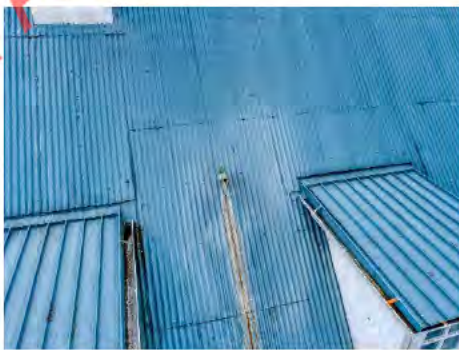
Ref.	Element	Description	Comments on condition/recommended works	Priority	Photograph
1.7	Main roof	Water overflow pipe	<p>Condition: Staining was noted to the overflow pipe which appears to have been overflowing for a period of time causing localised corrosion.</p> <p>Recommended works: Review if hot water is still overflowing and repair/rectify accordingly.</p>	●

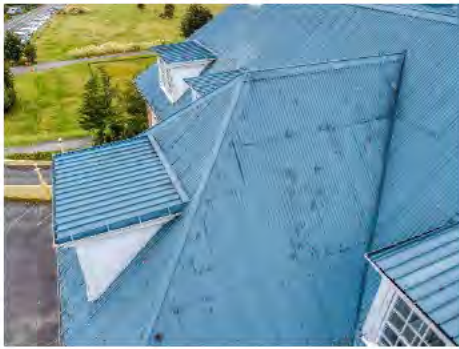
1.8	Main roof	The valleys and hips are formed from folded metal lining to the valleys and folded metal with soft edge to the hips.	<p>Condition: Lifting sections, localised corrosion and loose soft edges were noted over the roof surface.</p> <p>Recommended works: Overhaul the valleys and hips in the immediate term to address any loose soft edges and replace when the roof sheets are being replaced in the medium term.</p>	●

1.9	Main roof	Valleys and hips	As above	●

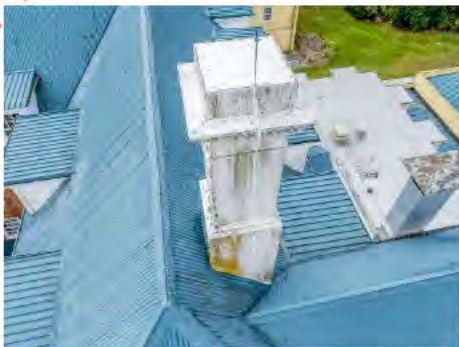
Ref.	Element	Description	Comments on condition/recommended works	Priority	Photograph
1.10	Chimneys	The chimneys are a combination of original masonry chimneys and a "fake" chimney constructed from metal ducting to the ventilation system.	<p>Condition: The rear west chimney masonry construction has been capped off and is redundant. Paint finish is poor, no ventilation is provided to the flue and the flashing detail is poor however appears watertight.</p> <p>Recommended works: Repaint chimney, insert vent to the flue and provide new flashing detail when the roof sheets are being replaced. Unreinforced masonry chimneys are a potential hazard in an earthquake event. Provisionally allow for seismic strengthening.</p>	●

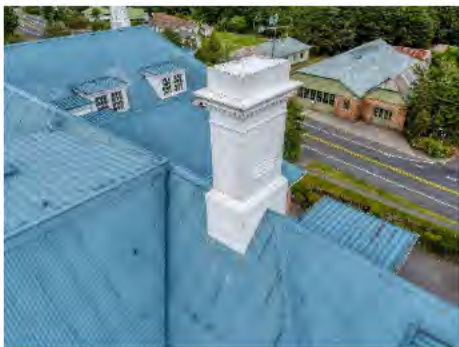
1.11	Chimneys	Front west chimney – vent duct to ventilation system - Not unreinforced masonry.	<p>Condition: The chimney to the front west is metal ductwork with vent grilles. Poor decorative condition.</p> <p>Recommended works: Repaint in the short to medium term.</p>	●

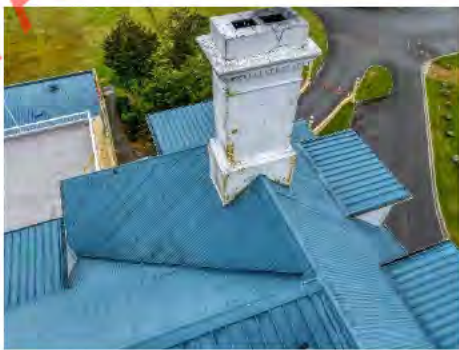
1.12	Chimneys	Main "live" chimney to the front east roof pitch.	<p>Condition: The chimney to the front east is the only "live" chimney. It is in poor condition with cracking noted. It is an unreinforced masonry chimney as per the WSP IEP report.</p> <p>Recommended works: Determine remedial works required once the DSA is completed. Unreinforced masonry chimneys are a potential hazard in an earthquake event. Provisionally allow for seismic strengthening.</p>	●

Ref.	Element	Description	Comments on condition/recommended works	Priority	Photograph
1.13	Chimneys	Main "live" chimney to the front east roof pitch.	As above – note cracking	●

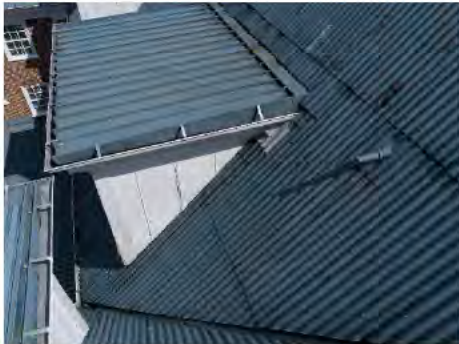
1.23	Main roof	Leaking dormer	<p>Condition: The dormer plasterboard wall lining in room 306 has recently been replaced. Externally repairs appear to have been undertaken to the roof however room 306 still smelt damp at the time of inspection.</p> <p>Recommended works: Monitor for signs of water ingress and continued damp/mould smell. Replace roof sheets and flashings when main roof is being replaced</p>	●

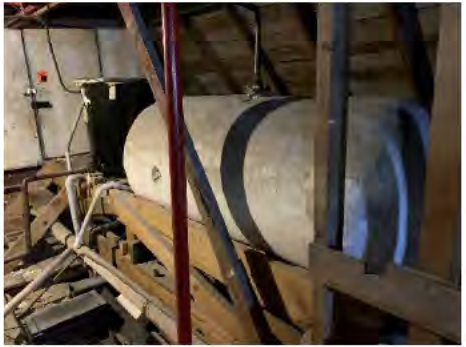
Ref.	Element	Description	Comments on condition/recommended works	Priority	Photograph
1.28	Main roof	Roof space services	<p>Condition: The services and water tanks within the roof space are not seismically restrained.</p> <p>Recommended works: Allow to seismically restrain all services within the roof space.</p>	●

1.29	Main roof	Roof space services	As above	●

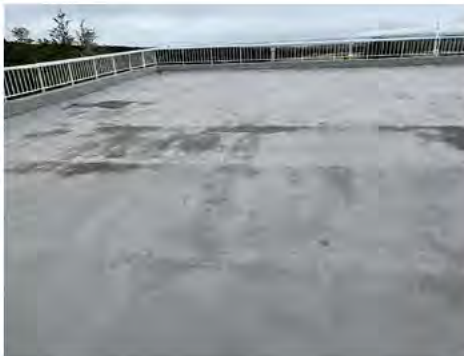
Ref.	Element	Description	Comments on condition/recommended works	Priority	Photograph
2.0	BALCONY ROOF (ORIGNAL)				
2.1	General view	The balcony roof is original concrete construction with a waterproof membrane and solar reflective paint finish.	<p>Condition: The balcony roof is in poor condition with worn solar reflective paint, cracking to the membrane, vegetation growth and general defects noted. The balcony appears to have a remedial liquid applied membrane finish.</p> <p>Recommended works: Remove the existing membrane, thoroughly prepare and apply a new waterproof membrane and solar reflective paint finish.</p>	●

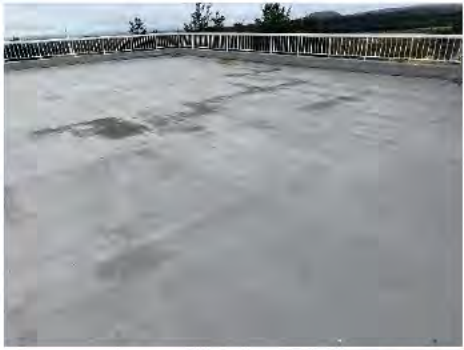
2.2	General view	As above	As above	●

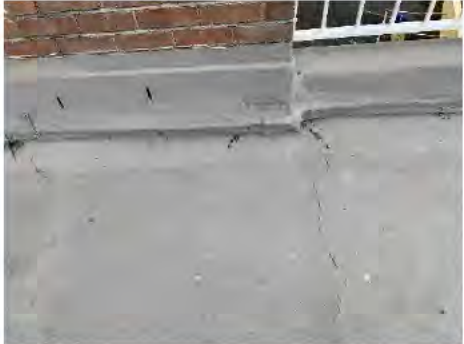
2.3	Waterproof membrane	Cracking was noted to the waterproof membrane (possibly original asphalt)	<p>Condition: Cracking was noted to the waterproof membrane to various areas. Evidence of water ingress was noted internally which can possibly be attributed to the cracking and subsequent water ingress. Subsurface cracking was also noted.</p> <p>Recommended works: Correctly repair the cracking with a suitable repair method prior to applying a new solar reflective paint finish.</p>	●

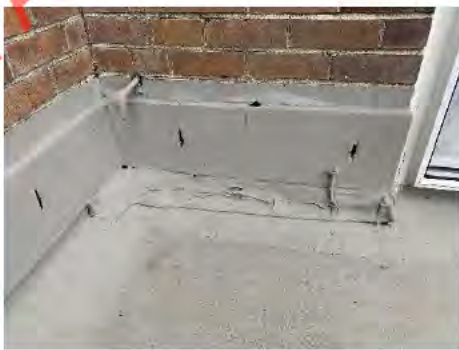
Ref.	Element	Description	Comments on condition/recommended works	Priority	Photograph
2.4	Perimeter flashing detail	Previous repairs	<p>Condition: The previous repairs are considered crude and poorly detailed. Gaps and open sections were noted which will allow water ingress.</p> <p>Recommended works: Correctly detail all junctions, upstands and roof details as part of the waterproof membrane remedial works.</p>	●

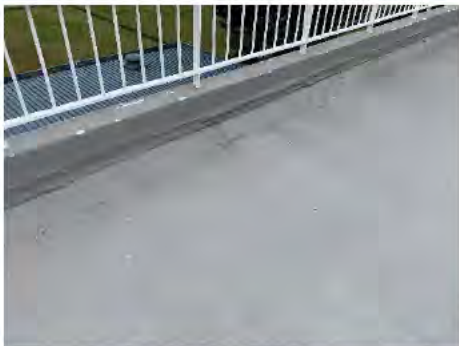
2.5	Perimeter parapet wall	A low-level parapet wall encloses the balcony roof. This is finished with a top cap flashing and painted metal balustrade.	<p>Condition: A remedial liquid applied waterproof membrane has been applied over the original cap flashing. The membrane is cracking along the wall and may allow water ingress.</p> <p>Recommended works: Thoroughly prepare and apply a new liquid applied waterproof membrane and solar reflective paint finish.</p>	●

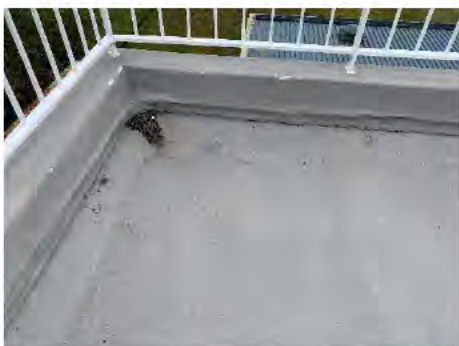
2.6	Perimeter wall	As above	As above	●

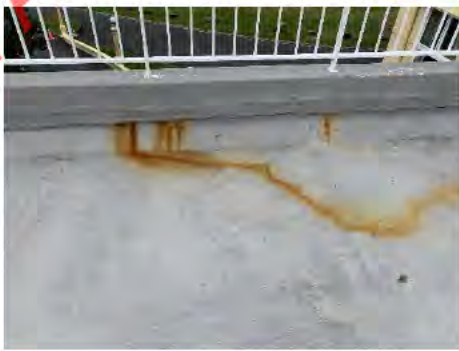
Ref.	Element	Description	Comments on condition/recommended works	Priority	Photograph
2.7	Perimeter wall	Corrosion staining	<p>Condition: Corrosion staining was noted emanating from under the perimeter wall capping.</p> <p>Recommended works: Investigate cause of the staining, repair and make good during roof repair works.</p>	●

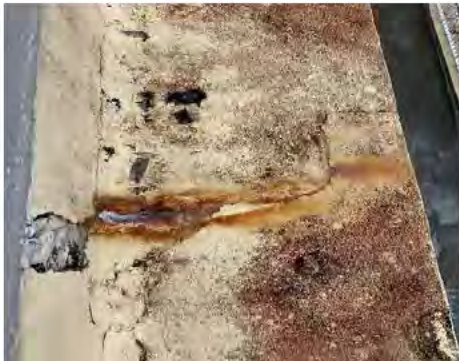
2.8	Perimeter edge capping	Perimeter edge capping	<p>Condition: The external side of the perimeter wall top capping has a paint/waterproof membrane finish which has failed, deteriorated and cracked.</p> <p>Recommended works: Replace the perimeter wall capping with a new waterproof membrane (or continue the liquid applied membrane over the parapet wall) with suitable cap detail.</p>	●

2.9	Perimeter edge capping	As above	As above	●

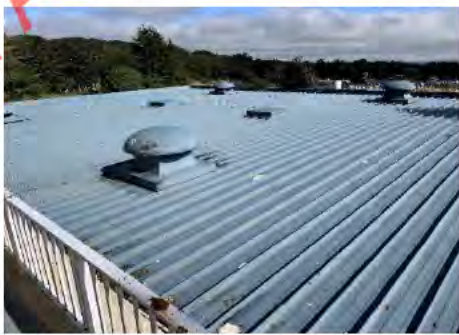
Ref.	Element	Description	Comments on condition/recommended works	Priority	Photograph
3.2	General view of roof	Service penetrations	<p>Condition: There are various service penetrations and vents to the Tongariro Room roof which are in poor condition with evidence of water ingress noted internally.</p> <p>Recommended works: In the immediate term overhaul the roof to prevent further water ingress. The service penetration to be replaced when the roof sheets are being replaced.</p>	●

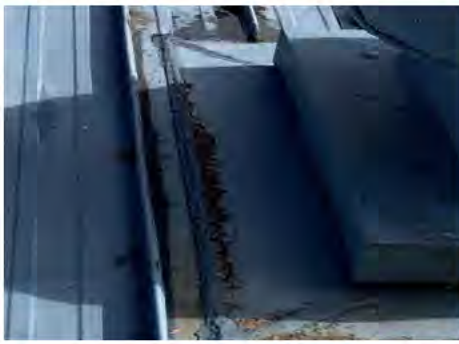
3.4	Corrosion to roof vent	Service penetration flashing detailing	<p>Condition: Close up of corrosion to the vent flashing.</p> <p>Recommended works: Provide a suitable back flashing to the service vents when the roof sheets are being replaced.</p>	●

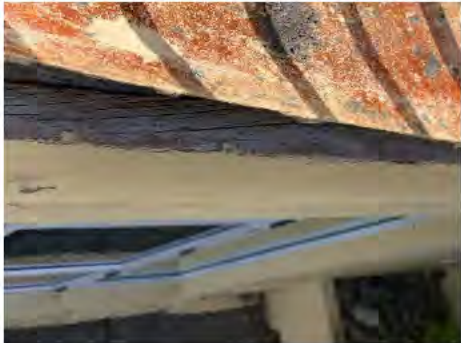
3.6	Roof perimeter detail together with additional flashing	Perimeter detail membrane debonded and lifting.	<p>Condition: The flashing to the perimeter edge detail has debonded from the substrate.</p> <p>Recommended works: Correctly detail the perimeter edge when the roof is replaced.</p>	●

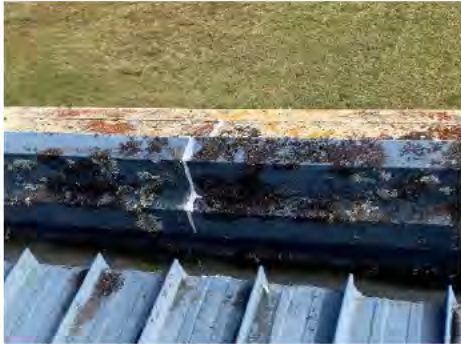
3.7	Roof perimeter detail	Sealant repair to edge flashing	<p>Condition: Previous repairs have been undertaken using surface applied sealant.</p> <p>Recommended works: All edge flashings to be correctly detailed and not reliant on surface applied sealant for weathertightness when the roof sheets are being replaced.</p>	●

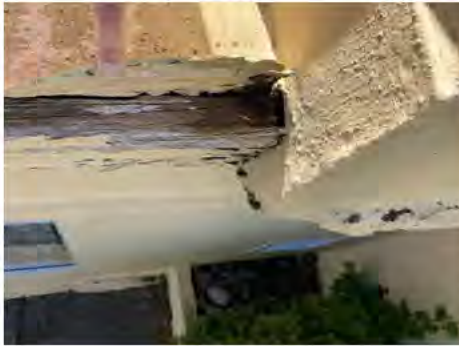
3.9	Tongariro wall/main wall intersection	Tongariro Room roof / main building intersection	<p>Condition: The junction between the Tongariro Room roof and main building is poorly detailed resulting in decayed timber and water run marks down the main elevation.</p> <p>Recommended works: As part of the roof replacement works this intersection should be correctly detailed to prevent deterioration and water running down the wall.</p>	●

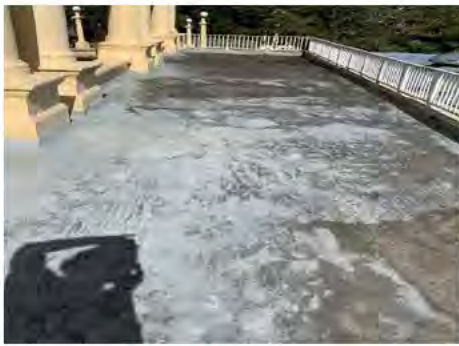
4.0	PODIUM ROOF (ORIGINAL)				
4.1	Original podium roof	The original section of podium roof is located between the Tongariro Room roof and main entrance. This is of concrete construction with asphalt or similar waterproof membrane and solar reflective paint finish.	<p>Condition: The original podium roof is in poor condition with deteriorated solar reflective paint, vegetation growth, splits in the waterproof membrane and general deterioration noted.</p> <p>Recommended works: The roof membrane will need to be replaced in its entirety to ensure a weathertight finish.</p>	●

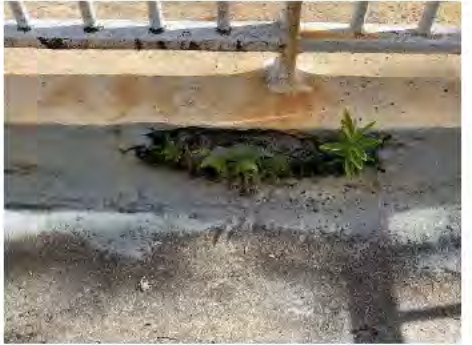
4.3	Original podium roof	Vegetation growth	<p>Condition: Vegetation growth was noted where the membrane has failed and cracks have developed.</p> <p>Recommended works: Remove all vegetation growth prior to replacing the membrane.</p>	●

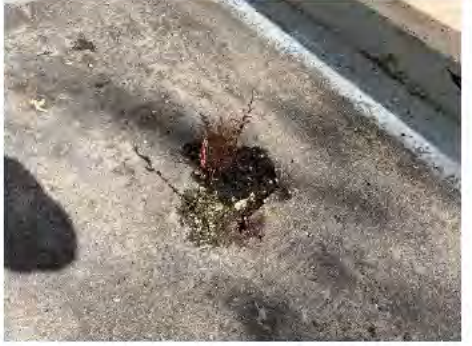
4.4	Original podium roof	Vegetation growth	As above	●

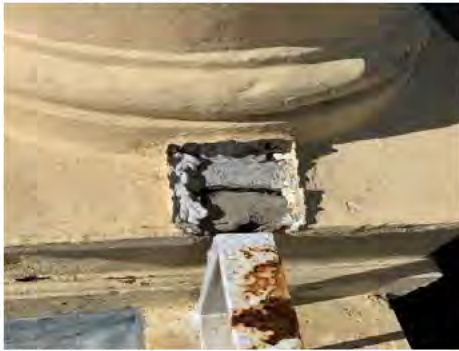
4.7	Original podium roof	Metal handrail/column connection	<p>Condition: The handrail fixing to the concrete column is missing or has been removed.</p> <p>Recommended works: Make good the handrail/column junction.</p>	●

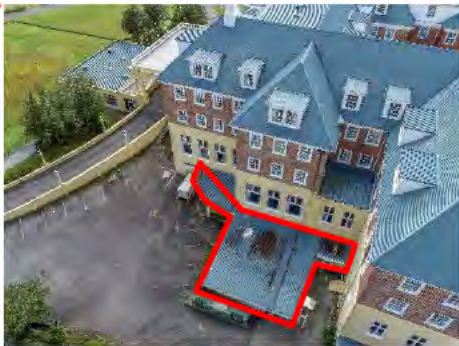
Ref.	Element	Description	Comments on condition/recommended works	Priority	Photograph
5.0	WORKSHOP ROOF (1950s)				
5.1	Workshop roof	Overview of workshop roof	We understand the workshop roof was constructed circa 1950s. the roof is finished with low pitched metal roof sheets which are both mono pitched and inward pitched to a central valley gutter.	●

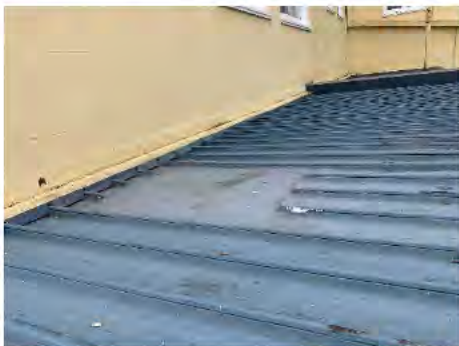
5.2	Workshop roof	Metal roof sheet finish	<p>Condition: The metal sheets are in poor condition and have been previously patch repaired. The paint finish is peeling and corrosion was noted. The roof sheets are circa 70 years old and are at the end of their effective life. The roof pitch is limited, and in some areas, is back falling.</p> <p>Recommended works: Allow for end of life replacement of the roof sheets.</p>	●

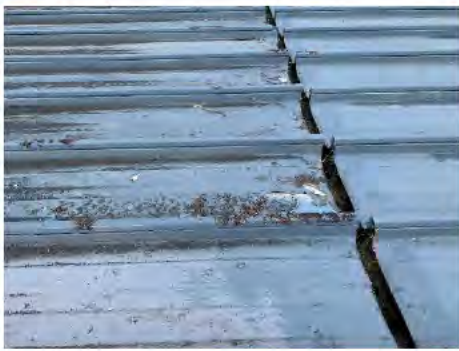
5.5	Workshop roof	Internal gutter	<p>Condition: There is an internal gutter to the workshop roof which is limited in size and prevents correct cleaning and maintenance of the gutter.</p> <p>Recommended works: As part of roof replacement works the gutter should be designed out or if required increased in size to allow for ongoing periodic repair and maintenance.</p>	●

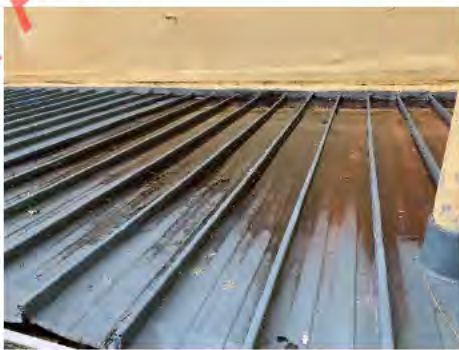
Ref.	Element	Description	Comments on condition/recommended works	Priority	Photograph
5.7	Workshop roof	Roof pitch	<p>Condition: Sections of the roof have been installed with limited or no pitch resulting in localised water ponding.</p> <p>Recommended works: As part of roof replacement works the roof will need to be repitched to comply with current codes of practice.</p>	●

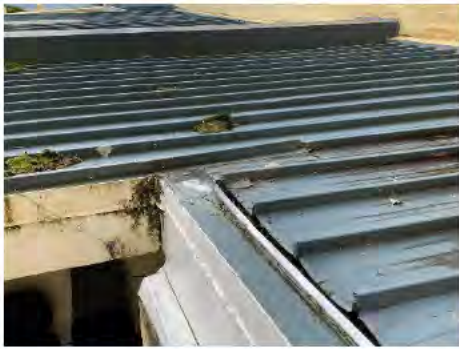
5.9	Workshop roof	Roof intersections	<p>Condition: The intersection of the various roofs is poorly detailed with the use of surface applied sealants which will deteriorate under UV light. The cap flashing fixings are working loose resulting in an unsealed hole.</p> <p>Recommended works: All roof junctions and intersections will require correct detailing to ensure robust and weathertight junctions when the roof sheets are replaced.</p>	●

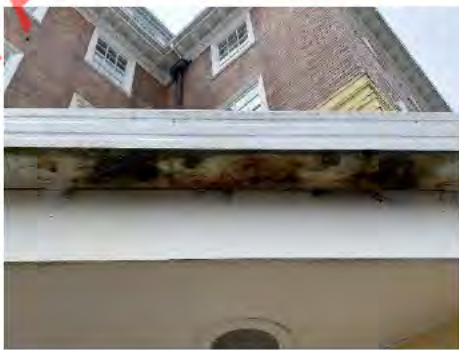
Ref.	Element	Description	Comments on condition/recommended works	Priority	Photograph
5.10	Workshop roof	Rainwater goods	<p>Condition: The rainwater goods include box section gutters and downpipes. The gutters are generally corroded, holed and leaking and are in poor condition.</p> <p>Recommended works: All gutters and downpipes to be replaced as part of roof sheet replacement works.</p>	●

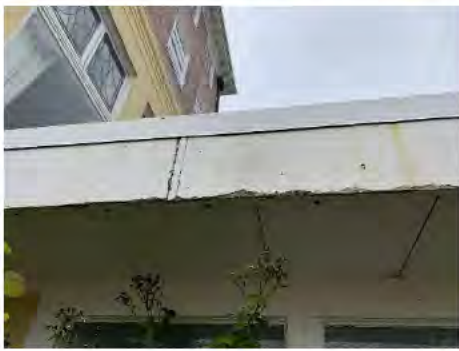
5.12	Workshop roof eaves	Fibre cement fascias and soffits	<p>Condition: The fibre cement fascias and soffits are delaminating, deteriorated and appeared to have suffered from localised impact damage.</p> <p>Recommended works: The fascias and soffits to be replaced as part of roof replacement works.</p>	●

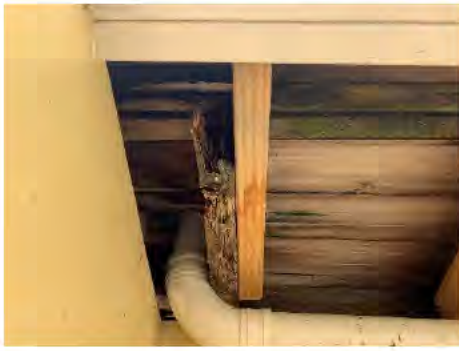
5.15	Workshop roof	Roof timbers	<p>Condition: Sections of the soffit have been removed and have exposed visibly decayed timber roof framing. Localised timbers have been replaced.</p> <p>Recommended works: Replace all the decayed timber roof framing as part of roof replacement works. The sections of missing soffit to be replaced in the immediate term to prevent bird or rodent access.</p>	●

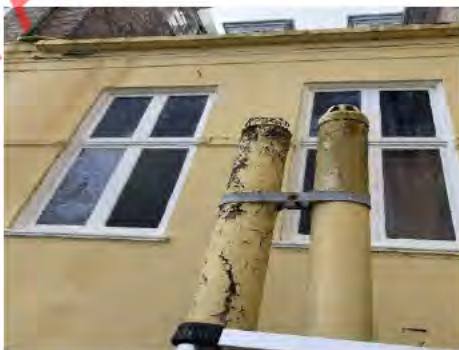
Ref.	Element	Description	Comments on condition/recommended works	Priority	Photograph
5.16	Workshop roof	Suspected asbestos cement pipe	<p>Condition: There are two pipes penetrating through the workshop roof. One pipe (left hand side) is a suspected asbestos containing material (ACM) however it was not tested.</p> <p>Recommended works: The pipe should be removed by an appropriately licenced asbestos contractor.</p> <p><i>Also see hazardous materials section of this report.</i></p>	●

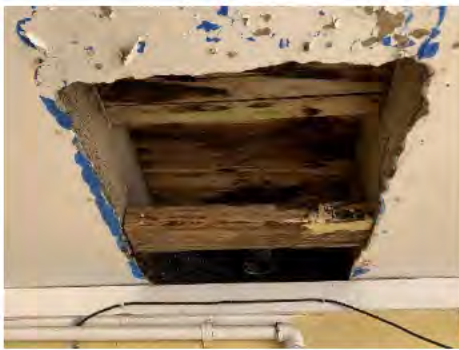
5.17	Workshop roof	Suspected (damaged) asbestos soffit	<p>Condition: The section of damaged soffit is a suspected ACM however this was not tested.</p> <p>Recommended works: The damaged ACM soffit should be removed by an appropriately licenced asbestos contractor as part of roof replacement works.</p> <p><i>Also see hazardous materials section of this report.</i></p>	●

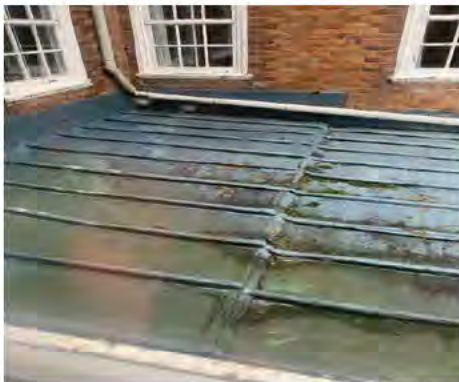
6.0	LEAD ROOF OVER KITCHEN (ORIGINAL)				
6.1	Lead roof	The small section of roof over the kitchen is considered to be finished with lead or other metal material. Water is discharging onto this roof from the missing section of gutter directly above and downpipes also discharge into this roof causing overloading and overflowing of the gutter.	<p>Condition: The lead roof is in poor condition with previous repairs noted and active water ingress identified internally.</p> <p>Recommended works: As part of overall roof replacement works this section of roof should also be replaced and the downpipes redirected.</p> <p>In the immediate term the gap/hole which is causing the leak should be repaired.</p>	● ●

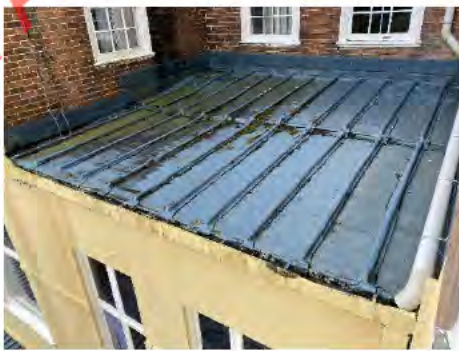
Ref.	Element	Description	Comments on condition/recommended works	Priority	Photograph
6.2	Lead roof	Rainwater goods	<p>Condition: The roof and external gutter are being overloaded during rain events resulting in water discharging onto the elevation causing dampness, peeling paint and also water ingress internally.</p> <p>Recommended works: The downpipes which discharge into the gutter should be diverted to prevent overloading the external gutter.</p>	●

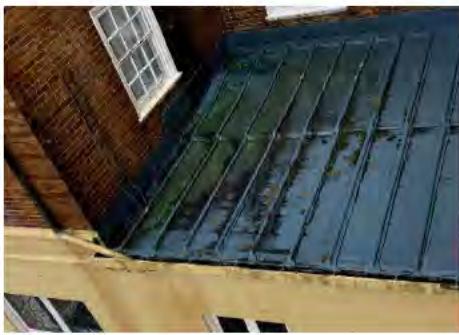
6.3	Lead roof	Water damage to main elevation	<p>Condition: The section of elevation directly below the gutter is visibly damp stained from the overflowing gutter.</p> <p>Recommended works: The downpipes should be redirected to prevent overloading the gutter. Once this is done the elevation should be made good.</p>	●

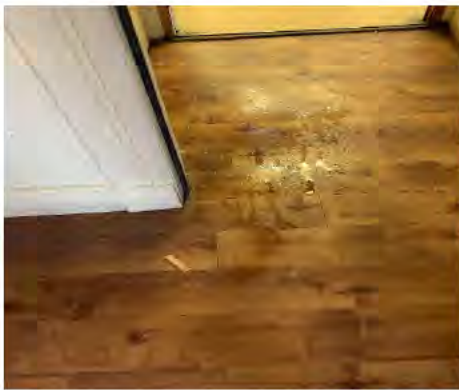
6.4	Water ingress	Internal water ingress	<p>Condition: Water ingress was noted internally to the doorway between the kitchen and main dining room. We could not identify if the water ingress was from the failed lead roof or the rainwater goods as there was no access directly onto the lead roof above.</p> <p>Recommended works: All flashings and junctions to the roof to be correctly detailed to prevent future watering ingress. In the meantime the flashings and roof to be overhauled and sealed to prevent ongoing water ingress. Downpipes to be rediverted as previously recommended.</p>	●

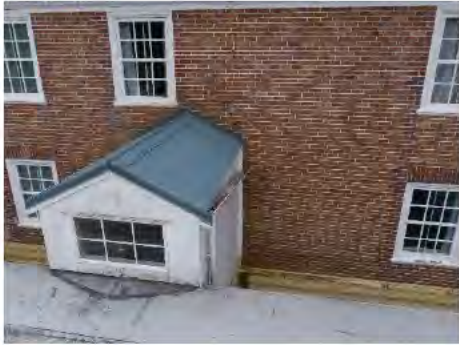
7.5	Staircase window structure	A small structure has been constructed to enclose the rear staircase leading to the accommodation.	<p>Condition: The small structure is in poor condition with deteriorated and delaminated fibre cement cladding, inadequate cladding clearances, bare timber and loose section of gutter.</p> <p>Recommended works: The small structure should be repaired in the immediate term to include replacing the loose gutter, replacing damaged cladding and re decorating sections of bare timber.</p>	●

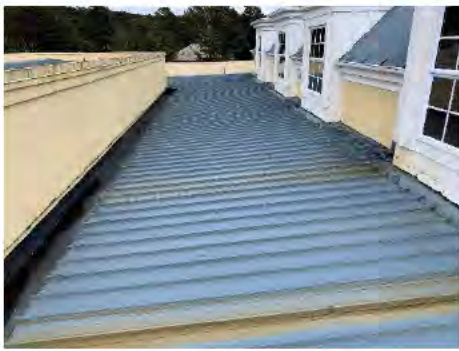
7.8	Mono pitched roof	The section of mono pitched roof between the canopy roof and accommodation is lined with trough section roof sheets which discharge into a Butyl gutter.	<p>Condition: The roof sheets are suffering from localised corrosion and localised increased water flow from downpipes resulting in surface deterioration.</p> <p>Recommended works: The sheets are circa 28 years old and with correct repair and maintenance their life span can be extended. In the immediate term all corrosion should be treated to prevent further deterioration.</p>	●

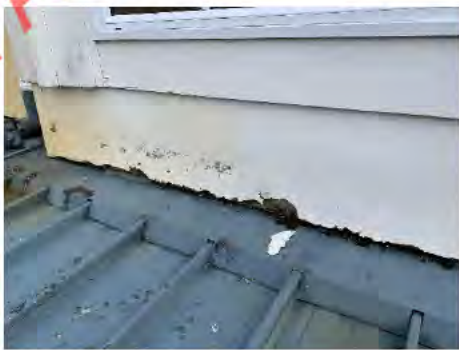
7.9	Dormers	There are dormer windows overlooking the mono pitched roof. These are constructed from timber framing with fibre cement cladding, aluminium windows and membrane lined roofs	<p>Condition: The cladding to the dormers is in poor condition with extensive damage and delamination noted due to inadequate clearance resulting in water penetration into the cladding.</p> <p>Recommended works: The fibre cement cladding will need replacement in the short term along with any decayed timber framing.</p>	●

Ref.	Element	Description	Comments on condition/recommended works	Priority	Photograph
7.10	Dormers	As above	As above	●

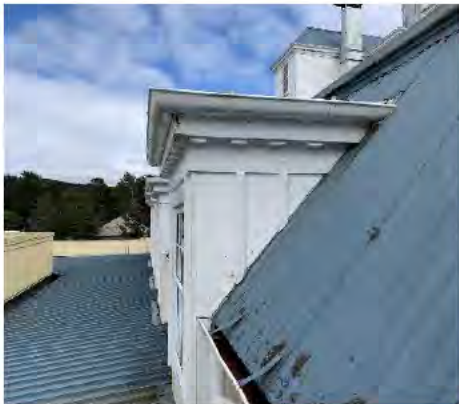
7.11	Dormers	As above	<p>Condition: The cladding to the side to the dormer has limited clearance to the apron flashing which is allowing water to wick into the cladding which is exacerbated by increased water from the gutter discharging directly above. The cladding is in poor condition with delaminated cladding and moss growth noted.</p> <p>Recommended works: The gutter from the dormer should be redirected to prevent concentrated water flow along the cladding. The damaged cladding and any decayed timber framing should be replaced in the immediate term. The painted timber should be repainted in the immediate term.</p>	●

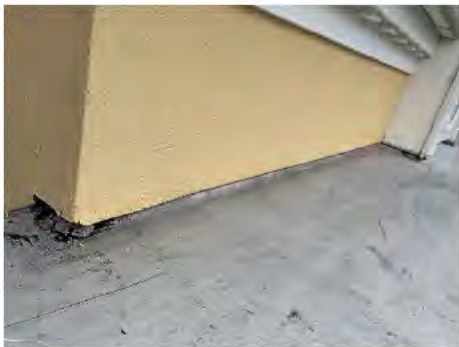
7.14	Dormers	As above	<p>Condition: The sections of cladding between each dormer window has limited clearance to the roof however appears in reasonable condition with only localised damage noted.</p> <p>Recommended works: Repaint the cladding in the short term.</p>	●

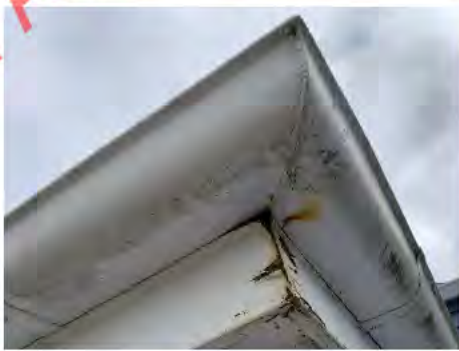
Ref.	Element	Description	Comments on condition/recommended works	Priority	Photograph
7.19	Rainwater goods	Metal gutters	<p>Condition: The gutters are in a various state of disrepair with corrosion and holes noted to numerous gutters.</p> <p>Recommended works: The gutters should be replaced in their entirety as they are considered beyond economical repair.</p>	●

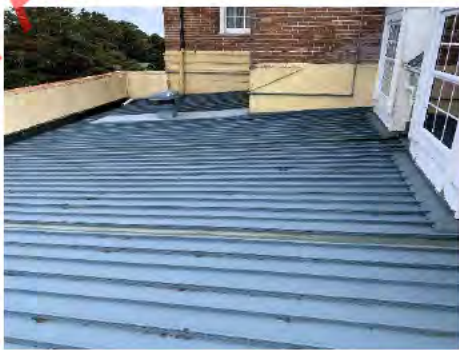
Ref.	Element	Description	Comments on condition/recommended works	Priority	Photograph
7.22	Roof directly over T-Bar	This is also a mono pitched roof similar to the previous roof which has the same roof detailing.	The defects identified to the previous roof are also applicable to this roof.	●

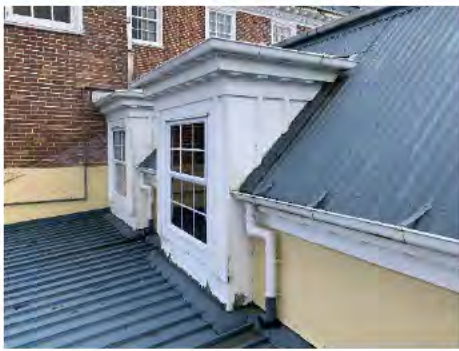
7.23	Roof directly over T-Bar	Cladding detail	Inadequate cladding clearance similar to previous roof.	●

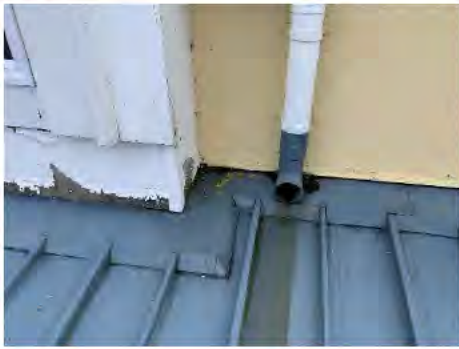
7.24	Roof directly over T-Bar	Downpipe detail	Downpipe discharging onto the apron flashing.	●

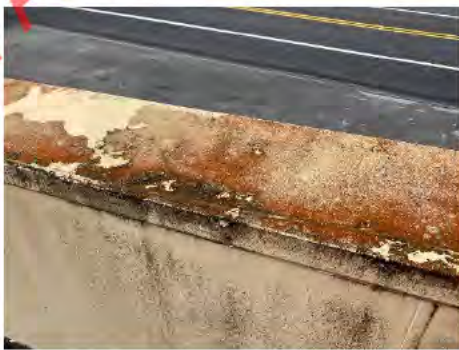
Ref.	Element	Description	Comments on condition/recommended works	Priority	Photograph
7.25	Parapet flashing cap	The parapet wall to the T Bar roof is finished with a top fixed metal cap flashing.	<p>Condition: The metal cap flashing has been fixed over the parapet wall and is complete with top screw fixings. The flashing is in poor condition with extensive moss and algae growth noted. The use of top fixings is not good practise as it can allow water penetration.</p> <p>Recommended works: The cap flashing should be replaced with a side fixed capping in the immediate term.</p>	●

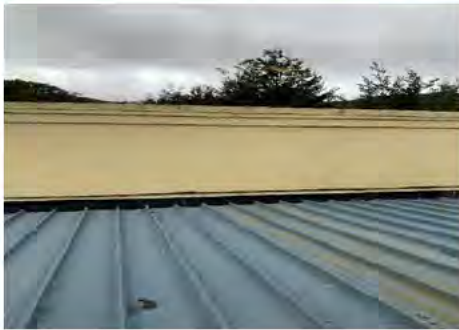
7.27	Rear canopy roof	The roof to the rear canopy is finished with metal roof sheets which discharge into Butyl lined gutters all enclosed within plywood clad parapet walls.	<p>Condition: The parapet walls have been lined internally with painted plywood which is in poor condition with peeling and deteriorated paint noted.</p> <p>Recommended works: The plywood cladding should be repainted in the immediate term.</p>	●

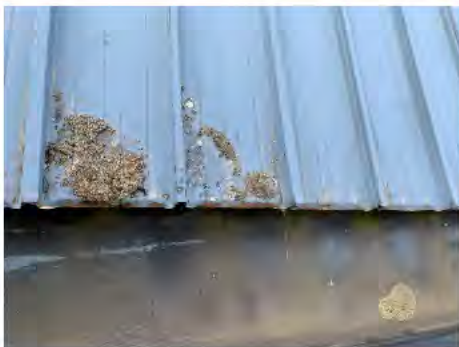
7.29	Rear canopy roof	As above	<p>Condition: The metal roof sheets are in poor condition with localised corrosion and damage noted particularly along the bottom edge.</p> <p>Recommended works: In the immediate term the corrosion should be spot treated to prevent further deterioration.</p>	●

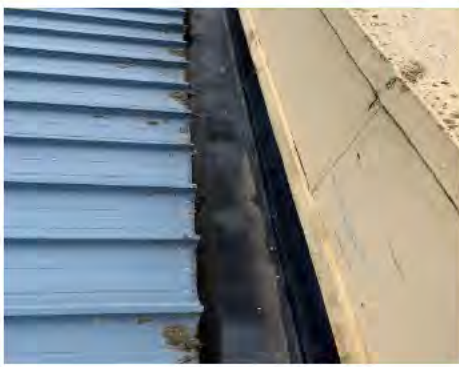
7.30	Parapet gutter	Butyl lined parapet gutters	<p>Condition: The Butyl membrane appears in reasonable condition however the penetrations and outlets have generally been poorly detailed.</p> <p>Recommended works: The membrane should be checked annually for signs of deterioration and water leaks.</p>	●

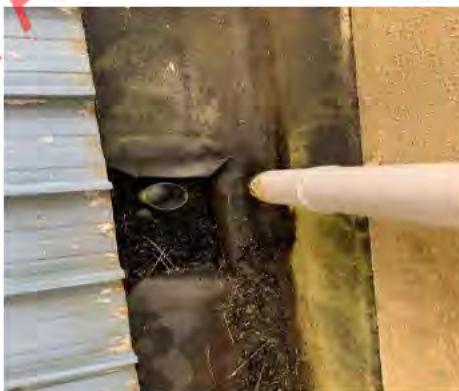
Ref.	Element	Description	Comments on condition/recommended works	Priority	Photograph
7.31	Parapet gutter	Butyl lined parapet gutters	<p>Condition: The membrane has been poorly lapped into the rainwater outlet and has debonded.</p> <p>Recommended works: The membrane to be overhauled and adhered to the outlet.</p>	●

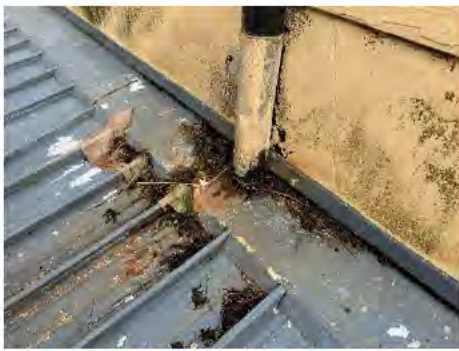
7.34	Void space between the original building and extension	Downpipe	<p>Condition: A downpipe was noted to be blocked with debris and it also discharges directly onto an apron flashing which is not good practice.</p> <p>Recommended works: The downpipe should be cleaned out to leave free flowing and checked/cleaned annually.</p>	●

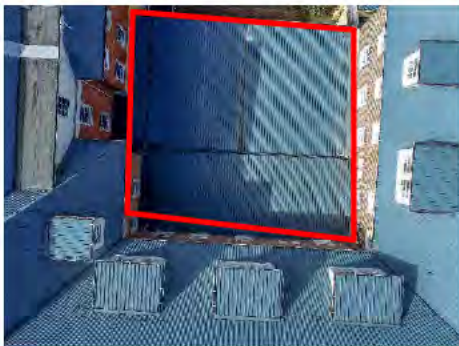
8.0	DINING ATRIUM ROOF (2005)				
8.1	Dining atrium roof	Aerial location over view of the dining atrium roof	We understand this roof was constructed circa 2005 under building consent BC10725 (however we believe the upper section is older construction). It is a mono pitched roof and features a central step. The roof is finished with metal roof sheets and box gutters both to the central step and edge gutter.	●

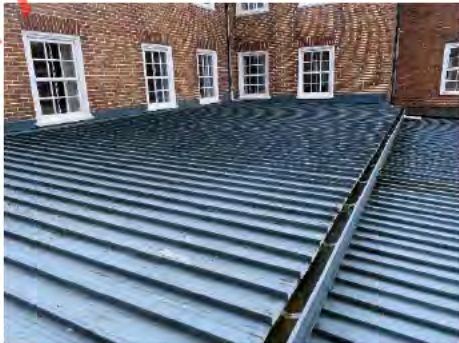
Ref.	Element	Description	Comments on condition/recommended works	Priority	Photograph
8.2	Dining atrium roof	Upper section of the roof	<p>Condition: The upper mono pitched section is finished with trough section roof sheets which discharges into a box section gutter. The roof sheet finish is in poor condition with localised corrosion and peeling paint noted.</p> <p>Recommended works: In the immediate to short term the roof paint should be repainted and any surface corrosion treated to prevent further deterioration. Depending on budget constraints the roof should be replaced in the medium to long term.</p>	●

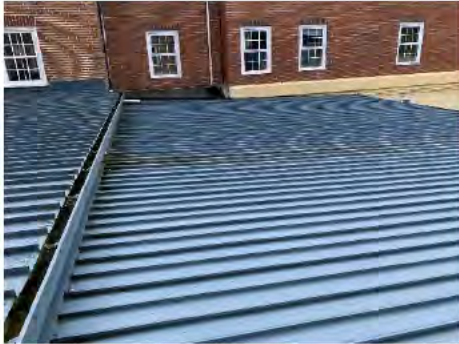
8.3	Dining atrium roof	Lower section of the roof	<p>Condition: The lower mono pitched section is finished with trough section roof sheets which discharges into a box section edge gutter. The roof sheets are in reasonable condition with localised corrosion and peeling paint noted.</p> <p>Recommended works: In the immediate short term the surface corrosion treated to prevent further deterioration and cleaned to remove contaminate build up.</p>	●

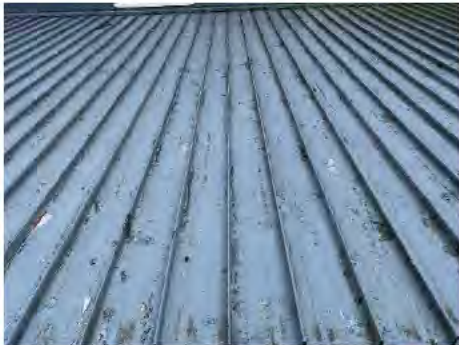
8.4	Dining atrium roof	Close up view of the upper roof sheets	<p>Condition: The upper roof sheets are peeling, deteriorating and surface corrosion was noted to numerous areas.</p> <p>Recommended works: In the immediate term the corrosion should be treated and the roof repainted to prevent further deterioration. Depending on budget constraints the roof should be replaced in the medium to long term.</p>	●

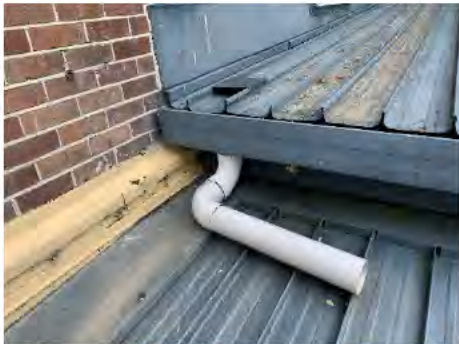
8.9	Dining atrium roof	Downpipes	<p>Condition: The uPVC downpipes discharged directly onto the roof sheet below. This is not good practise as it can lead to concentrated water flow causing premature deterioration.</p> <p>Recommended works: In the immediate term the downpipe should be extended into the lower gutter.</p>	●

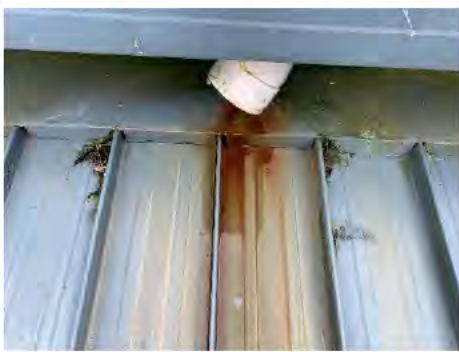
8.10	Dining atrium roof	Downpipe	<p>Condition: A downpipe from the upper roof is just charging directly onto the apron flashing which can result in water ingress as well as concentrated water flow causing deterioration of the roof sheet.</p> <p>Recommended works: In the immediate term the downpipe should be extended into the lower gutter.</p>	●

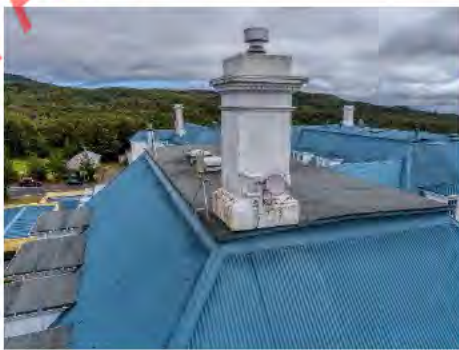
Ref.	Element	Description	Comments on condition/recommended works	Priority	Photograph
9.3	Chimney	The chimney to this roof would appear to be partly for aesthetic reasons a partly to conceal the gas flue.	<p>Condition: The chimney was inspected using a drone and was found to be in reasonable condition.</p> <p>Recommended works: Repaint the chimney in the medium term.</p>	●

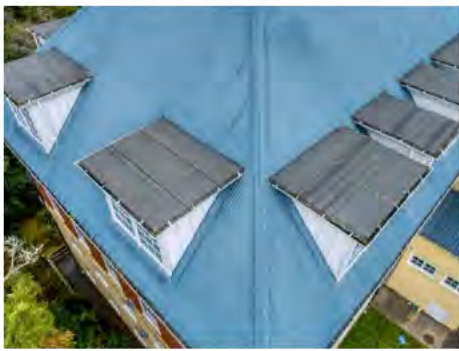
9.4	Dormer windows	The dormer windows are constructed from timber frame with aluminium windows, fibre cement cladding and torch on felt roof membrane. The gutters are metal complete with uPVC downpipes.	<p>Condition: The dormer windows were found to be in reasonable condition.</p> <p>Recommended works: Inspect annually for signs of deterioration or water ingress.</p>	●

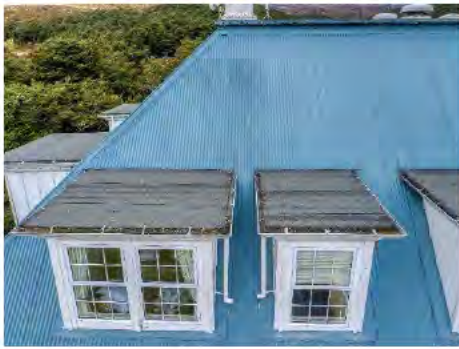
9.5	Dormer windows	Torch on felt membrane	<p>Condition: The torch on felt membrane to the dormers was found to be in good condition with no obvious defects noted.</p> <p>Recommended works: Inspect annually for signs of deterioration or water ingress.</p>	●

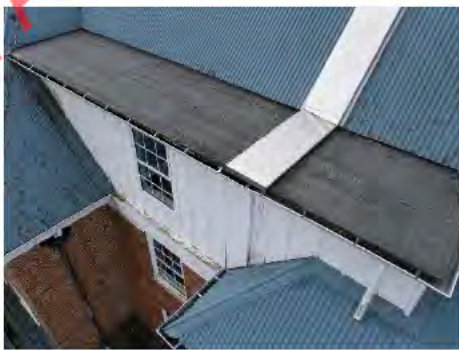
Ref.	Element	Description	Comments on condition/recommended works	Priority	Photograph
9.9	Corridor roof	The roof to the link corridor is finished with a torch on felt membrane finish.	<p>Condition: The membrane was inspected using a drone and was found to be in reasonable condition with no obvious defects noted.</p> <p>Recommended works: Inspect annually for signs of deterioration and repair accordingly.</p>	●

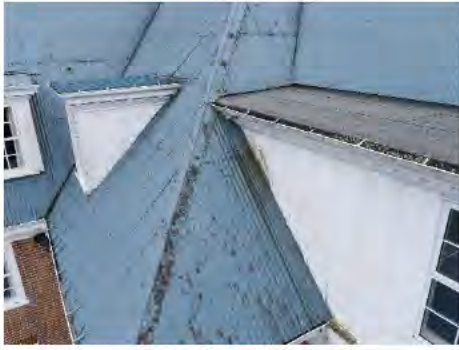
9.10	Corridor roof	The link corridor gutter discharges directly onto the apron flashing of the pitched roof.	<p>Condition: The gutter discharges directly onto the apron flashing of the main roof causing a concentrated water flow along the apron flashing/cladding junction. This in turn is overflowing from the gutter below causing water discharge onto the brickwork below.</p> <p>Recommended works: Ideally the gutter should be diverted into a separate downpipe to prevent water overflowing onto the brickwork which is causing brick damage and possible future dampness internally.</p>	●

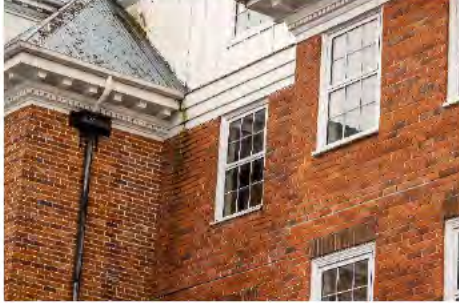
9.11	Corridor roof	As above	As above - see moisture staining on the brickwork	●

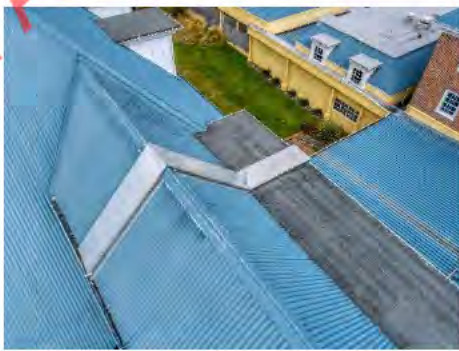
Ref.	Element	Description	Comments on condition/recommended works	Priority	Photograph
9.12	Seismic joint	The seismic joint has been extended over the roof and flashed with a metal flashing	<p>Condition: The seismic joint appeared in good condition with no obvious defects noted.</p> <p>Recommended works: No works required.</p>	●

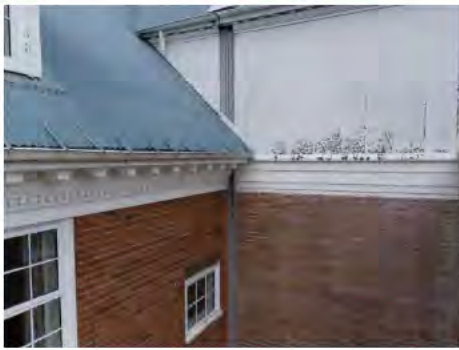
9.13	Seismic joint	As above	As above	●

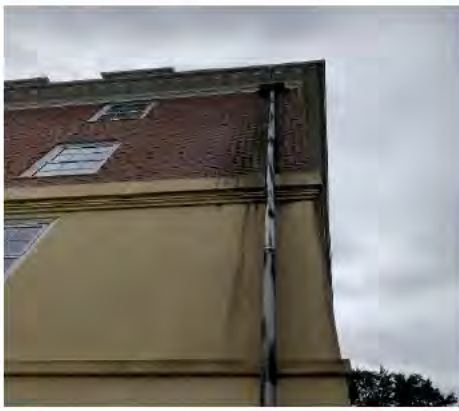
9.14	Rainwater goods	The gutters to the 2005 roof are connected into rain heads which in turn discharge into downpipes.	<p>Condition: The rain heads and downpipes were generally all noted to be blocked and overflowing causing damage to the brickwork and staining to the paint work. This can allow freezing water on the bricks resulting in spalling brickwork and dampness internally.</p> <p>Recommended works: In the immediate term all rain heads and downpipes should be cleaned out to leave free flowing. They should be cleaned out annually to prevent debris build up and subsequent blockages.</p>	●

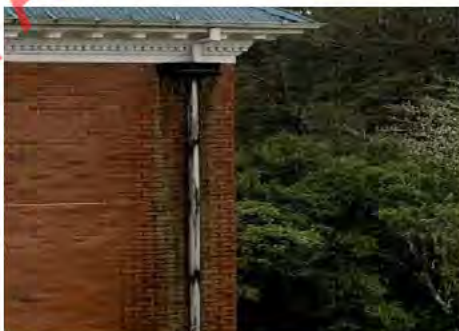
Ref.	Element	Description	Comments on condition/recommended works	Priority	Photograph
9.15	Rainwater goods	As above	As above	●

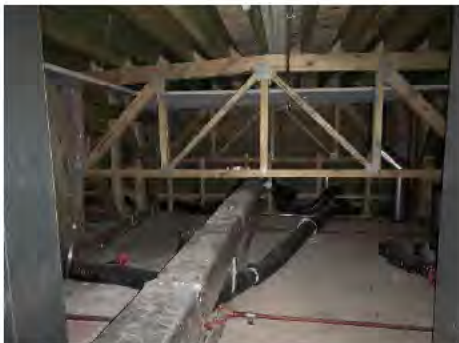
9.16	Roof space services	There are various ducts and services within the roof space to the 2005 extension.	<p>Condition: The ventilation ductwork was noted to be poorly installed with various bends and inefficient installation noted.</p> <p>Recommended works: To ensure a more efficient running off the ventilation system it would be considered worthwhile reviewing all ductwork to ensure there are a limited number of bends which can cause air friction within the ducts thereby reducing efficiency. The system should be balanced to ensure optimal running.</p>	●

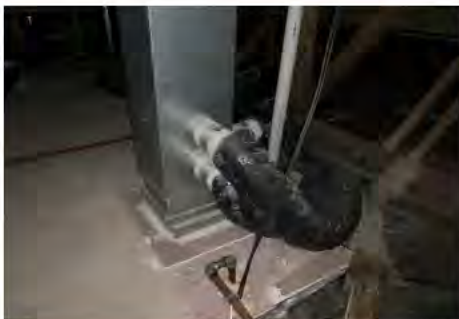
9.17	Roof space services	As above	As above	●

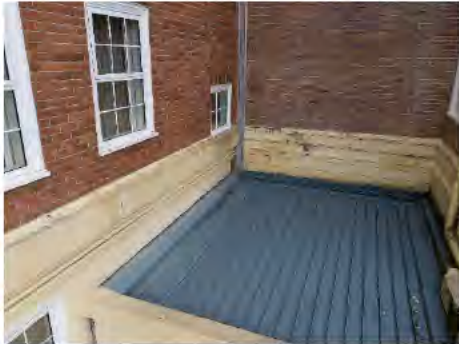
Ref.	Element	Description	Comments on condition/recommended works	Priority	Photograph
10.0	ROOF OVER GROUND FLOOR TOILETS (2005)				
10.1	Ground floor toilet roof	The roof to the ground floor was inspected using a drone and from the bedroom windows overlooking the roof.	<p>Condition: The roof generally appeared in reasonable condition with no signs of water ingress noted internally.</p> <p>Recommended works: Monitor roof for signs of water ingress and clean gutters out annually.</p>	●

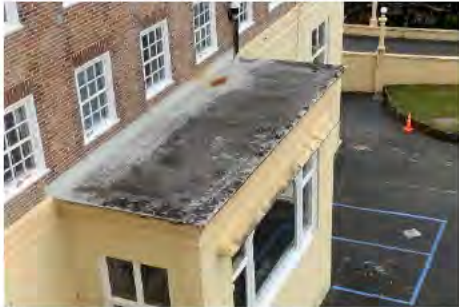
11.0	RUAPEHU FEATURE WINDOW ROOF				
11.1	Flat roof over Ruapehu feature window	The roof over the Ruapehu feature window appears to be concrete construction with a waterproof membrane finish. Given the dimensions of the membrane sections we believe it is an asbestos containing material (ACM).	<p>Condition: The roof membrane appears in a poor condition with deteriorated solar reflective paint finish. Lichen growth was noted throughout which can cause damage to the roof membrane.</p> <p>Recommended works: In the immediate term the membrane should be treated with a chemical treatment to kill off any lichen and a new solar reflective paint applied once the lichen has died off. As the material is a suspected ACM it should not be water blasted.</p>	●

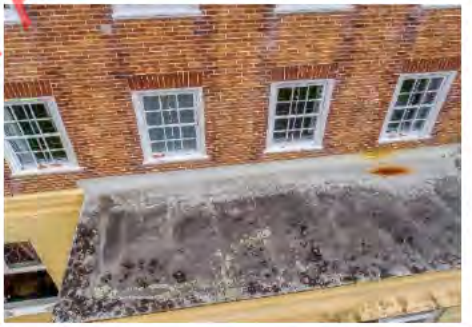
Ref.	Element	Description	Comments on condition/recommended works	Priority	Photograph
11.2	Flat roof over Ruapehu feature window	As above	As above	●

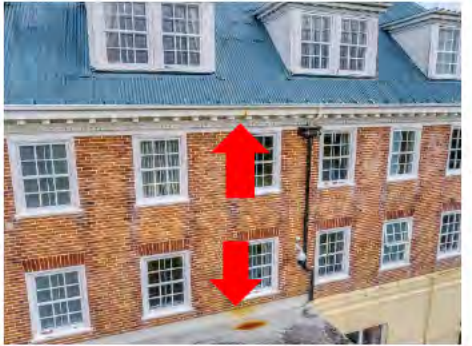
11.4	Flat roof over Ruapehu feature window	As above	<p>Condition: Brown rust staining was noted on the membrane. This appears to be originating from the leaking gutter directly above as shown in the photo.</p> <p>Recommended works: In the immediate term the leaking gutter above should be repaired and the rust stain carefully cleaned, bearing in mind it is likely to be an ACM, prior to the re application of a solar reflective paint.</p>	●

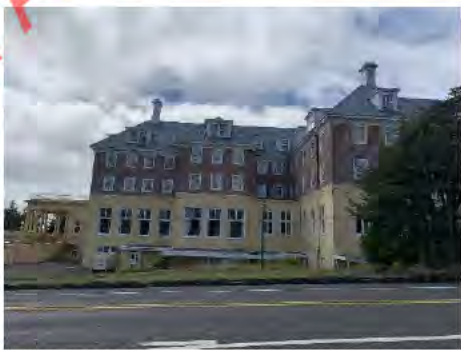
Ref.	Element	Description	Comments on condition/recommended works	Priority	Photograph
12.4	Overview - Right hand side of main building	The right-hand side elevation consists of the 1929 original construction and the 1955 workshop extension at ground floor level.	<p>Condition: The right-hand side extension is suffering from moisture related defects, damage from overflowing gutters, moss and algae growth from concentrated water from the rainwater goods and general deterioration of the paint finish.</p> <p>Recommended works: All previously painted surfaces will need to be thoroughly prepared, scraped back and repaint it in the immediate to short term once the rainwater goods are repaired.</p>	●

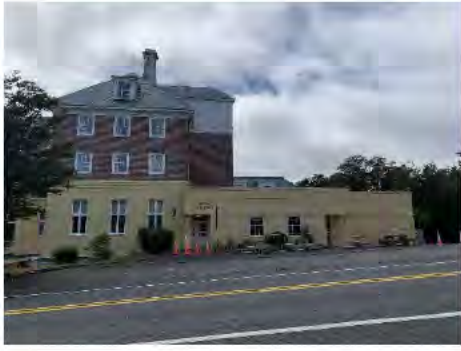
12.5	Overview - Right hand side elevation (T-Bar extension)	The rear right hand side extension forms the T-Bar and was constructed in 1995. It is of timber frame construction with a polystyrene external cladding.	<p>Condition: Polystyrene cladding has known potential inherent defects related to moisture ingress. Cracking was noted to this cladding suggesting possible water ingress resulting in the cracks. This should be fully investigated to determine if the timber framing is also suffering from decay as this can be concealed behind the cladding.</p> <p>Recommended works: Investigate causes of the cladding cracking prior to considering any remedial works.</p>	●
