BUILDING CONDITION APPRAISAL.

Chateau Tongariro Hotel - State Highway 48,
Whakapapa Village, Mount Ruapehu

Prepared for: Department of Conservation

Date: April 2023

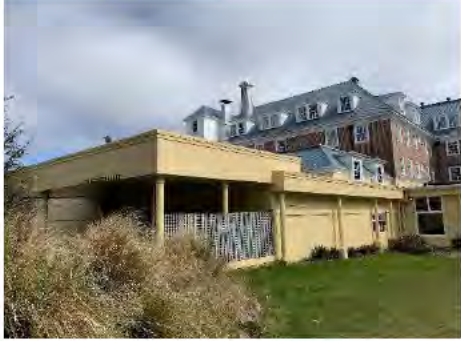
12.6	Overview - Rear elevation of 1995 extension	The rear extension was constructed in 1995. It is of timber frame construction where the polystyrene external cladding.	Same defect and issues as the right-hand side 1995 extension.	●

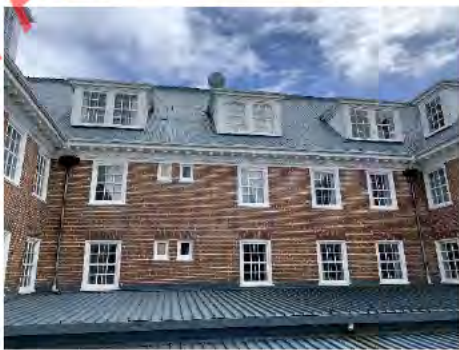
Ref.	Element	Description	Comments on condition/recommended works	Priority	Photograph
12.10	Overview - Upper level of original building rear elevation (central section)	As above	As above	●

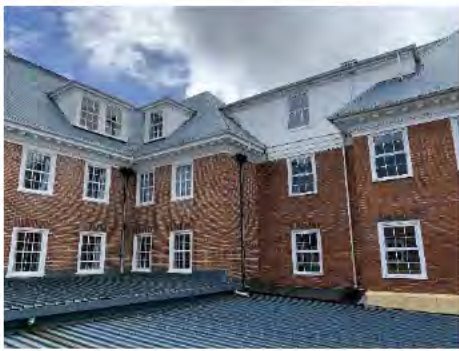
12.11	Overview - Upper level of original building rear elevation (Right hand side section)	As above	As above	●

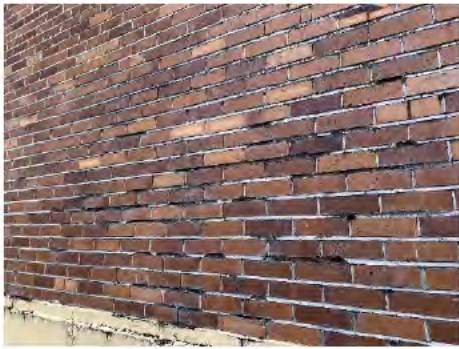
12.12	Brickwork	Missing pointing to the original brickwork	<p>Condition: Sections of missing pointing were noted to the original 1929 brickwork.</p> <p>Recommended works: In the short term the missing pointing should be replaced with a suitable mortar in keeping with the historic nature and materials used in this building.</p>	●

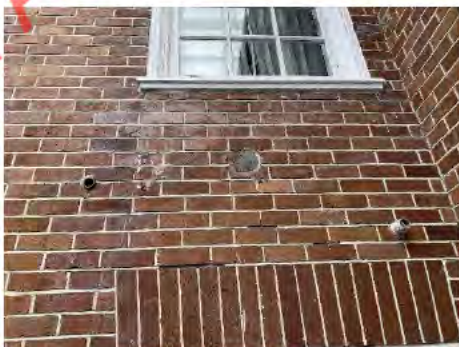
Ref.	Element	Description	Comments on condition/recommended works	Priority	Photograph
12.16	Brickwork	Missing pointing and inappropriate repair	As above	●

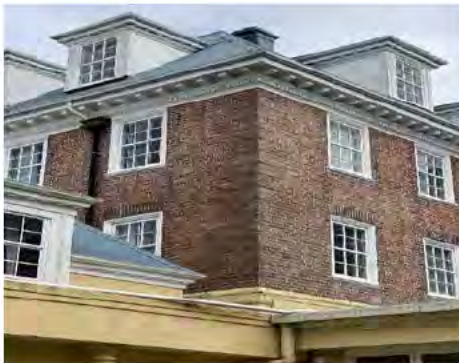
12.18	Brickwork	Damaged and missing pointing to the front corner of the original building	<p>Condition: The mortar pointing to a number of corners was noted to be worn or missing.</p> <p>Recommended works: Repoint missing pointing as found necessary.</p>	●

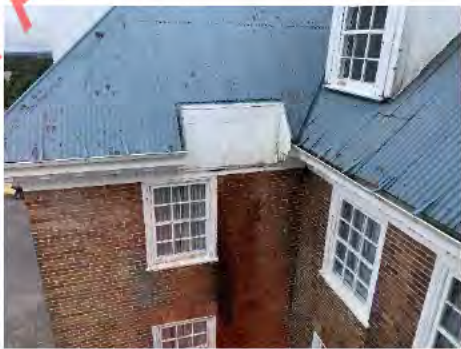
Ref.	Element	Description	Comments on condition/recommended works	Priority	Photograph
12.19	Brickwork	A missing section of gutter is allowing water to discharge directly onto the brickwork which is causing moss growth and damaging the bricks.	<p>Condition: The brickwork is heavily stained and extensive moss growth noted.</p> <p>Recommended works: In the immediate term a section of gutter should be installed to prevent water discharging directly onto the wall. The moss growth should be treated with a chemical treatment as moss will cause damage to the bricks and pointing</p>	●

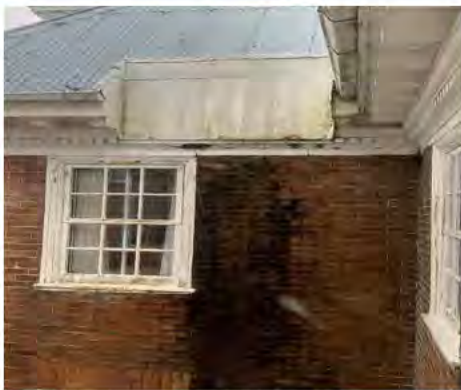
12.20	Brickwork	As above	As above	●

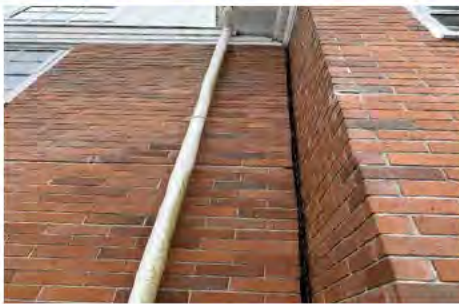
12.23	Brickwork	The brickwork at the junction of the original building and 2005 extension has not been sealed or a suitable flashing provided.	<p>Condition: There is an unsealed vertical gap which is allowing bird entry and possible water ingress.</p> <p>Recommended works: The vertical gap should be flashed or sealed with a flexible sealant material to allow for movement along this line.</p>	●

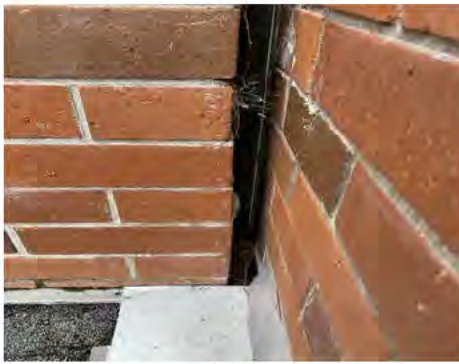
12.24	Brickwork	Close up of the right-hand side unsealed gap and evidence of bird entry (nesting material)	As above	●

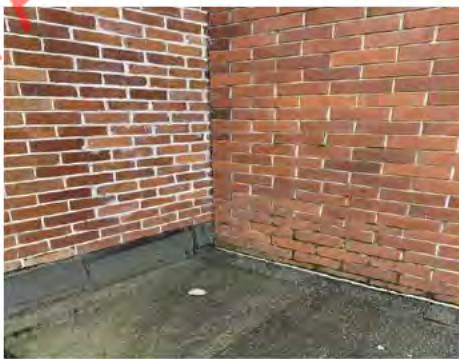
Ref.	Element	Description	Comments on condition/recommended works	Priority	Photograph
12.25	Brickwork	The corresponding brick joint to the left-hand side is also unsealed.	As above	●

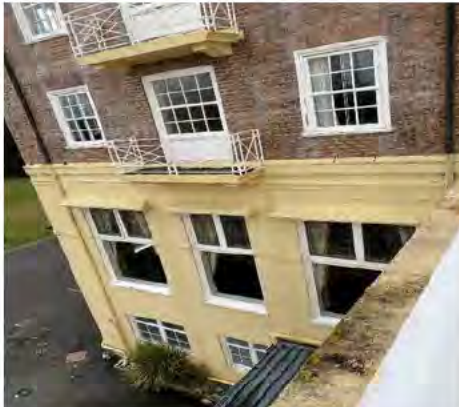
12.27	Painted masonry wall	The plastered and painted masonry section of wall extends from ground level to 2nd floor level where it changes to brick veneer cladding. We understand from the WSP report that the wall is possibly unreinforced masonry.	<p>Condition: The paint finish is in poor condition with numerous areas of peeling paint, missing paint, bubbling paint and general neglect noted.</p> <p>Recommended works: All previously painted external wall areas will need to be scraped back, thoroughly prepared and repainted with a suitable exterior quality paint.</p>	●

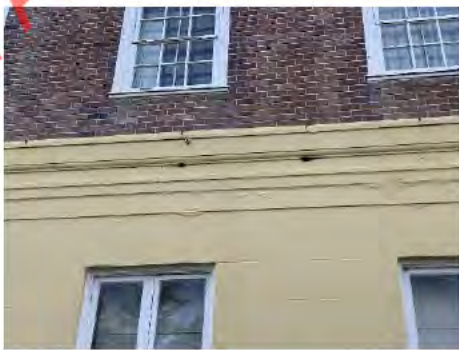
Ref.	Element	Description	Comments on condition/recommended works	Priority	Photograph
12.28	Painted masonry wall	As above	As above	●

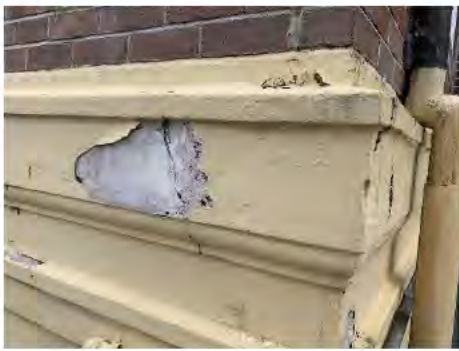
12.29	Plastered features	Plastered and painted featured details create the junction between the lower levels and brick upper levels.	<p>Condition: As the original building is a heritage building the paint finish will need to be correctly specified to ensure a breathable paint is applied which is in keeping with the historic nature of the building.</p> <p>Recommended works: Correctly specify a suitable paint system. Any necessary repairs to the plastered features will need to be correctly specified and detailed.</p>	●

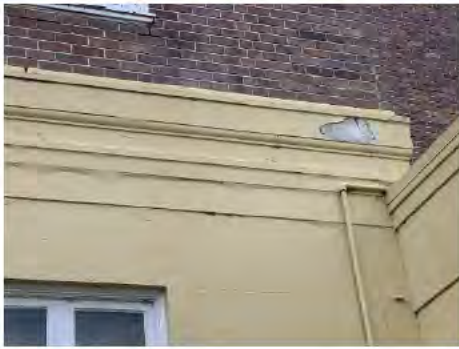
12.30	Plastered features	As above	As above	●

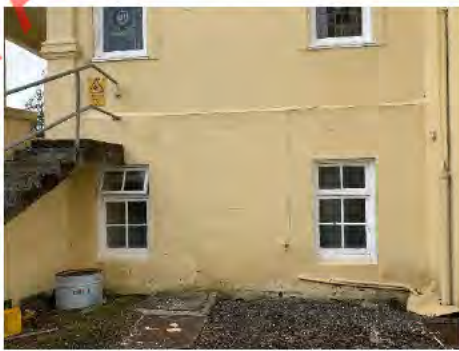
Ref.	Element	Description	Comments on condition/recommended works	Priority	Photograph
12.31	Painted surfaces	Low-level painted surfaces.	<p>Condition: The low-level paint is also suffering from water damage along the bottom edge due to inadequate drainage.</p> <p>Recommended works: Prior to redecoration the drainage and low-level paint to be correctly treated, the walls allowed to dry out prior to painting.</p>	●

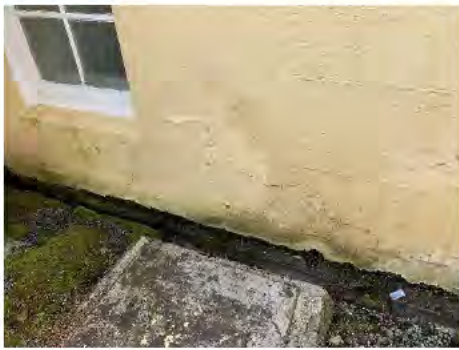
12.32	Painted surfaces	Low-level painted surfaces.	As above	●

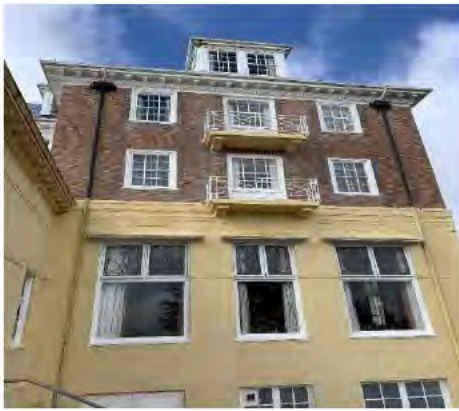
12.33	Juliet balconies	There are Juliet balconies to each side of the front elevation	<p>Condition: The Juliet balconies are in various states of disrepair including having poor surface membrane, corroded metal handrails and missing front section to one balcony. It was noted internally that damp staining is occurring directly under the Juliet balconies in the dining room and Ngauruhoe Room which we believe is emanating from the balconies.</p> <p>Recommended works: Fully inspect the balcony/wall junction and make good as required to prevent dampness in the rooms below.</p>	●

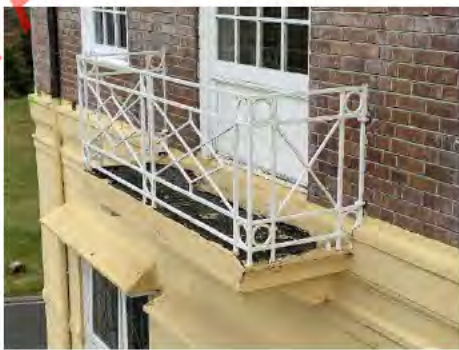
Ref.	Element	Description	Comments on condition/recommended works	Priority	Photograph
12.34	Juliet balconies	Close up of Juliet balcony	As above	●

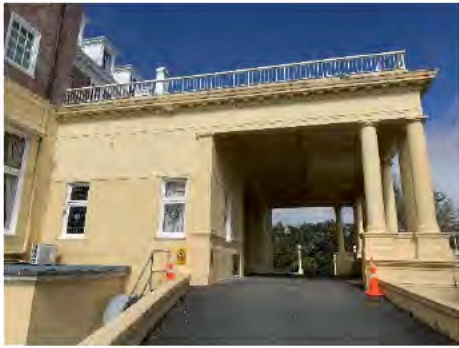
12.35	Entrance portico	The entrance portico is formed by the balcony above supported on circular columns and the main walls.	<p>Condition: The paint work to the portico is in poor condition with bubbling, peeling and defective paint noted.</p> <p>Recommended works: The paint to the portico to be repainted when the main elevations are being repainted.</p>	●

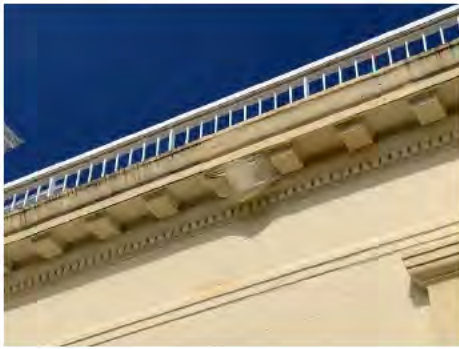
12.36	Entrance portico	Large bubbles and stretching of the paint work noted due to trapped moisture behind the paint.	<p>Condition: The bubbling paint work confirms years of water ingress and lack of maintenance.</p> <p>Recommended works: The paint to the portico to be repainted when the main elevations are being repainted.</p>	●

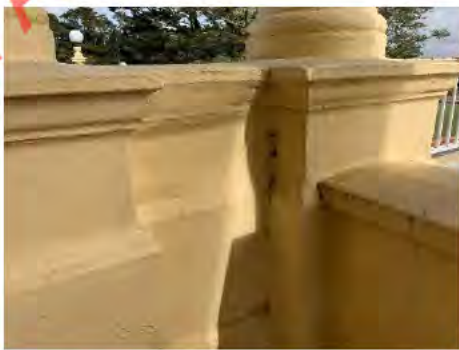
Ref.	Element	Description	Comments on condition/recommended works	Priority	Photograph
12.37	Entrance portico	As above	As above	●

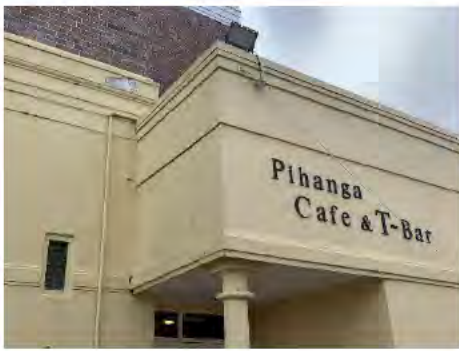
12.38	West elevation	The West elevation forms part of the 1995 extension. We understand it is timber framed construction with polystyrene exterior cladding.	<p>Condition: The paint work is approaching a redecoration cycle and is considered to be in poor decorative condition with algae growth noted.</p> <p>Recommended works: In the immediate term the paint work should be treated with a chemical treatment to kill off the algae growth.</p>	●

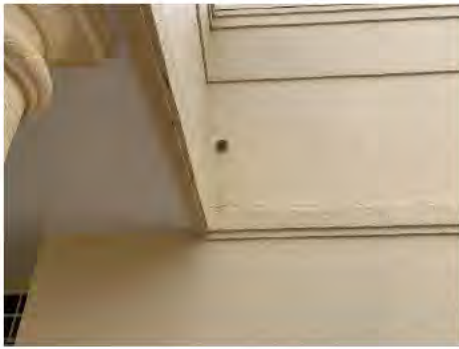
12.39	West elevation	Overflow pipe	<p>Condition: The overflow pipe from the roof above does not extend correctly beyond the wall surface.</p> <p>Recommended works: Consider extending the pipe work to discharge away from the cladding.</p>	●

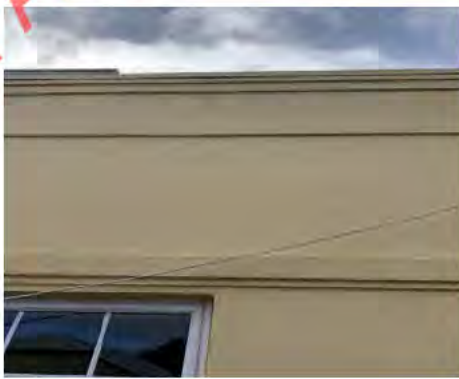
Ref.	Element	Description	Comments on condition/recommended works	Priority	Photograph
12.40	West elevation	Cracking	<p>Condition: Cracking was noted to localised and random areas over the West elevation.</p> <p>Recommended works: Given the known potential issues with polystyrene cladding, investigations should be carried out to determine the cause of cracking and the condition of the timber frame. In the immediate term the cracking should be sealed to prevent water ingress.</p>	●

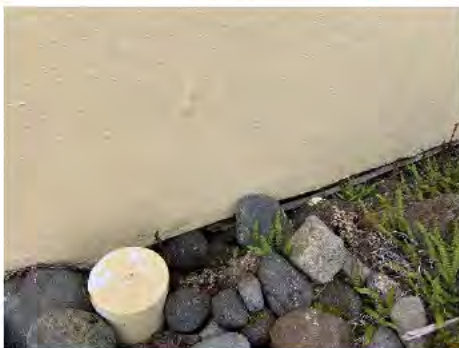
12.42	West elevation	Ground clearance	<p>Condition: The polystyrene cladding has been brought down to ground level with limited clearance provided. This can allow water to wick into the cladding and prevent drainage along the bottom edge.</p> <p>Recommended works: In the immediate term remove stones and other materials to create ground clearance to the cladding.</p>	●

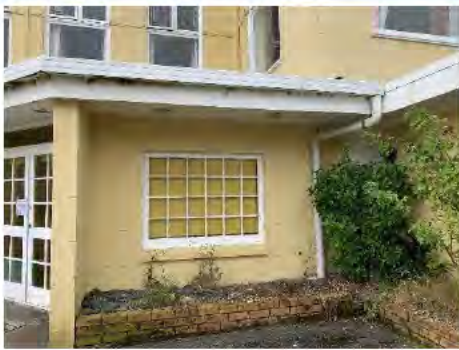
12.44	1955 workshop extension	The West elevation forms the workshop at the entrance to the basement level facilities.	<p>Condition: The paint finish to these elevations is in poor condition. Planters have been created along the elevation which can cause moisture ingress internally.</p> <p>Recommended works: Consideration to be given to removing the planters and making good the affected wall surfaces.</p>	●

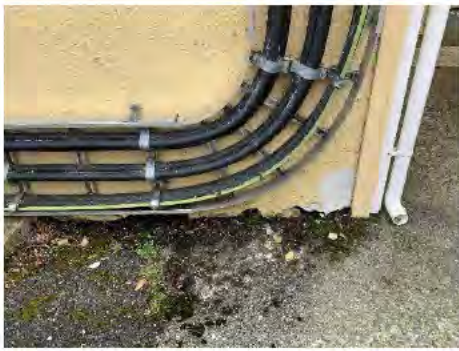
12.45	1955 workshop extension	Fibre cement cladding	<p>Condition: The workshop has direct fixed fibre cement cladding which is damaged at low level due to inadequate clearances and possible impact damage.</p> <p>Recommended works: Make good the cladding at low level and provide adequate ground clearance to prevent moisture wicking into the cladding.</p>	●

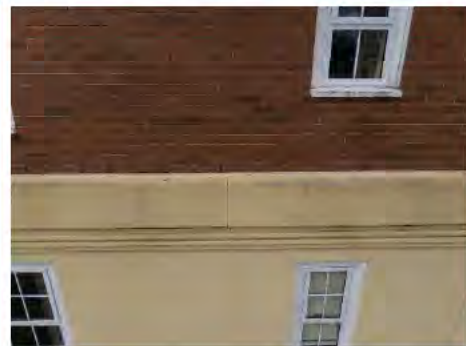
12.50	Polystyrene cladding	Polystyrene feature detail to the 2005 extension	<p>Condition: Cracking and missing sections of plaster were noted particularly to the front elevation polystyrene cladding along the feature detail. This will allow water ingress and it should be repaired in the immediate term.</p> <p>Recommended works: Investigate the cause of cracking prior to repairing. In the immediate term make good the cracks with a suitable sealant to prevent moisture ingress.</p>	●

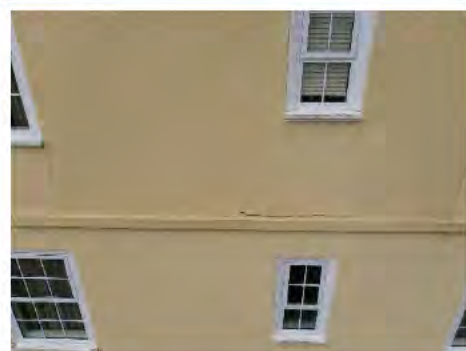
12.51	Polystyrene cladding	As above	As above	●

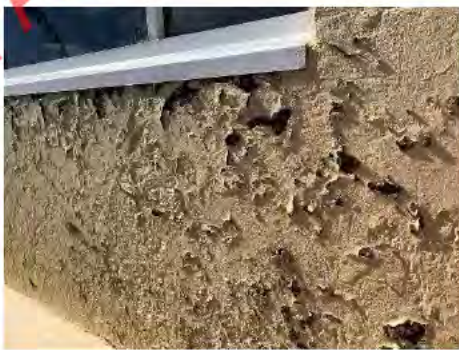
Ref.	Element	Description	Comments on condition/recommended works	Priority	Photograph
12.55	Tongariro Room conference centre	As above	As above	●

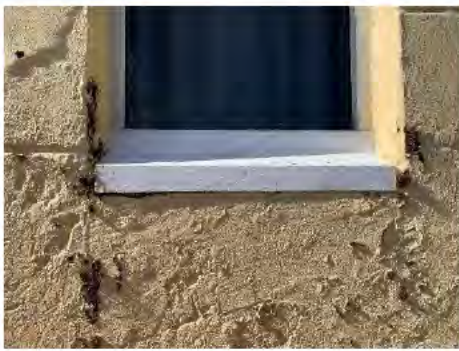
12.56	Tongariro Room conference centre	As above	As above	●

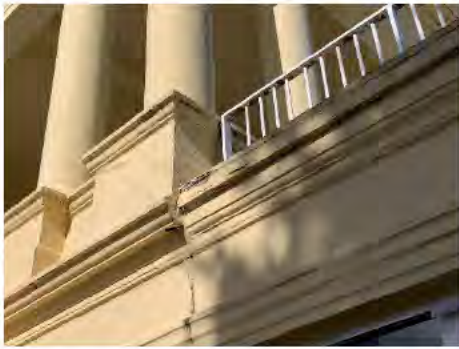
12.57	Wall junctions	The junction of the Tongariro Room conference centre and main portico are poorly detailed resulting in extensive damage to the building structure and associated moisture damage.	<p>Condition: Decayed timber and extensive water damage was noted to both the east and west sides.</p> <p>Recommended works: Provide a suitable flashing or connection detail between the two buildings to prevent ongoing water damage.</p>	●

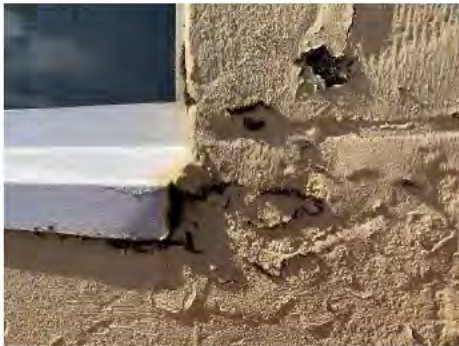
13.2	Tongariro Room windows	Conference room windowsill flashing detail	<p>Condition: The external windowsill detail has also been incorrectly installed which is preventing water draining correctly. Moss growth and damaged paint finish was noted confirming the presence of moisture over a long period of time.</p> <p>Recommended works: The windowsill detail should be reinstalled correctly to prevent future water damage.</p>	●

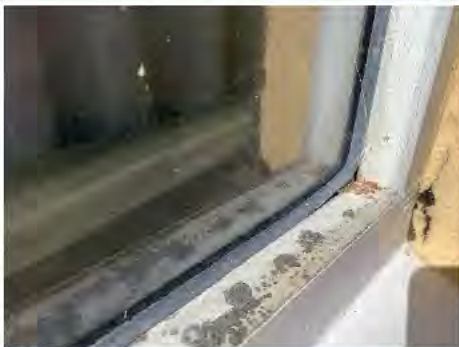
13.3	Tongariro Room windows	Conference room window glazing bead/gasket	<p>Condition: The window glazing bead/gasket have shrunk and will allow a direct path for water ingress internally.</p> <p>Recommended works: The window glazing bead/gasket to be replaced in the immediate term.</p>	●

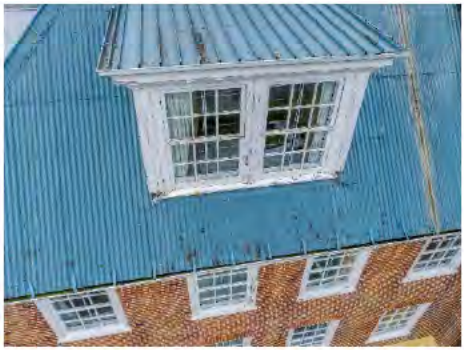
13.5	Dormer windows to main roof	Original painted timber windows and surrounds to the dormer windows	<p>Condition: The original dormer timber windows to the 1929 building are in poor condition with peeling paint, decayed timber and bare sections timber noted.</p> <p>Recommended works: In the immediate term all timber windows will need to be thoroughly prepared, scraped, overhauled and repainted to prevent further deterioration. This to include the timber surrounds and trim details.</p>	●

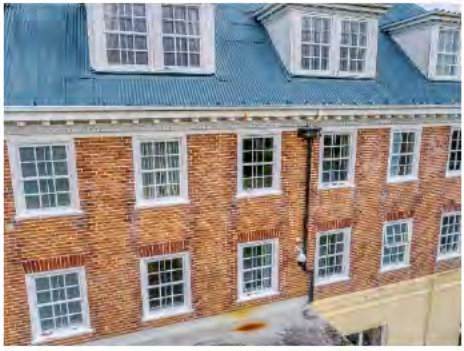
13.6	Dormer windows to main roof	As above	As above	●

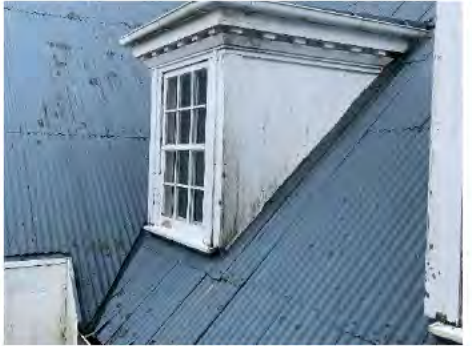
Ref.	Element	Description	Comments on condition/recommended works	Priority	Photograph
13.7	Dormer windows to main roof	As above	As above	●	 
13.8	Dormer windows to main roof	As above	As above	●

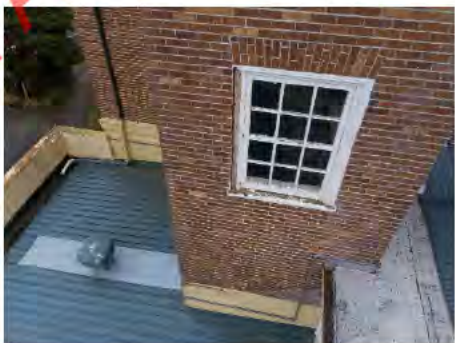
Ref.	Element	Description	Comments on condition/recommended works	Priority	Photograph
13.10	Original west staircase window	The external reveal to the original west staircase window has been removed or is missing.	<p>Condition: The external timber reveal to the staircase window is missing which may allow water ingress.</p> <p>Recommended works: In the immediate term the missing timber section to be replaced with new section to match the existing profile.</p>	●

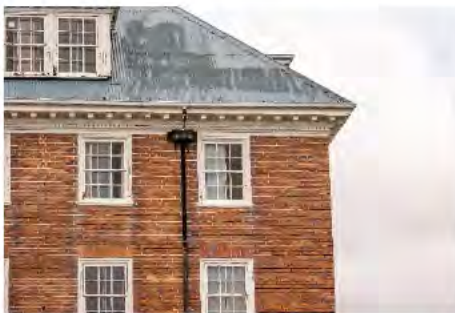
13.11	Original timber windows	The original timber windows are painted timber with opening top casement and fixed lower section.	<p>Condition: The original timber windows are in a poor state of repair with peeling paint, corroding fixings, bare timber, missing putty and deterioration noted to the majority of the windows.</p> <p>Recommended works: The windows will need to be overhauled to replace missing sections of putty, repaired, thoroughly prepared and repainted. Any decayed sections of timber will need to be cut out and new treated timber scarfed in.</p>	●

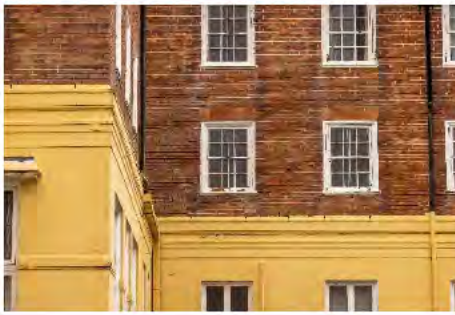
13.12	Original timber windows	As above	As above	●

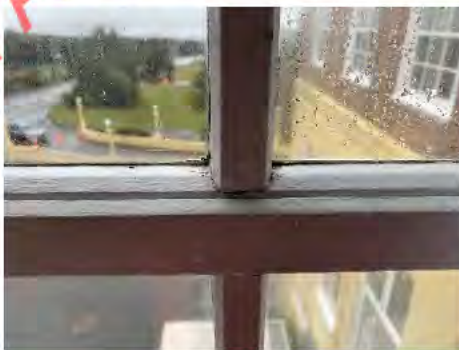
Ref.	Element	Description	Comments on condition/recommended works	Priority	Photograph
13.16	Evidence of water ingress	As above	As above	●

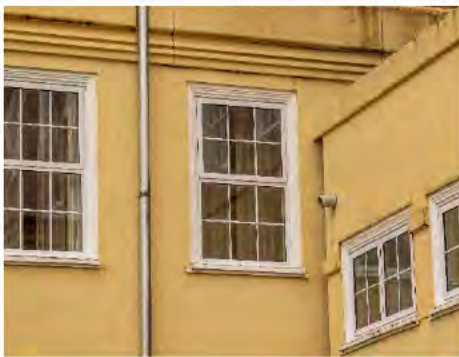
13.17	2005 extension windows	The windows to the 2005 extension are powder coated aluminium with painted timber surrounds and windowsills.	<p>Condition: The aluminium windows were found to be in good condition however the timber sills, and partly the surrounds, are in poor condition. A number of the sills are considered to be flat which is allowing water to pond causing deteriorated paint, moss growth and soft timber (possibly early decay).</p> <p>Recommended works: To rectify the flat sills would require the windows to be removed and the sills adjusted which would cause additional damage.</p>	●

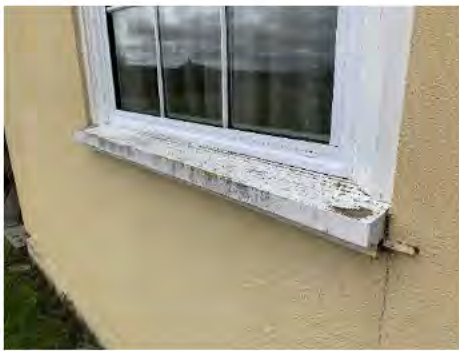
13.18	2005 extension windows	As above	As above	●

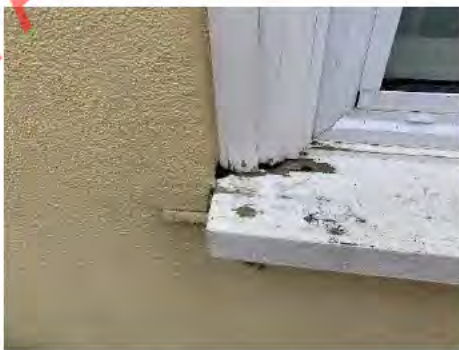
Ref.	Element	Description	Comments on condition/recommended works	Priority	Photograph
	2005 extension windows	As above	As above	●

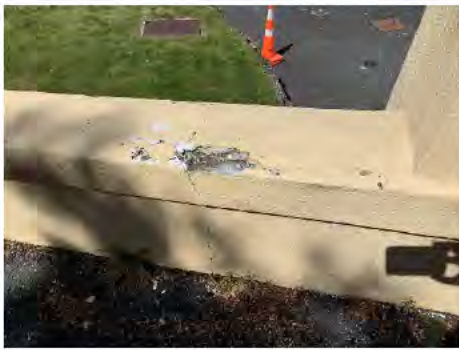
14.0	EXTERNAL AREAS				
14.1	Low level walls	The external low-level walls are masonry construction with a plastered and painted finish.	<p>Condition: The low-level walls are in poor condition with missing paint, cracking and general deterioration noted.</p> <p>Recommended works: In the immediate term all external walls to be crack repaired, thoroughly prepared and redecorated.</p>	●

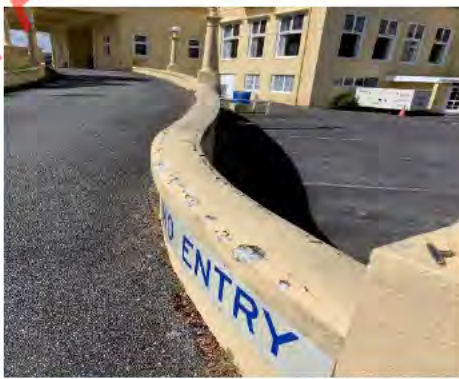
Ref.	Element	Description	Comments on condition/recommended works	Priority	Photograph
14.2	Low walls level	As above	As above	●

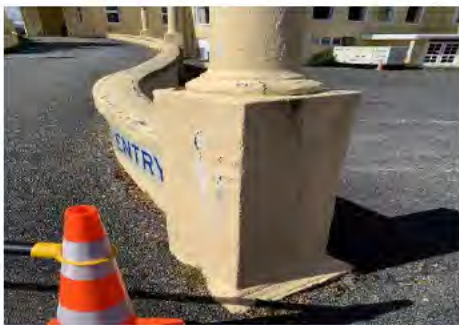
14.3	Low walls level	As above	As above	●

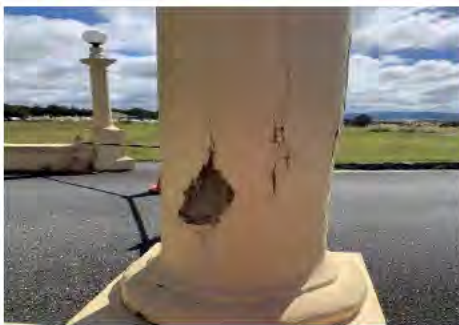
14.4	External light standards	The external light standards are concrete construction with a painted finish	<p>Condition: The external light standards are in poor condition with cracking, missing plaster and paint noted.</p> <p>Recommended works: In the immediate term all light standards to be made good and redecorated.</p>	●

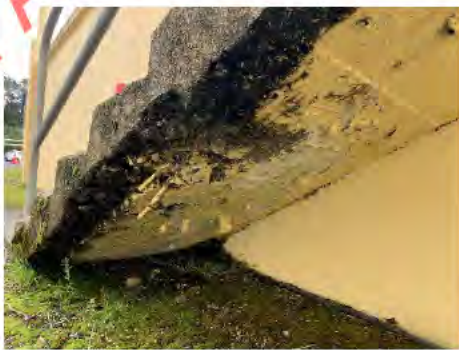
Ref.	Element	Description	Comments on condition/recommended works	Priority	Photograph
14.8	Concrete external steps	Exposed reinforcement bars to the underside of the stairs	As above	●

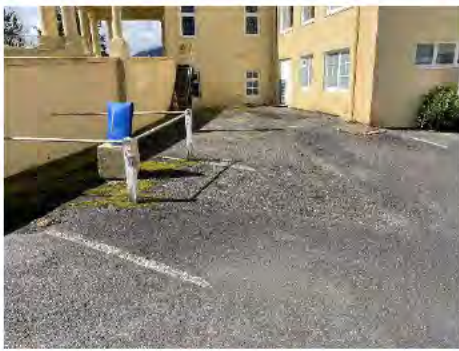
14.9	External areas	The external areas consist of asphalt car parking and general hard standing areas.	<p>Condition: The external asphalt and hard standing are in poor condition with general deterioration, previous poor repairs and frost damage noted.</p> <p>Recommended works: Given that the asphalt areas form the main entrance to the Chateau consideration to be given to resurfacing all areas to leave a consistent surface finish.</p>	●

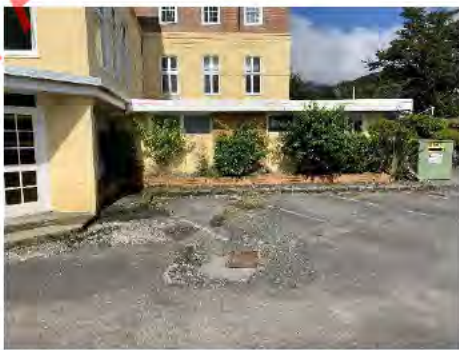
Ref.	Element	Description	Comments on condition/recommended works	Priority	Photograph
14.11	External areas	Previous poor repairs and general deteriorated surfaces	As above	●

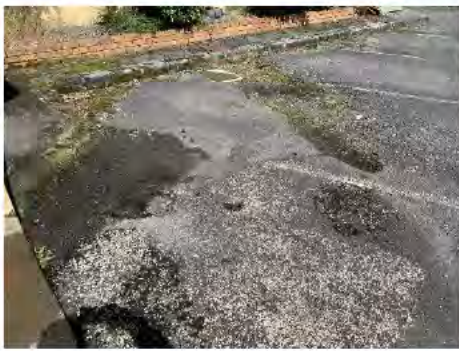
14.12	External areas	Previous poor repairs and general deteriorated surfaces	As above	●

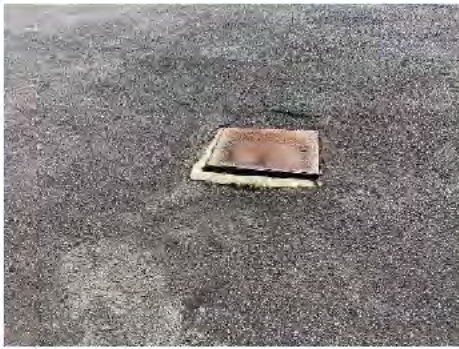
14.13	Drainage	Concealed underground pipe work	<p>Condition: We understand there is an ongoing issue with underground drainage and cross contamination of pipe work.</p> <p>Recommended works: The underground drainage lines should be CCTV inspected to determine their condition and identify any necessary repair works.</p>	●

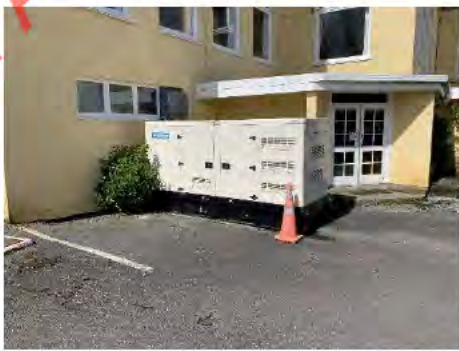
Ref.	Element	Description	Comments on condition/recommended works	Priority	Photograph
14.14	Standby generator		<p>Condition: A standby generator has been placed at the main entrance to the basement facilities. This is not considered a suitable location for the generator.</p> <p>Recommended works: Consider relocating the generator or providing suitable screening to conceal the generator.</p>	●

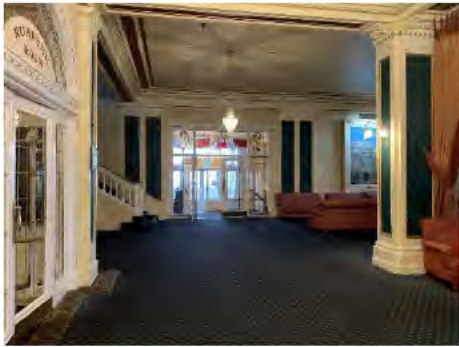
15.0	INTERNAL AREAS				
15.1	Furniture and general storage	Whilst the furniture and general storage do not affect the repair and maintenance of the building, they should have been removed by the outgoing tenant and they are considered a potential fire loading and risk.	<p>Condition: Ideally all internal furniture and storage should be removed by the outgoing tenant as part of their lease responsibilities.</p> <p>Recommended works: Remove internal furniture or adequately protect if the furniture is to be reused.</p>	●

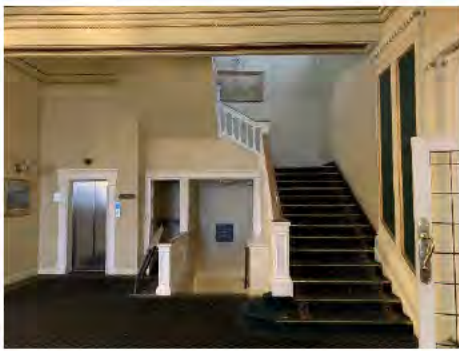
15.10	Internal wall surfaces	We have not seen a copy of the lease to determine the redecoration liabilities of the outgoing operator.	<p>Condition: The internal wall surfaces are generally in fair condition however would benefit from redecoration in the medium term.</p> <p>Recommended works: As part of any lease negotiations consideration to be given to redecorating the walls.</p>	●

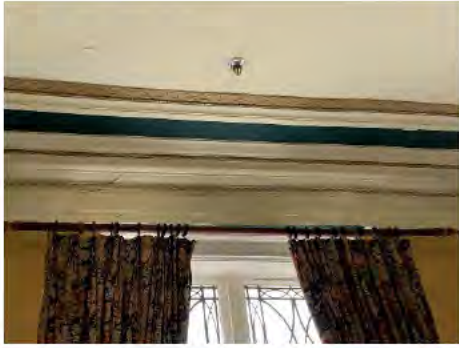
15.20	Internal ceiling	Water damage internally above Ruapehu Room and Ngauruhoe Room windows.	<p>Condition: As previously mentioned under the Elevation section of this report, water ingress is occurring from the Juliet balconies externally.</p> <p>Recommended works: Once the Juliet balconies have been repaired and water ingress abated the internal cornice and walls to be made good and re decorated.</p>	●

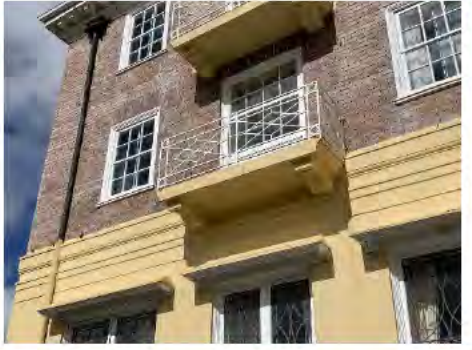
15.22	Juliet balconies externally	General view of the Juliet balconies externally which are causing moisture ingress internally	As above	●

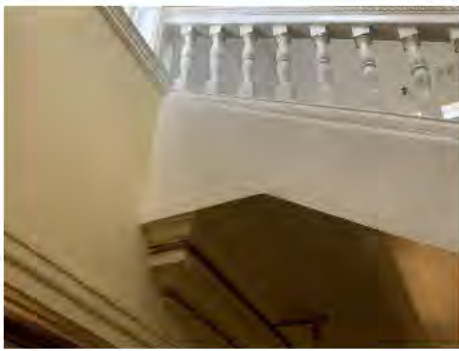
15.25	Main staircase	Localised cracking	<p>Condition: Localised cracking was noted to the main staircase. This was also commented on in the WSP report.</p> <p>Recommended works: Investigate cause of cracking and repair.</p>	●

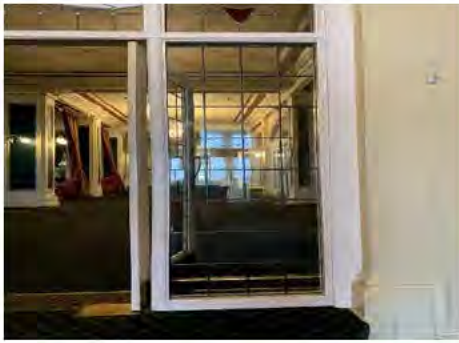
16.0	HEALTH AND SAFETY				
16.1	H&S	A number of general health and safety and non-compliance issues were identified.	<p>Condition: The stained glass to the main entrance and internal doorways is not safety glass and loose panes were noted.</p> <p>Recommended works: In the immediate term allowed to carry out a review of the glazing to determine which low-level panes are safety glass, if any.</p>	●

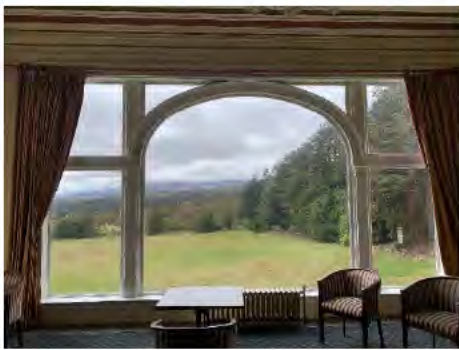
16.6	H&S	Low level, full height glazing to the Ruapehu lounge	As above	●

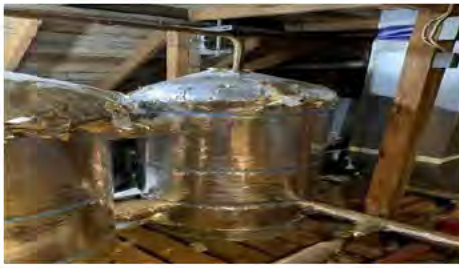
17.0	BUILDING SERVICES				
17.1	Water tanks	There are a number of water storage tanks located within the roof space of the original building.	<p>Condition: The water tanks are not seismically restrained.</p> <p>Recommended works: All water tanks should be seismically restrained or braced.</p>	●

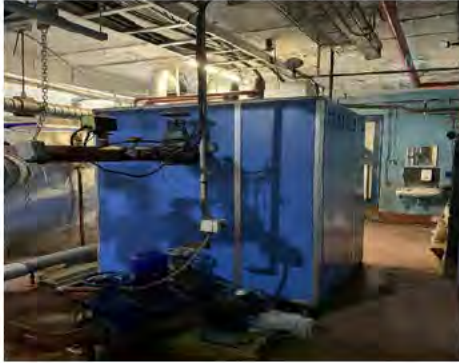
17.4	Boiler	There is a hot water boiler located within the plant room at basement level. We understand this was installed in 1998 and has subsequently been rebuilt.	<p>Condition: We understand the boiler is operational and is in working order.</p> <p>Recommended works: Allow for annual maintenance to the boiler.</p>	●

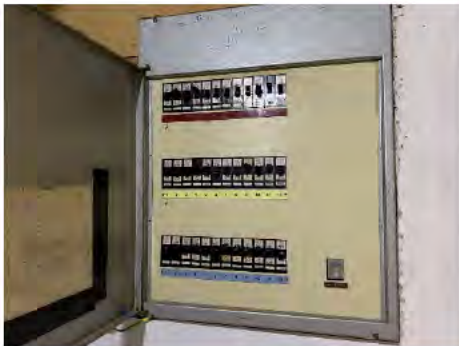
17.7	Electrical	Electrical distribution boards	<p>Condition: There are various distribution boards located around the building. These are a mixture of modern and dated boards.</p> <p>Recommended works: Allow for an electrical inspection and testing of all electrical equipment to ensure it is safe and operational.</p>	●

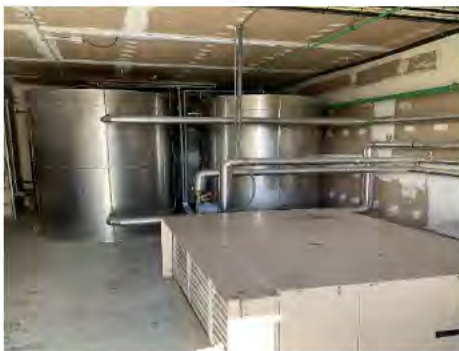
17.9	HVAC	Modern plant and machinery locations in the 2005 extension	<p>Condition: There is a modern HVAC system to the 2005 extension.</p> <p>Recommended works: Allow for annual/periodic inspection, testing and maintenance of the HVAC system.</p>	●

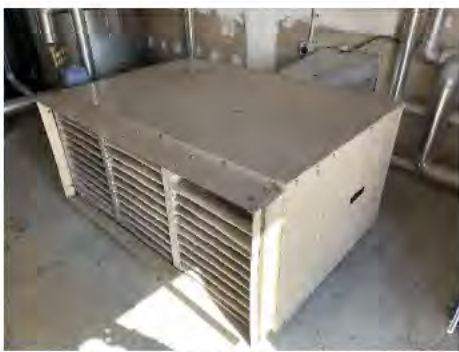
17.10	HVAC	Modern plant and machinery located in the 2005 extension	As above	●

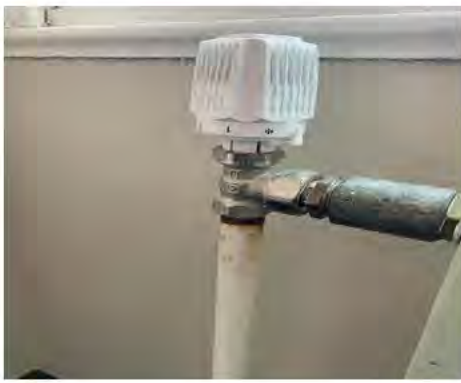
17.12	Radiators	Hot water radiators and heating system	<p>Condition: Localised corrosion and evidence of water leaks were noted to the hot water heating system. With old gun barrel pipe work this can rust internally and can fail. They also become blocked and restrict water flow. We understand there are limited valves for isolating the pipe work and replacement of radiators and sections of pipe is difficult.</p> <p>Recommended works: Carry out a full inspection of the hot water system to determine its condition and remaining life. Allow for daily inspections for leaks from the radiators and pipe work.</p>	●

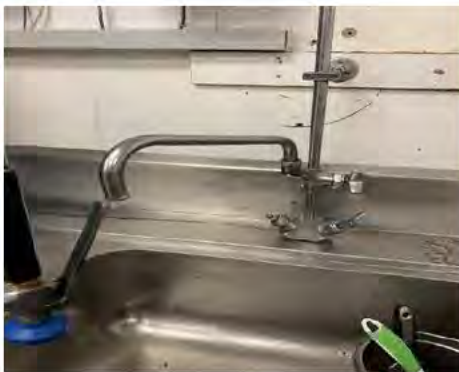
17.15	Kitchen equipment	Water leak	<p>Condition: A leak was noted on the kitchen tap and pipe work which is causing localised flooding within the kitchen.</p> <p>Recommended works: Allow to fix the leaking tap and pipe connections.</p>	●

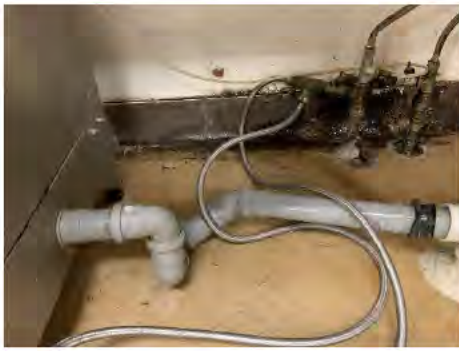
17.16	Kitchen equipment	Water leak	As above	●

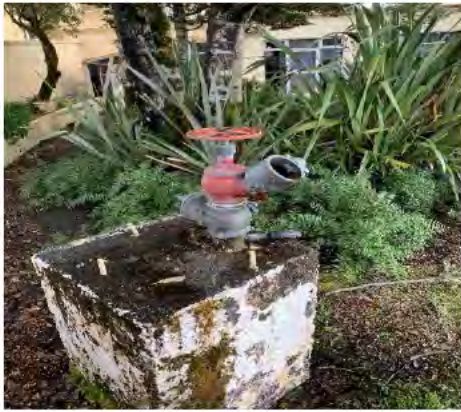
17.22	Standpipe	Fire and emergency standpipe	<p>Condition: The standpipe located adjacent to the conference centre is leaking.</p> <p>Recommended works: In the immediate term the valves to the standpipe should be replaced to prevent constant leaking.</p>	●

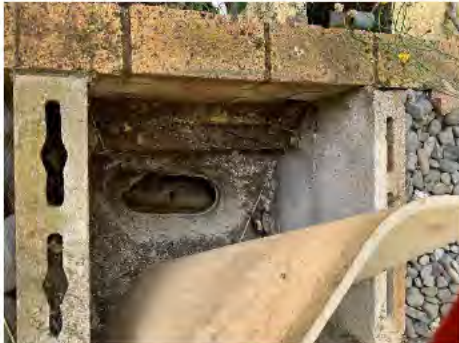
17.24	Drainage grille	The drainage grille to the planter area of the workshop extension was missing.	<p>Condition: Missing grille cover.</p> <p>Recommended works: Provide a suitable cover or grille to the exposed gully.</p>	●

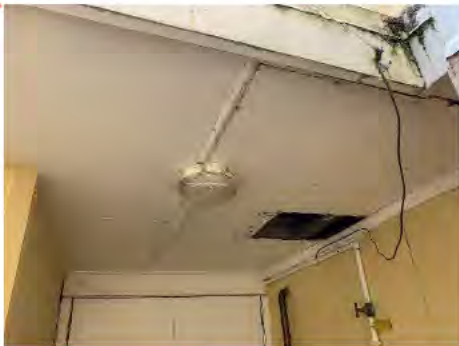
Ref.	Element	Description	Comments on condition/recommended works	Priority	Photograph
18.0	HAZARDOUS MATERIALS				
18.1	Asbestos containing materials (ACMs)	There were a number of suspected asbestos containing materials (ACMs) located throughout the building. These were not tested however are highly likely to be asbestos.	<p>Condition: We have not seen an asbestos register for the building however this should have been done to comply with asbestos management regulations. Damaged sections of suspected ACMs were noted</p> <p>Recommended works: In the immediate term asbestos register management plan should be prepared to identify asbestos containing materials in the building.</p>	●

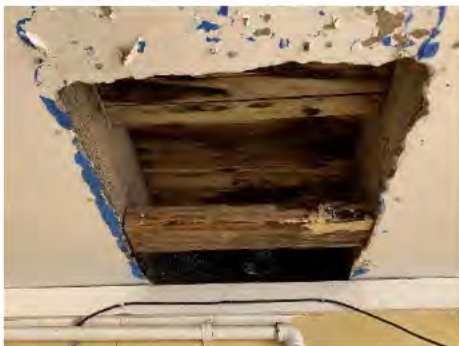
18.2	ACM	Workshop soffit	<p>Condition: The soffit to the workshop has been damaged and is a suspected ACM.</p> <p>Recommended works: As above</p>	●

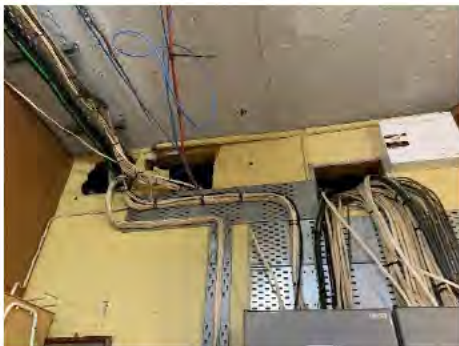
18.3	ACM	Plant room cladding	<p>Condition: The high-level cladding around the pipe penetrations is a suspected ACM.</p> <p>Recommended works: As above.</p>	●

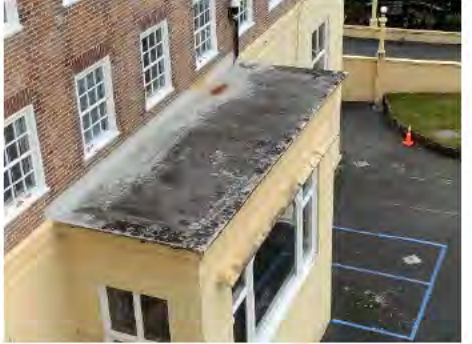
18.6	Waterproof membrane	Ruapehu Lounge	<p>Condition: The waterproof membrane to the Ruapehu lounge roof is a suspected ACM.</p> <p>Recommended works: As above</p>	●

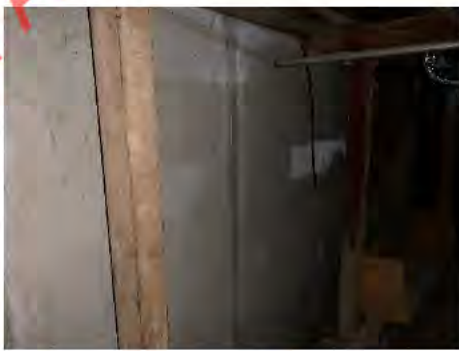
Ref.	Element	Description	Comments on condition/recommended works	Priority	Photograph
18.7	Basement wall lining	Basement wall lining	<p>Condition: The wall lining within the basement is a suspected ACM.</p> <p>Recommended works: As above</p>	●

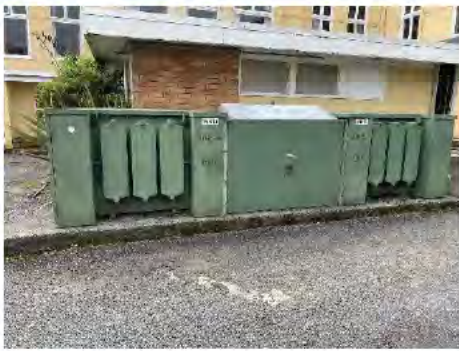
18.8	Electrical transformer	There is an electrical transformer located adjacent to the workshop. There are known hazards with oil and PCBs within transformers.	<p>Condition: Ownership of the electrical transformer to be determined and whether this poses a safety risk or not.</p> <p>Recommended works: Determine ownership of the transformer.</p>	●

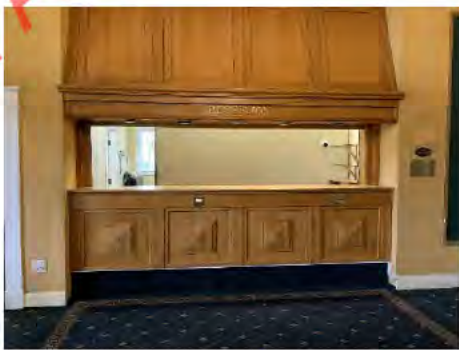
Ref.	Element	Description	Comments on condition/recommended works	Priority	Photograph
19.2	Non-compliant matters	Reception desk	<p>Condition: The reception desk could not be deemed compliant for wheelchair users.</p> <p>Recommended works: Review reception desk and provide low level access.</p>	●

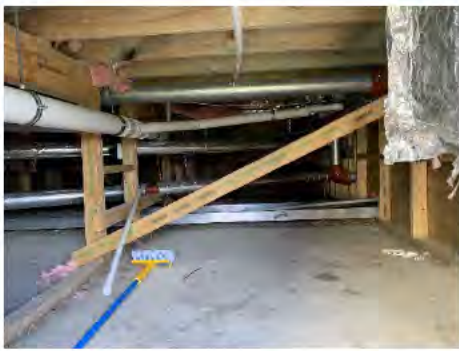
19.3	Non-compliant matters	Subfloor bracing	<p>Condition: The timber bracing to the subfloor was raised in the WSP as non-compliant.</p> <p>Recommended works: Provide additional bracing to the subfloor as required to comply with seismic strength requirements.</p>	●

Hazardous materials	<ul style="list-style-type: none">• Prepare an asbestos register and management plan.			
Miscellaneous items	<ul style="list-style-type: none">• Investigate charring to the subfloor timber.	<ul style="list-style-type: none">• Ideally remove the foil underfloor insulation.	<ul style="list-style-type: none">• Check non-complaint items• Check subfloor bracing.

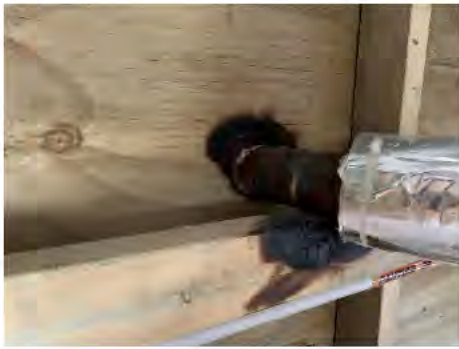
19.4	Potential fire risk	Charring wood	<p>Condition: Localised charred wood was noted around a pipe to the toilet subfloor void. We believe this is from the original construction however it should be reviewed in case the charring is caused by a hot pipe.</p> <p>Recommended works: Review immediately.</p>	●
