Restoration of riffle habitat in the Ōtākaro/Avon River

In 2013–15 the Ōtākaro/Avon River in Christchurch underwent in-river and riparian restoration as part of the wider Te Papa Ōtākaro Avon River Precinct (ARP) project. The ARP was part of the rebuild following earthquakes in 2010/11.

Overall, works were undertaken along a 3.2 km stretch of the 14 km long Ōtākaro/Avon River. This case study focuses on the 70 m section at Montreal St.

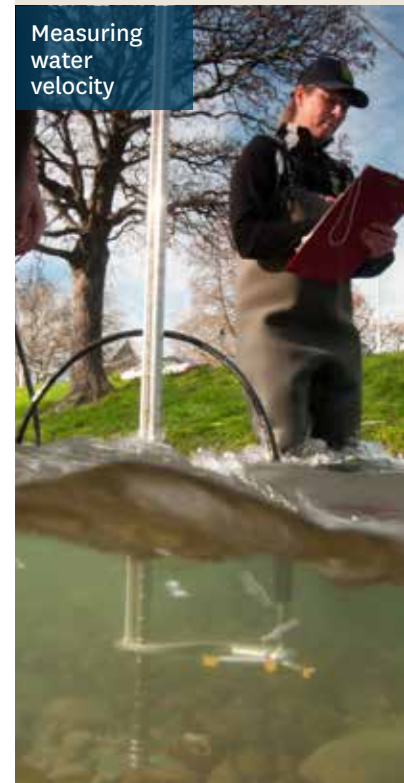
Measuring water velocity

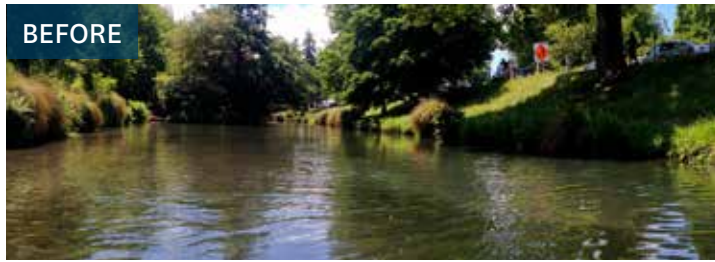
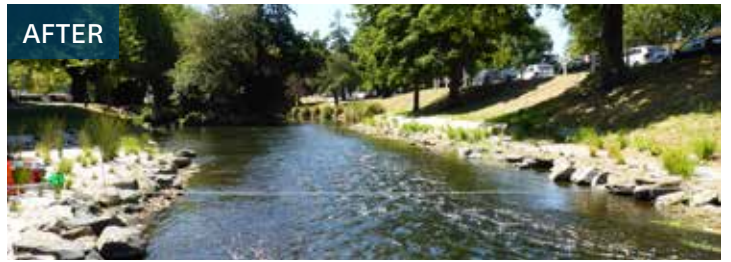
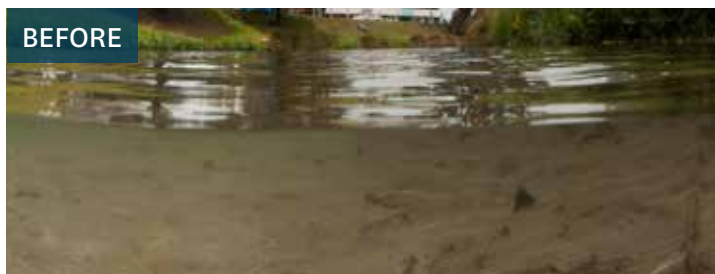
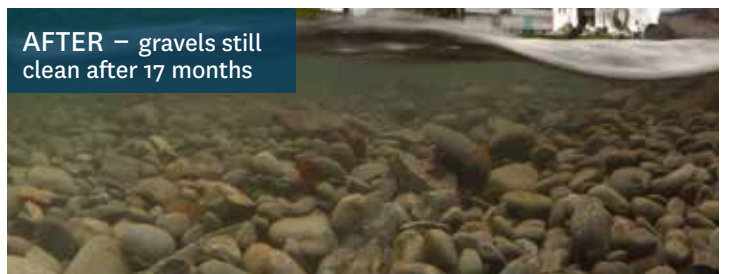
Detailed habitat monitoring showed that sites with medium-high intervention (including the Montreal St site) had a significant increase in the variation of water velocity and substrate size, a significant increase in overall water velocity and substrate size, and a significant decrease in fine sediment cover and substrate embeddedness following intervention, all of which remained for the 17 months of monitoring. However, for those areas where restoration intervention did not include some form of increasing water velocity (i.e., channel narrowing or increased gradient) the cleaned gravels soon started to silt up again.
