File Ref:		Permission No:	107380-OTH
Inspection Date:	16/11/2023		
Persons Present:	Department of Conservation Rangers, Nataalia Lunson Community, and Warren Geraghty Heritage and Visitor.		
	Lincoln Smith Terra Firma Mining Limited Managing Director Terra Firma Mining New Zealand.

SECTION 1: DESCRIPTION OF OCCUPATION

Location 2: 29261 - No.8 Level Portal Pad

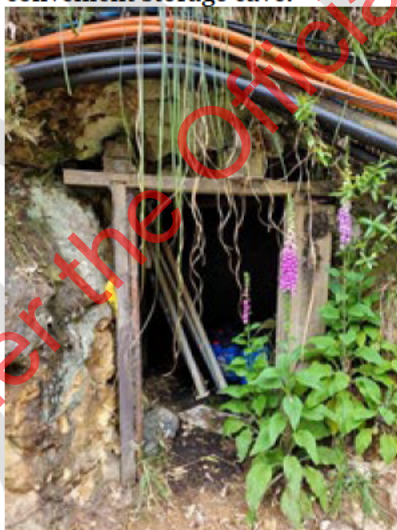
<p>This requires technical advice. Settling ponds are below in the gully behind the fenced area. We did not enter this area during this visit.</p>
Are adequate sediment controls in place?		NA	This requires technical advice and assessment. Efforts are evident towards mitigating surface flooding.
Is water discharge of an acceptable standard?		NA	This requires technical advice and assessment. Water testing has not been included in this visit.
Are access tracks/batter slopes stable & free from erosion?		NA	<p>I did not see purposeful mitigation against erosion risks. An open structure was visible and accessible. It appears to be used as a convenient storage cave.</p>

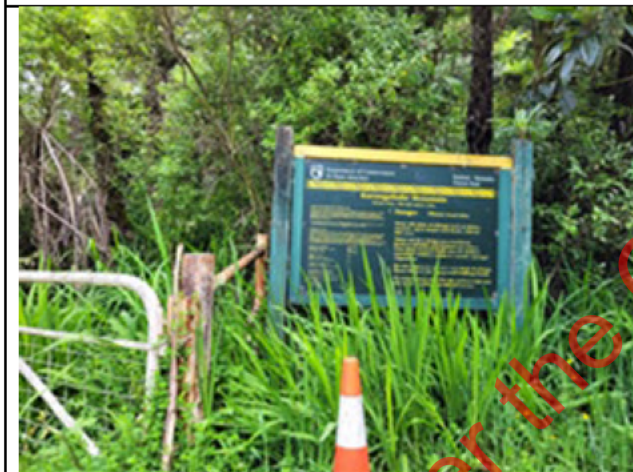
No.8 level access road has several track signs describing Karangahake walking tracks and history.
