**AN ARCHAEOLOGICAL INSPECTION AND UPDATE OF THE  
PREVIOUSLY RECORDED ARCHAEOLOGICAL SITES ON  
MOTUOPAO ISLAND,  
TE PAKI**

Prepared for  
**Department of Conservation**  
**Northland Conservancy**  
**Kaitia Area Office**

By  
James Robinson MA (Hons)  
Archaeologist

November 2006

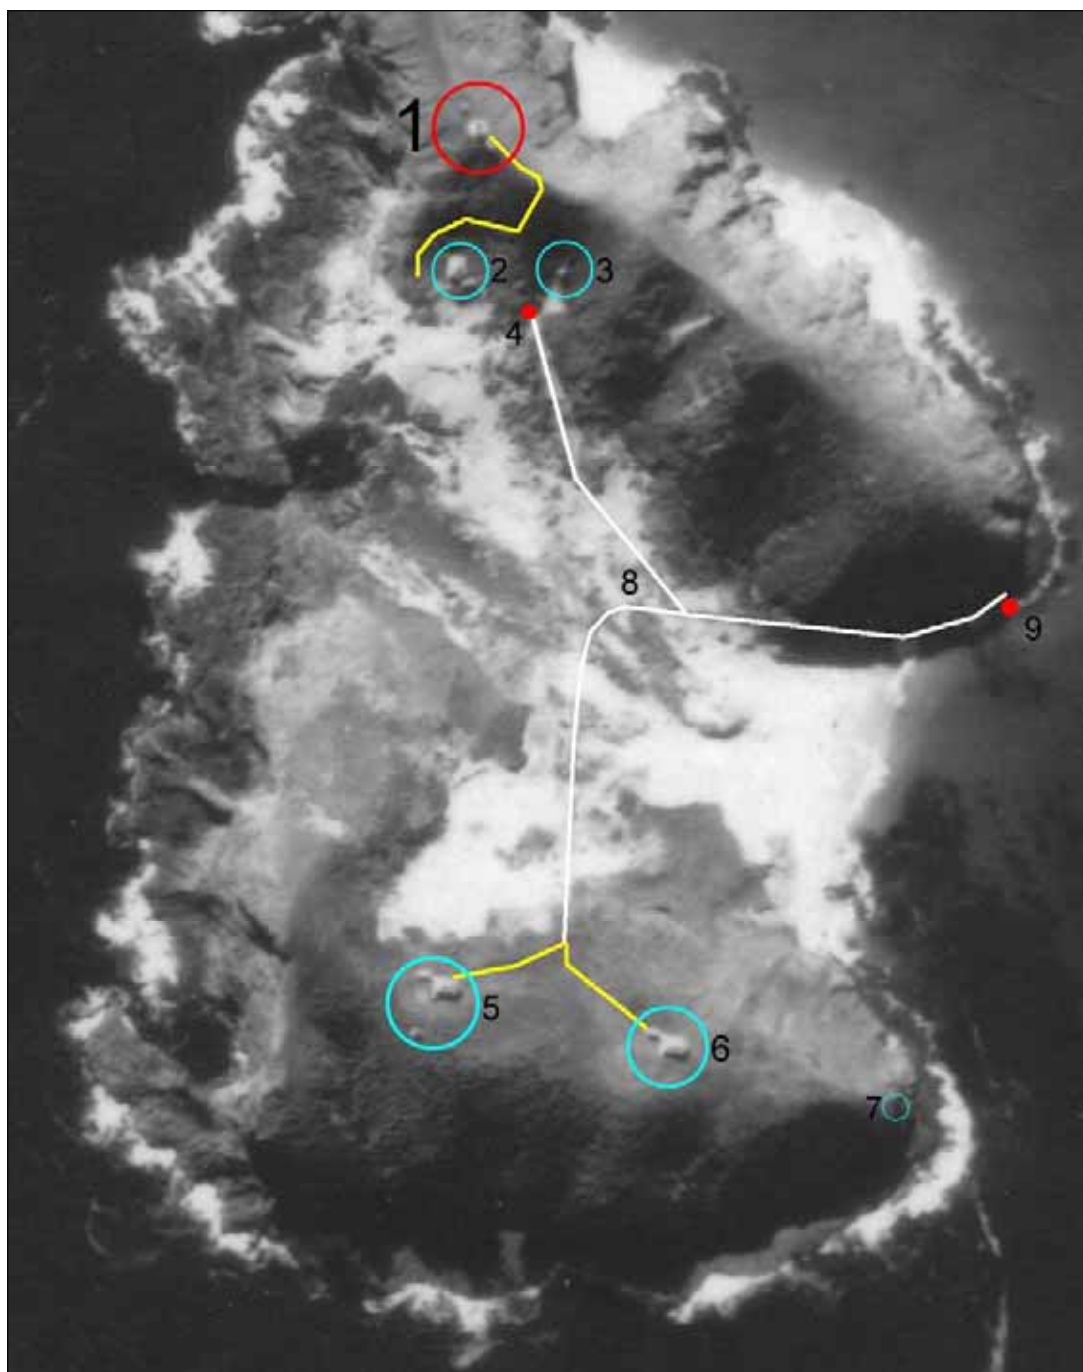
The second site record (M02-180) is based in part on personal recollections of Hedley Budd, who was present on the island in the late 1930s, and also an aerial photograph taken in 1947. Although this photo was taken 7 years after the light mechanism and its keepers moved to the new settlement 10km north at Cape Reinga, it still showed the Motuopao lighthouse settlement structures as they were in its final phase of operation in 1940. This was due to delays in its planned demolition caused by WWII (Plate 3).

Plate 3: 1947 aerial photo showing the last phase of the Motuopao Lighthouse Settlement that ended in 1940.
