# MILFORD OPPORTUNITIES PROJECT- ENGINEERING FEASIBILITY REPORT

26 JUNE 2024

WSP  
Invercargill  
65 Arena Avenue  
PO Box 647  
Invercargill 9810, New Zealand  
+64 3 211 3580  
wsp.com/nz

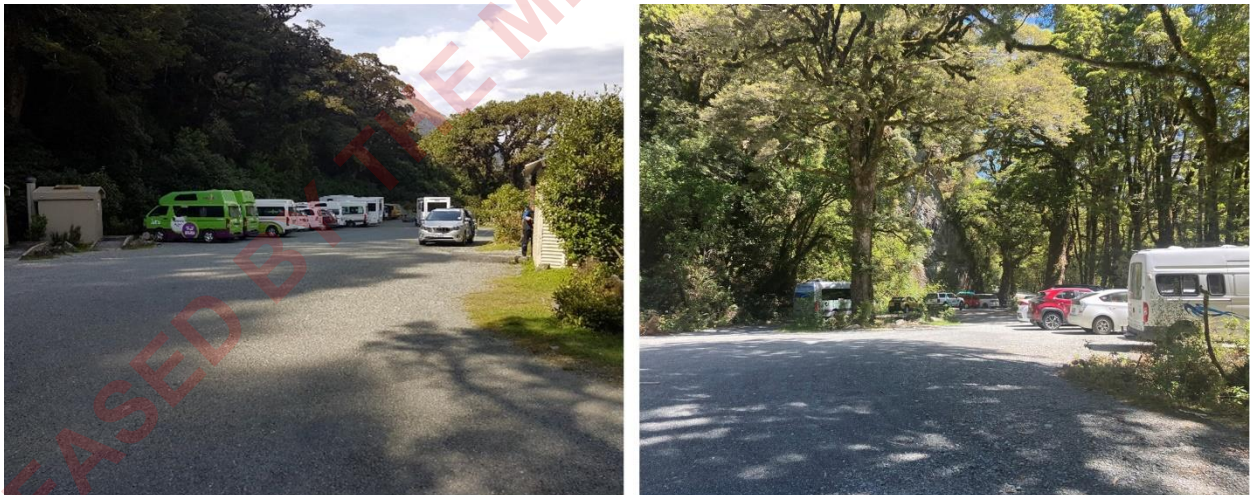
Figure 27: The Divide Carpark (left) and Lake Marian trails head carpark (right)

Both sites likely consist of alluvial fan deposits and debris over bedrock at depth. The alluvial deposits are likely to be angular and well-graded silts to gravels and cobbles. Based on the distance from the rivers in the area, groundwater may be encountered at shallow depths.

- Environment Southland Liquefaction Risk Map: Site is located on the boundaries of Negligible, Low and Medium Risk zones. Note mapping completed between 2006 and 2012. Data may be outdated under current liquefaction assessment techniques.
- Site visit and photographs indicate the site soils are likely fan deposits. The site is also likely to have been disturbed during the construction of the carpark and current structures at site and fill is likely to have been placed on the site. At this time no records were available for the placement of the fill. See Figure 27 below.

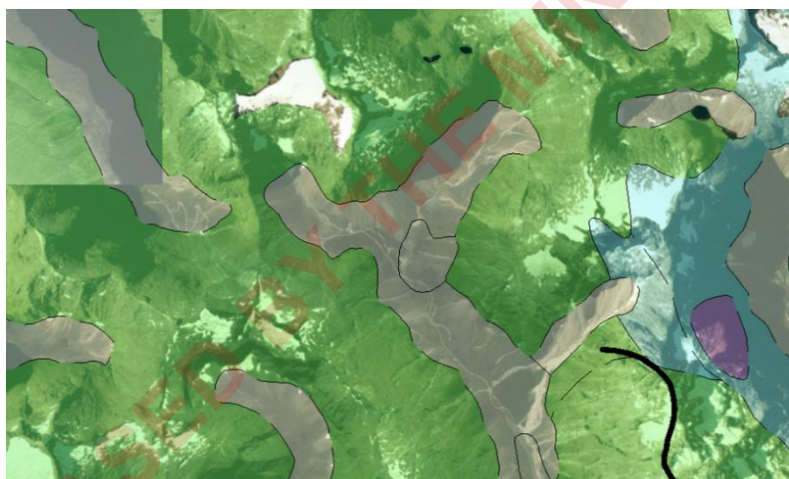
Figure 29: Gertrude Valley – Published Geology

- Elevation: The site is approximately 780 m ASL
- Closest active fault: Unnamed Fault #9214, located approximately 9.5 km northeast of the site.
- Geological Map Information: Site is located on the boundary between the following two geological units, one covering the eastern side of the site and the other covering the western side. See Figure 29 below.

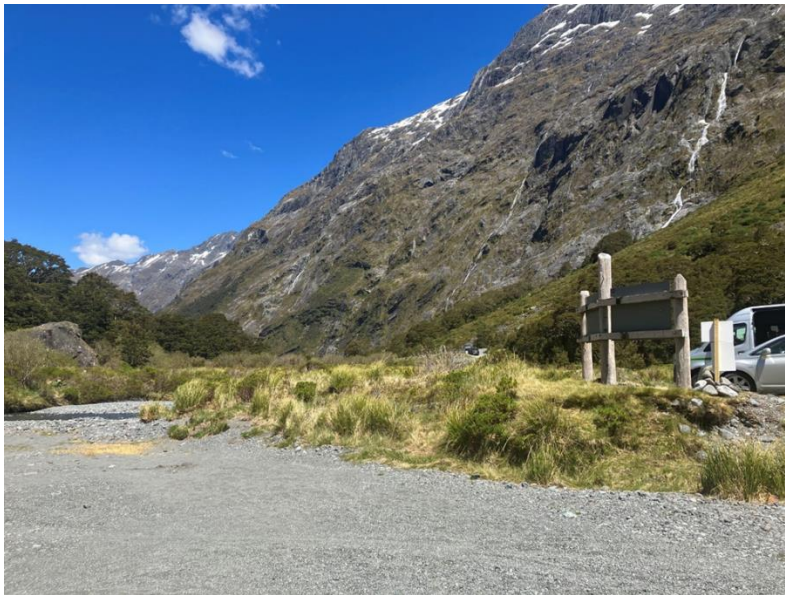
Figure 30: Gertrude Valley looking southwest from the proposed location.

Site likely consists of glacial moraine and alluvial fan deposits over bedrock at depth. Both sediment types are likely to comprise a wide range of grainsizes from silts to gravels and boulders. At this stage the site is assumed to have a negligible to low liquefaction potential. However, geotechnical investigation of the site will be used confirm the soils onsite and whether groundwater is present at shallow depths and allow for determination if further liquefaction assessment of the site is required.

- Site visit and photographs indicate that the site is likely to be underlain by glacier deposits, with gravel visible at the surface and a stream reworking coarse alluvial sediments up to cobble sized, see Figure 30 below.

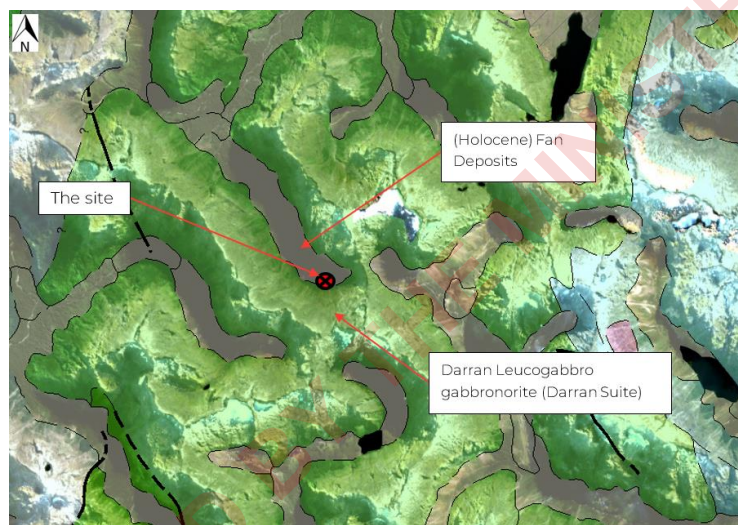
Figure 33: Cleddau Cirque – Published Geology

- Geological Map Information: Site is located on the boundary between the following two geological units, one covering the northern side of the site and the other covering the southern side. See Figure 33 below.

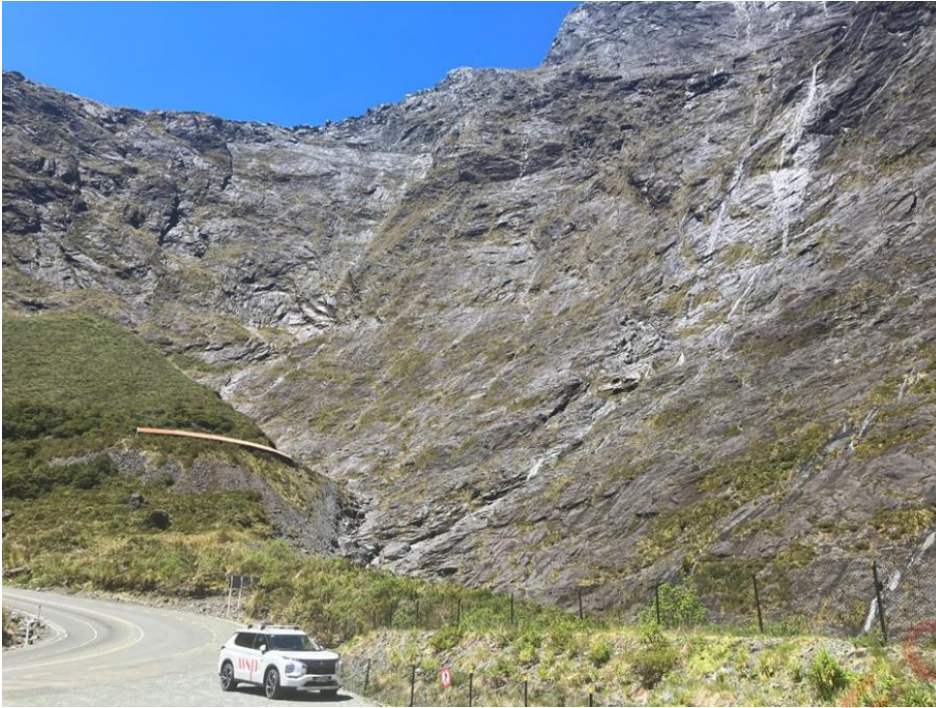
Figure 34: Cleddau Cirque looking east from the existing carpark.

Site likely consists of alluvial fan deposits over bedrock at depth. Based off site observations the site is likely to have rockfall debris covering the area. The underlying soils are likely to consist of gravels and cobbles. At this stage the site is assumed to have a low liquefaction potential. There is an active stream approximately 30 m to the south of the existing carpark.

- Site visit and photographs indicate that the site soils are likely a mix of alluvial deposits and rockfall debris. The site has a rockfall protection bund constructed to protect the road and carpark, see Figure 34 below.

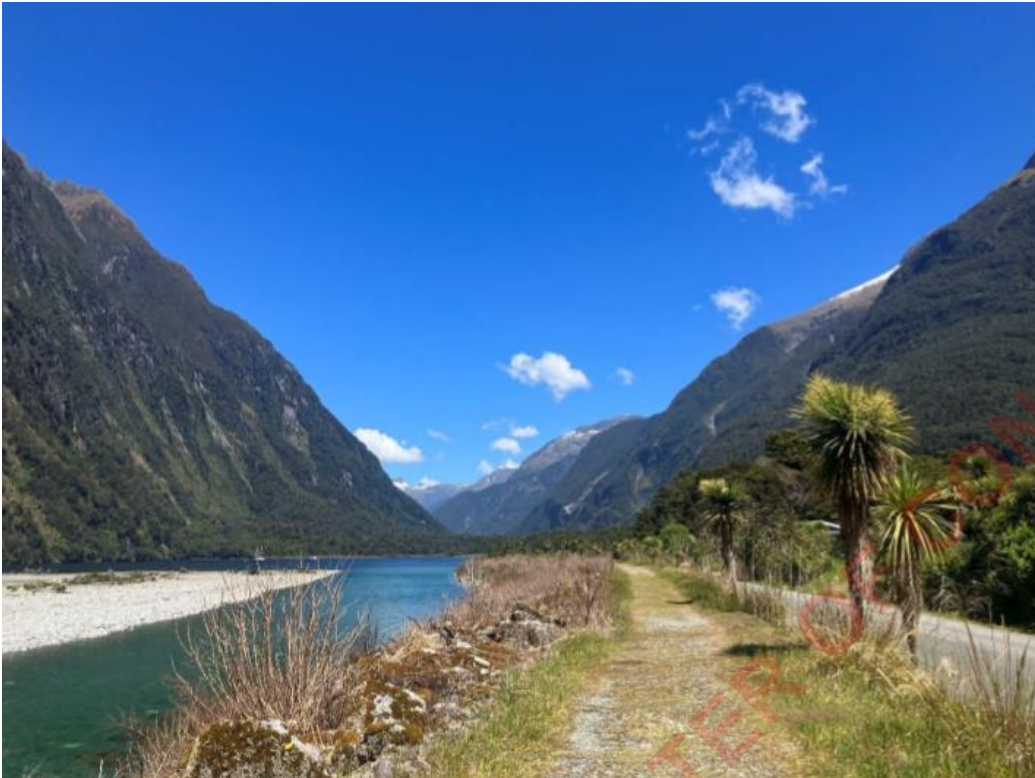
Figure 38: The flood mitigation stop bank on the northern margin of the Cleddau River looking out towards Milford Sound.

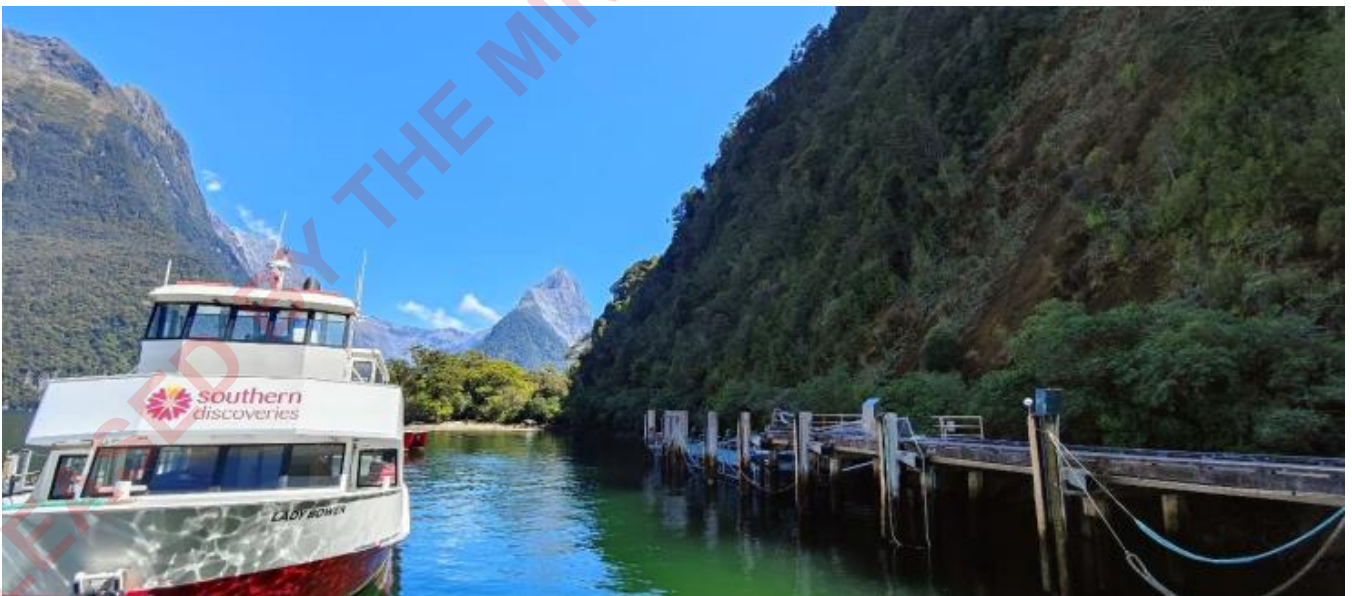
Figure 39: Freshwater Basin with an old tree slide scarp to the right of the image.

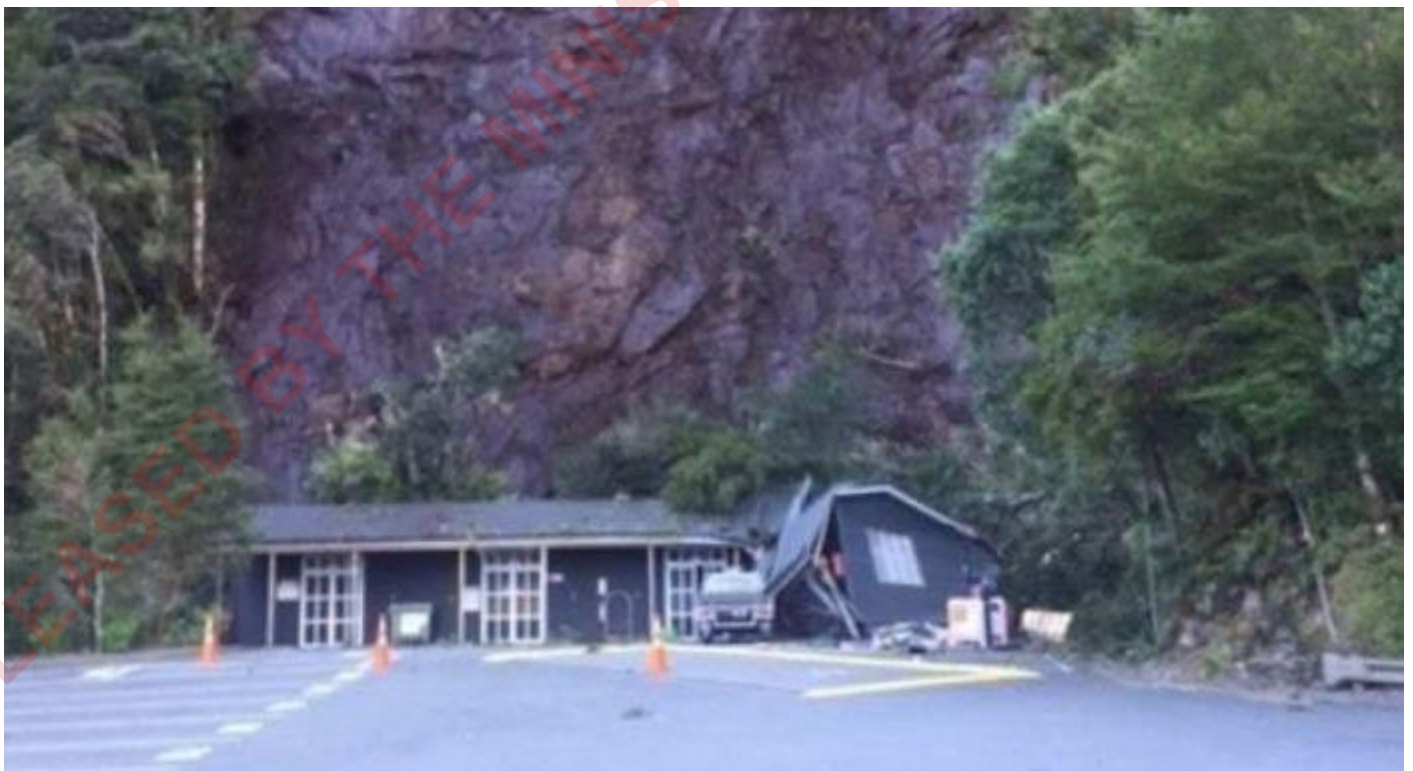
Figure 41: Damage to a storage building in Milford Sound from a rockfall in 2016 (source: Tim Holland)

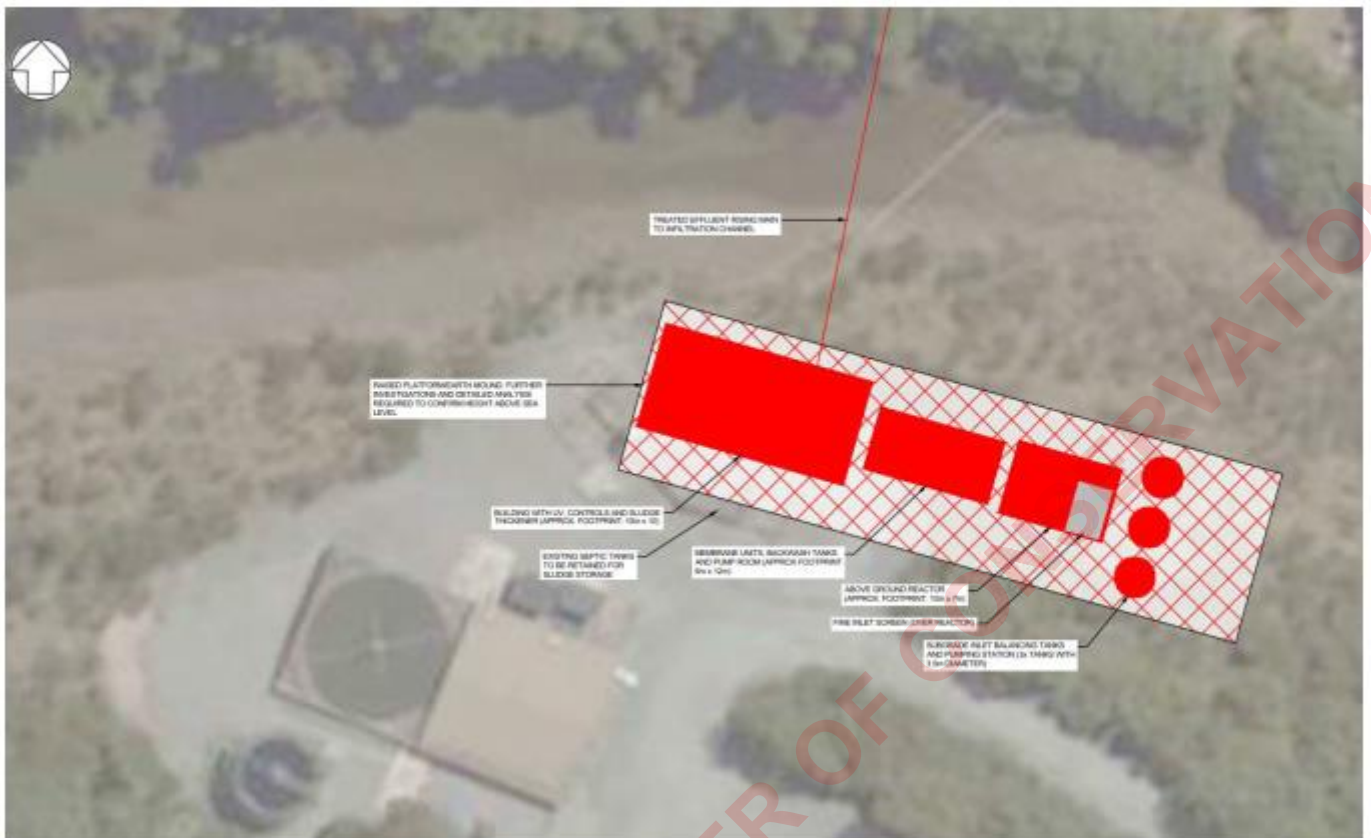
- New inlet balance tanks to buffer peak loading.
- Pumps to feed treatment plant.
- 2 mm fine screens, mounted over the treatment reactor.
- An anoxic zone and aerated reactor zone.
- Membrane modules
- Washwater and backwash tanks
- Pipe, pump, and blower room.
- UV disinfection.
- building with operations facility and sludge thickener.
- Reuse of septic tanks for sludge storage.
- The entire system should be constructed on a raised platform/earth mound.

Figure 42: Indicative Site Layout. The existing septic tanks could be repurposed for sludge storage.

Figure 42 presents an indicative layout of the proposed effluent soakage system adjacent to the airport. There are several other locations that the soakage system could be located, and the final location should be determined as the design is developed and the final layout of the Masterplan is confirmed.

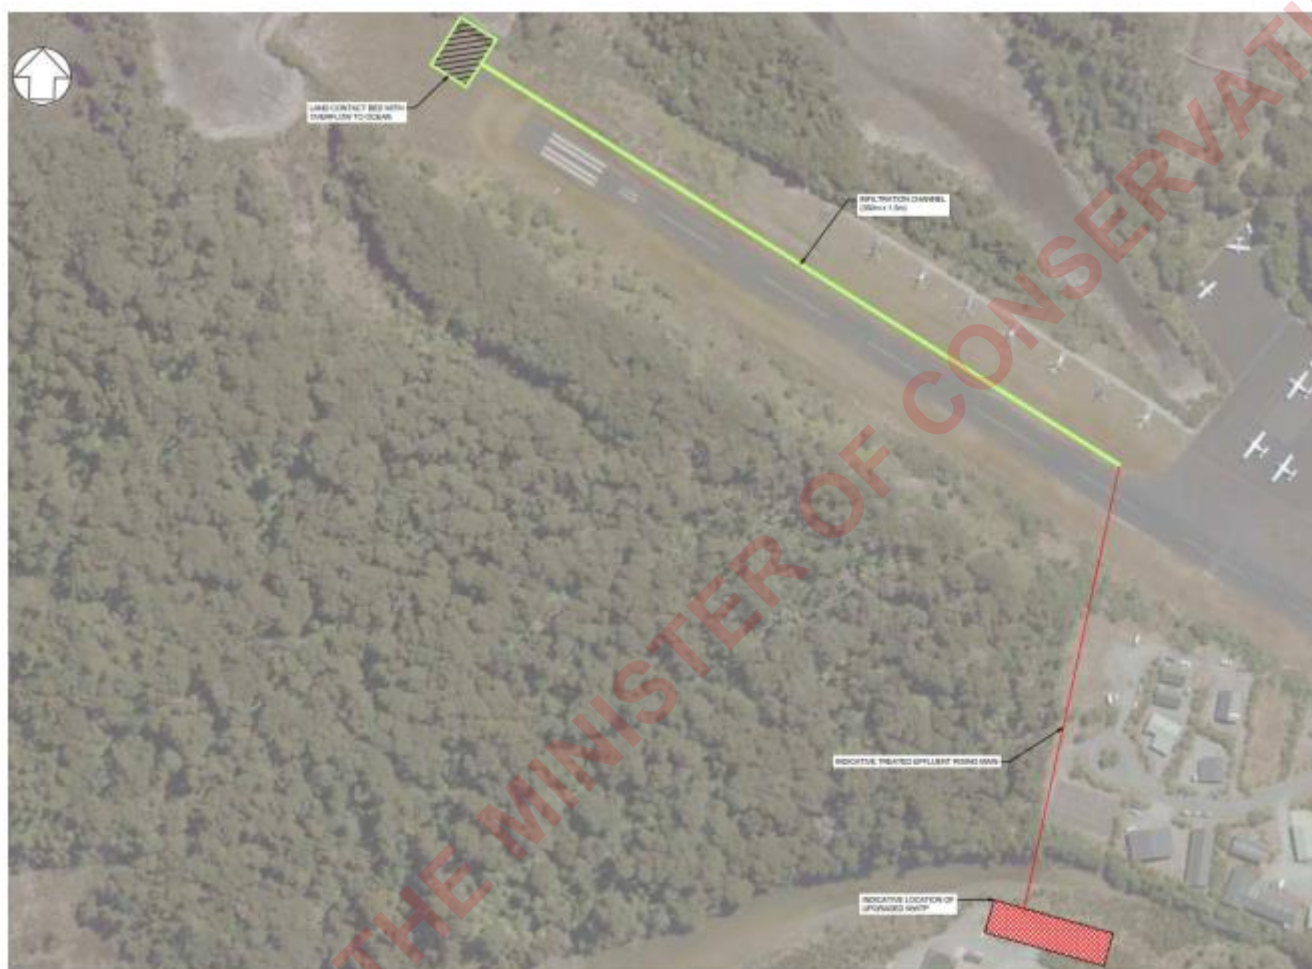
Figure 43: Milford Sound Piopiotahi indicative effluent disposal system layout

It is noted that there are several sites listed in the HAIL register in proximity to the proposed system that should be considered when selecting the final location. These include the extent of the airport itself, a historic refuelling compound on the southside of the runway and the old airport control tower (possible lead paints) (WSP, 2024). These sites present a potential risk that should be investigated as the preferred location of the effluent soakage is developed.

Additionally, previous studies have identified that the north-western end of the runway is affected by high groundwater levels during high tides, impacting drainage of the runway. These investigations recommended that this section of runway be raised to a minimum RL of 2.6 m to mitigate drainage issues (Stantec, 2022). The indicative soakage location requires the runway to be raised to this level to prevent groundwater inundation to the soakage system; if the elevation increase does not occur, an alternative location for soakage should be considered.

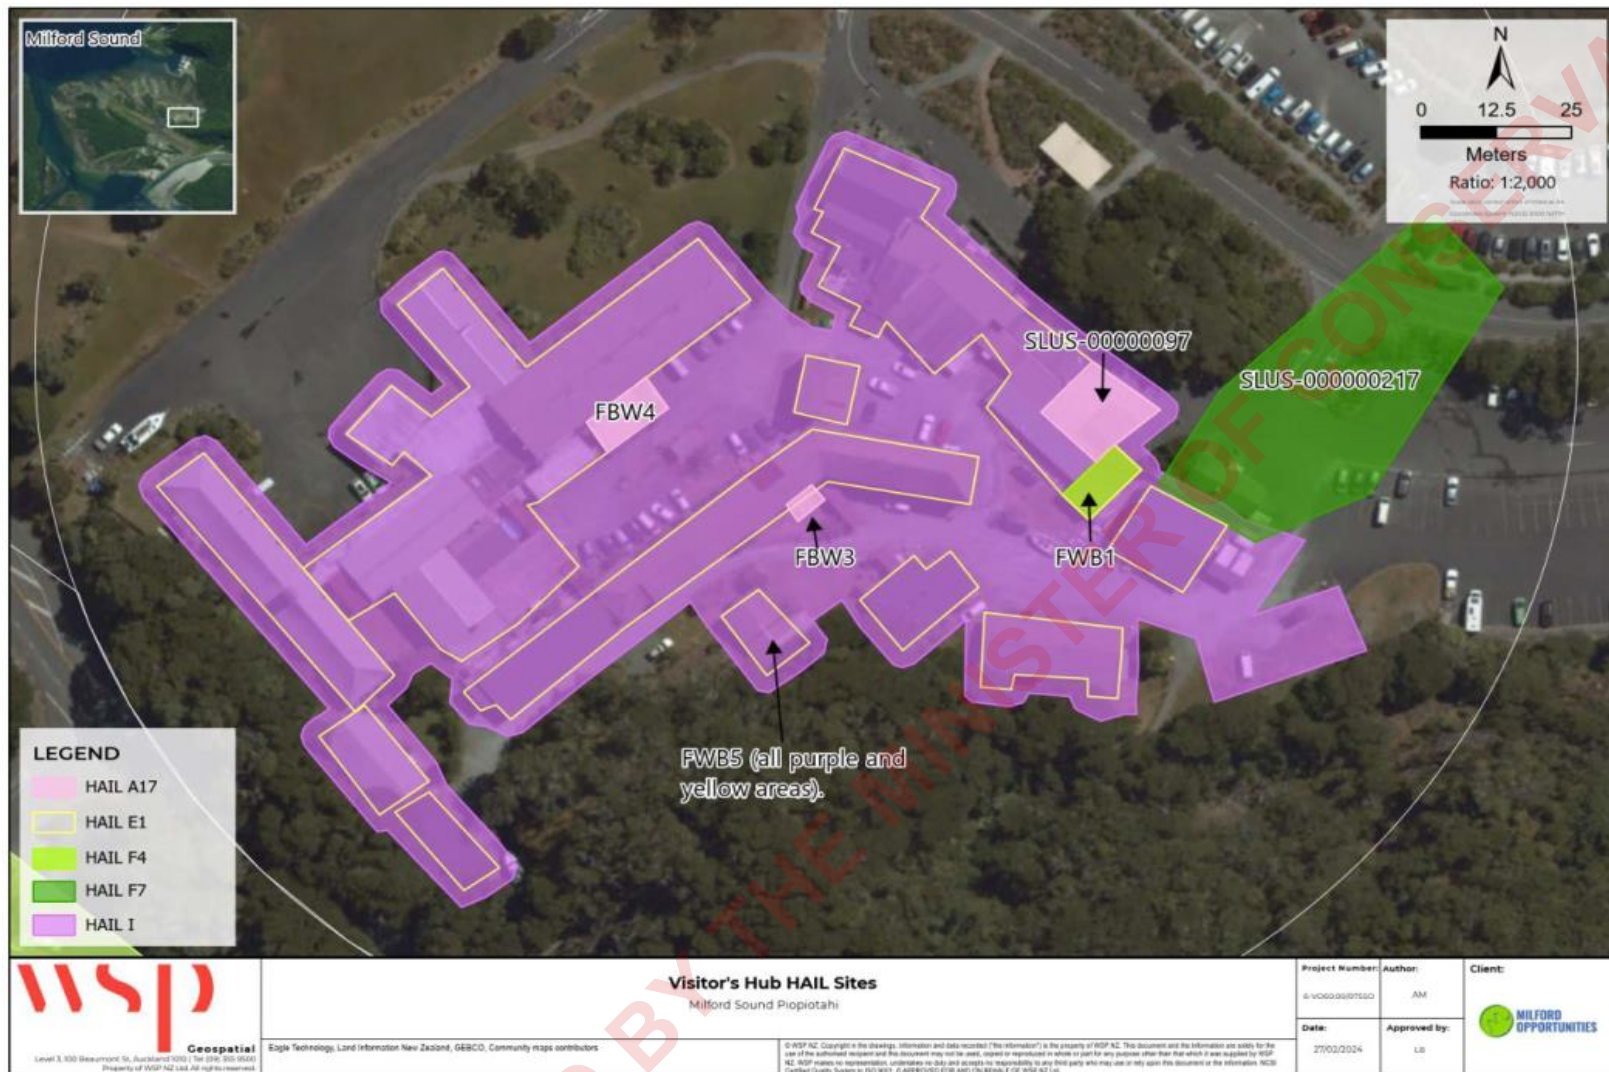
Figure 44: HAIL activity location plan

As Hazardous Activities and Industries List (HAIL) activities have been identified on the site, the Visitor's Hub has been classified as **RED** requiring further assessment to the risks to human health and the environment prior to development. A summary of the identified HAIL activities is provided in Table 55 below, with a HAIL activity location plan presented in Figure 44.

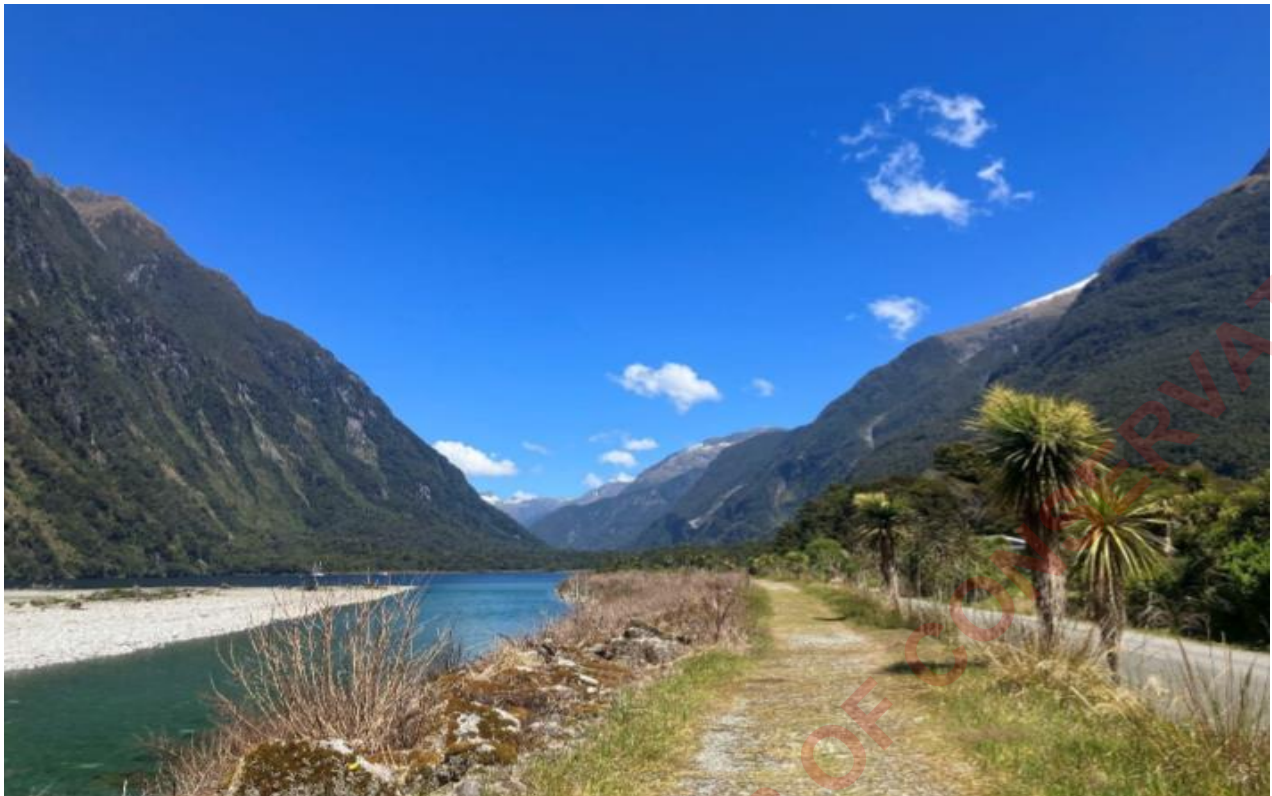
Figure 48: The flood mitigation stop bank on the northern margin of the Cleddau River looking out towards Milford Sound.

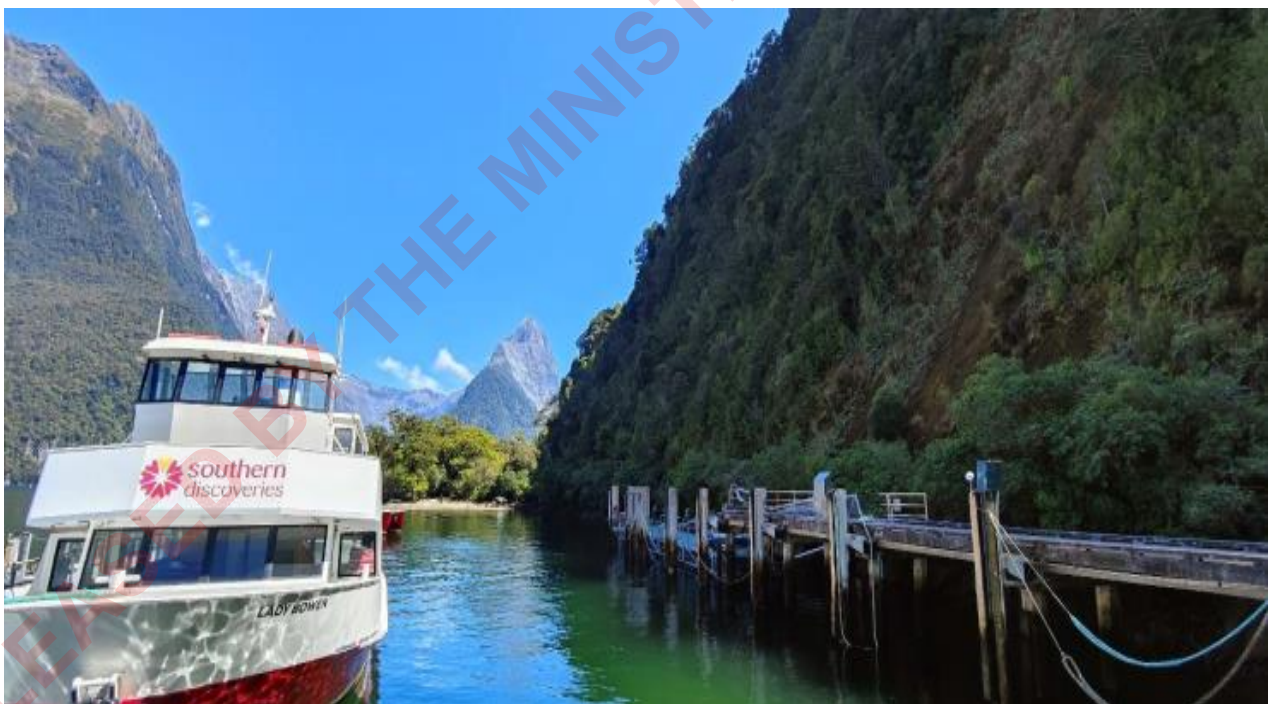
Figure 49: Freshwater Basin with an old tree slide scarp to the right of the image.

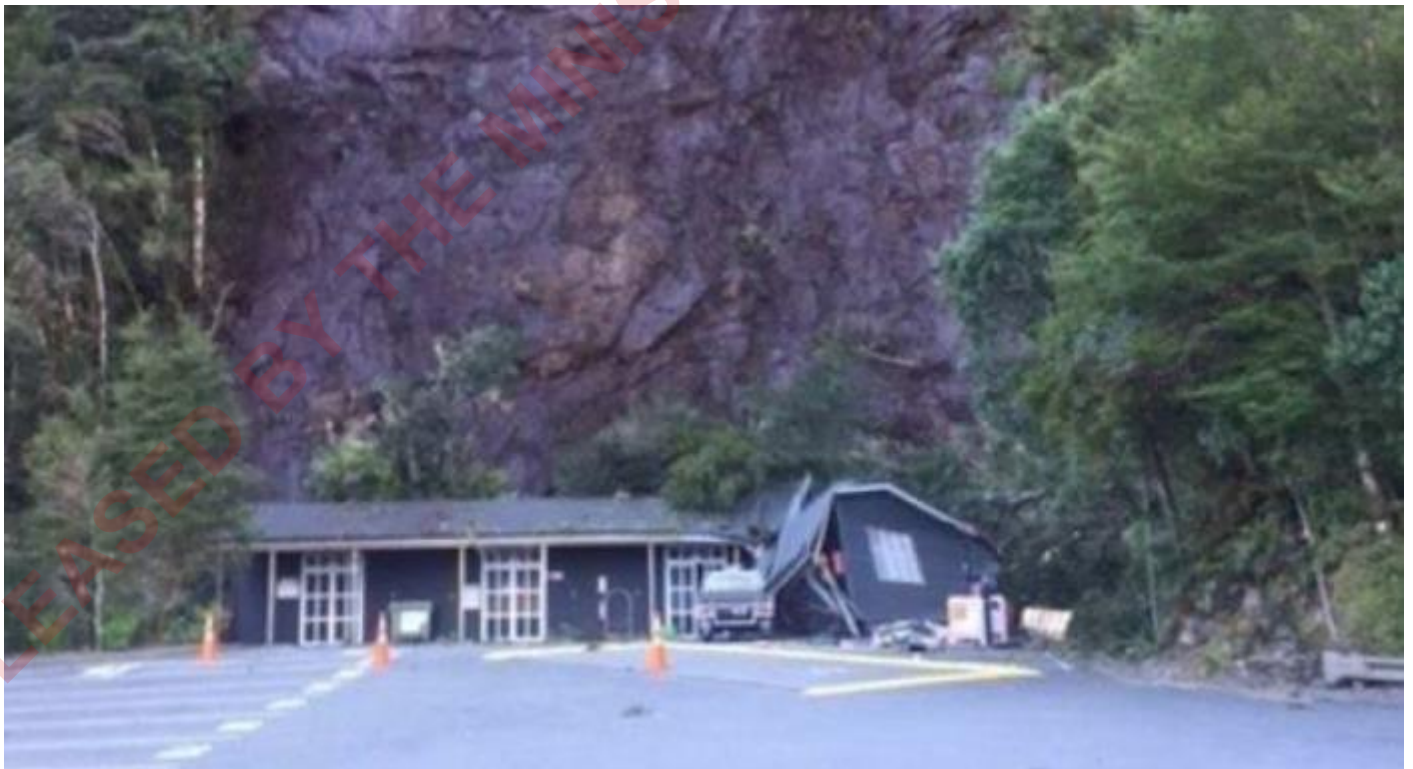
Figure 51: Damage to a storage building in Milford Sound from a rockfall in 2016 (source: Tim Holland)

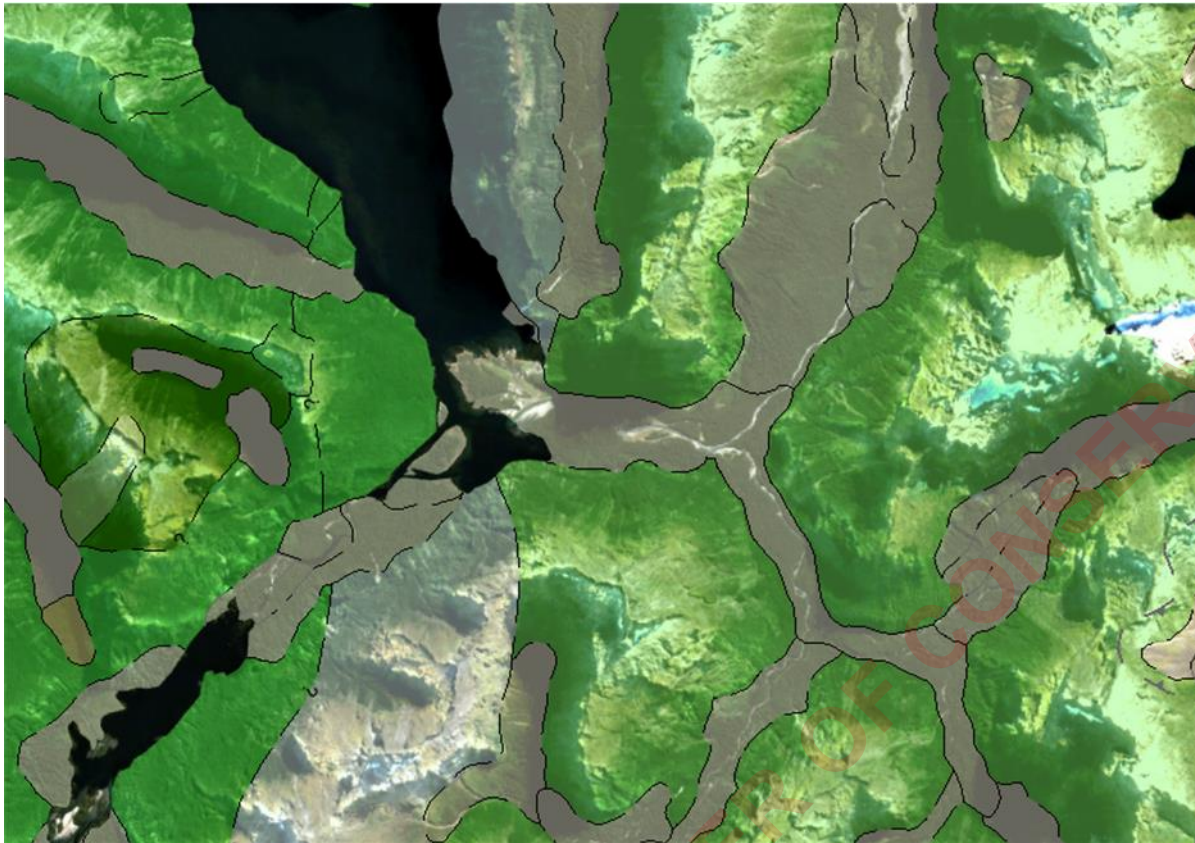
Figure 53: Freshwater Basin – Published Geology

- Elevation: The site is approximately 0 m – 5 m ASL.
- Closest active fault: Anita Shear Zone #8756, located approximately 12 km west of the site.
- Geological Map Information: The site is located within the mapped geological unit: Holocene River deposits (Unweathered, loose, bouldery gravel, sand, and mud in modern floodplains. Peat and carbonaceous mud bands may be interbedded). See Figure 53 below.

- Existing geotechnical investigation information (as per Figure 52 Milford Sound Piopiotahi Visitor Hub) indicates that the site is likely to be underlain by uncontrolled fill of varying thickness with deltaic sediment and interbedded organic swamp deposit below, and gabbro bedrock at unknown depth. Depth to groundwater level is assumed to be approximately 2 m. See Figure 53 below.

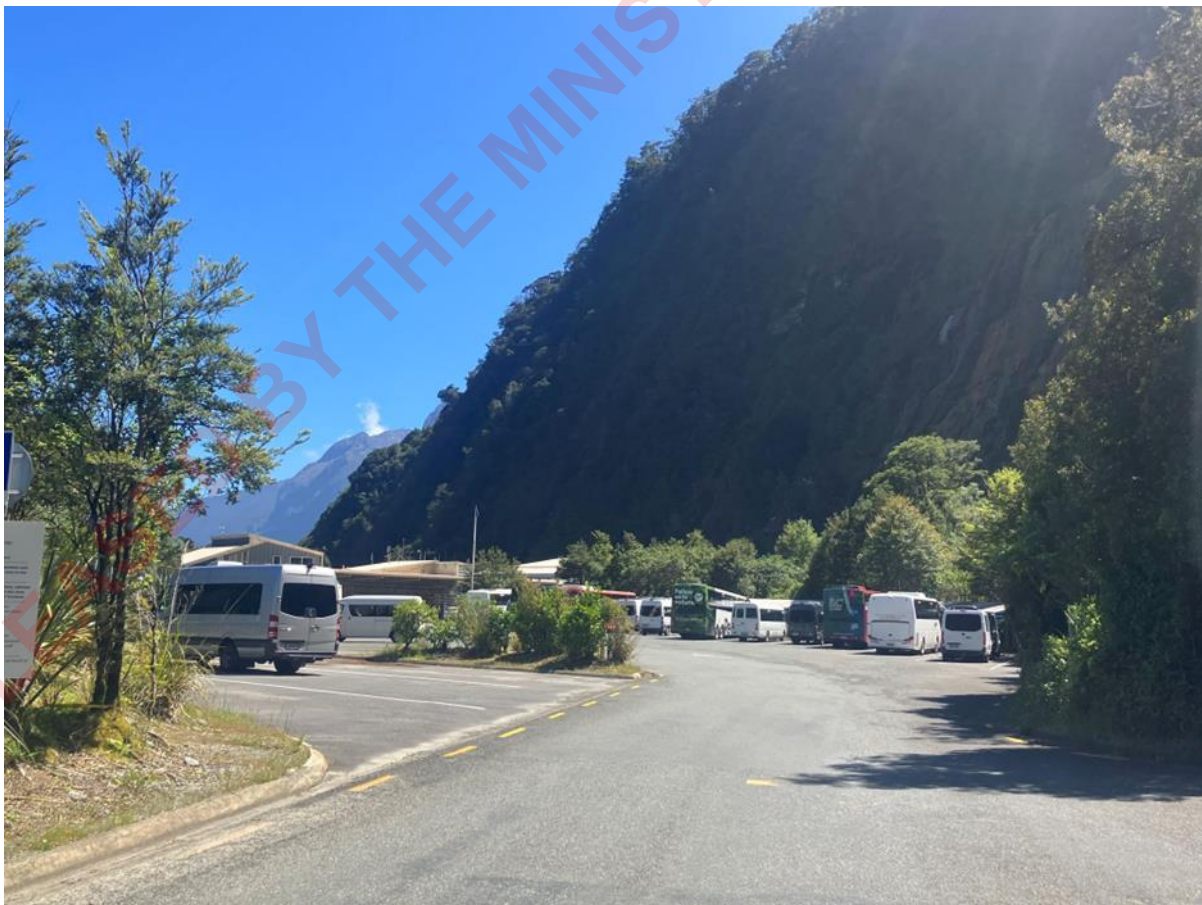
Figure 54: Freshwater Basin looking northwest from the existing carpark and visitor terminal.

Foreshore areas of the site likely consist of deltaic sediments interbedded with organics over bedrock at depth. It is also assumed that water will be encountered at shallow depths below the site. It is likely that the site will have potential for liquefaction and that lateral spreading may occur if located near to the foreshore. Ground conditions on the hills above the foreshore are likely to be bedrock, overlain by a thin layer of organic matter. At this stage the quality of the rock (strength, fractures etc) is unknown.

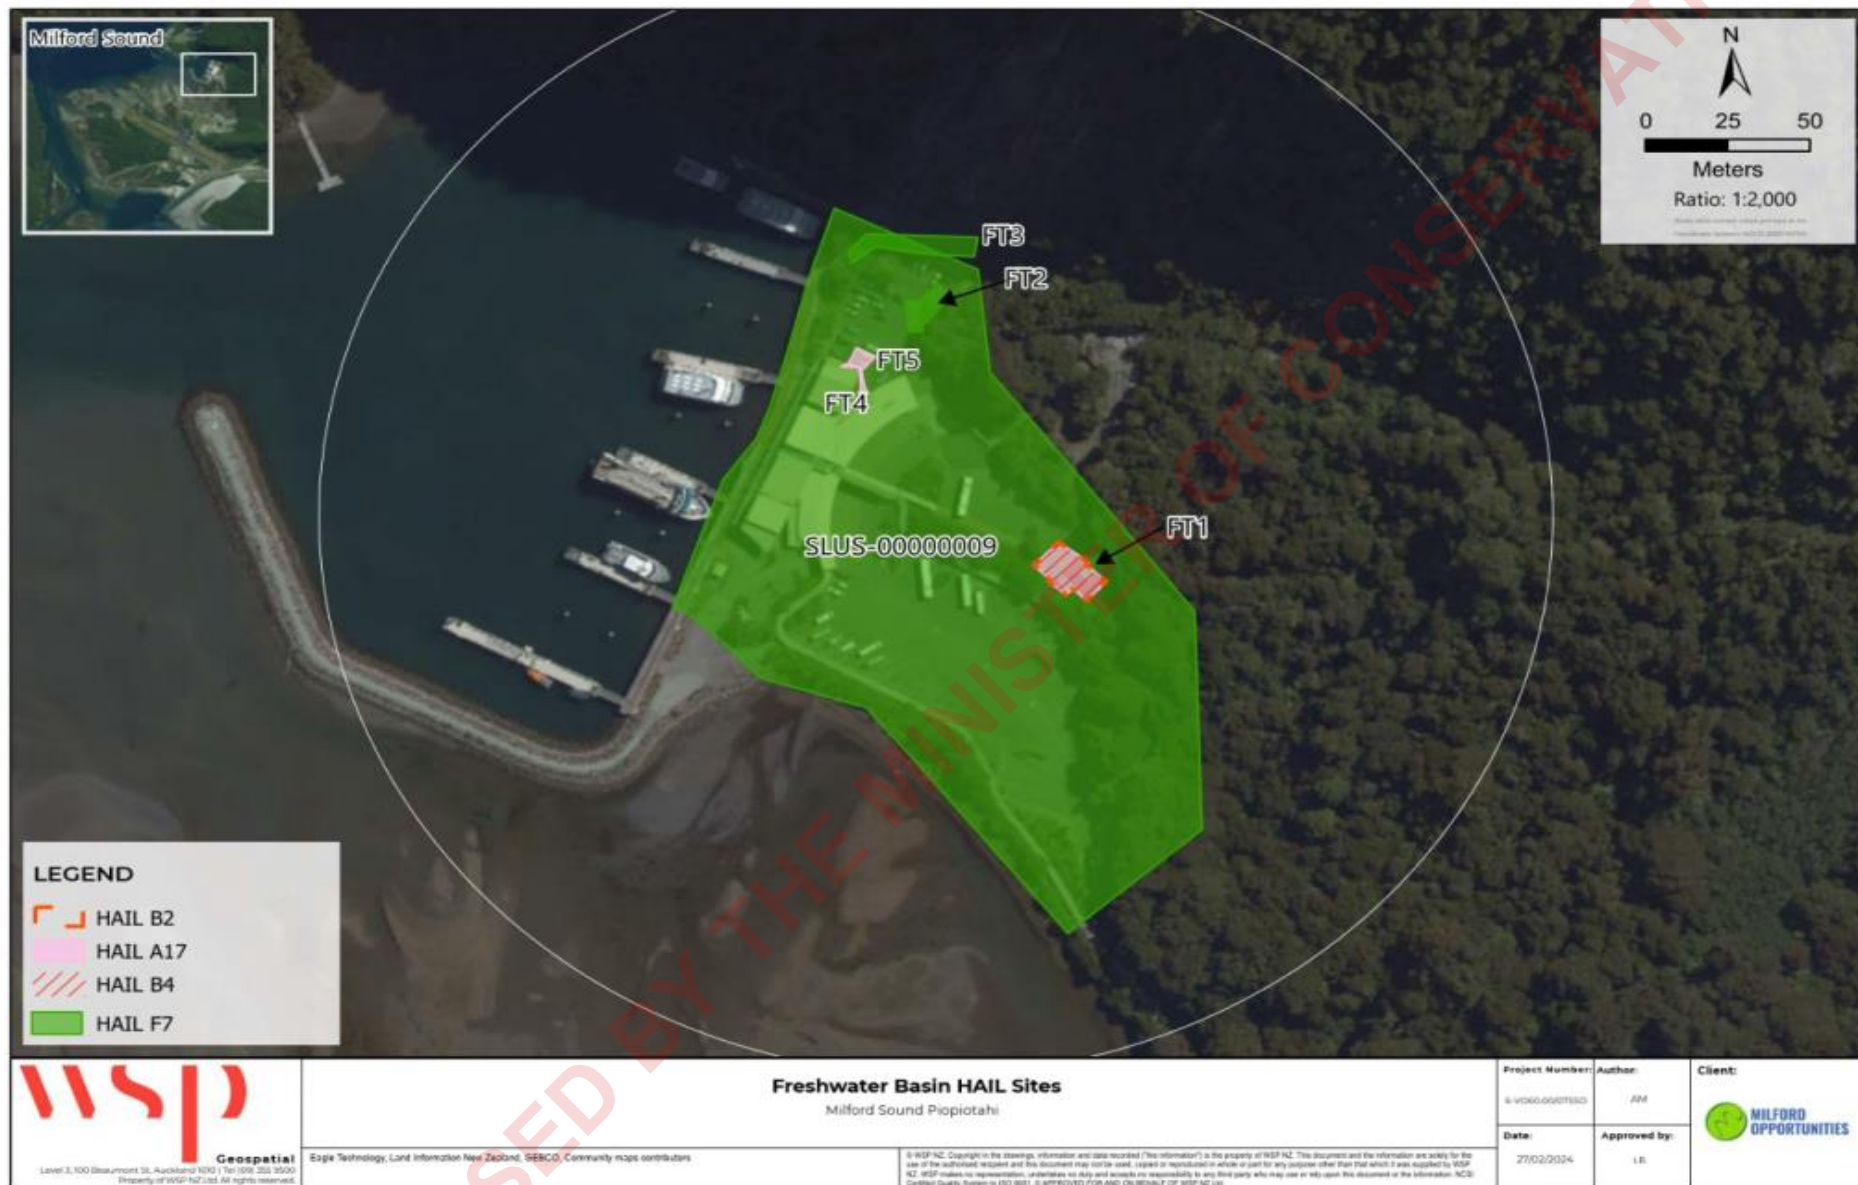
Figure 55: Site Location Plan Freshwater Basin with identified HAIL sites.

As Hazardous Activities and Industries List (HAIL) activities have been identified on the site, the Freshwater Basin Node has been classified as **RED** requiring further assessment to the risks to human health and the environment prior to development. A summary of the identified HAIL activities and their locations has been provided in Table 58 and Figure 55 respectively. **RED** – HAIL indicates that activities (current or past) are likely or known.

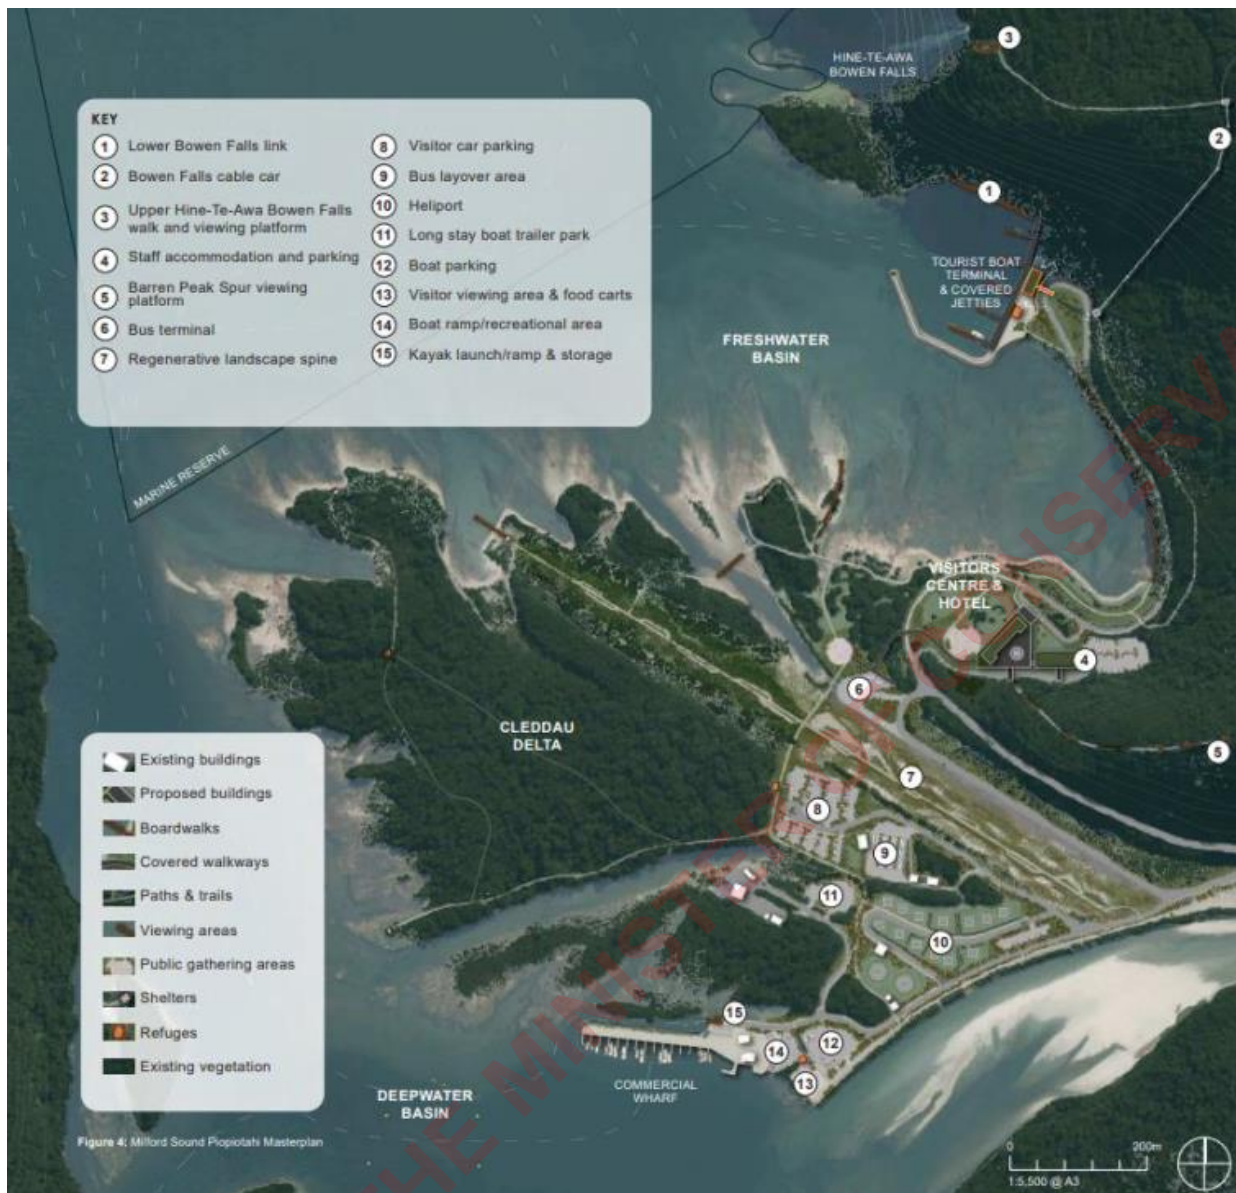
Figure 58: Milford Sound Piopiotahi sites under the MOP Master Plan (source: Stantec and Boffa Miskell)

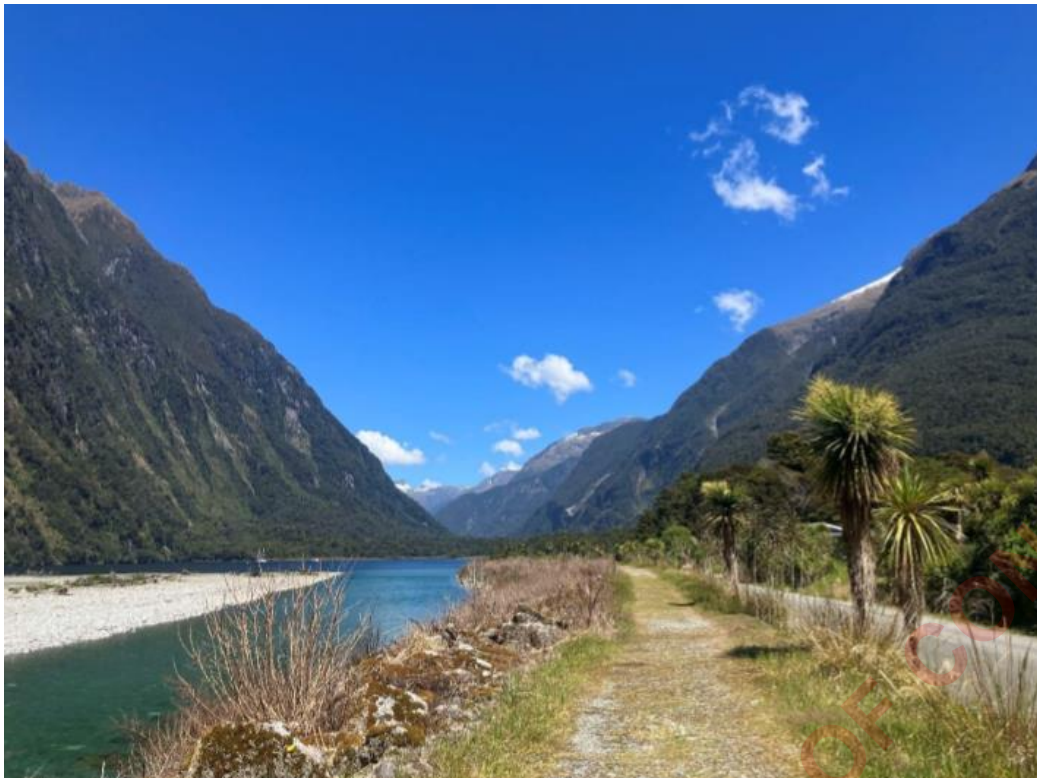
Figure 59: The flood mitigation stop bank on the northern margin of the Cleddau River looking out towards Milford Sound.

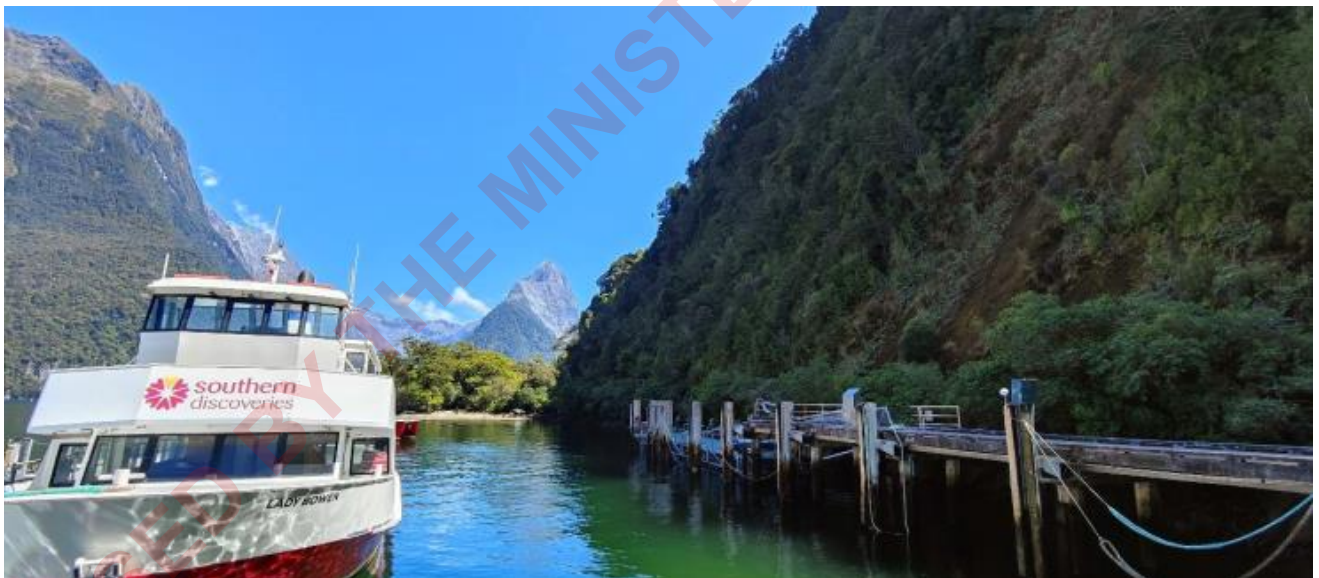
Figure 60: Freshwater Basin with an old tree slide scarp to the right of the image.
