# MILFORD OPPORTUNITIES PROJECT- ENGINEERING FEASIBILITY REPORT

26 JUNE 2024

WSP  
Invercargill  
65 Arena Avenue  
PO Box 647  
Invercargill 9810, New Zealand  
+64 3 211 3580  
wsp.com/nz

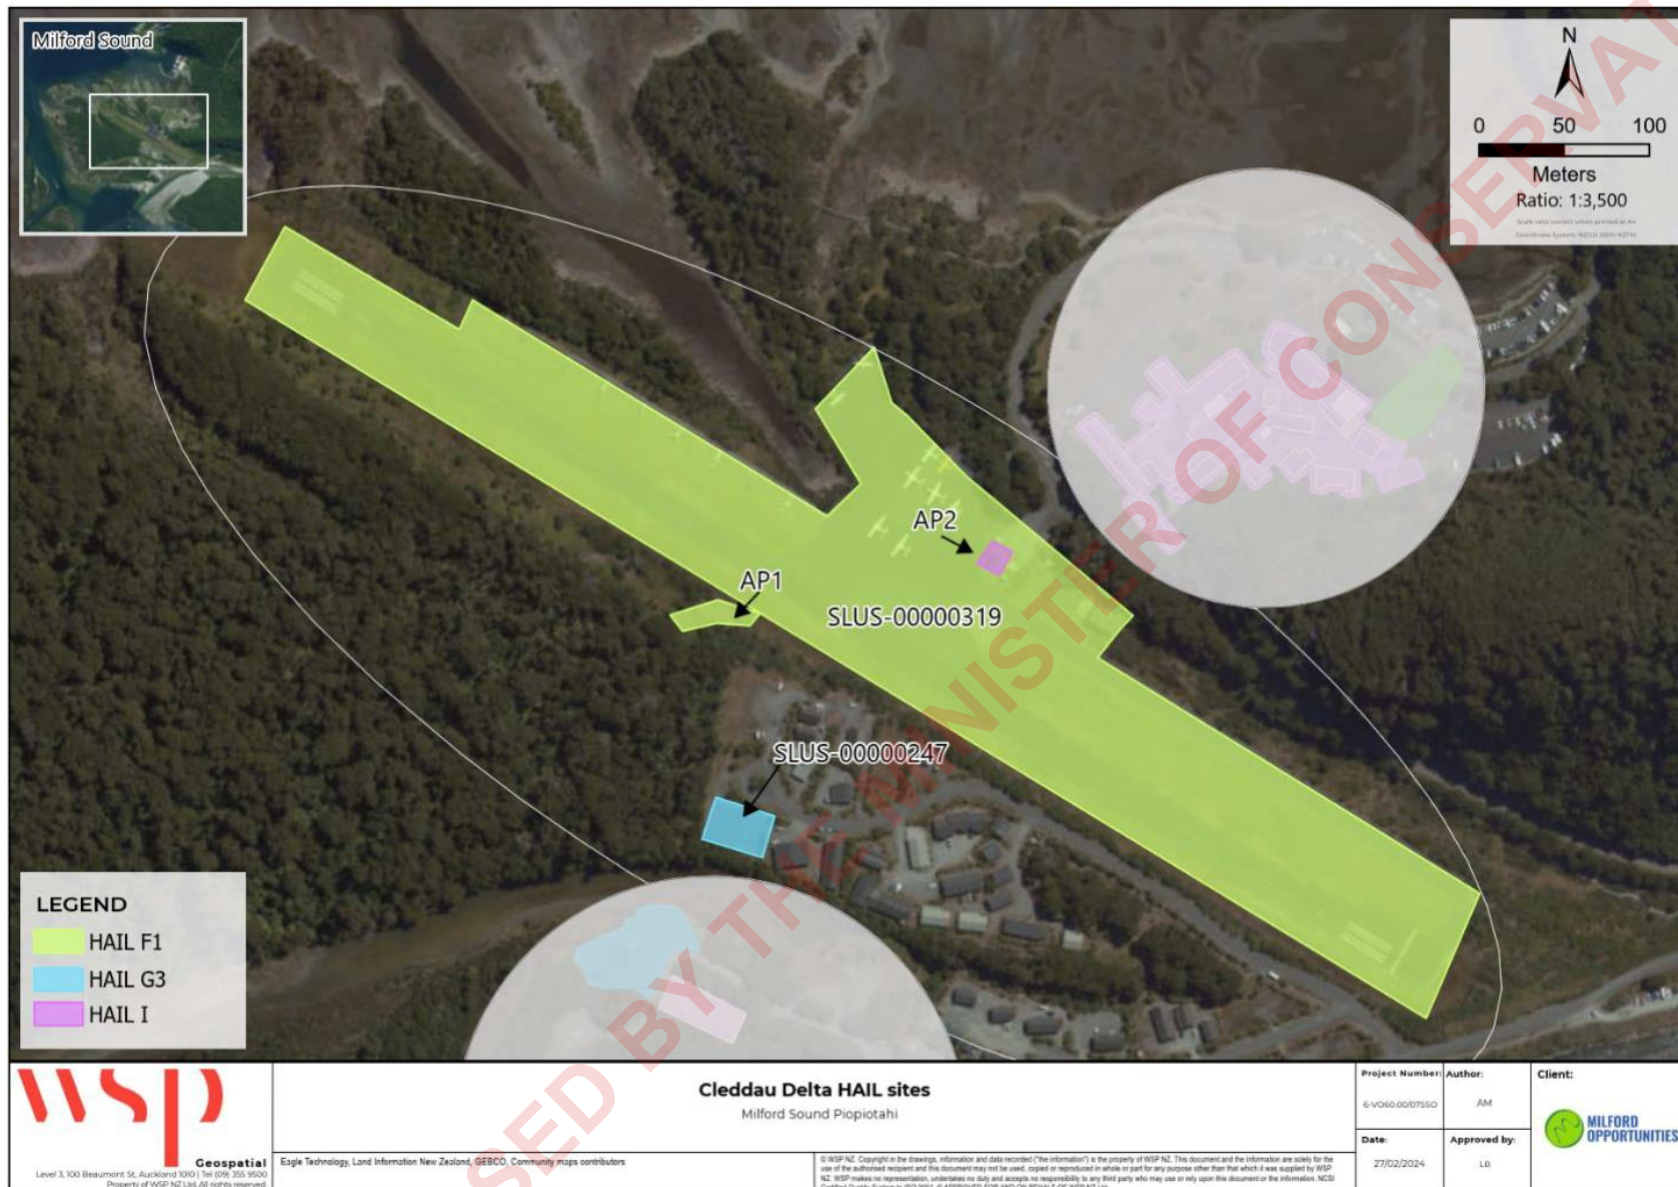
Figure 64: Site location Cleddau Delta with Identified HAIL Sites

A review of two PSIs undertaken by e3Scientific for Cleddau Village (e3Scientific, 2022c) and the Airport (e3Scientific, 2022b) has revealed a historic landfill site and multiple fuel storage areas. Details of the identified HAIL activities are summarised in Table 61 below with a site location plan provided in Figure 64.

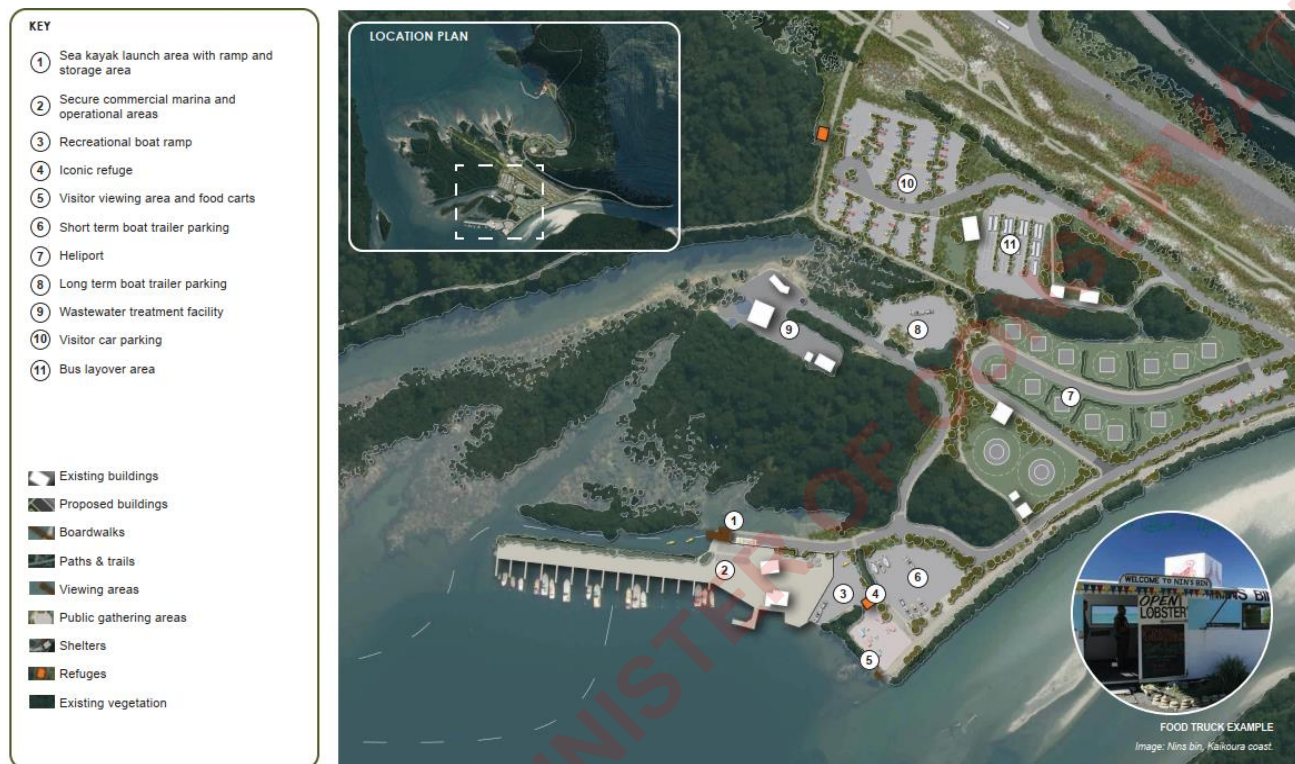
Adjacent to the existing outlet of the Cleddau River, the Deepwater Basin node accommodates an existing marina for commercial fishing, kayak operations and a boat ramp/boat trailer park for recreationalists. It is proposed that a new visitor viewing area and refuge are incorporated with these activities and that the heliport is relocated.

Figure 66: Deep water basin node

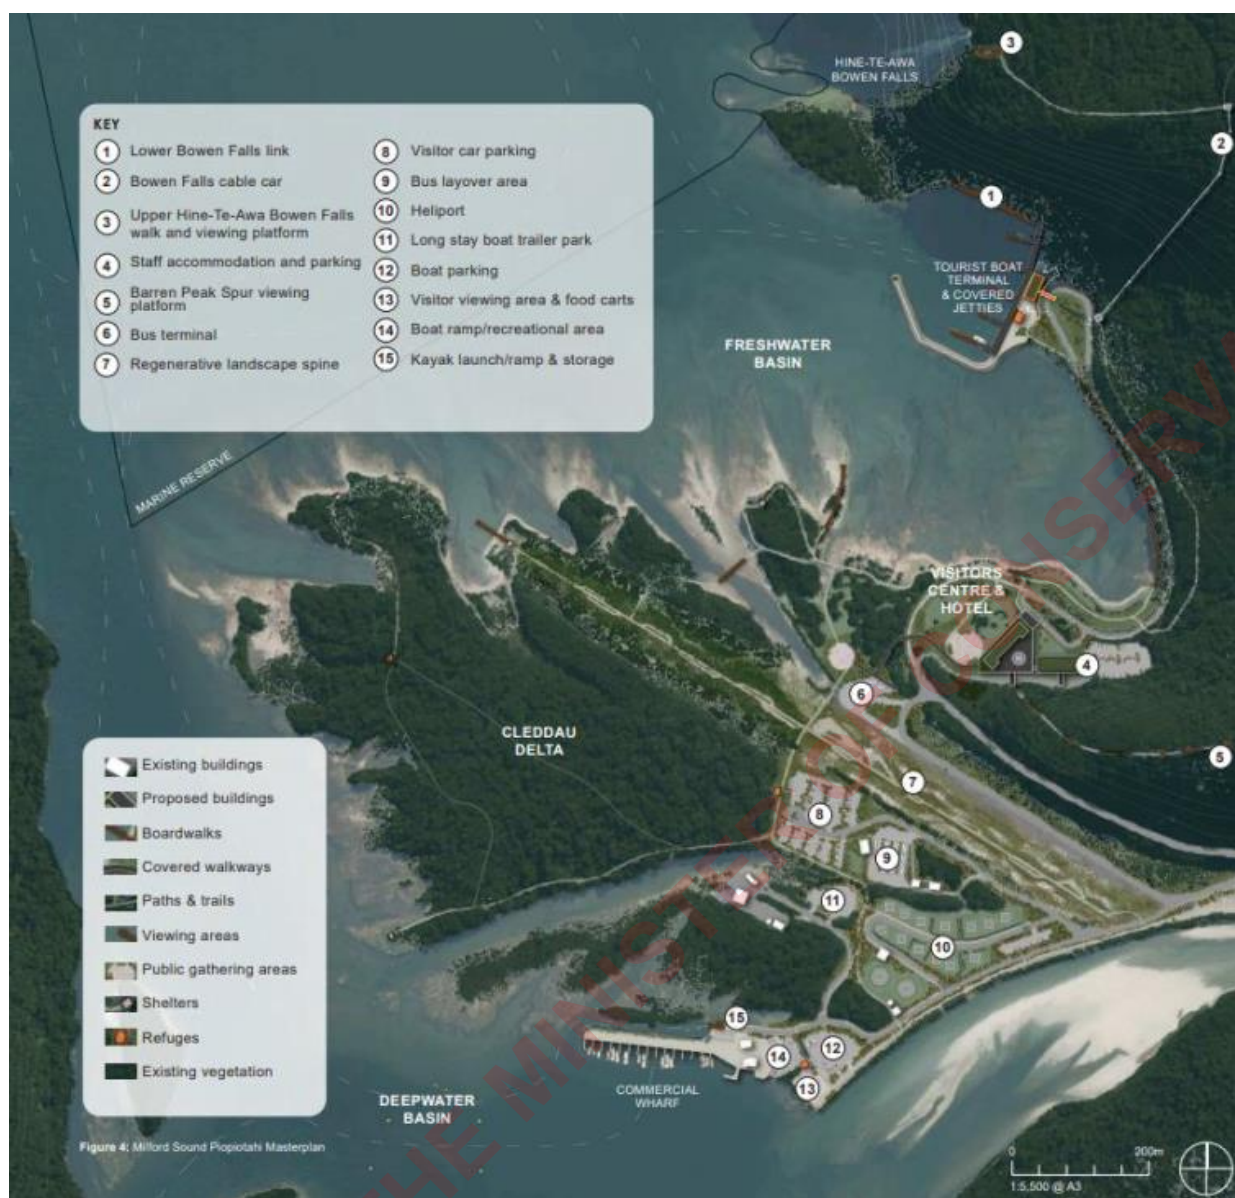
Figure 68: Milford Sound Piopiotahi sites under the MOP Master Plan (source: Stantec and Boffa Miskell)

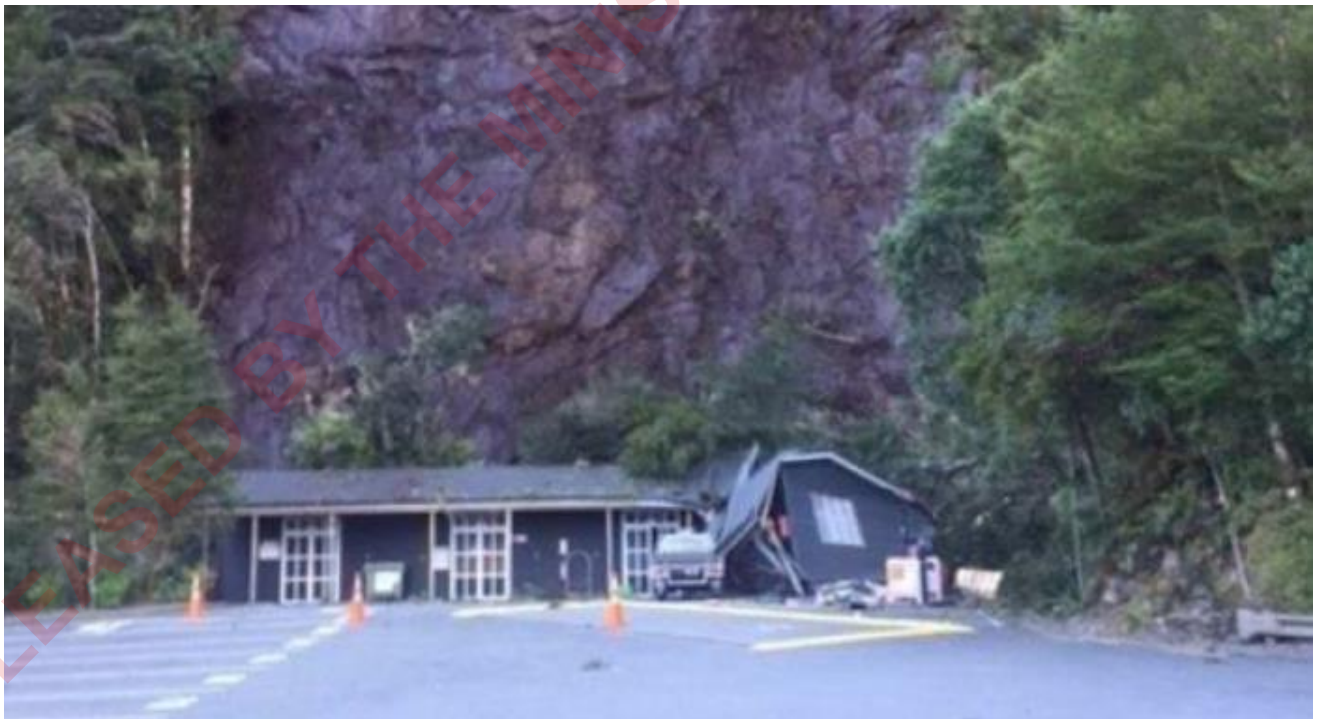
Figure 72: Damage to a storage building in Milford Sound from a rockfall in 2016 (source: Tim Holland)

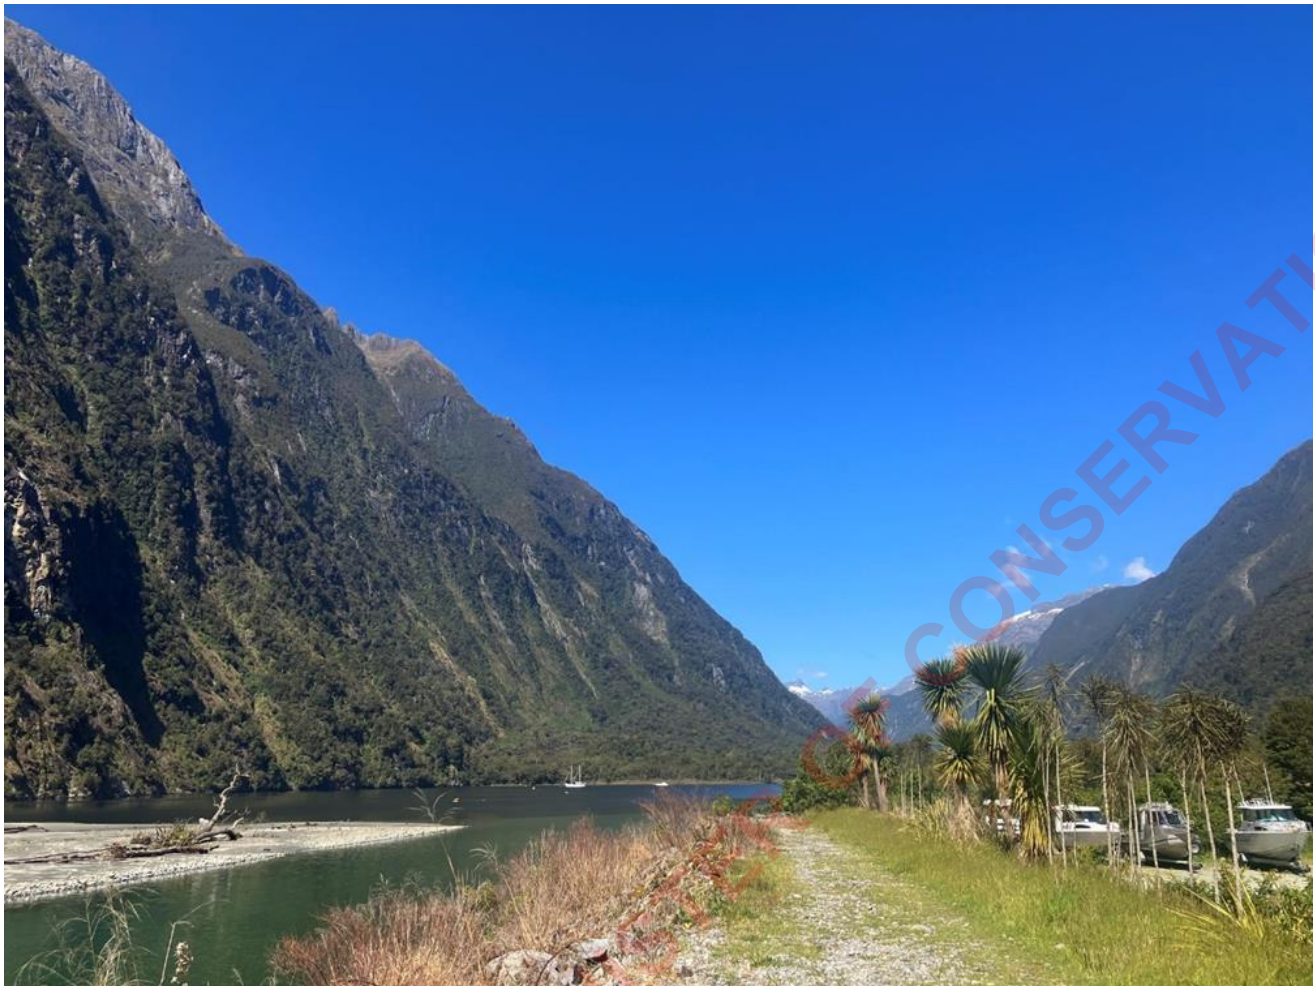
Figure 73: Deepwater basin looking southwest from the northern bank of the Cleddau River

- Based on the proximity of the Cleddau River and the likely soils, groundwater is assumed to be relatively shallow at approximately 2 m bgl. See Figure 73 below.

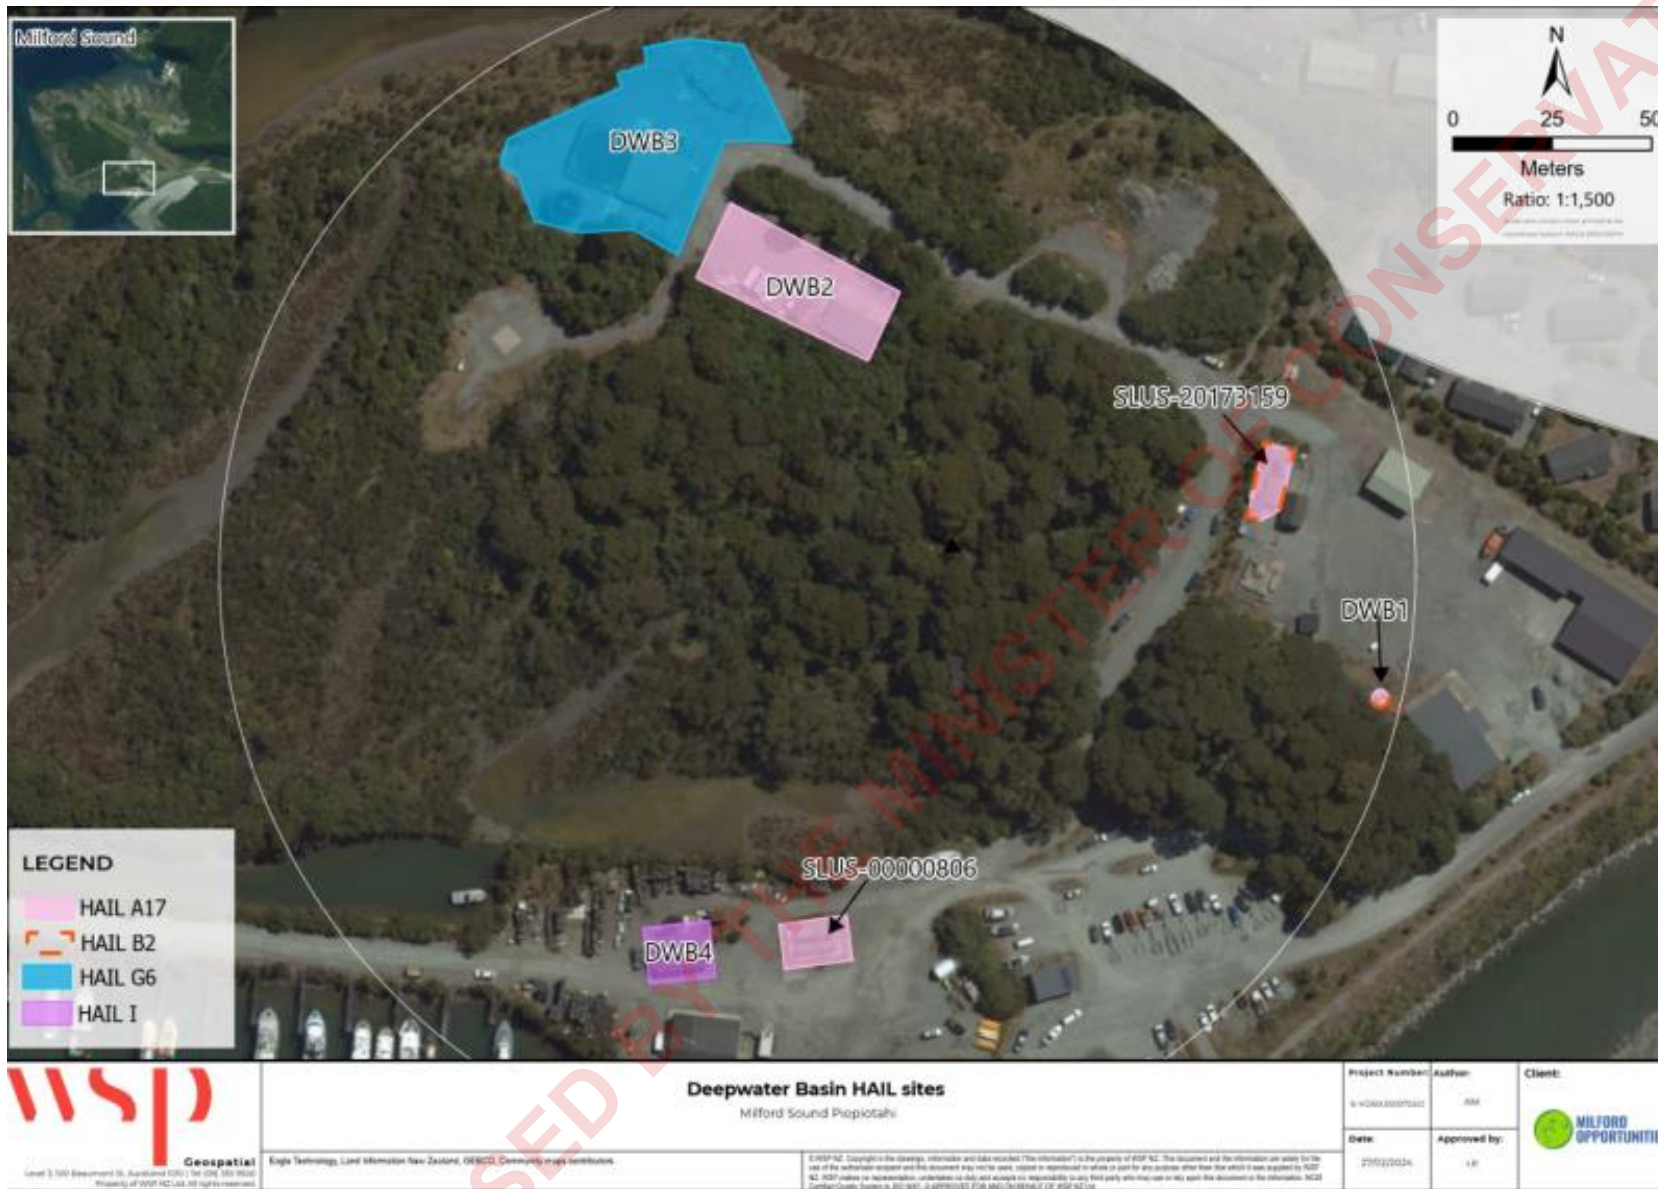
Figure 74: Site location plan Deepwater Basin with identified HAIL sites

As Hazardous Activities and Investigations List (HAIL) activities have been identified on the site, the Deepwater Basin Node has been classified as **RED** requiring further assessment to the risks to human health and the environment prior to development. A summary of the identified HAIL activities has been provided in Table 64 with a location plan in Figure 74. **RED** – indicates that HAIL activities (current or past) are likely or known.

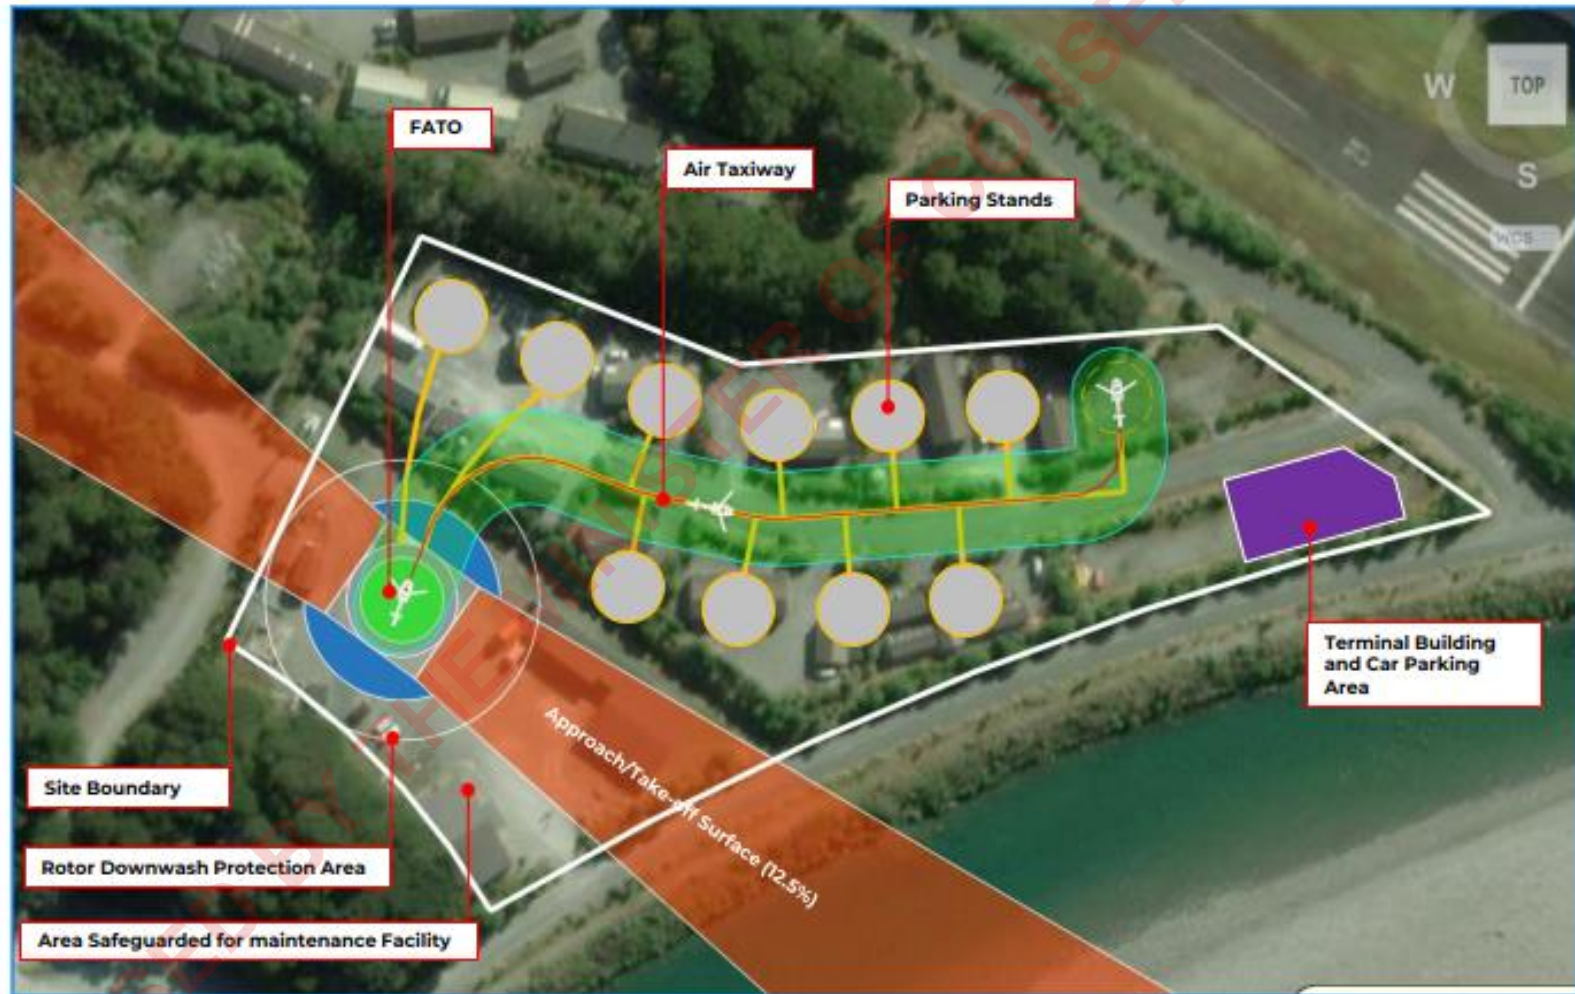
#### 13.8.5.1 HELIPORT CONCEPT 1

The area shown for maintenance and the terminal facility is tentative and not measured to scale.

The location of the FATO requires further optimisation based on the planned boundary fence height, it is possible that the location may be moved slightly to the south from the current location to allow sufficient separation from the FATO to the boundary fence, so that the fence does not infringe the approach/take-off surface.

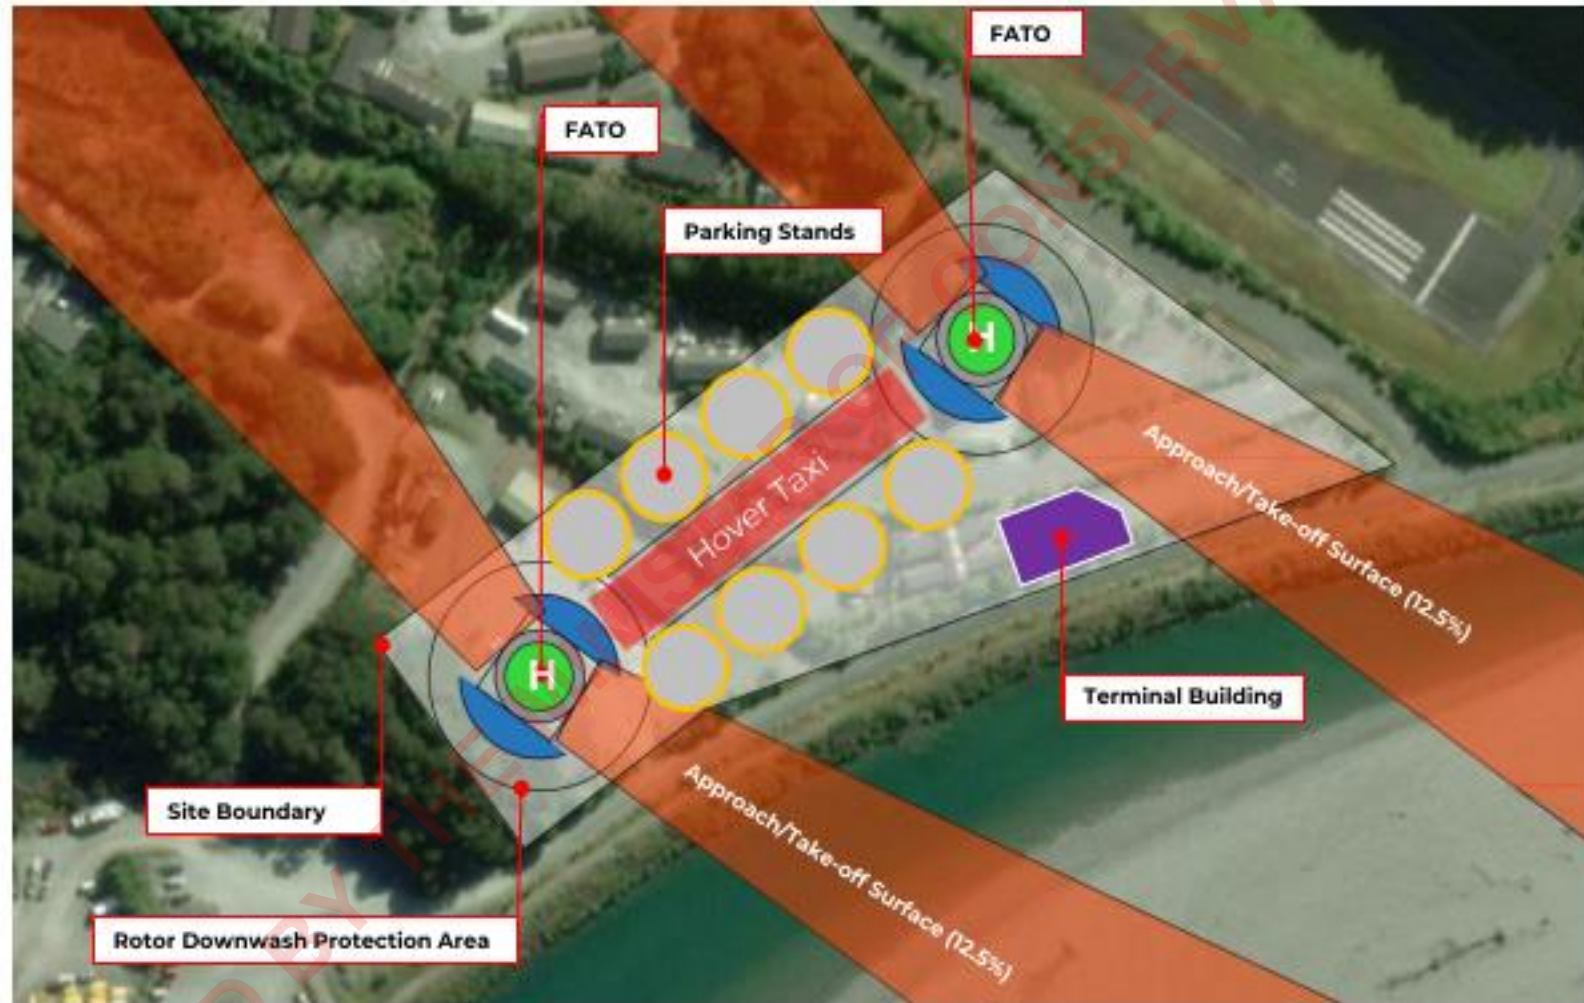
### 13.8.5.2 HELIPORT CONCEPT 2

This concept/configuration can accommodate 8 parking stands and 2 FATO's.

This concept follows a pier topology, and a resilient design with two FATO's. Even if one of the FATO become unusable due to an incident the system can still operate safely using the other.

The taxi time is substantially reduced compared to the previous concept, as the helicopters are not restricted to land or take off from a single FATO.

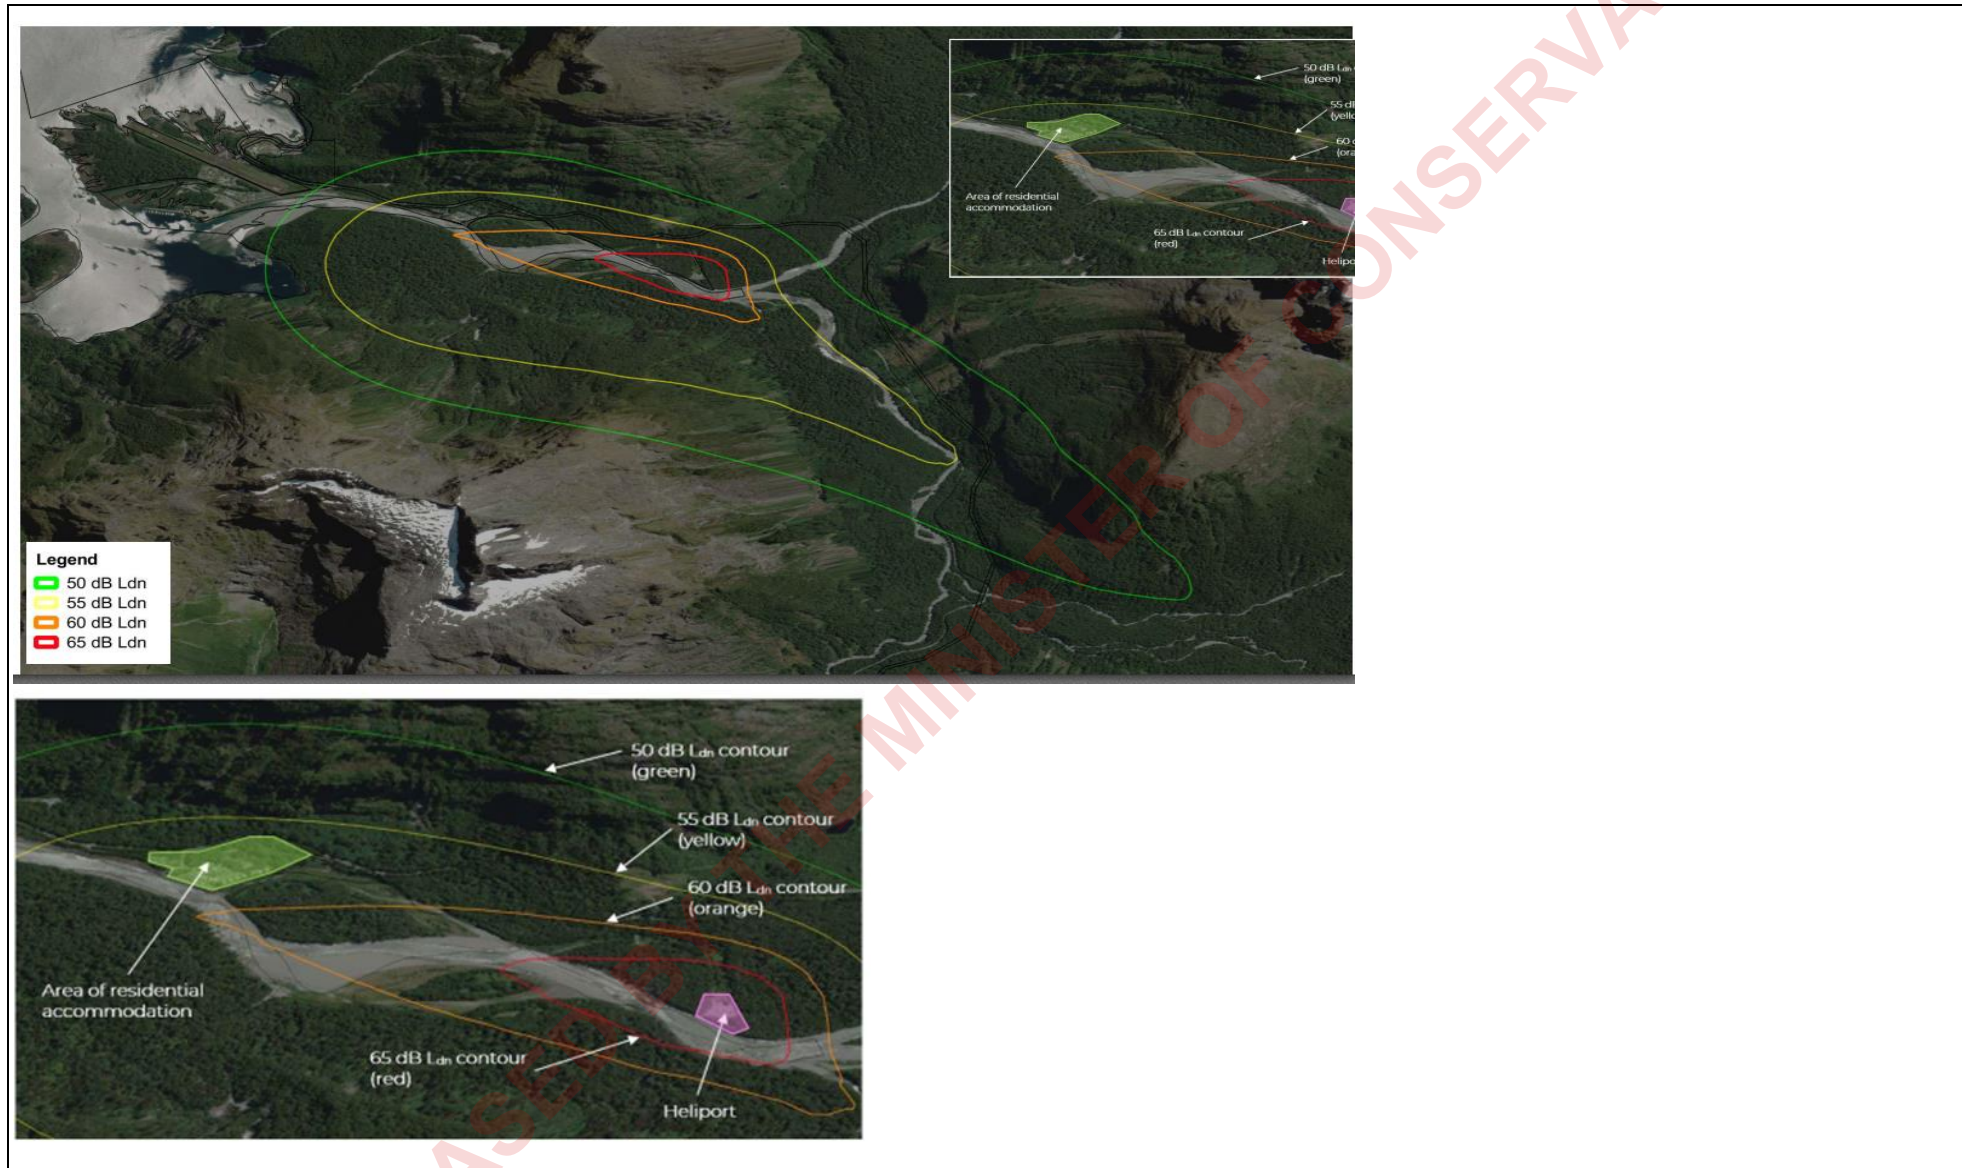
### 13.8.7.3 NOISE ASSESSMENT (SITE 2 – LITTLE TAHITI FINDINGS)

Milford Sound Lodge and campervan park to the west of the proposed Little Tahiti heliport are the only developed locations which are predicted to receive noise levels greater than 50 dB Ldn. Noise at other locations is either roads or are undeveloped areas.

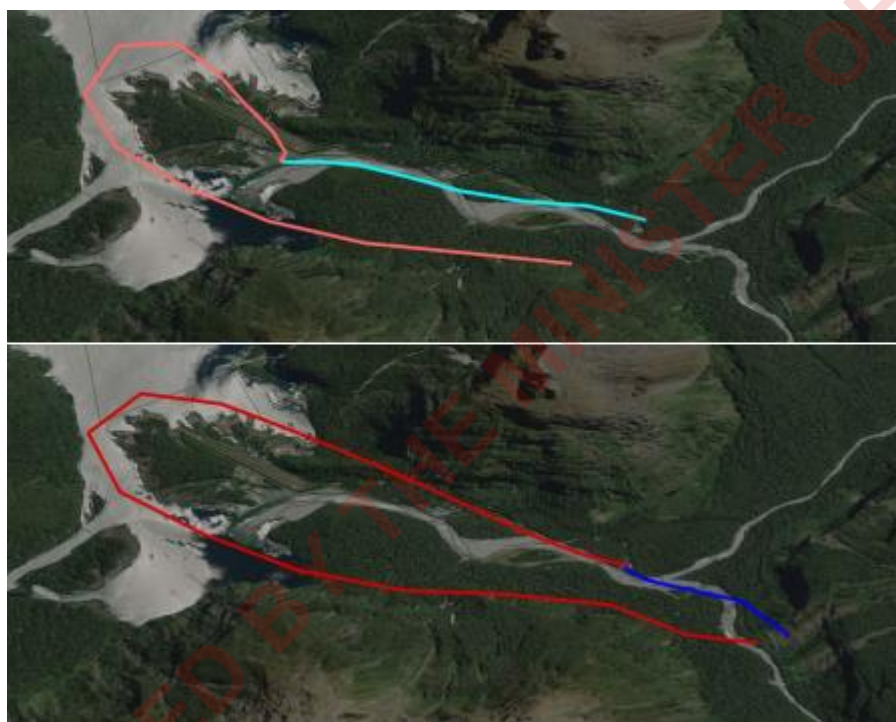
Figure 76: Deepwater basin (top) and Little Tahiti (bottom) flight paths for Tranquillity rating assessment

The typical route of tourism helicopters was used in the noise modelling. 3D GPS coordinates were provided by the helicopter operators using a GNSS receiver which had a 10-second sampling rate with an accuracy of 2-5 metres. These arrival and departure tracks for each heliport location are provided in Figure 76.

PARAMETER	DESCRIPTION
Aircraft Movement	1 movement
Flight path	Given in Figure 3
Breakdown of aircraft	Airbus H125 (formally AS350 Squirrel)
Helipad location	Deepwater Basin: -44.6763467, 167.92567 Little Tahiti: -44.6814415, 167.95277
Natural and Contextual Features	100%
Moderating Factor	0

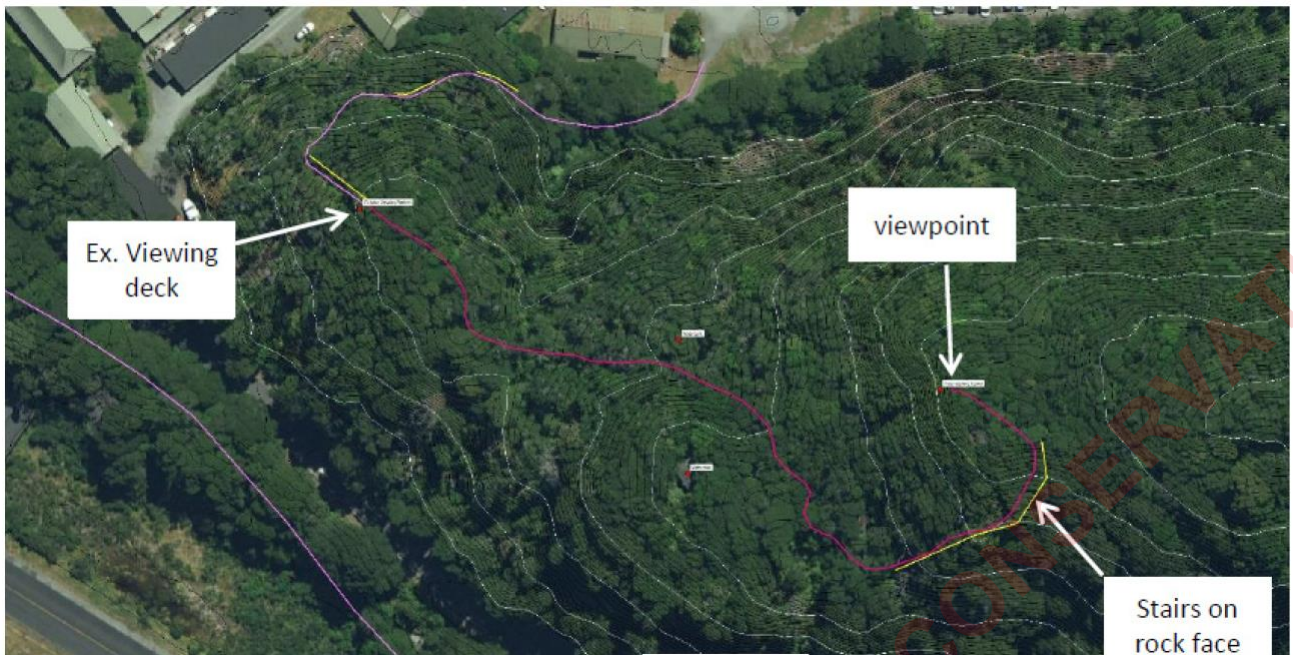
Figure 90: Barren Peak Spur Stairs and Viewing Platform location (Source: Southern Land)

The Southern Land report provides details of the proposed short walk to a new Barren Peak Spur viewing platform. The walkway will be located within dense vegetation and will require steps and stairs. Southern Land has identified a section of the walkway that will require stairs at an exposed rock face.

The site has shallow topsoil and vegetation root mass over bedrock and the structure's foundations will require rock anchors. The preferred foundations are rock anchors embedded in reinforced concrete plinths to provide long term durability.
