Milford Opportunities

# MILFORD OPPORTUNITIES PROJECT GEOTECHNICAL FEASIBILITY

24 APRIL 2024

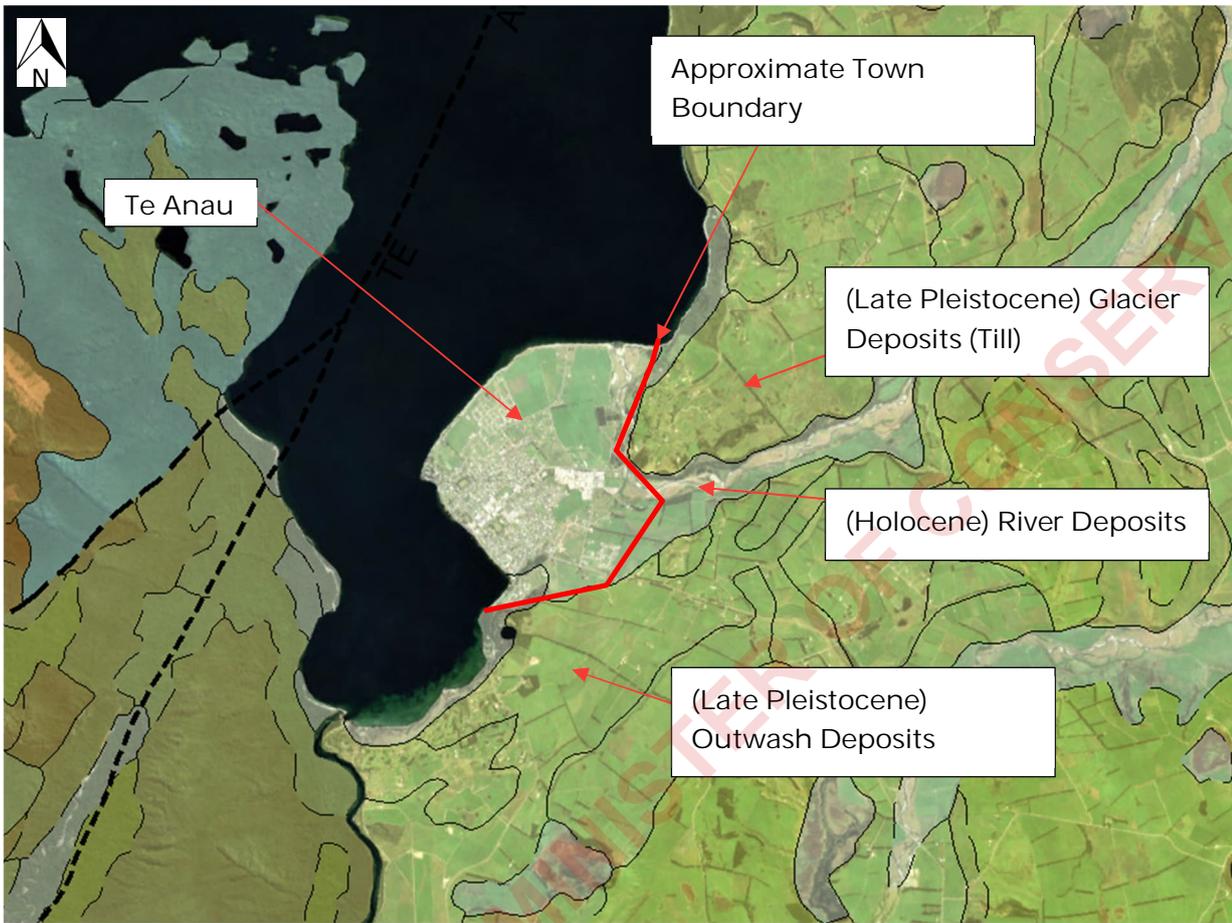
Figure 2: Te Anau – Published Geology<sup>9</sup>

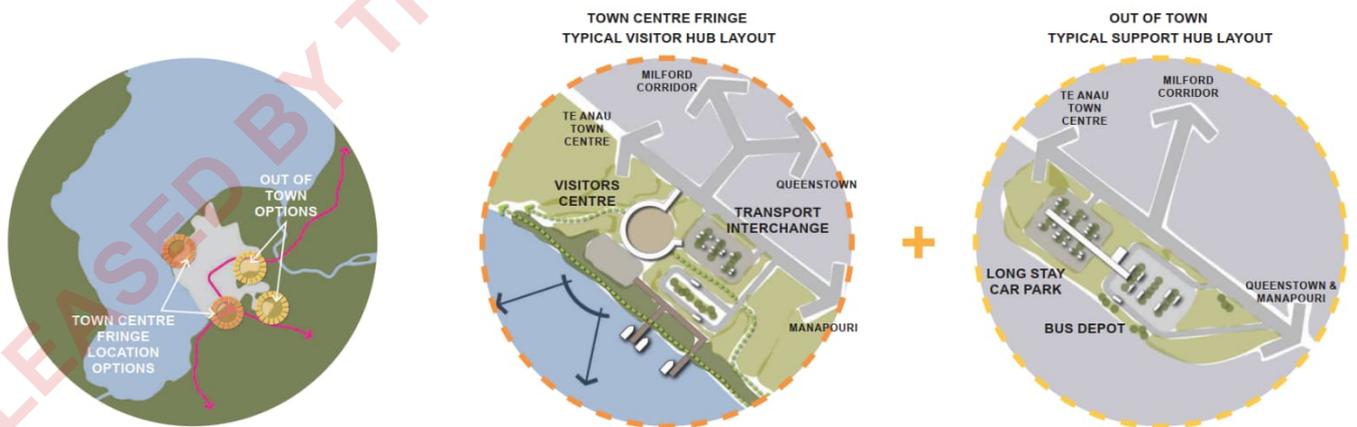
Figure 3: Te Anau Hub Locations and Concepts from Masterplan

- Site location not yet selected – the Masterplan indicates site options could include; the town centre, on the town fringe or out of town, see Figure 3 below.

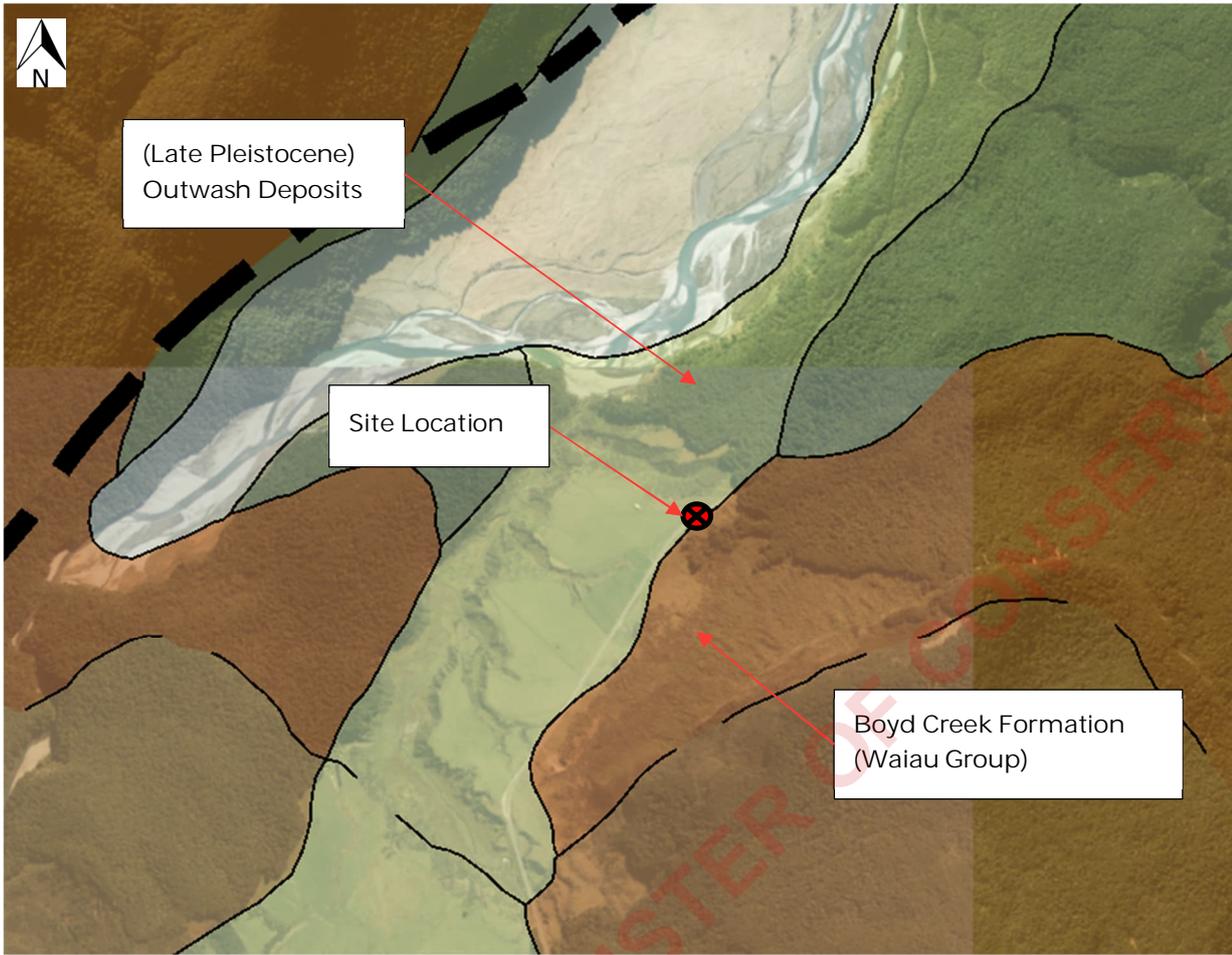
Figure 4: Te Rua-o-Te-Moko Fiordland National Park Gateway – Published Geology

- Geological Map Information: Site is located on the boundary between the following two mapped geological units, see Figure 4 below.
- Eastern Side Labelled: Boyd Creek Rock Formations (Discontinuous basal mudstone; thin-bedded graded sandstone, upper part is massive siltstone/mudstone with lenticular massive sandstone).

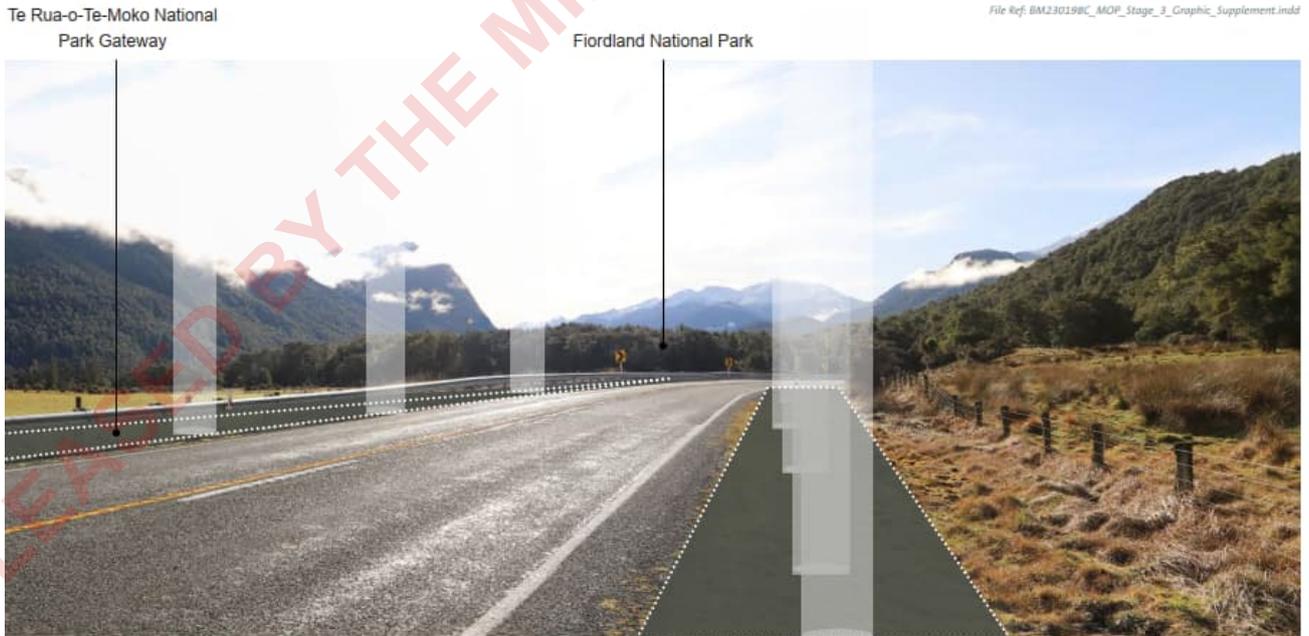
Photograph 1: Te Rua-o-Te-Moko Fiordland National Park Gateway – Eastern side of the site (vegetation types appear to indicate wet ground conditions)<sup>3</sup>

- Based on the MOP Masterplan concept, a site visit, and photographs the site is likely to be situated on outwash deposits. It should be noted that a culvert is located within the site that appears to drain the eastern side of the highway to the west. It is likely that either shallow ground water or overland water flow should be expected, see Photograph 1 below.

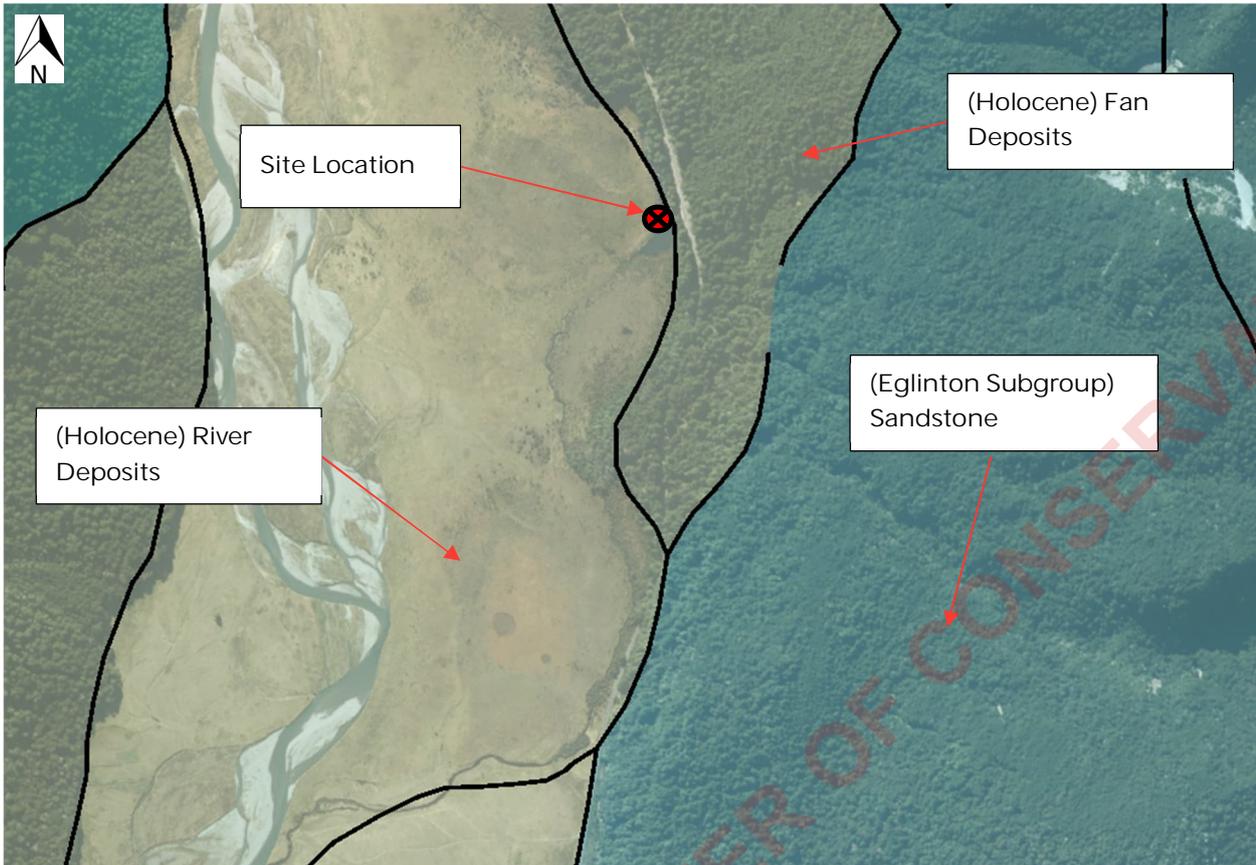
Figure 5: Short Stop: Mirror Lakes Waiwhakaata – Published Geology

- Geological map information: Site is located on the boundary between the following two mapped geological units, see Figure 5 below:
- Underlying the road, carpark, and part of the walkway: Holocene fan deposits (Loose, commonly angular, boulders, gravel, sand and silt forming alluvial fans; grades into scree upslope) and valley alluvium.

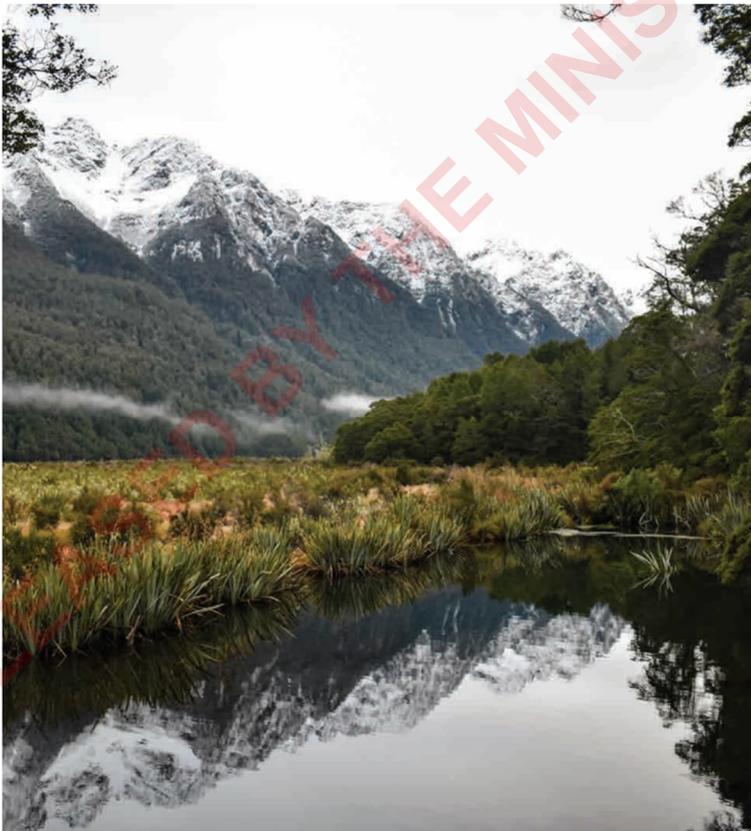
Photograph 2: Short Stop: Mirror Lakes Waiwhakaata looking northwest across the Eglinton Valley (MOP Masterplan, 2021)

- Photographs from the earlier stages of the project indicate that the site is likely to be composed of flood plain sediment with saturated ground conditions. See Photograph 2 below.

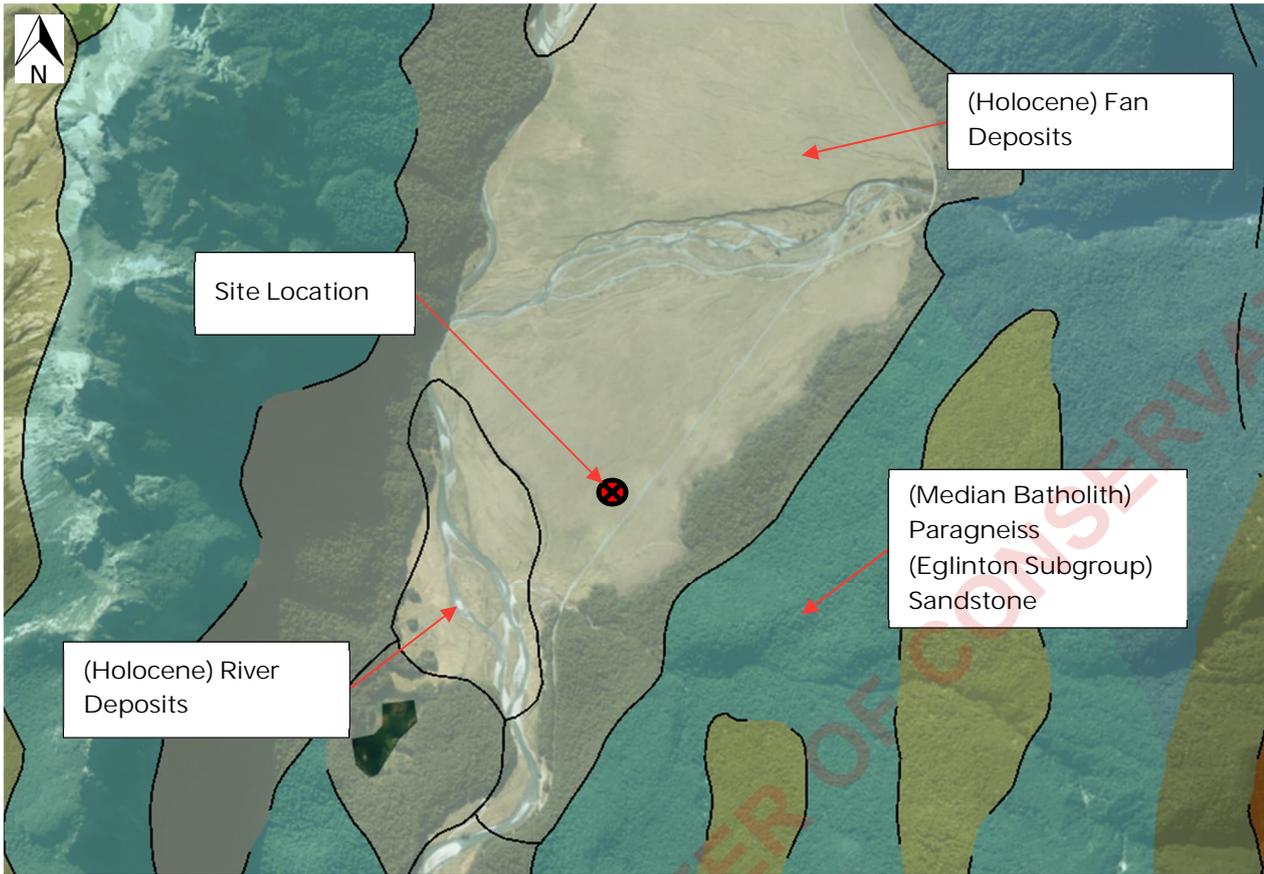
Figure 6: Eglinton Reveal – Published Geology

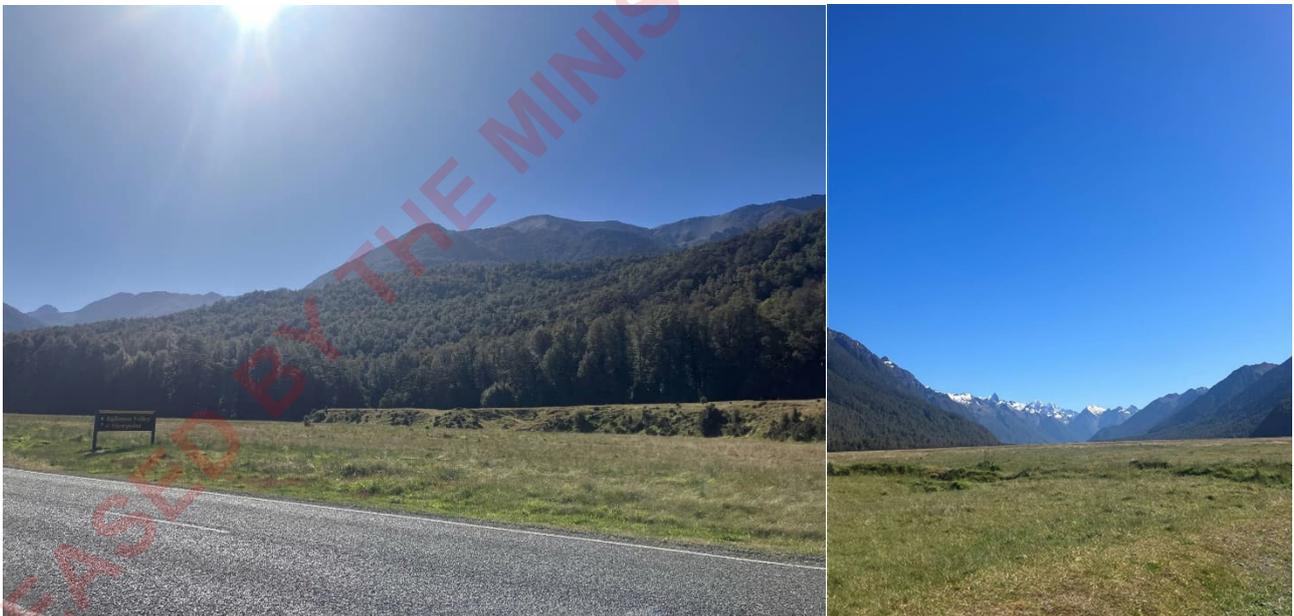
Photograph 3: Eglinton Reveal looking east (left) and north (right) from the proposed site location

- The Masterplan structures listed at this site are a visitor shelter, a carpark, and an access restriction point.
- Elevation: the site is approximately 320 m ASL.
- Closest active fault: Unnamed Fault #8429, located approximately 4.3 km northeast of the site.
- Geological map information: Site is located within the mapped geological unit: Holocene fan deposits (Loose, commonly angular, boulders, gravel, sand and silt forming alluvial fans; grades into scree upslope) and valley alluvium. See Figure 6 below.
- Environment Southland Liquefaction Risk Map: Low Risk. Note mapping completed between 2006 and 2012. Data may be outdated under current liquefaction assessment techniques.
- Site visit and photographs indicate that the site is likely to be composed of alluvial fan sediment with ground water at shallow depth influenced by the river. See Photograph 3 below.

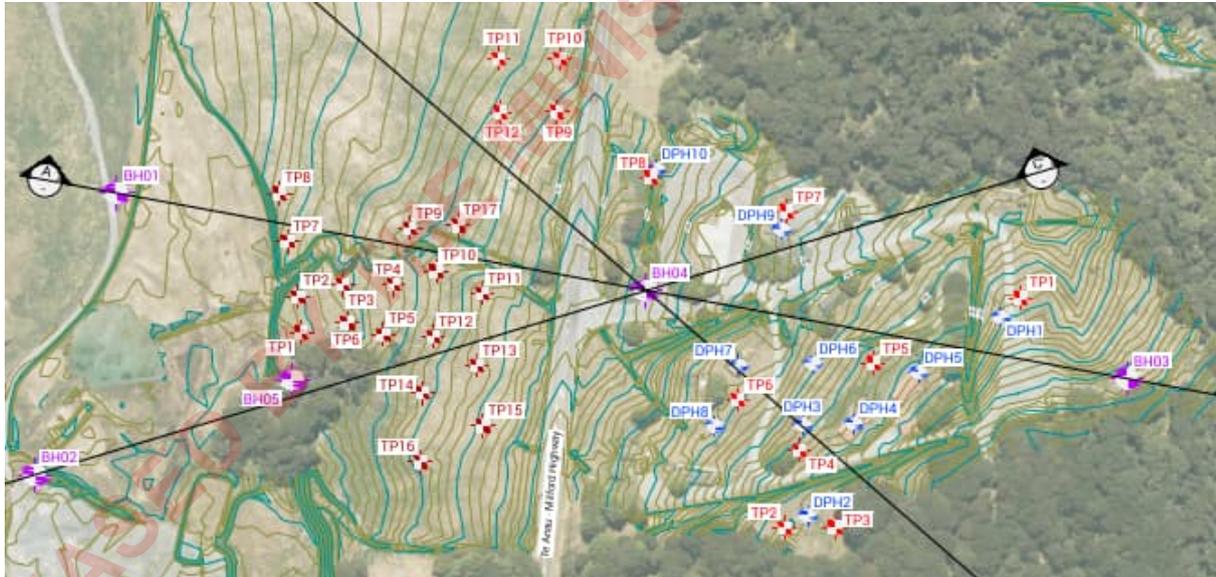
Figure 8: GeoSolve Map of their Geotechnical Investigation<sup>13</sup>

- A geotechnical investigation was completed by GeoSolve and issued as a draft in July 2019 for the Knobs Flat Te Huakaue site<sup>13</sup>. Note that the investigation did not include the Kiosk Creek area. The investigation consisted of 29 Test Pits (TP), 10 Super Heavy Dynamic Probe (DPSH) tests, 2 Scala Penetrometer Tests (Scala), 4 Sonic Boreholes (BH) and 1 Cored Borehole. The TPs were advanced to a maximum depth of 5.5m bgl and BHs to 20m bgl. See Figure 8 below.

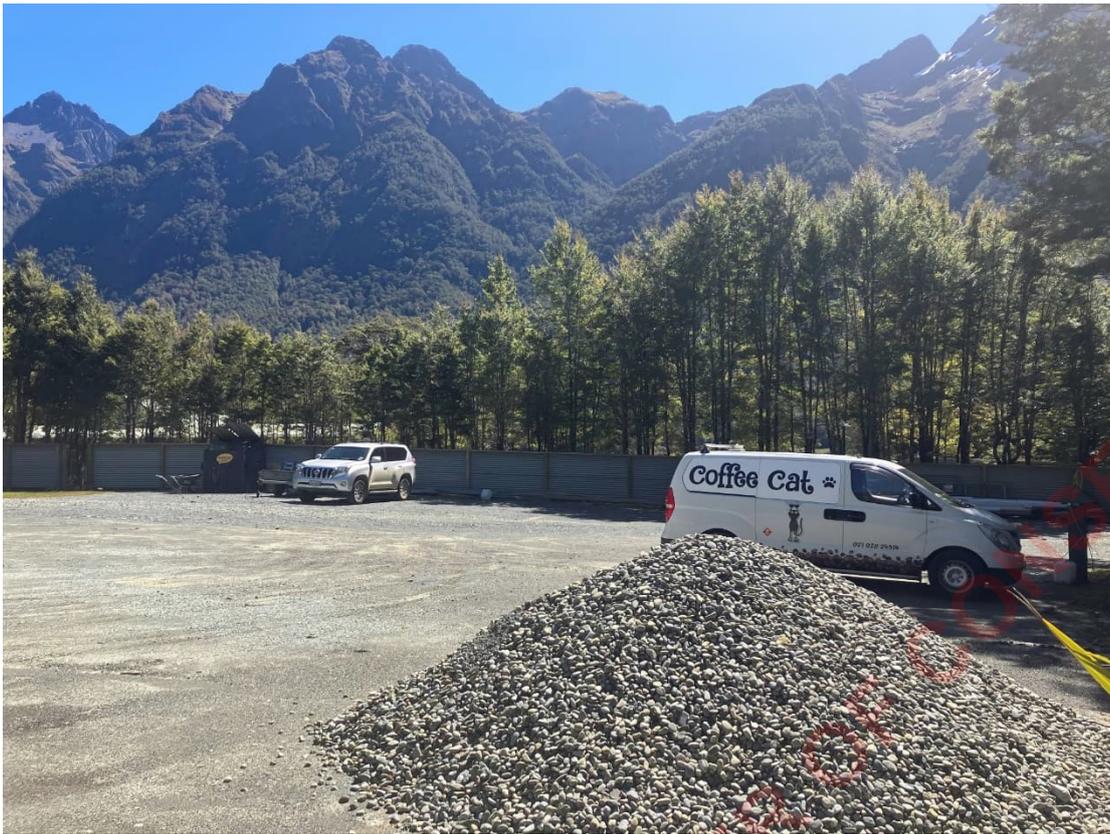
Photograph 4: Knobs Flat Te Huakaue parking lot with gravel stockpile

- GeoSolve's report, site visit and photographs indicate that the site has been disturbed by historical construction and earthworks. It is likely that uncontrolled fill has been placed over alluvial fan deposits, such as the parking lots. The site will also likely have deposits from the Kiosk Creek, which passes close to the east and north sides of the site. See Photograph 4 below.

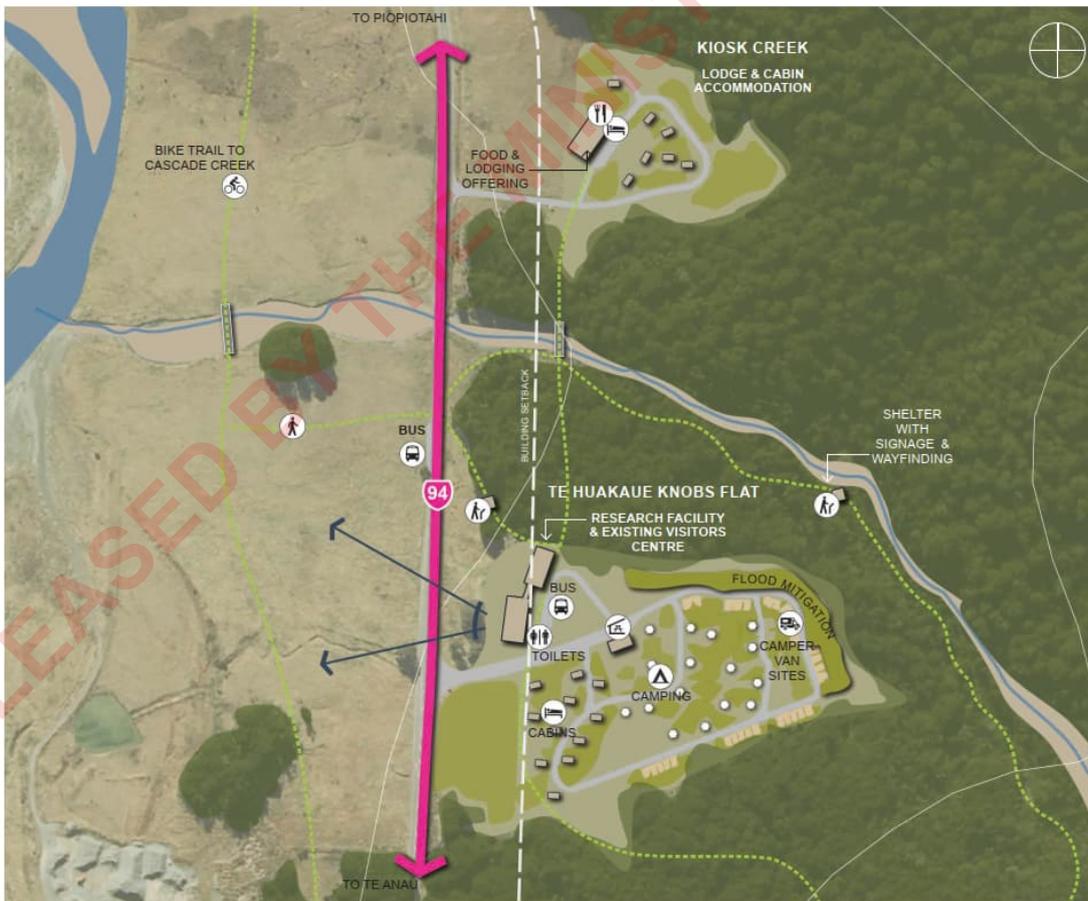
Figure 9: Conceptual plan for Knobs Flat Te Huakaue & Kiosk Creek<sup>3</sup>

- The Masterplan structures listed at this site are an accommodation expansion, modifications to the camping and campervan layout, new accommodation at Kiosk Creek Te Huakaue and trail head facilities (refer Figure 9).
- Elevation: The site ranges from approximately 360 m to 370 m ASL.
- Closest active fault: Unnamed Fault, located approximately 6.5 km southeast of the site.

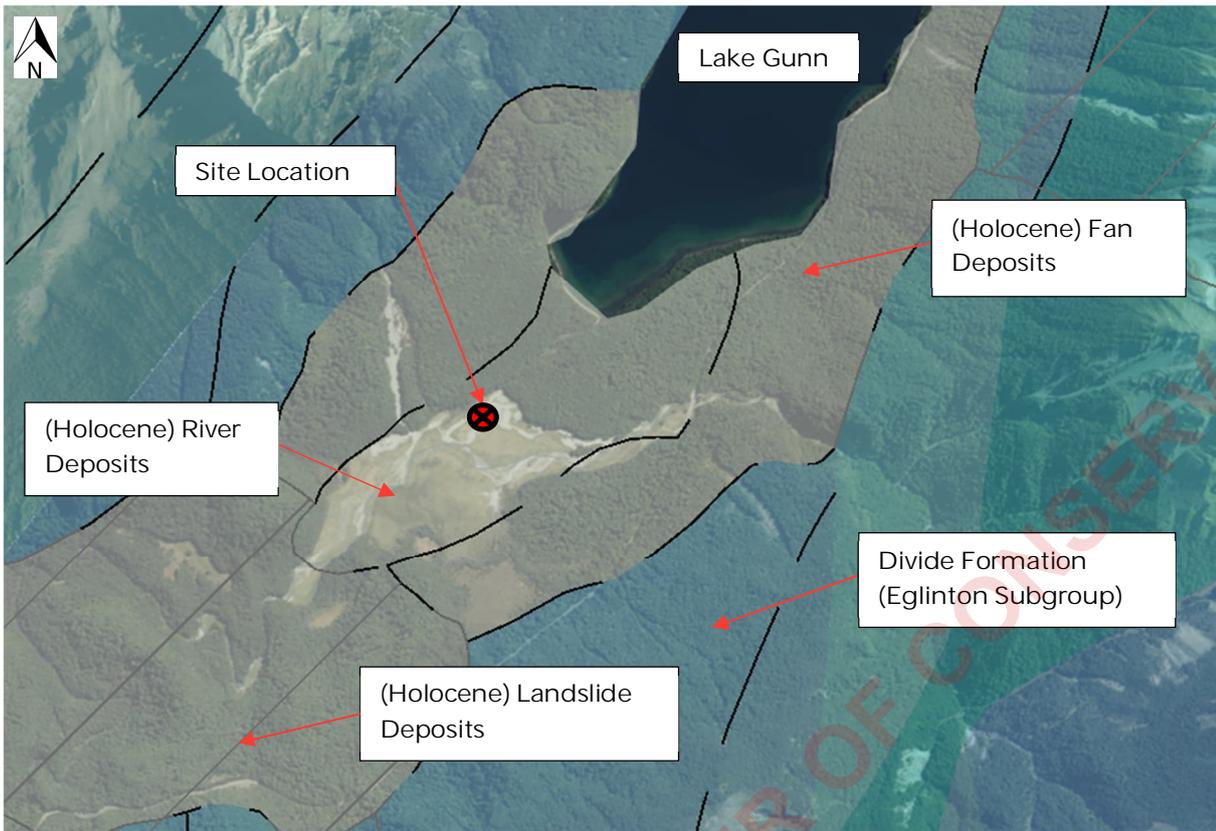
Figure 10: Ōtāpara Cascade Creek – Published Geology

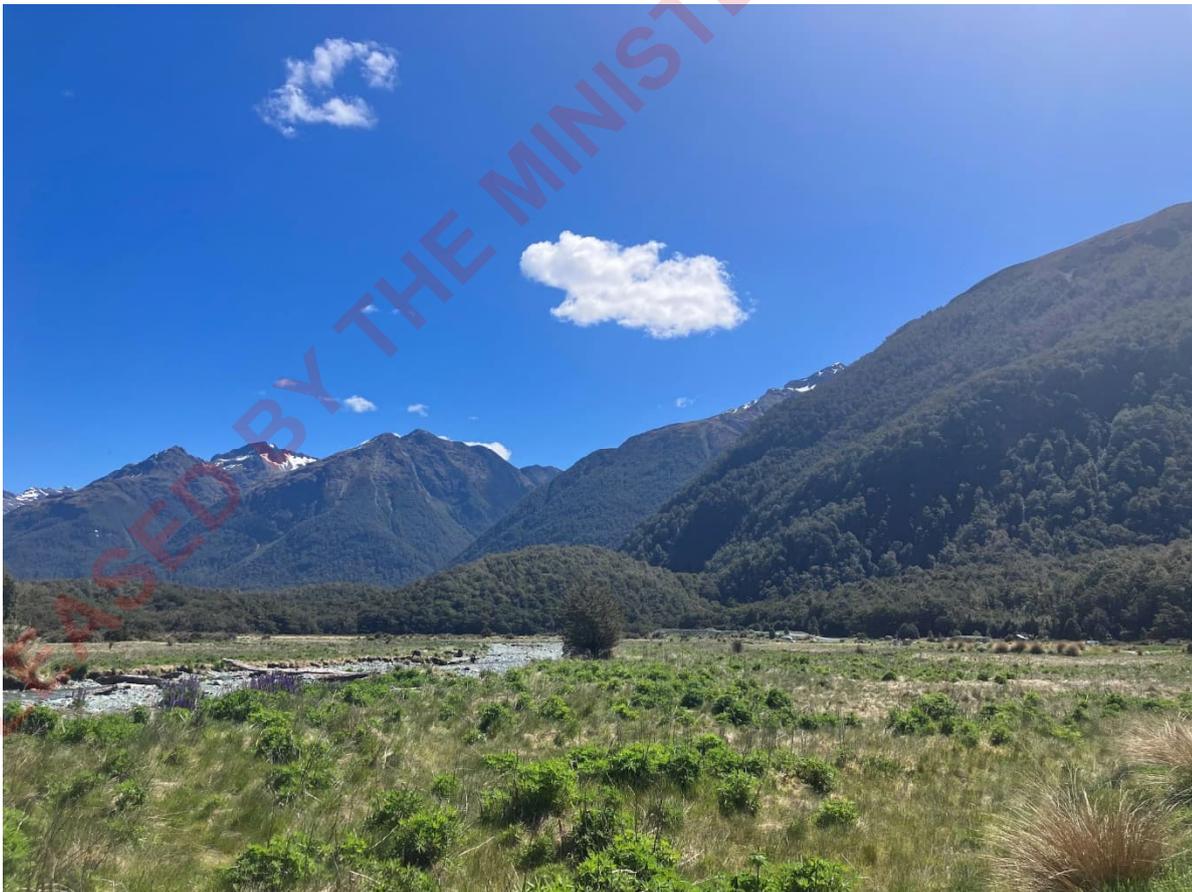
Photograph 5: Ōtāpara Cascade Creek looking south from the existing carpark

- Proximity to Ōtāpara Cascade Creek increases likelihood that the site has been inundated during flooding events. These previous events would have deposited new soils across the site. The site has flood mitigation bunds installed around the Ōtāpara Cascade Creek camp site. At this time no records were available for works completed on site. See Photograph 5 below.

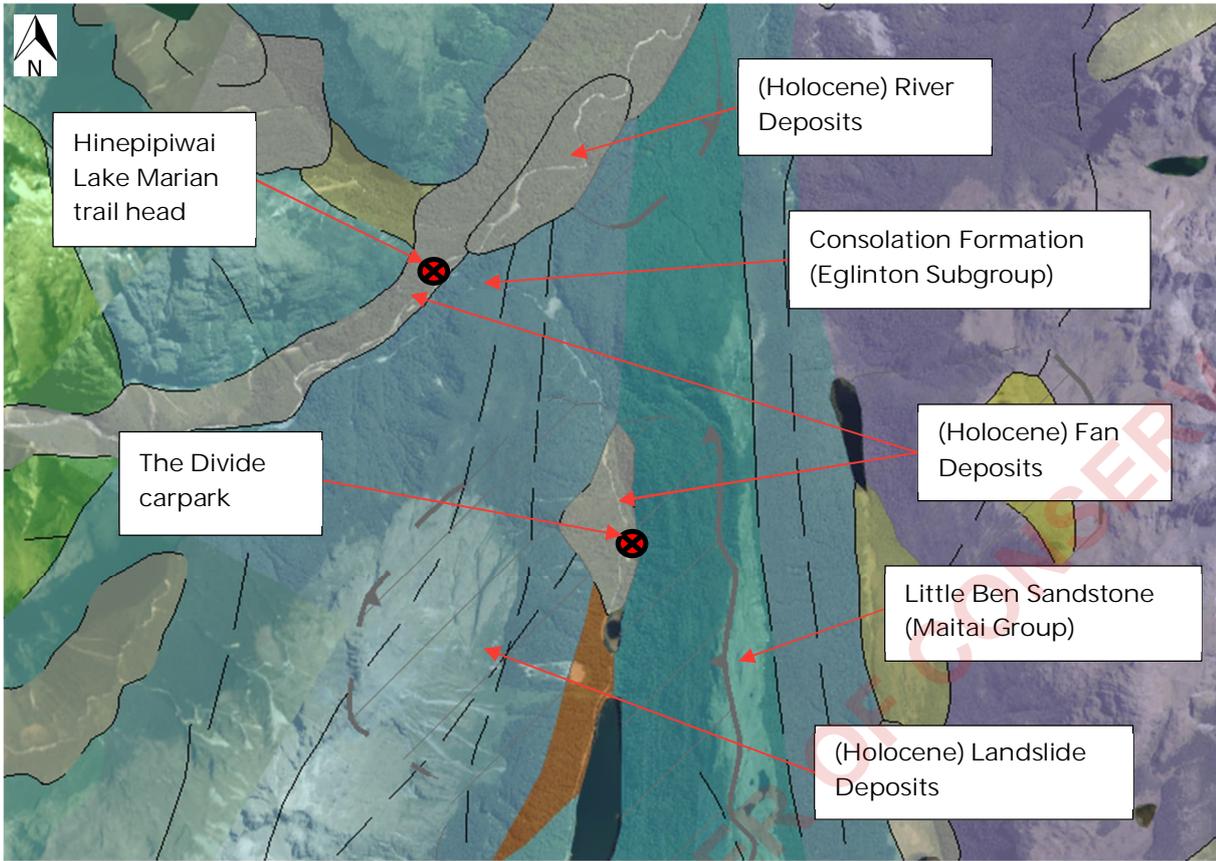
Figure 11: The Divide / Hinepiwai Lake Marian Trails head – Published Geology

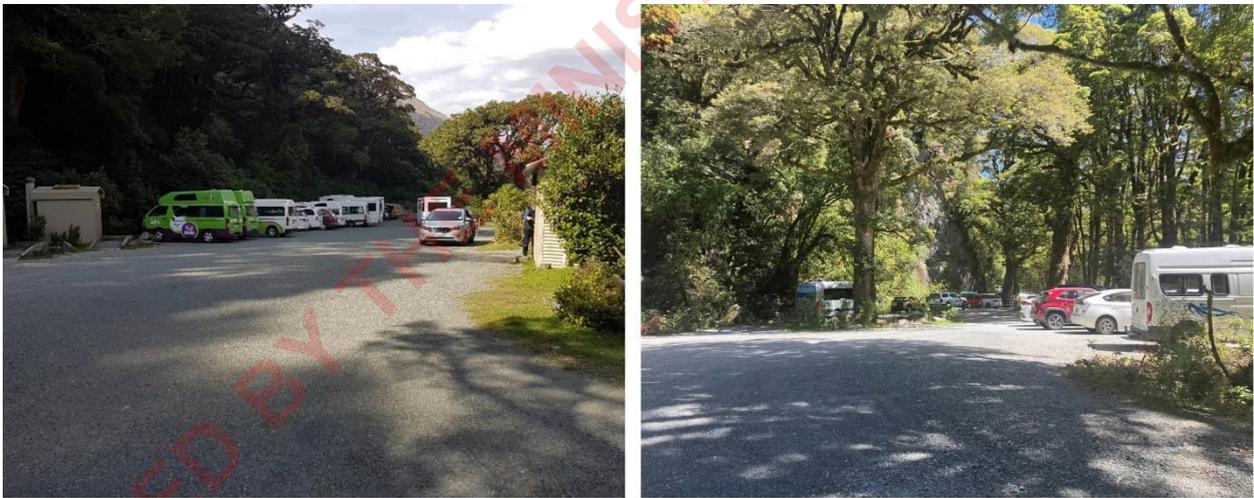
Photograph 6: The Divide carpark (left) and Lake Marian trails head carpark (right)

- Site visit and photographs indicate the site soils are likely fan deposits. The site is also likely to have been disturbed during the construction of the carpark and current structures at site and fill is likely to have been placed on the site. At this time no records were available for the placement of the fill. See Photograph 6 below.

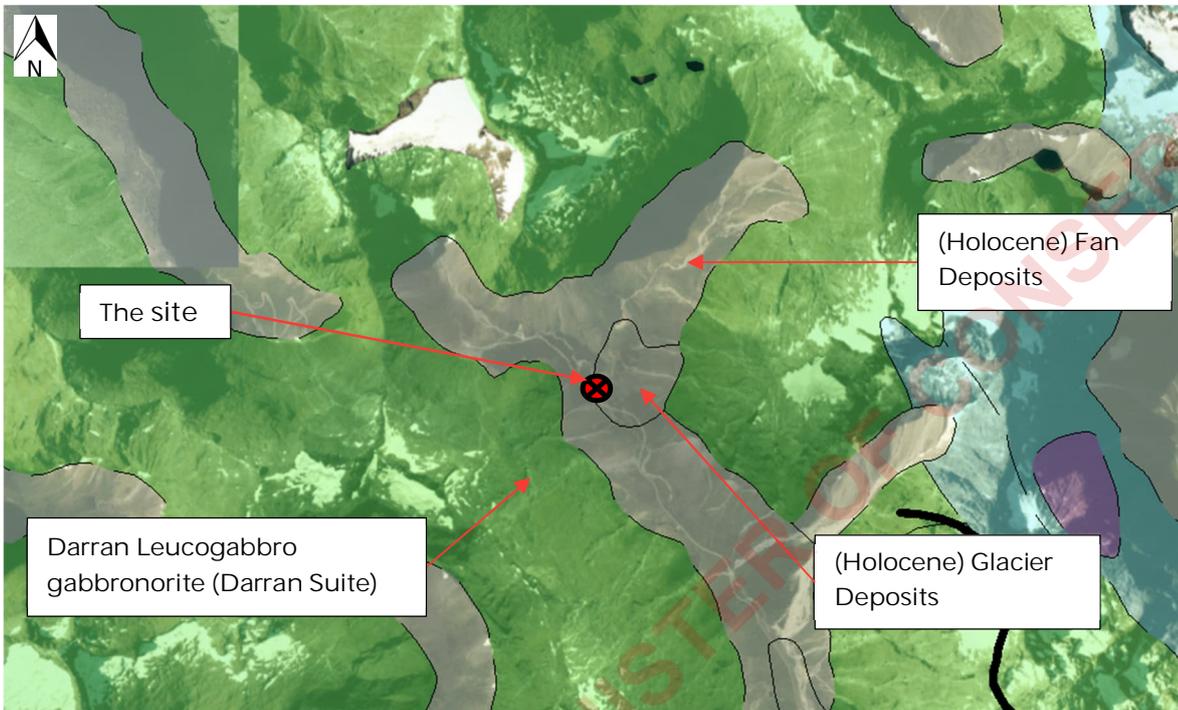
Figure 12: Gertrude Valley – Published Geology

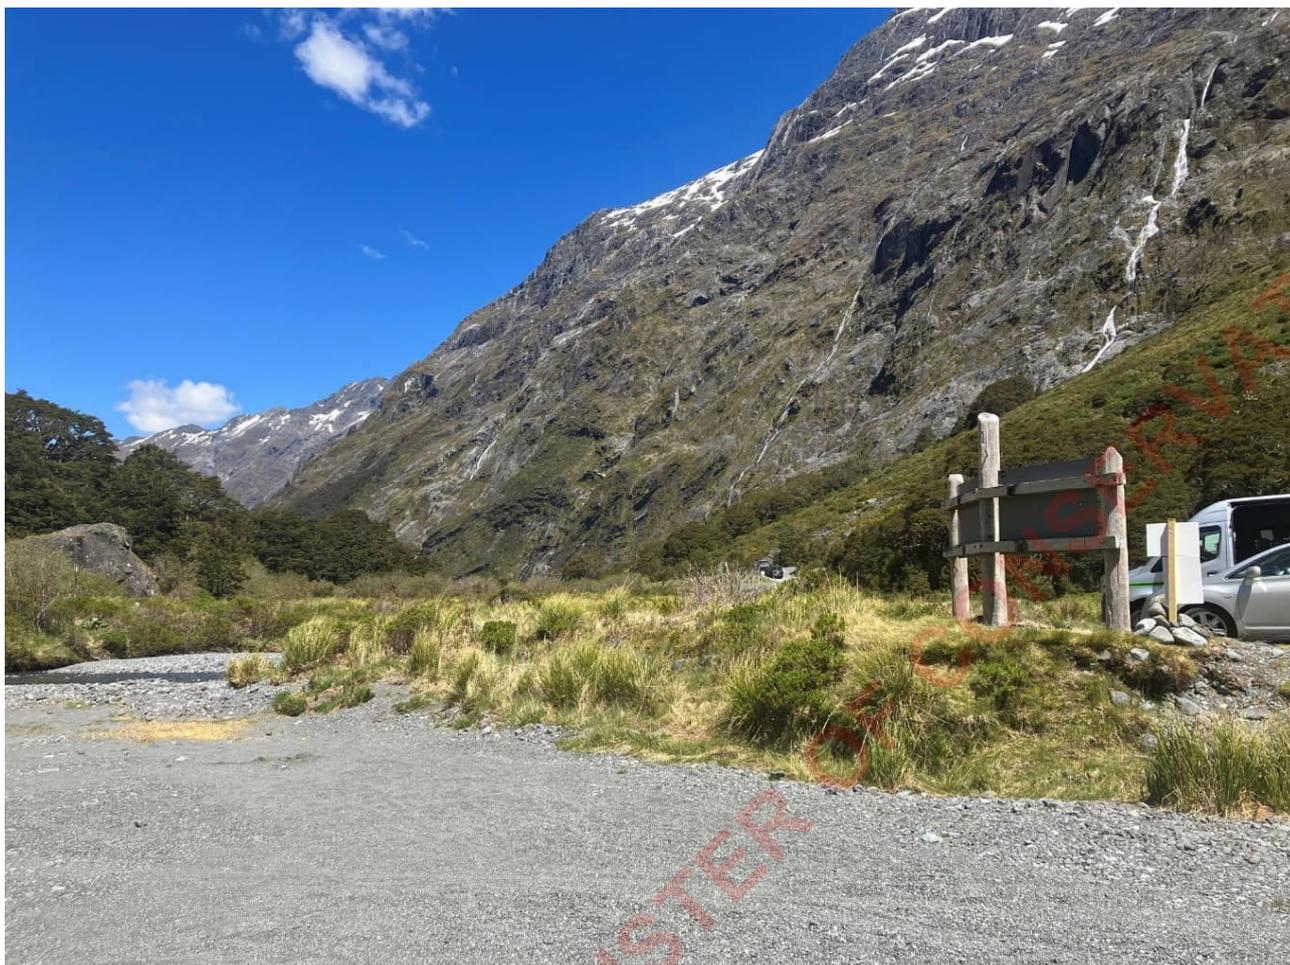
Photograph 7: Gertrude Valley looking southwest from the proposed location

- Environment Southland Liquefaction Risk Map: Site is located on the boundaries of Negligible and Low Risk zones. Note mapping completed between 2006 and 2012. Data may be outdated under current liquefaction assessment techniques.
- Site visit and photographs indicate that the site is likely to be underlain by glacier deposits, with gravel visible at the surface and a stream reworking coarse alluvial sediments up to cobble sized, see Photograph 7 below.

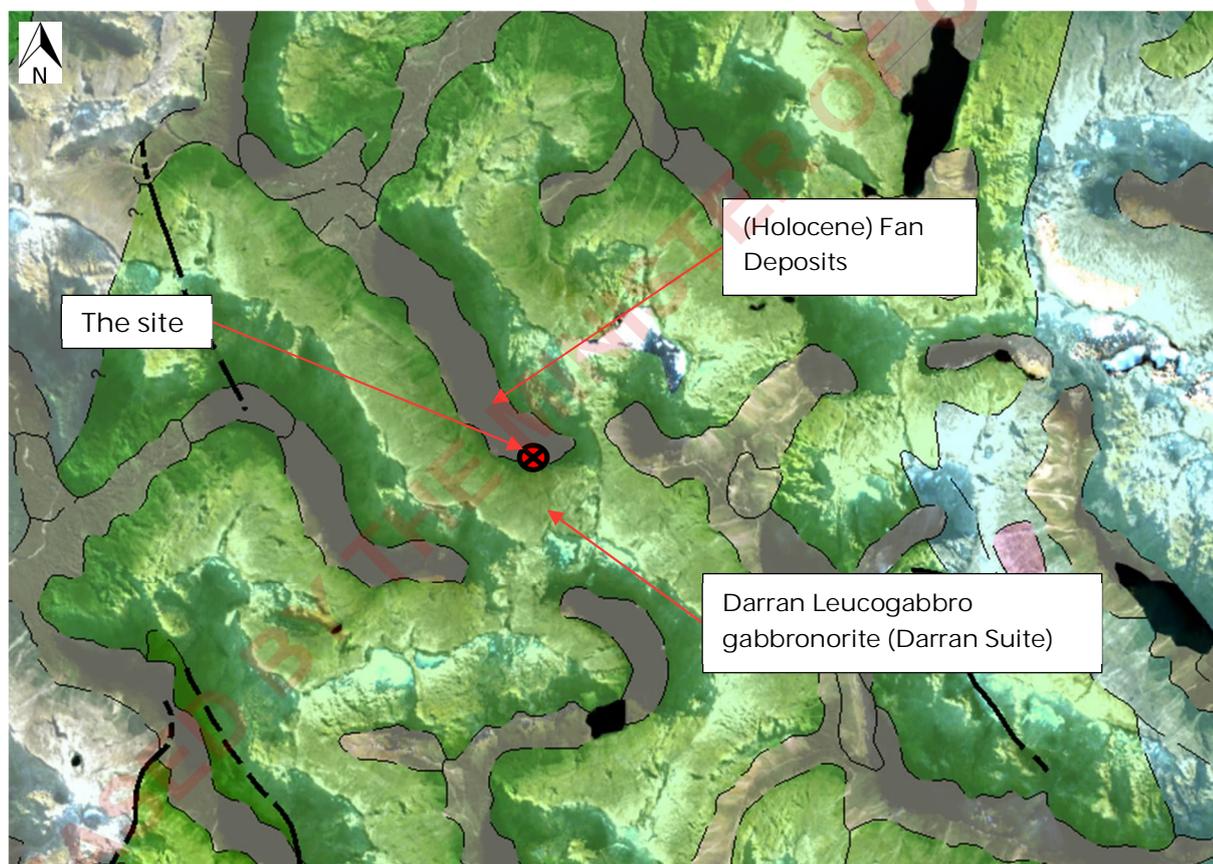
Figure 13: Cleddau Cirque – Published Geology

- Elevation: The site is approximately 730 m ASL.
- Closest active fault: Unnamed Fault #9214, located approximately 11.5 km east of the site.
- Geological Map Information: Site is located on the boundary between the following two geological units, one covering the northern side of the site and the other covering the southern side. See Figure 13 below.

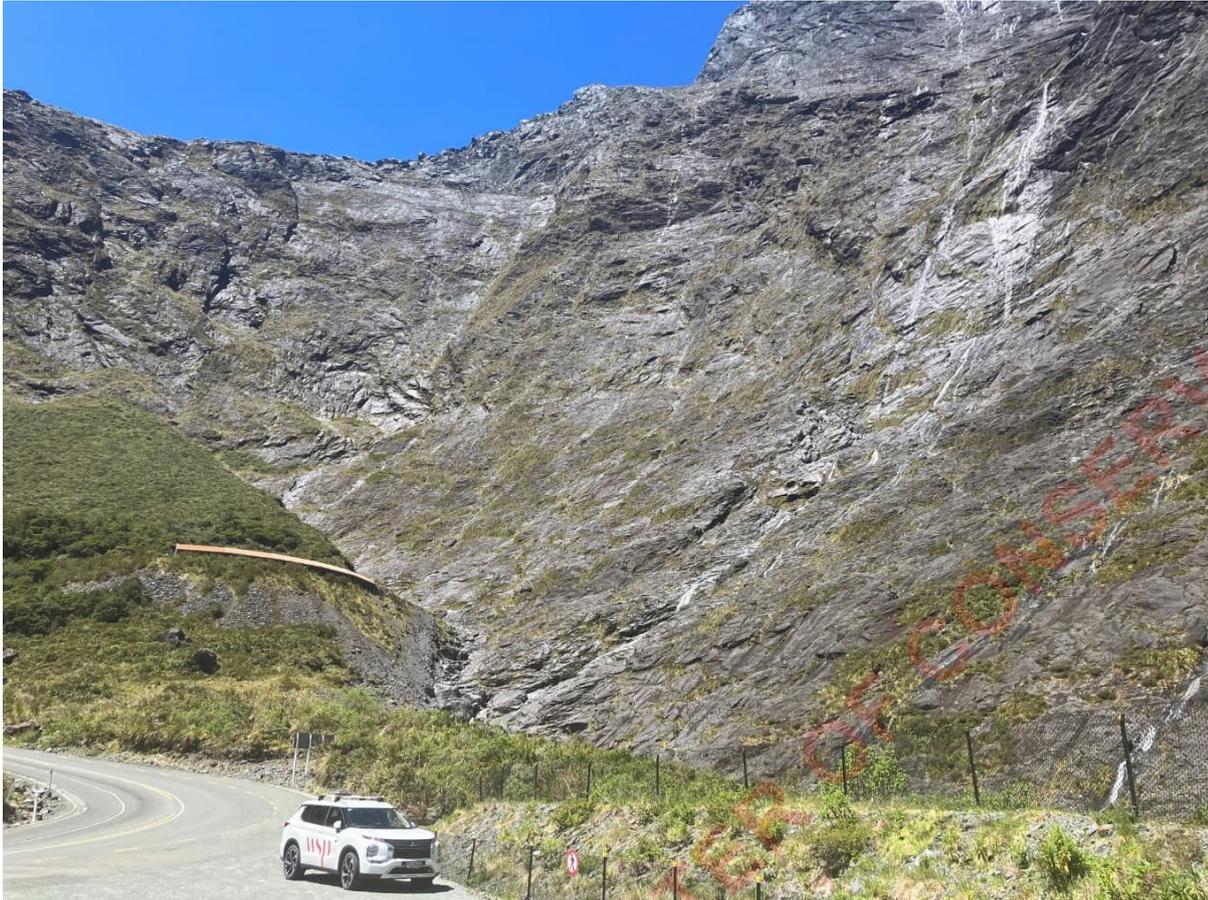
Photograph 8: Cleddau Cirque looking east from the existing carpark

- Site visit and photographs indicate that the site soils are likely a mix of alluvial deposits and rockfall debris. The site has a rockfall protection bund constructed to protect the road and carpark, see Photograph 8 below.

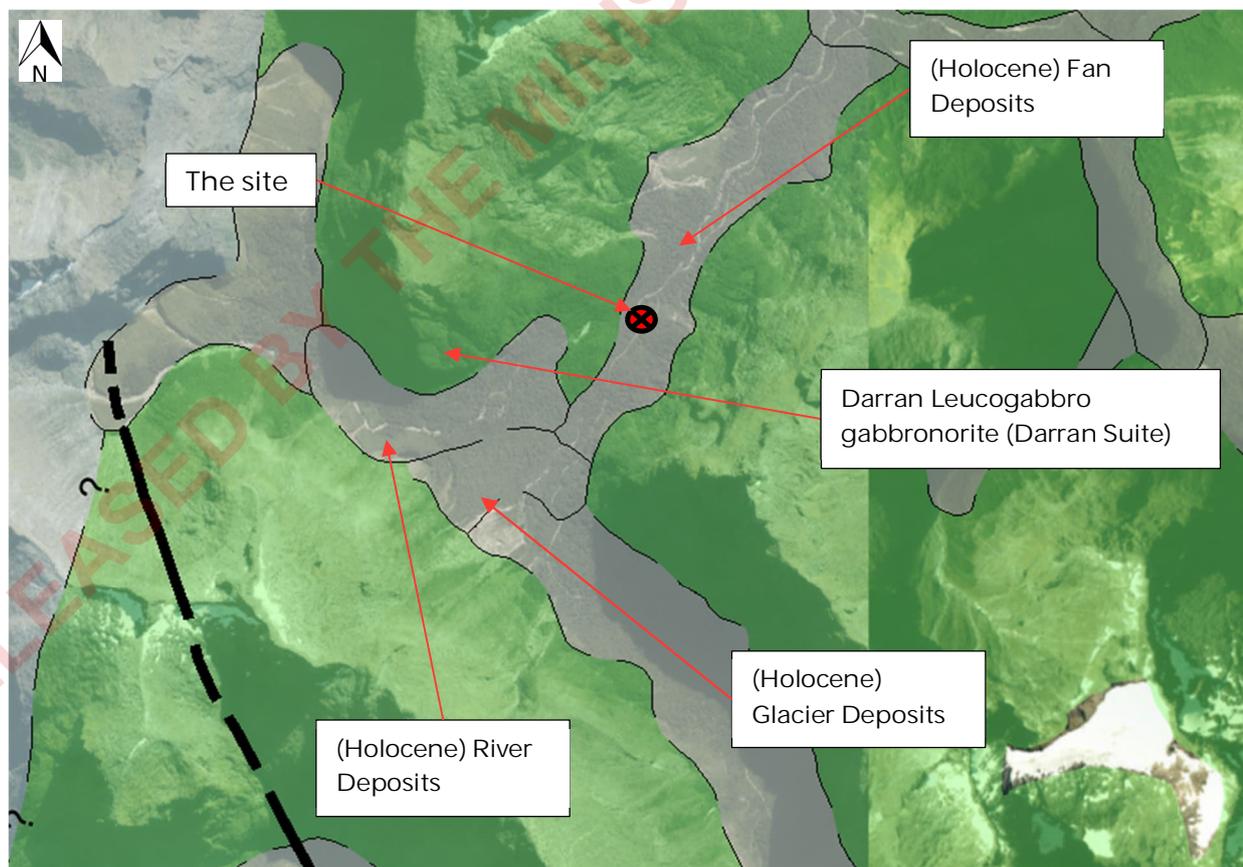
Figure 14: Short Stop: The Chasm – Published Geology

- The Masterplan structures listed at this site are carpark upgrades, a bus shelter, and toilet facilities.
- Elevation: The site is approximately 210 m ASL
- Closest active fault: Unnamed Fault #9213, located approximately 12.5 km east of the site.
- Geological Map Information: The site is located within the mapped geological unit: Holocene fan deposits (Loose, commonly angular, boulders, gravel, sand and silt forming modern alluvial fans; may include debris flow and avalanche deposits). See Figure 14 below.
- Environment Southland Liquefaction Risk Map: Low Risk. Note mapping completed between 2006 and 2012. Data may be outdated under current liquefaction assessment techniques.
- Site visit and photographs indicate that the site is likely to be debris flow deposits, with the carpark seemingly built on a cut and fill bank of debris above the floor of the valley.

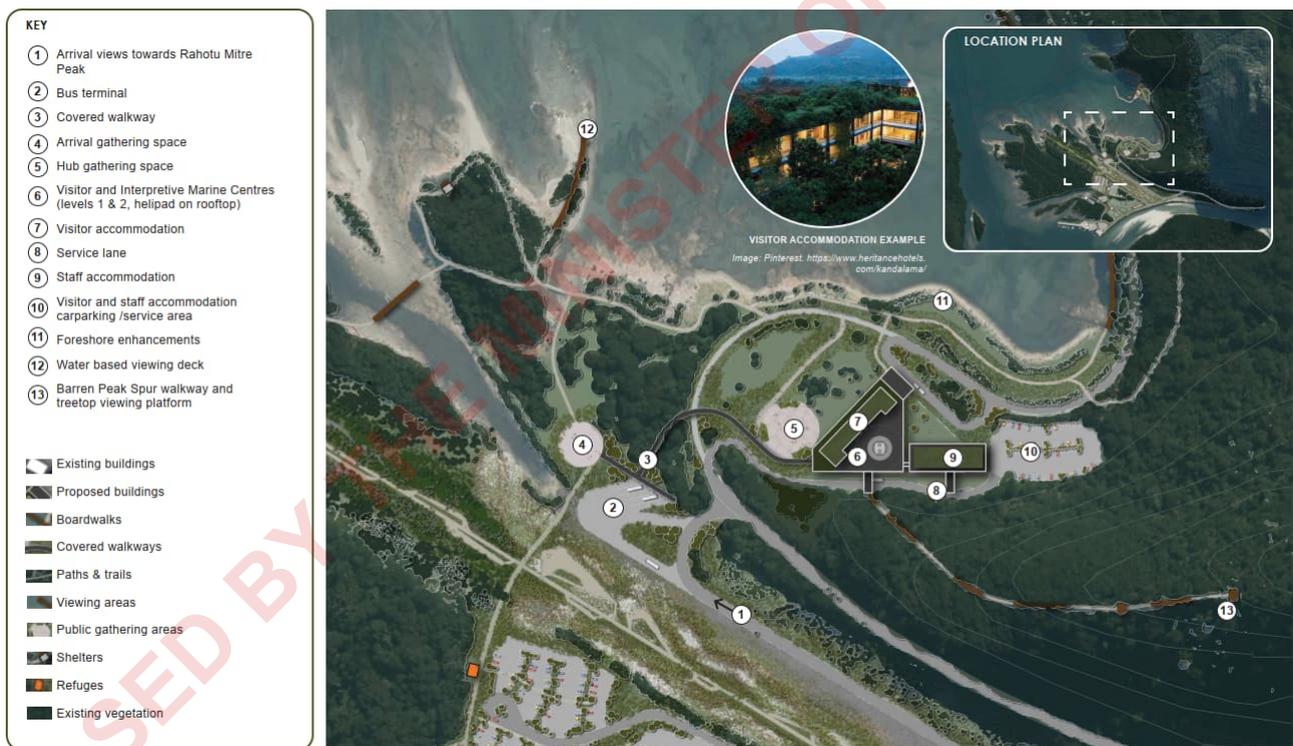
Figure 15: Masterplan Milford Sound Piopiotahi Visitor Hub Concept Layout

- The Masterplan structures listed at this site are new visitor and staff accommodation, a visitor hub building, a bus terminal, carpark upgrades, a Barren Peak Spur treetop lookout, new covered walkways, and new foreshore engagements (viewing decks). See Figure 15 and Photograph 9 below.
