Milford Opportunities

# MILFORD OPPORTUNITIES PROJECT GEOTECHNICAL FEASIBILITY

24 APRIL 2024

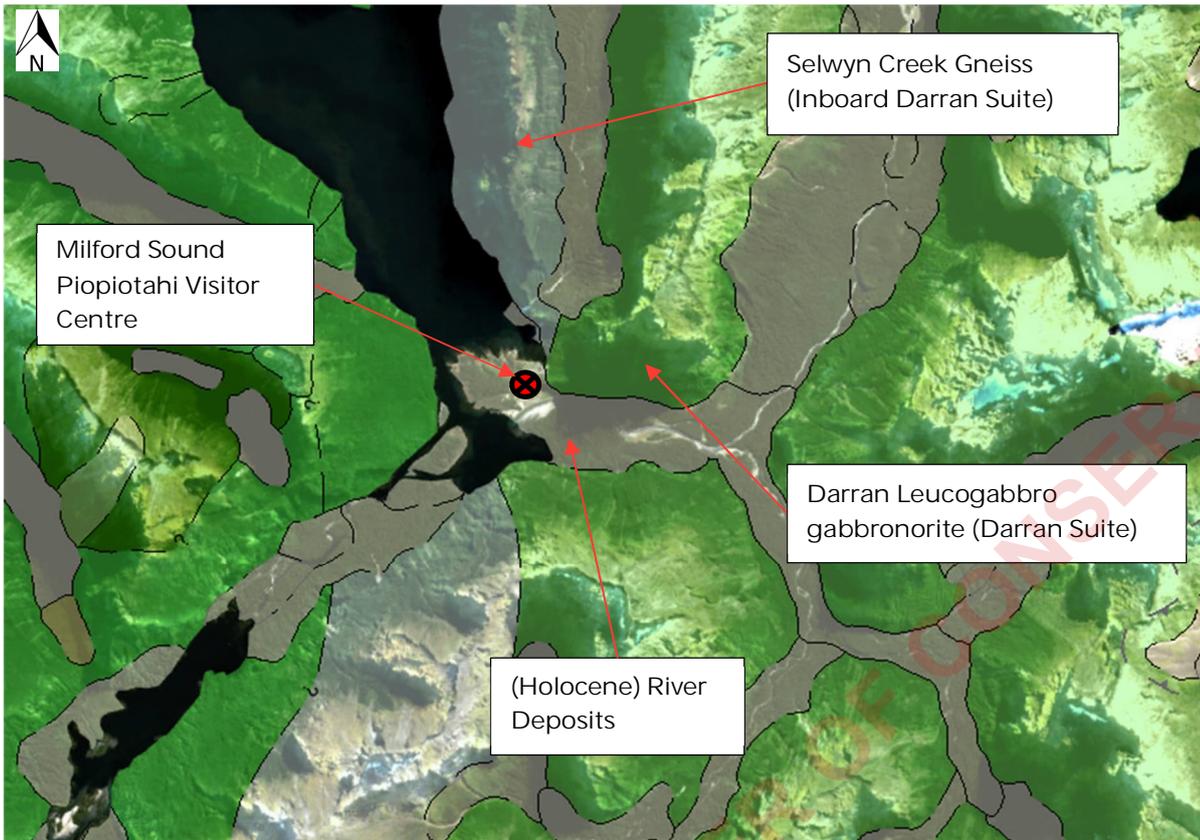
Figure 16: Milford Sound Piopiotahi Visitor Hub – Published Geology

- Elevation: The site is approximately 0 m – 5 m ASL
- Closest active fault: Anita Shear Zone #8756, located approximately 12 km west of the site.
- Geological Map Information: The site is located within the mapped geological unit: Holocene river deposits (Unweathered, loose, bouldery gravel, sand and mud in modern floodplains. Peat and carbonaceous mud bands may be interbedded). See Figure 16 below.

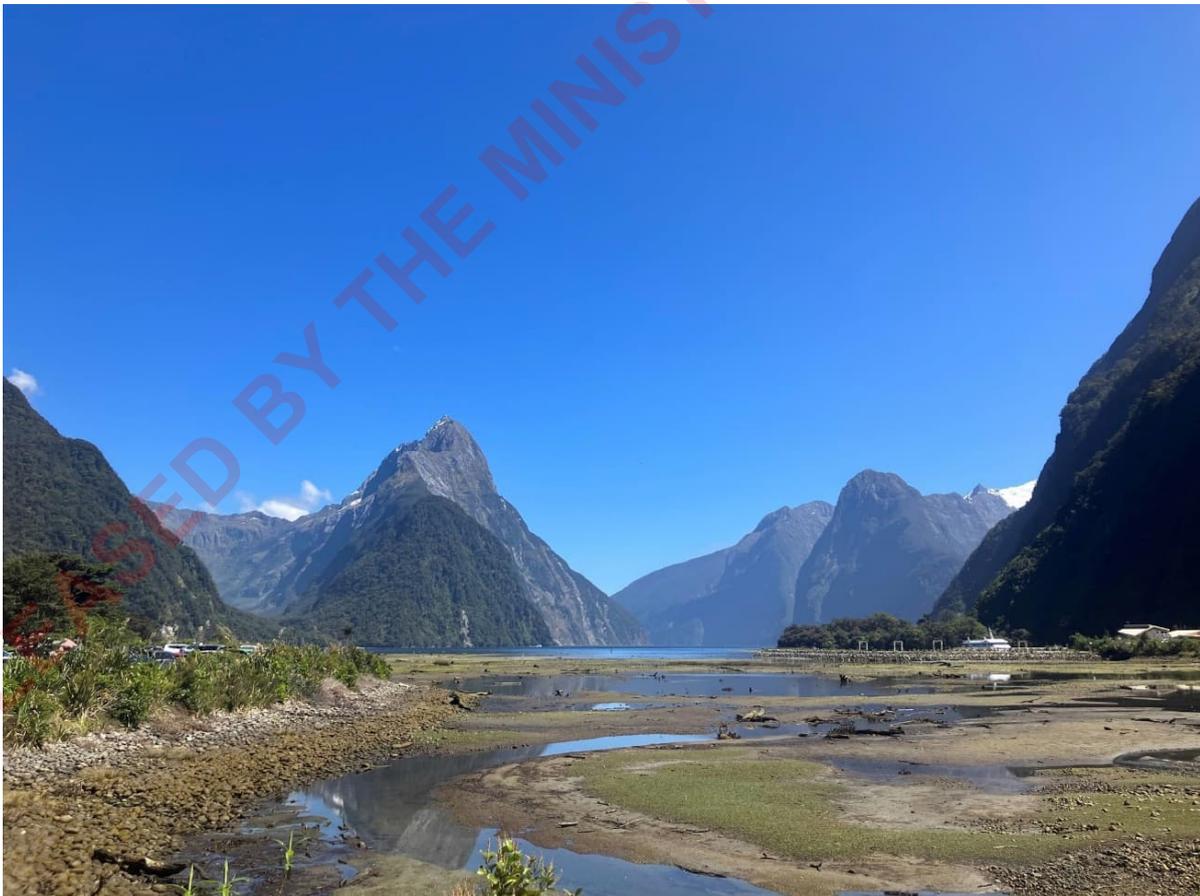
Photograph 9: Milford Sound Piopiotahi (Freshwater Basin) looking northwest from the foreshore carpark

- The Masterplan structures listed at this site are new visitor and staff accommodation, a visitor hub building, a bus terminal, carpark upgrades, a Barren Peak Spur treetop lookout, new covered walkways, and new foreshore engagements (viewing decks). See Figure 15 and Photograph 9 below.

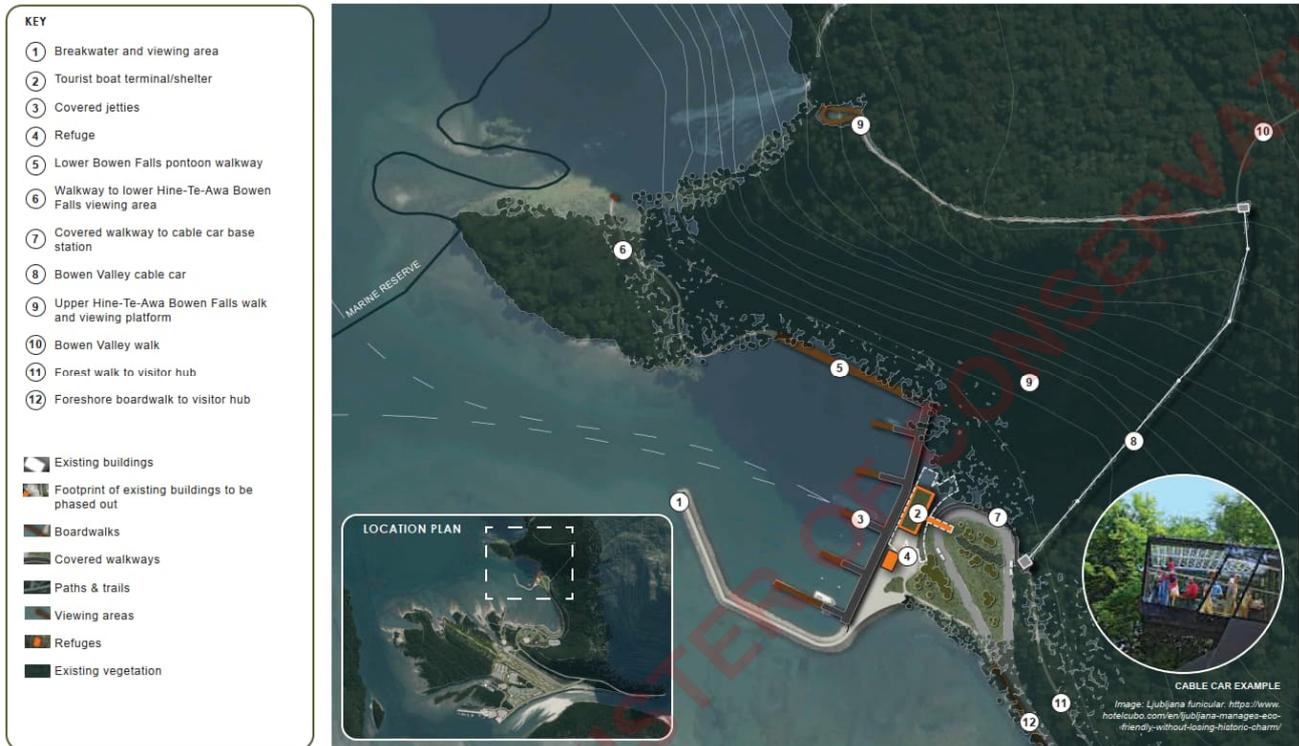
Figure 17: Masterplan Freshwater Basin Layout Concept

- The Masterplan structures listed at this site are Bowen Falls cable car, Bowen Falls/Valley walk, Bowen Falls viewing platforms, a pontoon walkway to access Bowen Falls, a refuge, and redevelopment of the boat terminal. See Figure 17 below.

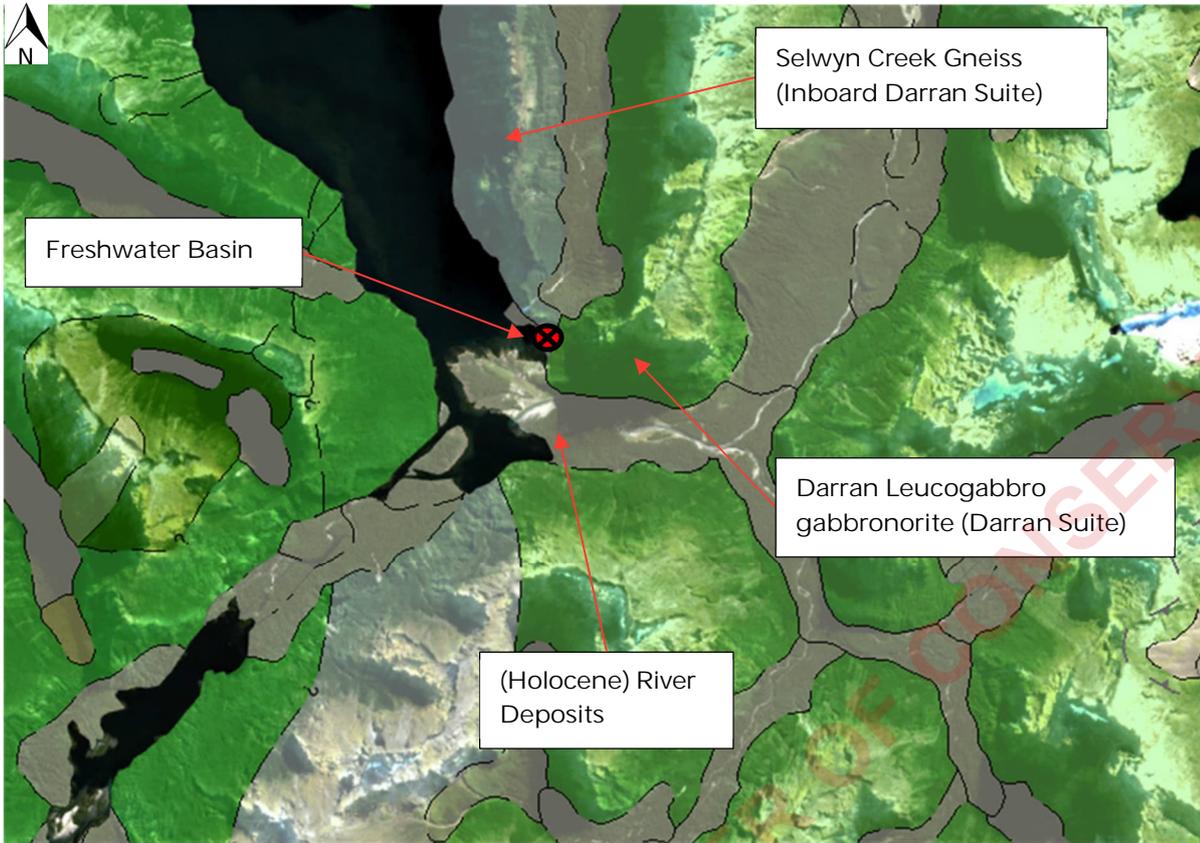
Figure 18: Freshwater Basin – Published Geology

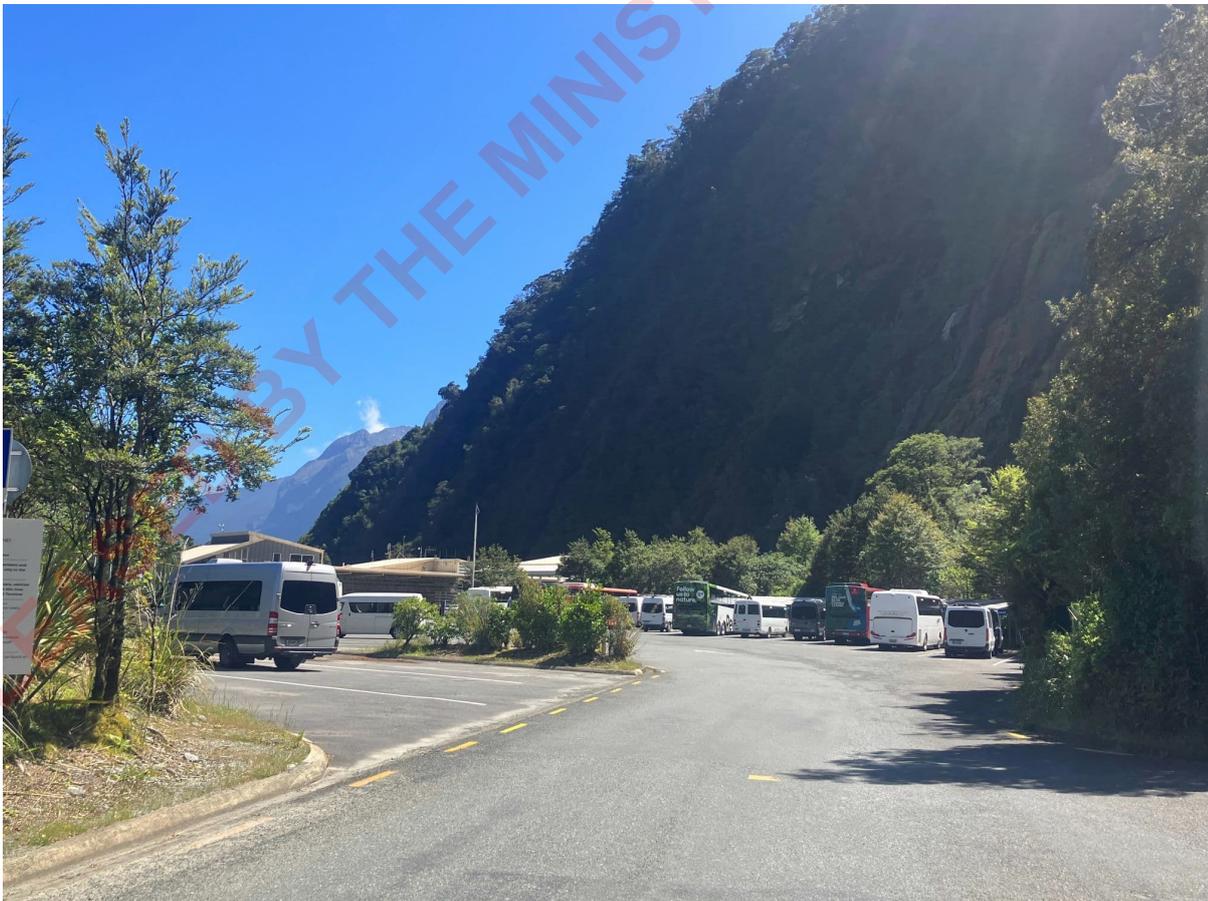
Photograph 10: Freshwater basin looking northwest from the existing carpark and visitor terminal

- Existing geotechnical investigation information (as per Section 2.11 Milford Sound Piopiotahi Visitor Hub) indicates that the site is likely to be underlain by uncontrolled fill of varying thickness with deltaic sediment and interbedded organic swamp deposit below, and gabbro bedrock at unknown depth. Depth to groundwater level is assumed to be approximately 2 m. See Photograph 10 below.

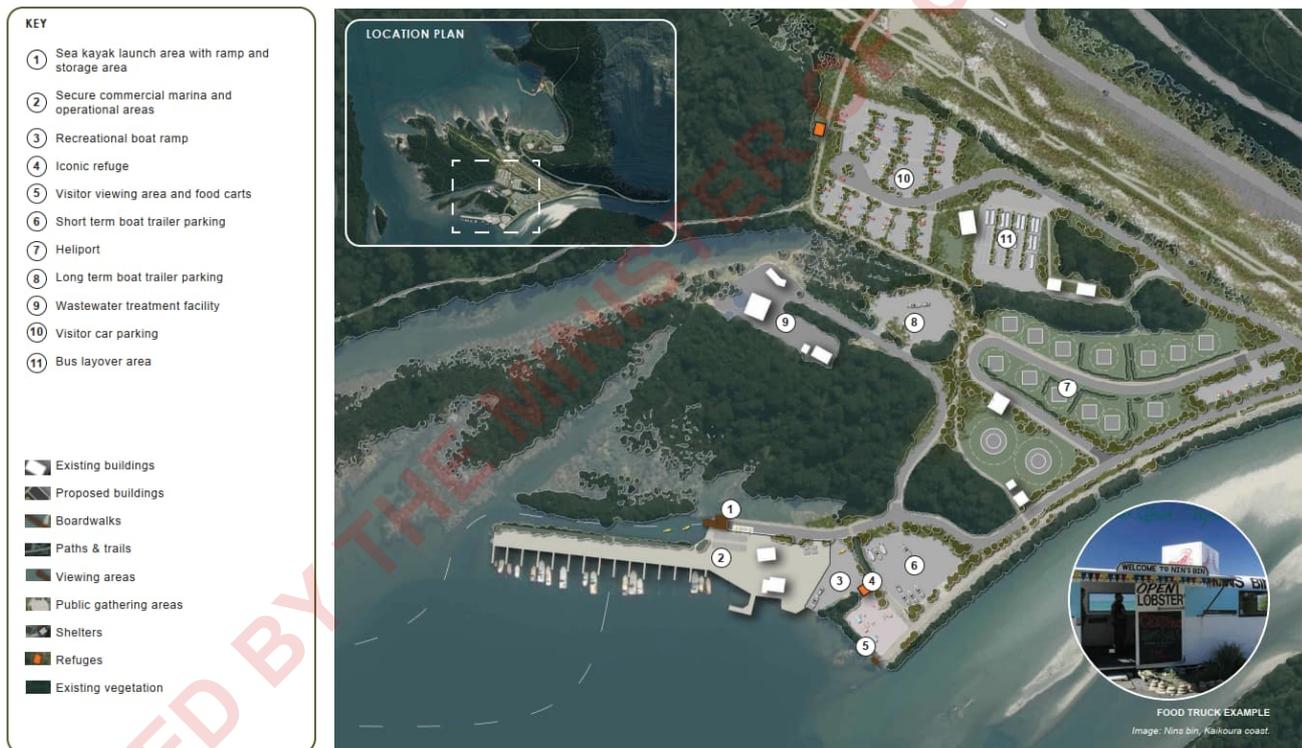
Figure 19: Masterplan Deepwater Basin Layout Concept

- The Masterplan structures listed at this site are carpark upgrades, redevelopment of the boat ramp, new facilities for kayaking, a refuge, and a heliport. See Figure 19 below.

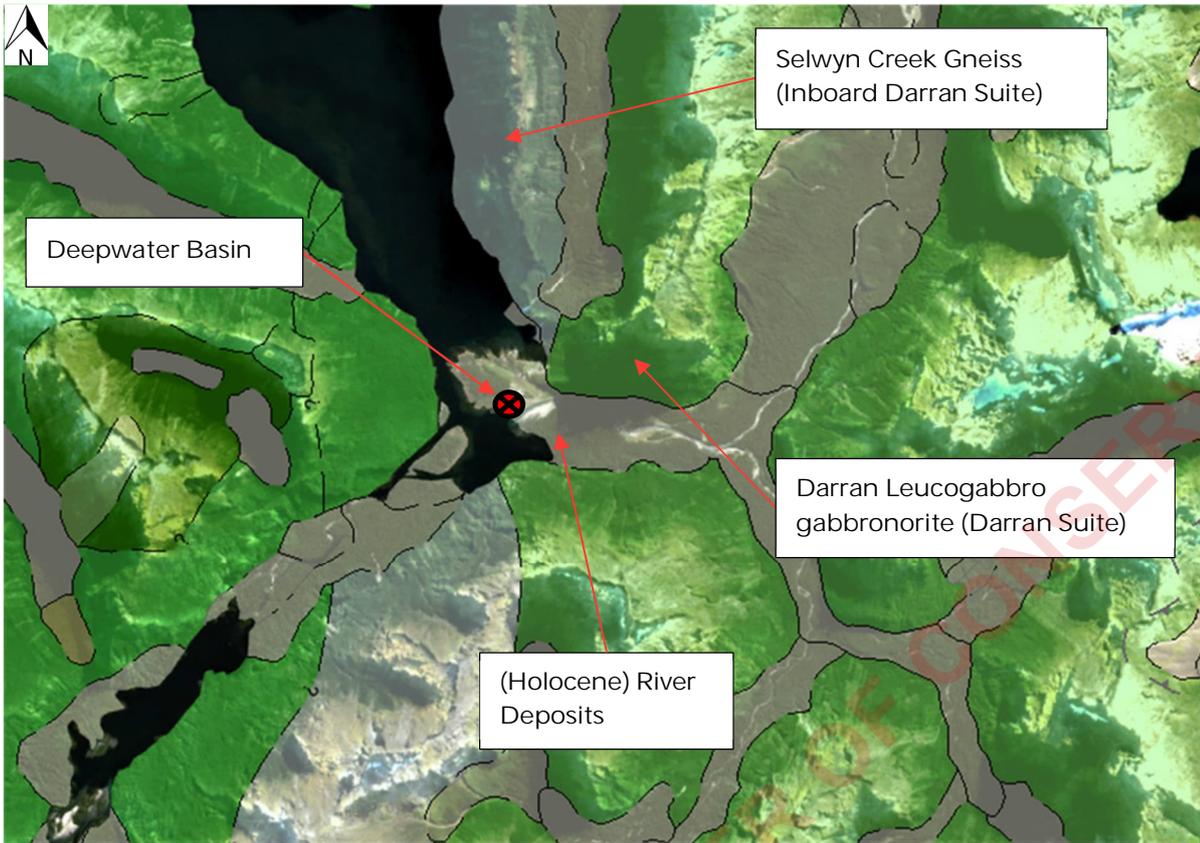
Figure 20: Deepwater Basin – Published Geology

- Elevation: The site is approximately 0 m – 5 m ASL.
- Closest active fault: Anita Shear Zone #8756, located approximately 12 km west of the site.
- Geological Map Information: The site is located within the mapped geological unit: Holocene river deposits (Unweathered, loose, bouldery gravel, sand and mud in modern floodplains. Peat and carbonaceous mud bands may be interbedded). See Figure 20 below.

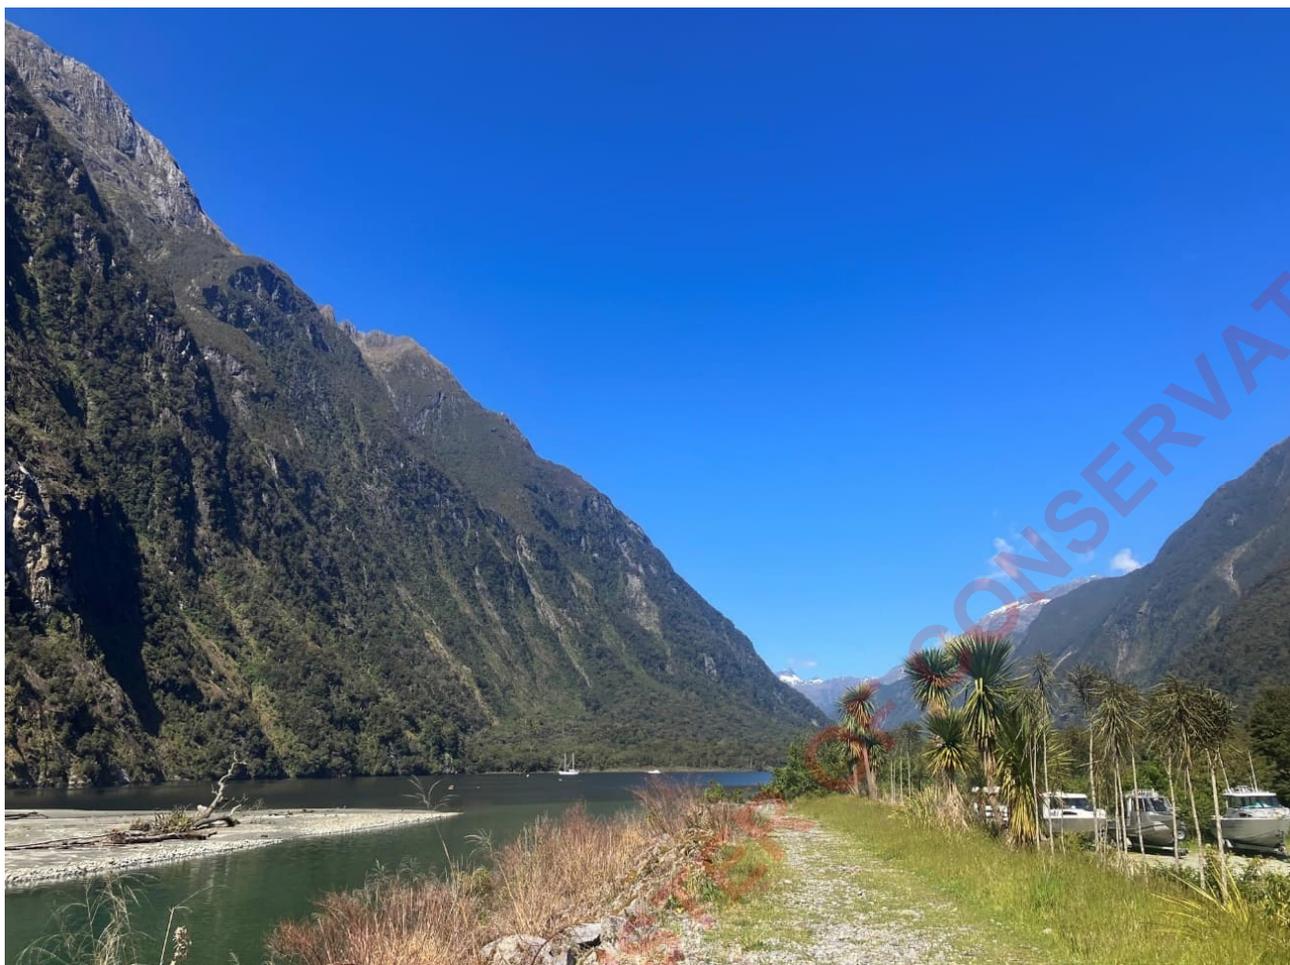
Photograph 11: Deepwater Basin looking southwest from the northern bank of the Cleddau River

- Based on the proximity of the Cleddau River and the likely soils, groundwater is assumed to be relatively shallow at approximately 2 m bgl. See Photograph 11 below.

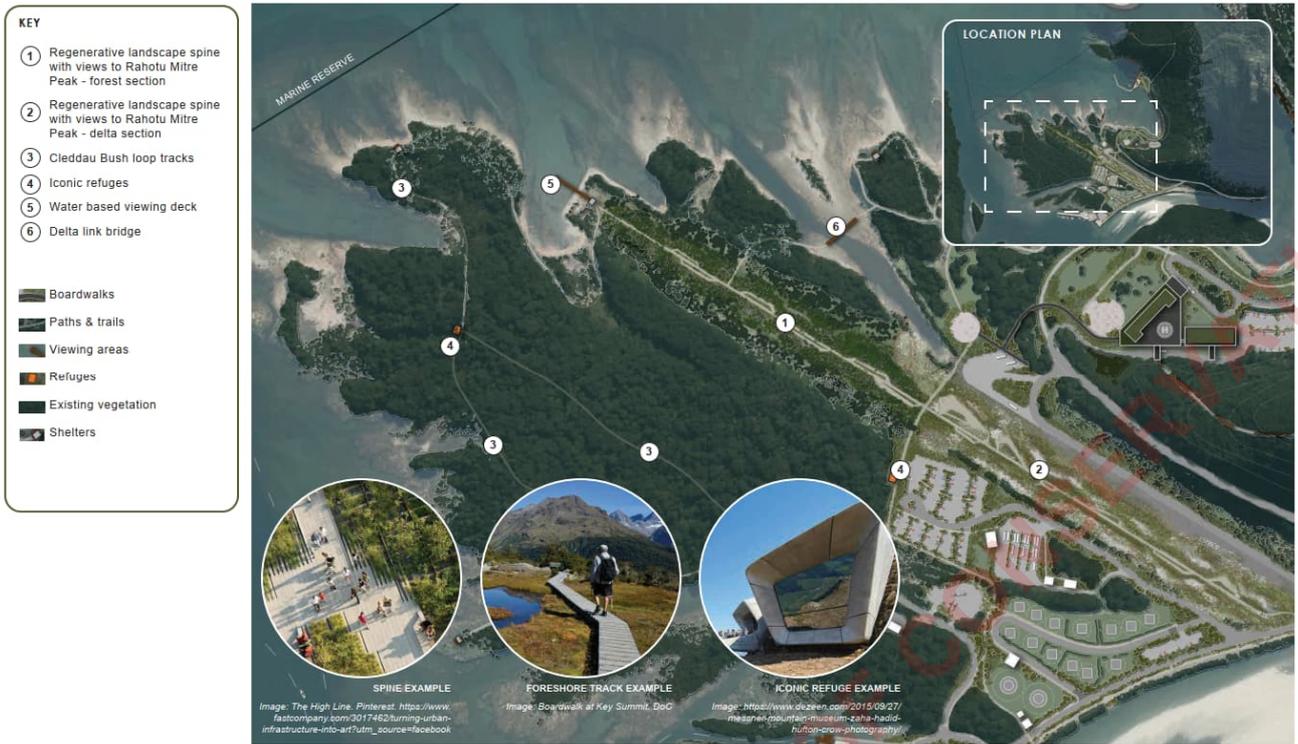
Figure 21: Masterplan Cleddau Delta Layout Concept

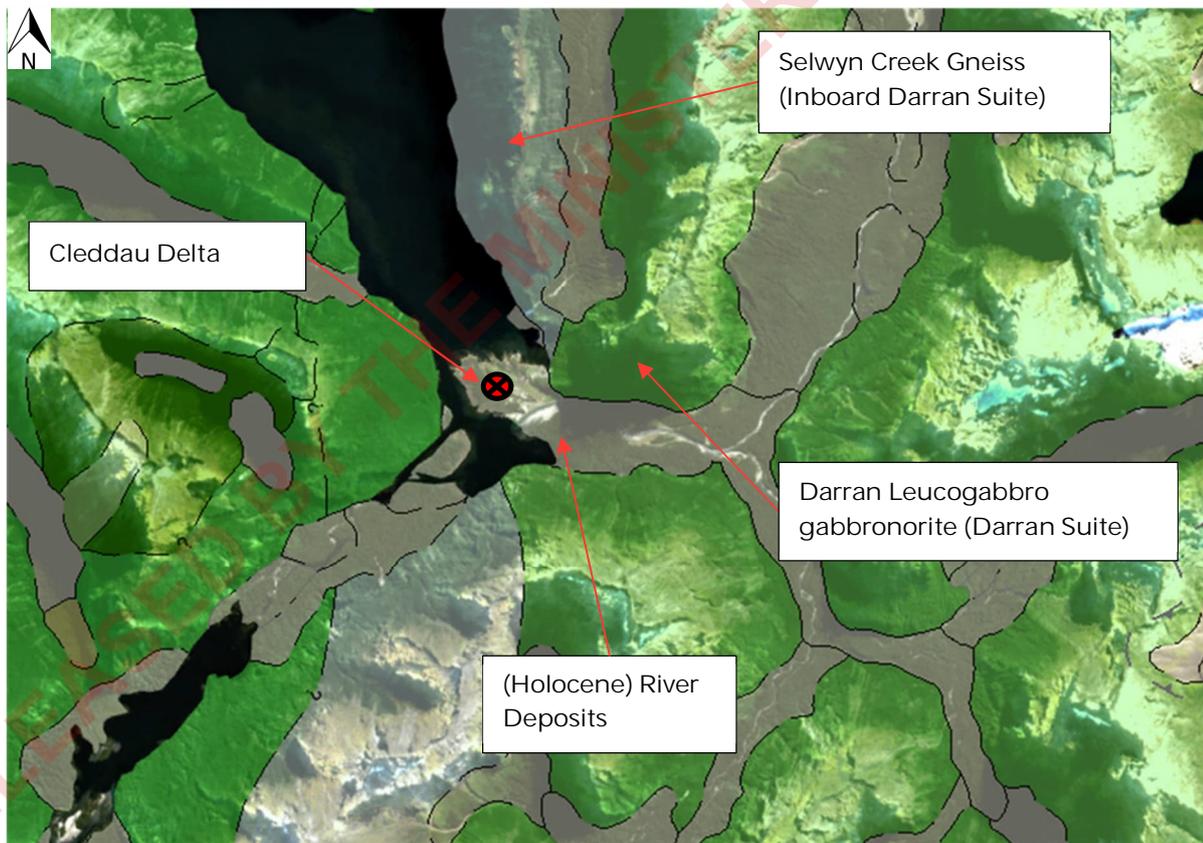
Figure 22: Cleddau Delta - Published Geology

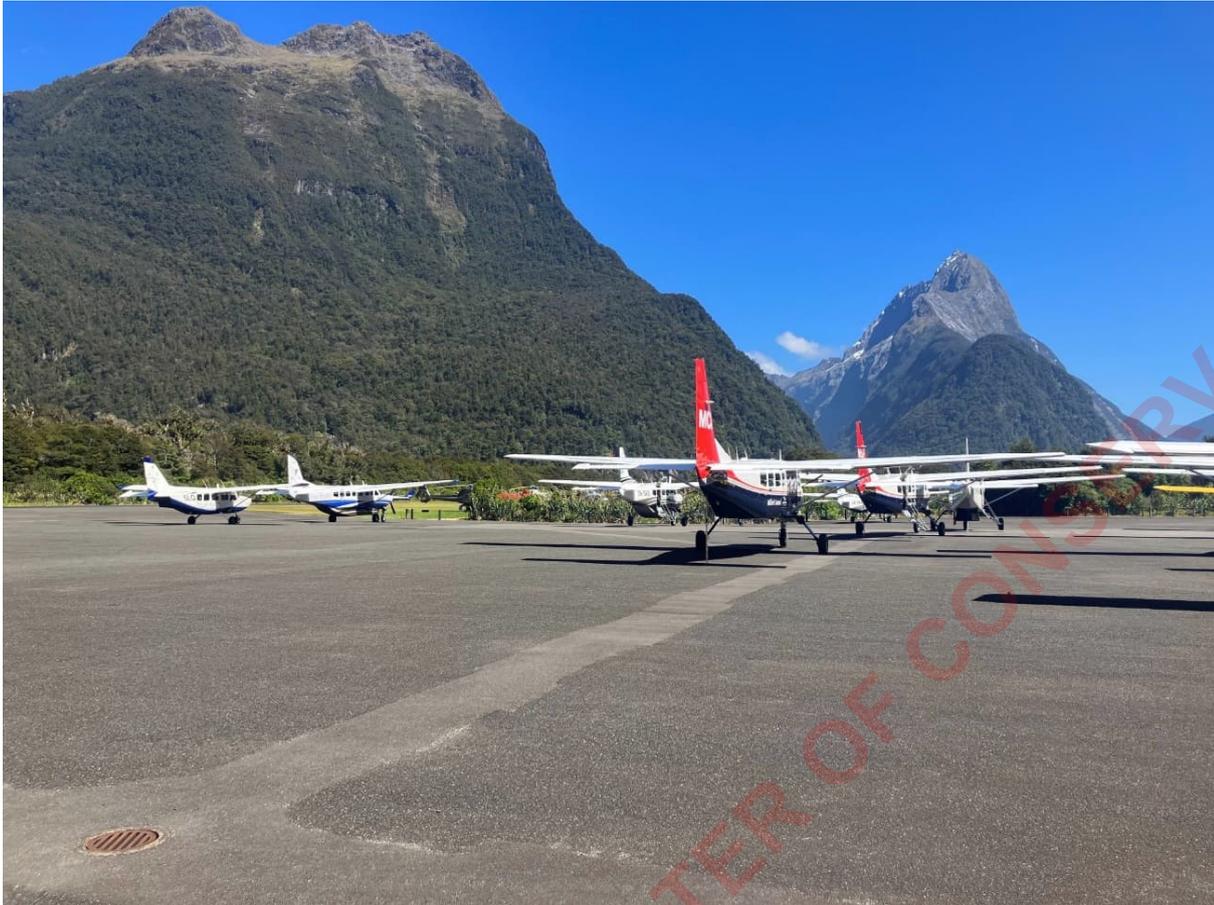
Photograph 12: Cleddau Delta looking west from the existing aerodrome aircraft parking area

- Existing geotechnical investigation information (as per Section 2.11 Milford Sound Piopiotahi Visitor Hub) indicates that the site is likely to be underlain by uncontrolled fill of varying thickness with deltaic sediment and interbedded organic swap deposit below, and gabbro bedrock at unknown depth. Groundwater level is assumed to be <2 m. See Photograph 12 below.

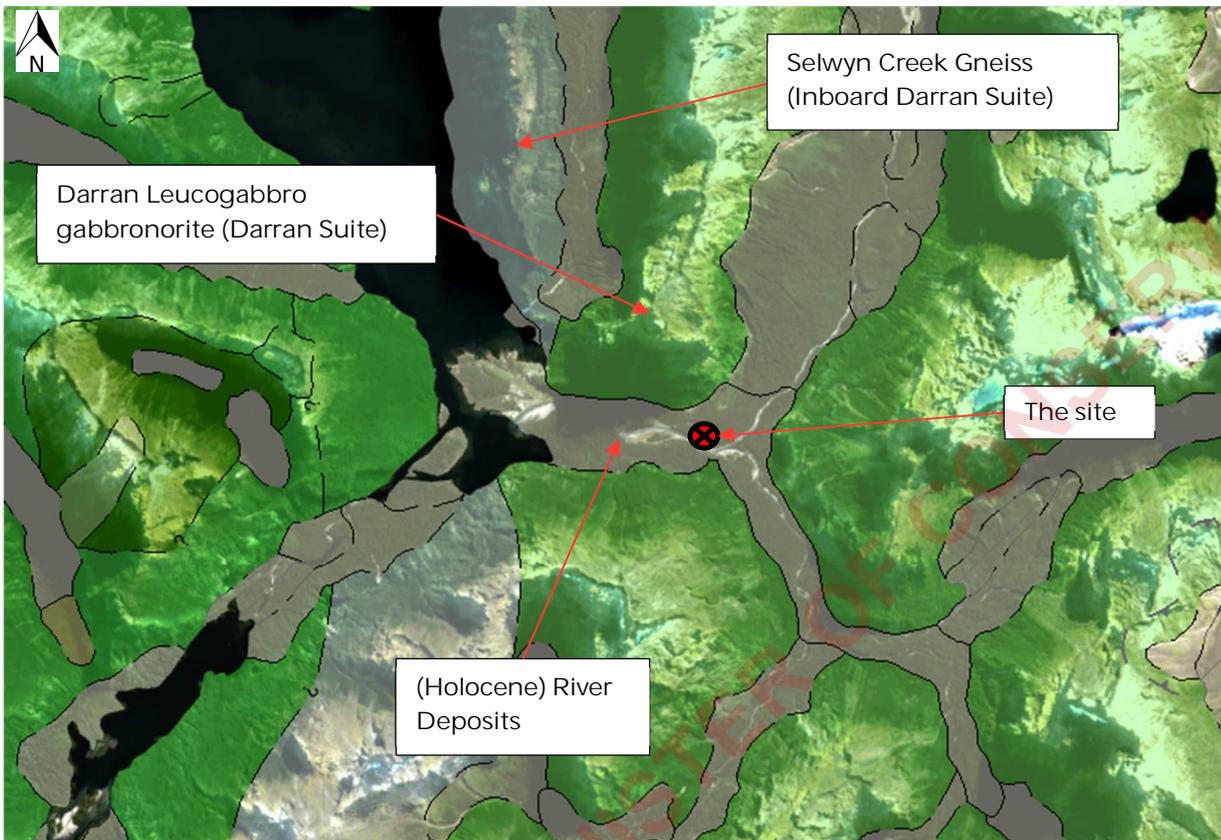
Figure 23: Little Tahiti – Published Geology

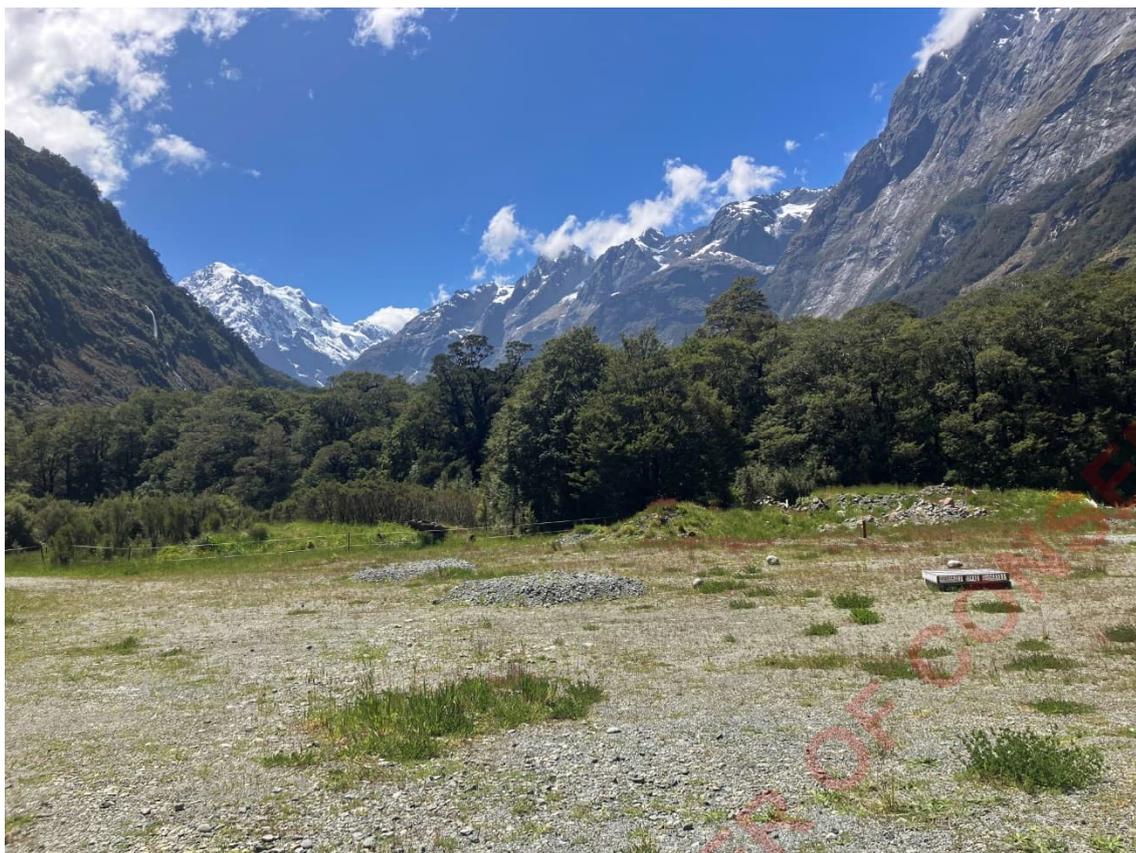
Photograph 13: Little Tahiti looking northeast from the southern end of the site

investigations) must consider the risk of soil and water contamination in their methodologies. Groundwater level is assumed to be 1 m -2 m bgl as per e3Scientific report. See Photograph 13 below.

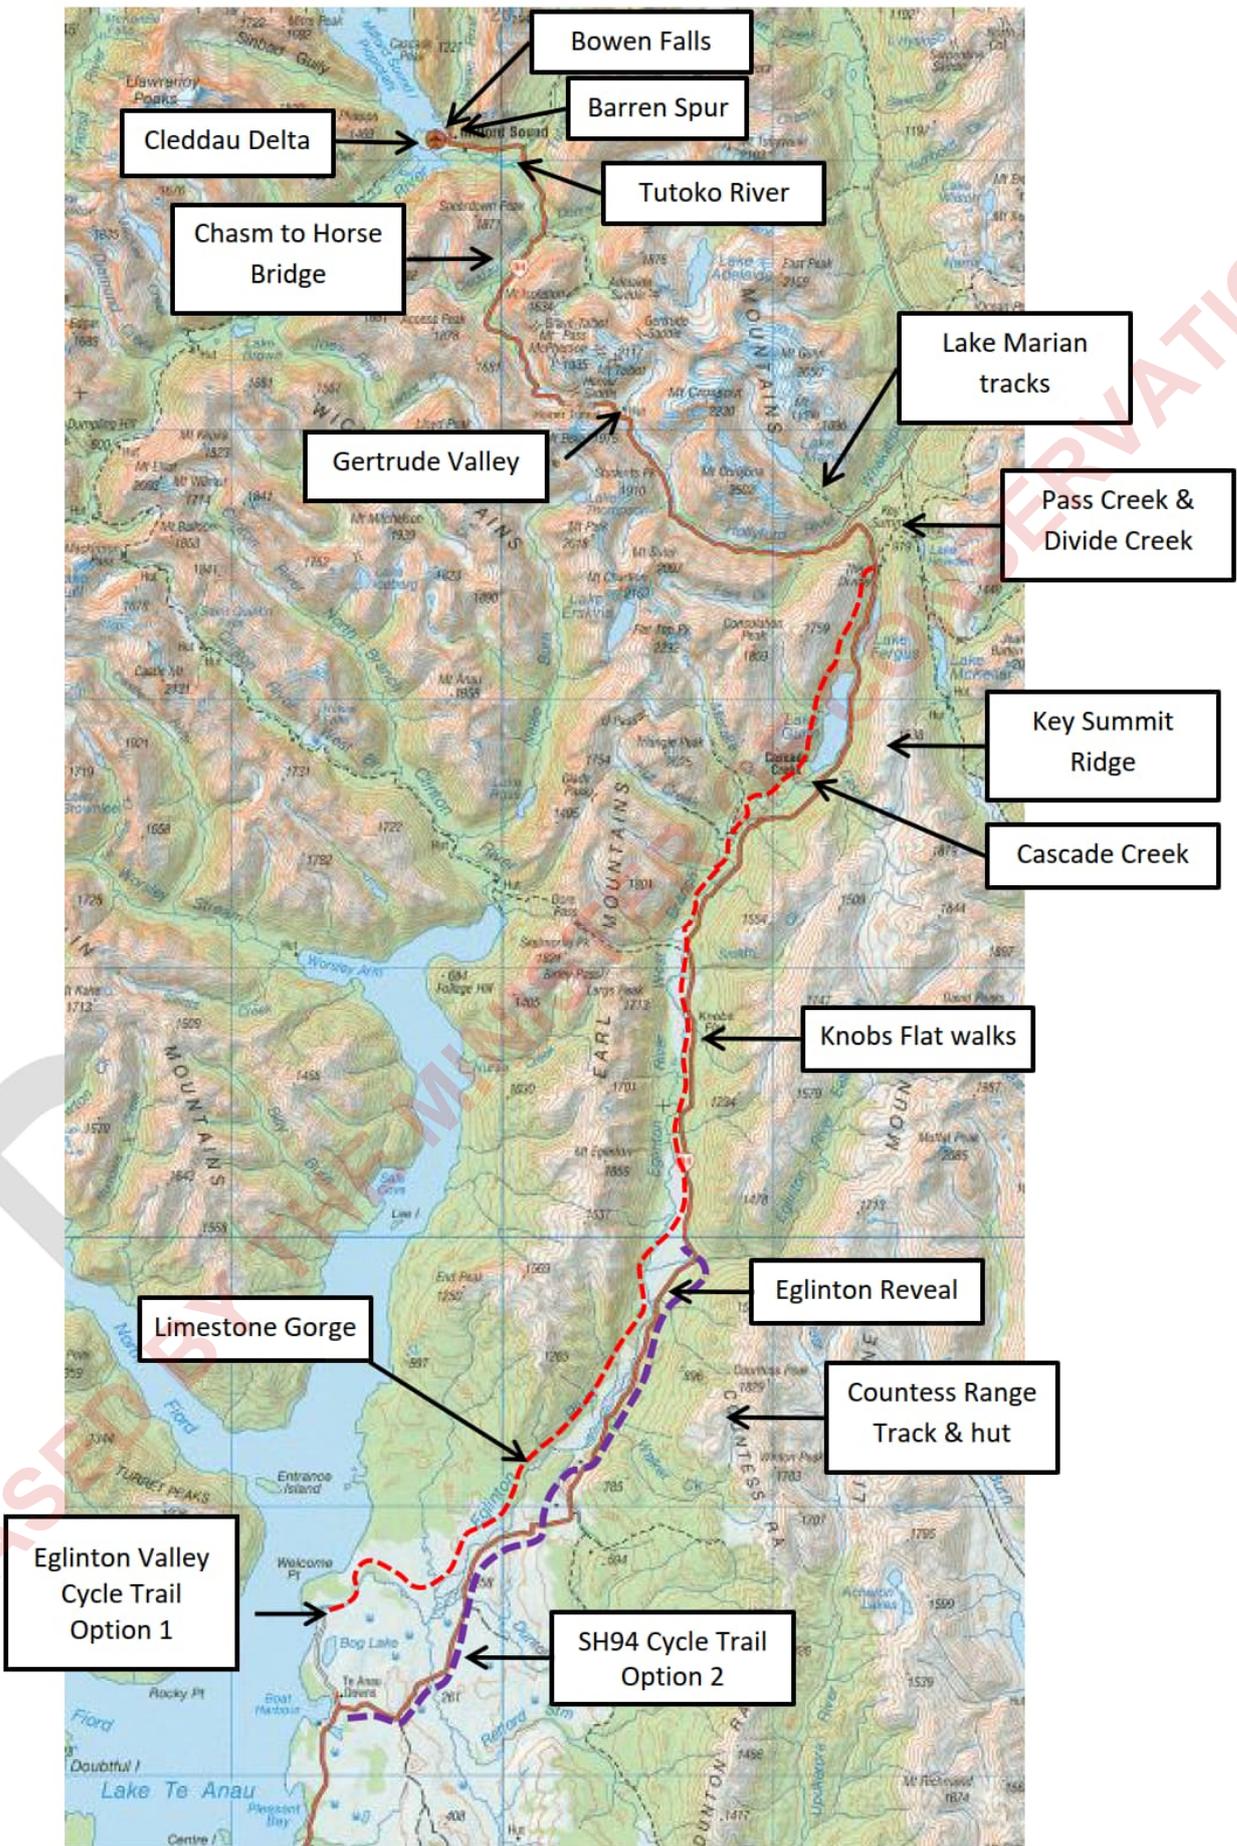
Figure 24: Walking and Cycling Trail Map taken from Southern Land Report<sup>25</sup>
