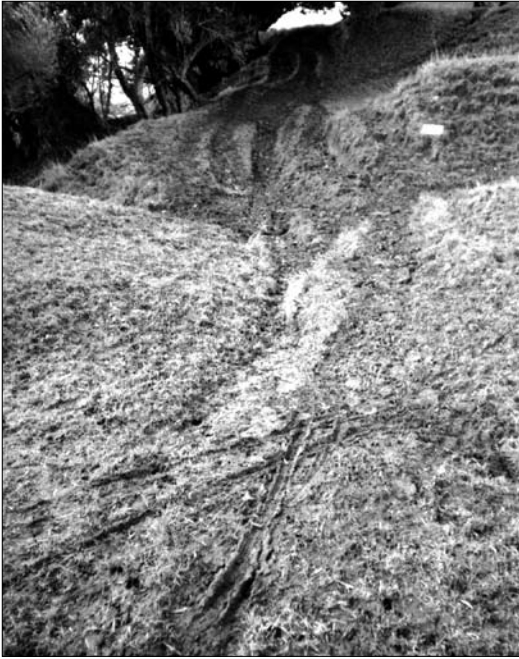
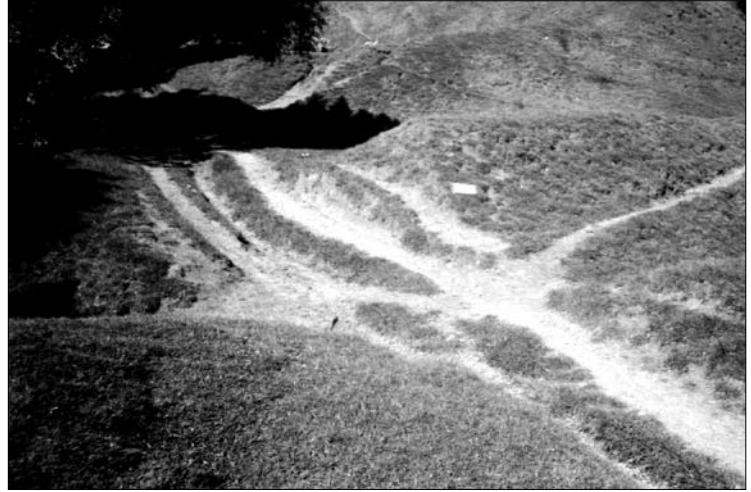
Figure 5. Typical branching tracks in summer (left) and winter (above) on One Tree Hill. The multiple tracks are formed because people prefer to walk on a grassed surface rather than a muddy or dusty one. The solution is to limit visiting, or to re-route and re-design the track so that people are comfortable walking on it. *Photographs: Dianne Harlow.*

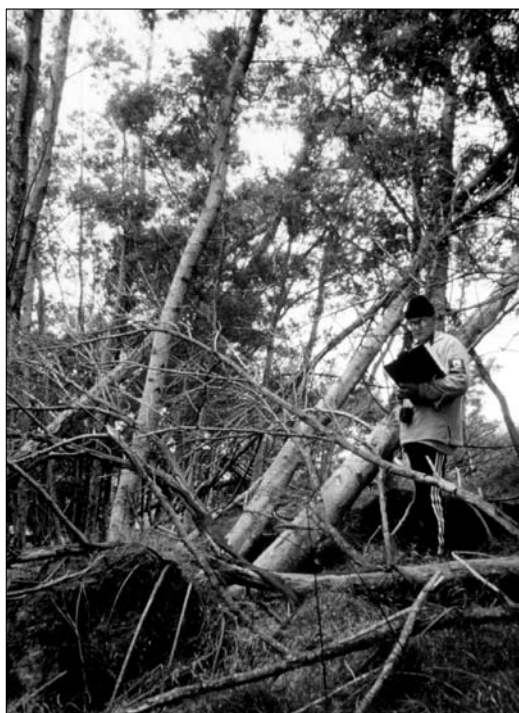
Figure 6. Monitoring wattle blown over on Matekerepu Historic Reserve, Bay of Plenty. The wattle has grown from seeds fallen into cattle-pugged areas of a former grazed grassland. Although part of a process of natural soil formation and plant succession (in this instance, to coastal hardwood forest), this type of damage is unnecessary and can be controlled on archaeological sites.

Any acceleration in the rate of movement, or cracking of the soil or soil surface, should be examined for possible causes. The rate of acceleration may give a clue as to whether catastrophic failure is possible. However, most of the damage done to sites is creeping and accumulative. Fretting (patches of surface erosion) are cause for concern because they are the clearest indicator of a process that in the long term will accumulate severe damage. On many earthwork sites it is possible to observe small areas under active erosion (e.g. where a foot track goes over a bank or where the bank is undermined by sheep camping). In some instances, the erosion will heal by natural processes. In others, some intervention is needed. In yet other instances, the eroded profile may be more stable and intervention in the erosion process will interfere with the original fabric, introducing the need for costly long-term maintenance. Another frequent cause of disturbance is the growth of tree weeds (Fig. 6). In time these will become unstable and will be toppled by high winds.

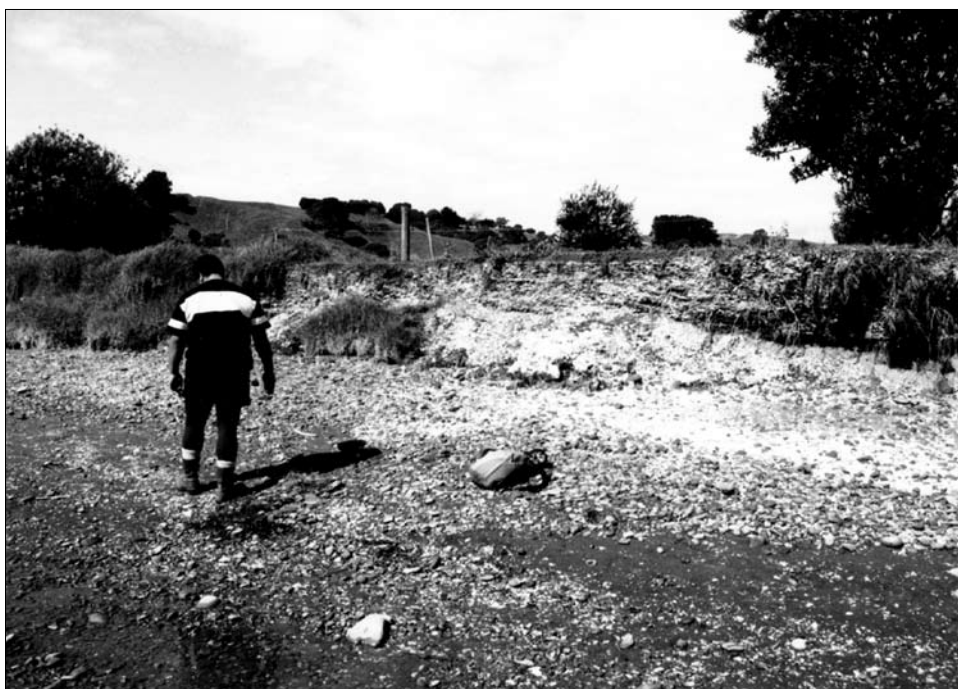
Figure 7. Ill-advised planting of trees is failing to protect this deep, rapidly eroding midden at the mouth of the Waioatahi River, Bay of Plenty.

Erosion of archaeological sites by wind, water, and slope movement is a frequent cause of their degradation or loss (Fig. 7). This section is an introduction to the protection of sites from erosion, with some advice on where assistance might be obtained.

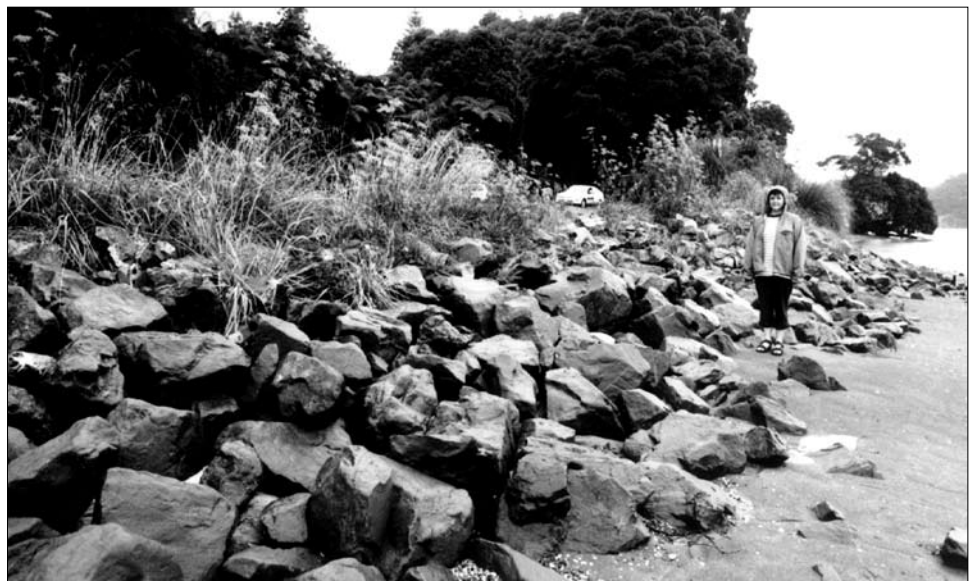
Figure 8. Rip-rap sea wall protecting areas of the site of Tokitoki, Ohiwa Harbour.

Interventions can include groynes to trap sediment moving along a beach, off-shore artificial reefs to break waves before they reach the shore, addition of sediment to beaches, and sea walls (Fig. 8). The last

of these poses particular problems. Sea walls reflect waves and cause greater turbulence and erosion immediately in front of them; they often fail through being undermined by such erosion; and they often fail to retain the beach material behind them and the erosion continues despite their presence. Specialist engineering advice is needed for any of these structures.
