Heaphy Track Repair Updates

Newsletter 3 – 23/03/2022

Heaphy Bridge Salvage Complete

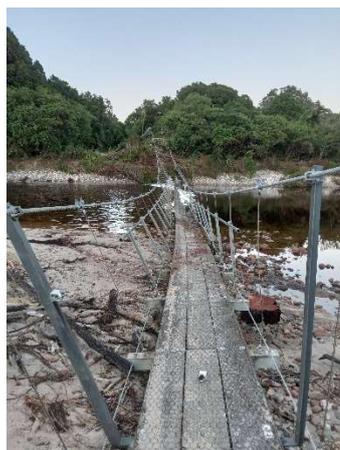
Images from Edifice Structures (left to right): the bridge when they arrived, nearly done, the salvaged materials ready to be flown out.

Contractors Edifice Structures have now finished the salvage work on the Heaphy Bridge. They flew in on Friday 11th March and completed the salvage on Thursday 17th March. It's great to have this first big piece of work done.

This was a big job. The bridge had over 2000 fixtures, main cables which were 148m long and weighed 360kg each plus a whole lot of wood. The combined weight of material is approximately 12 tonnes (excluding the towers and bridge anchors). All of this was entangled with debris in the river after the storm. Wherever possible, materials will be reused in the new bridge, but regardless, every little piece must be taken out to ensure no waste pollutes the area or endangers wildlife.
