Milford Opportunities Project

MILFORD OPPORTUNITIES PROJECT NATURAL HAZARDS ASSESSMENT PART A: PRELIMINARY SCREENING ANALYSIS

26 MARCH 2024

PART A: PRELIMINARY SCREENING ANALYSIS

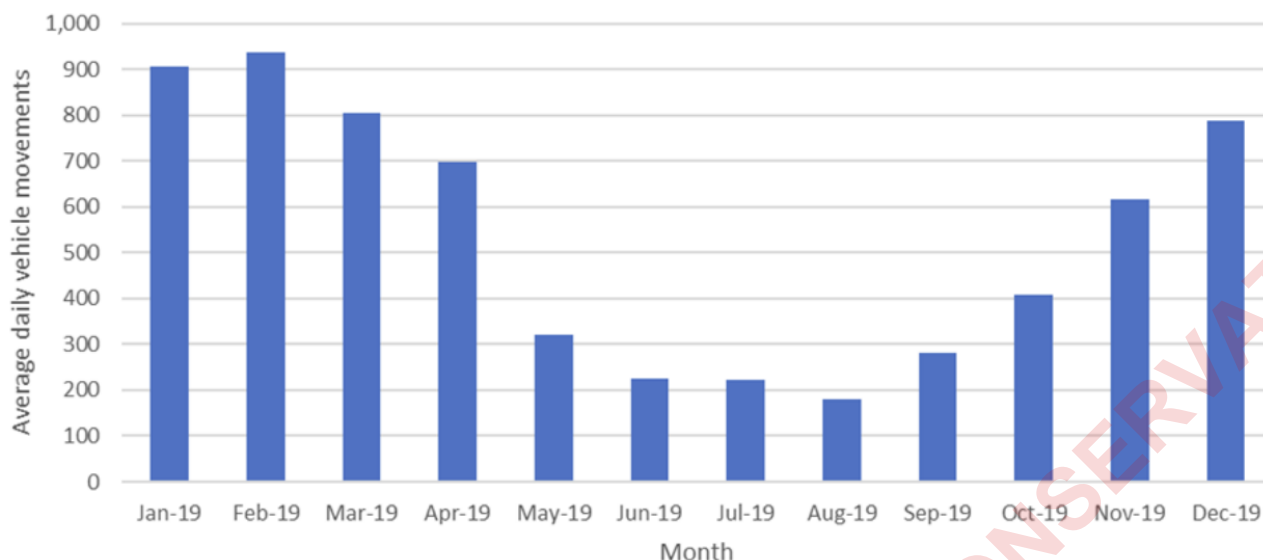
Figure 1: Homer Tunnel monthly in-bound vehicle movements in 2019 (source: MOP master plan 2019).

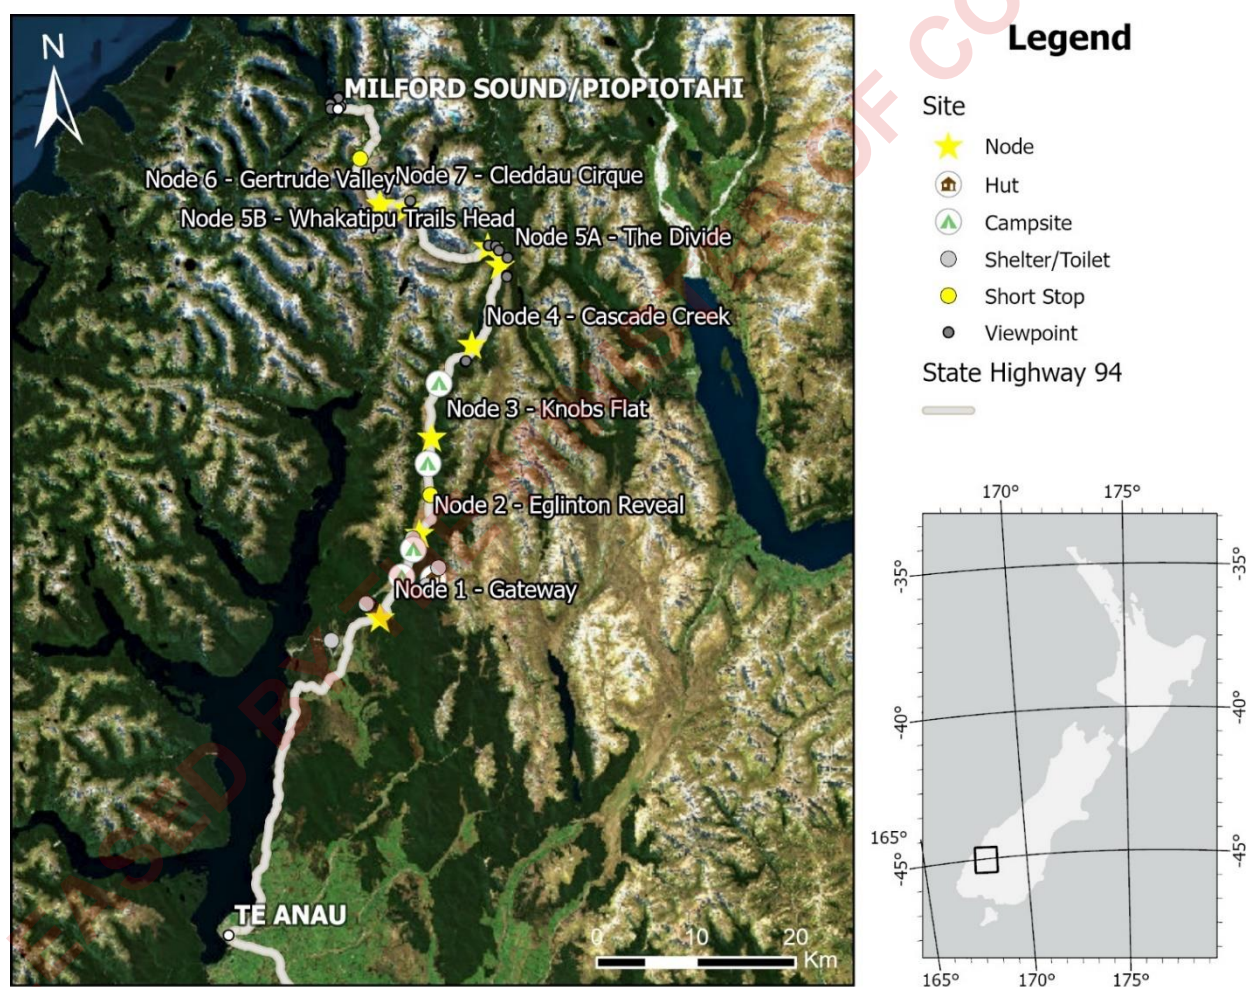
Figure 2: The Milford Road with key nodes and features of the Milford Opportunities Project labelled.

As part of the MOP seven key 'Nodes' have been identified⁴, these are accompanied by short stops, walking/biking tracks, accommodation locations, and viewpoints (

Figure 2). These sites and the surrounding area are defined as the study area for this Stage 3 report.

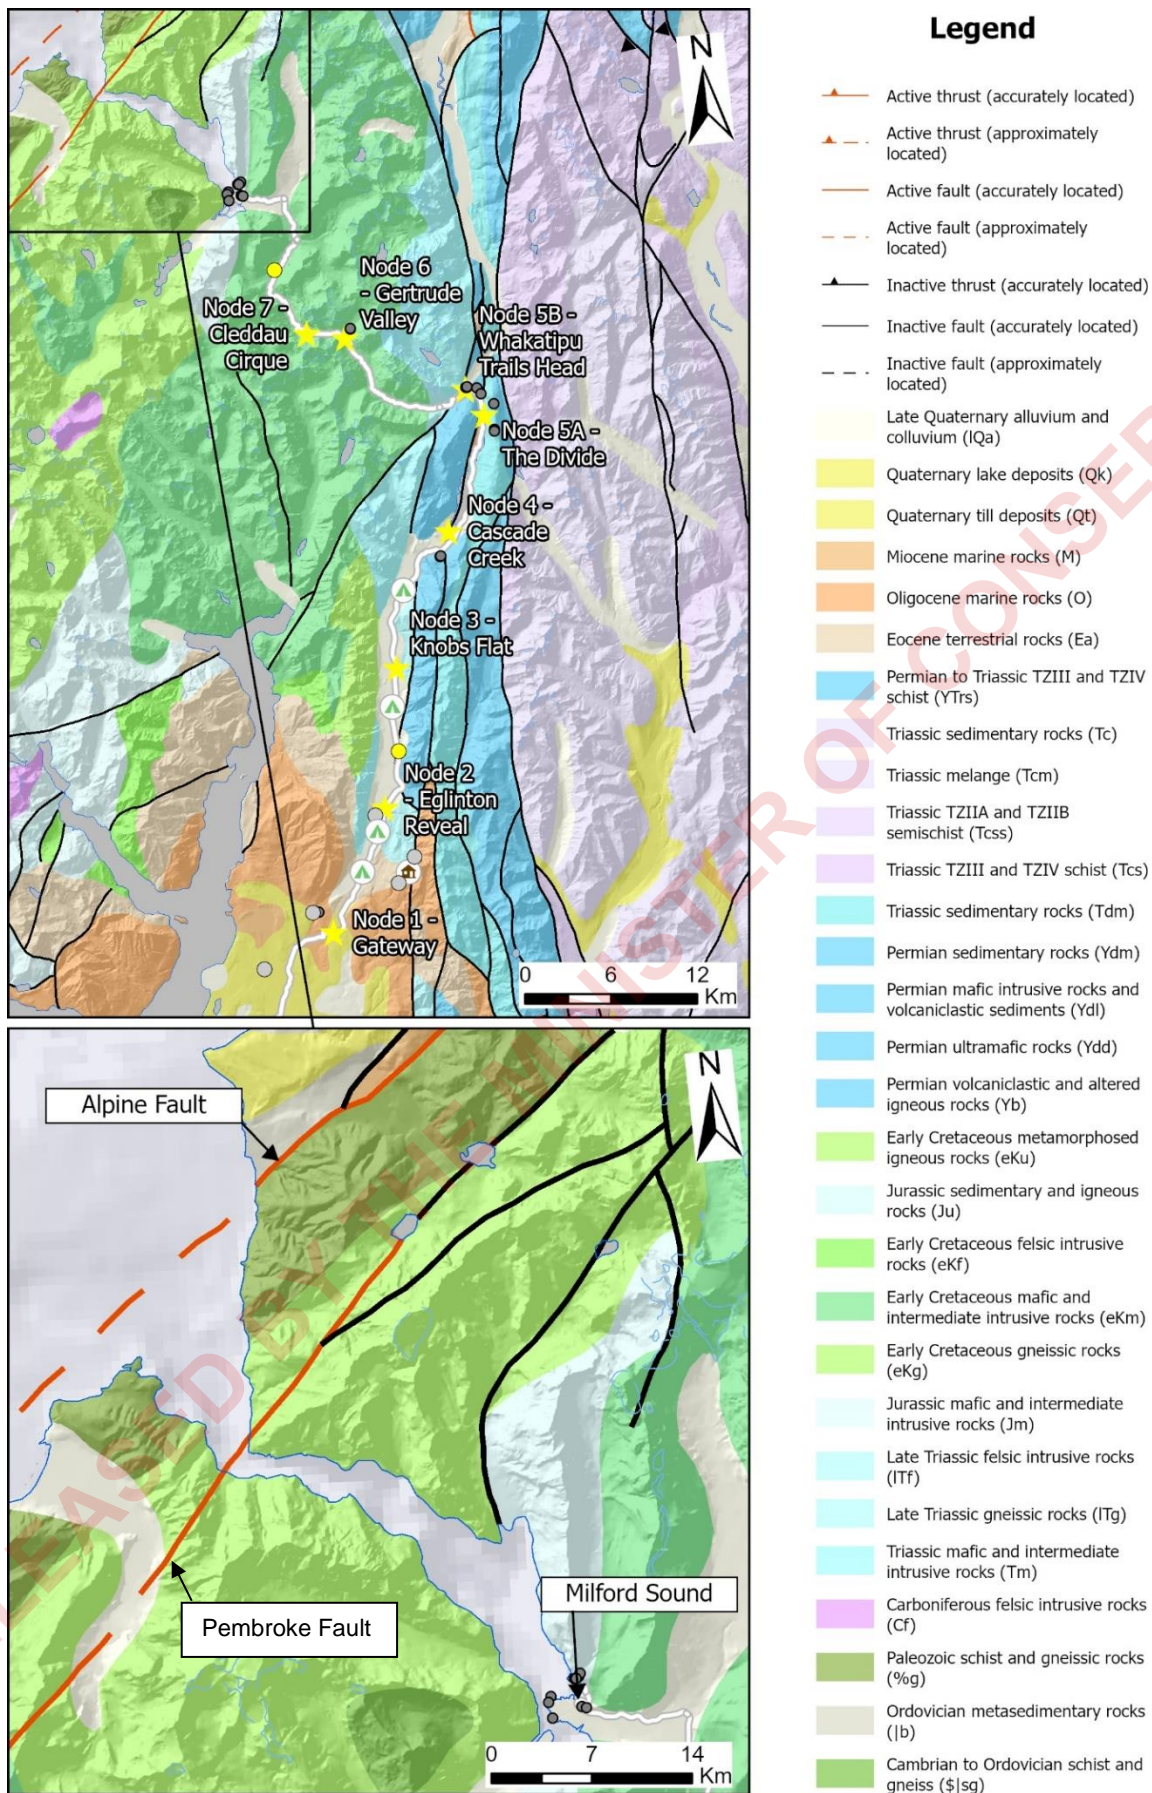
Figure 3: The GNS 1:1M Geological Map of the study area with a zoomed in inset map of Milford sound and the Alpine Fault (bottom).

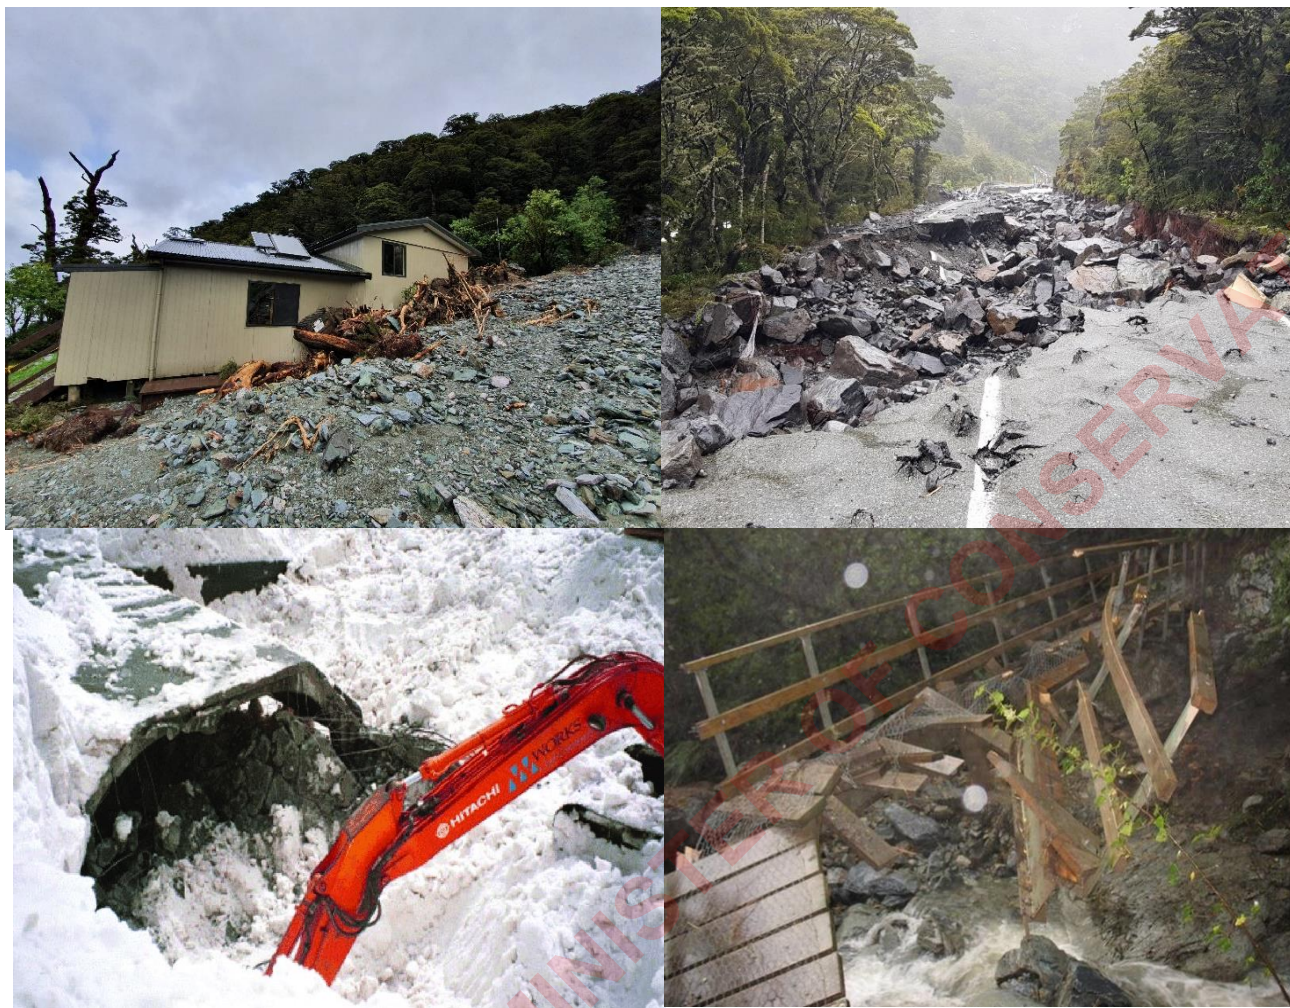
Figure 4: Hazards within the study area. Top left: Rock avalanche/landslide damage to Lake Howden Hut following a storm (source: Luke Bovill – Department of Conservation). Top right: Scouring of the Milford Road due to flooding (source: Dylan O'Neill/Waka Kotahi). Bottom left: The eastern portal of the Homer tunnel damaged by an avalanche (source: Conway et al. 2000). Bottom right: A damaged bridge on the Routeburn track due to flooding (source: Department of Conservation).

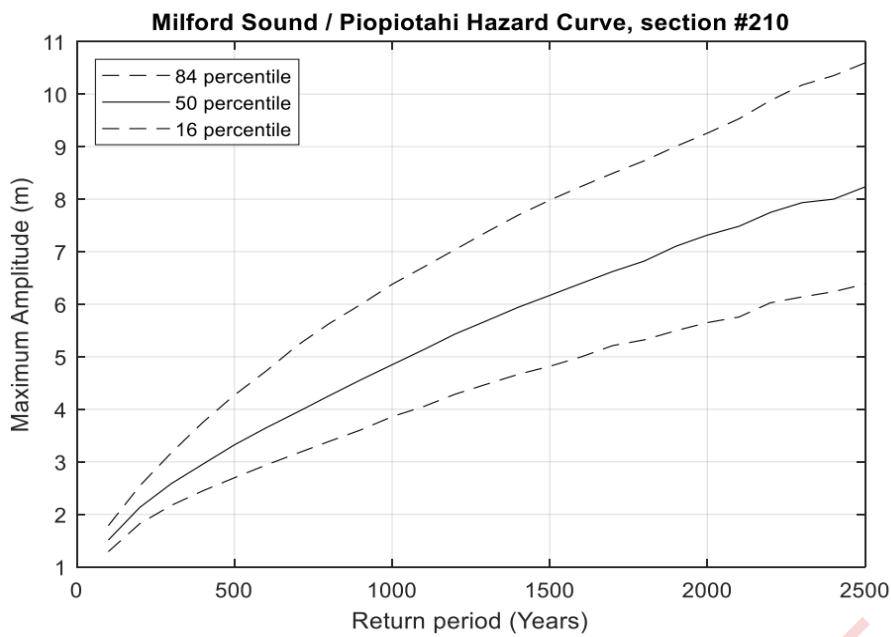
Figure 5: Return period of different tsunami waves heights at Milford Sound Piopiotahi (source: GNS science 2021 National Tsunami Model).

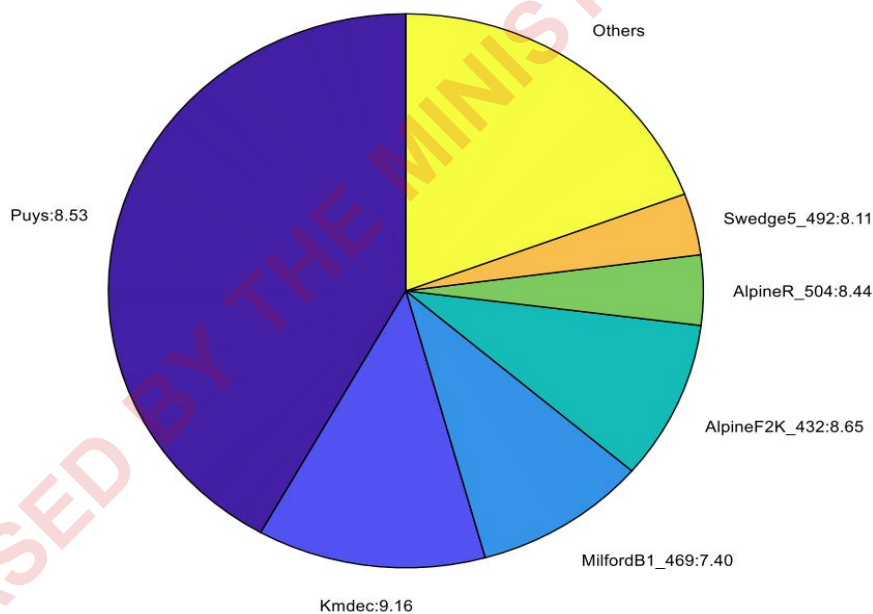
Deaggregation of Section:210, Return Period:500 years, Tsunami Height (Maximum Amplitude) at:50th percentile:3.32 m

Figure 6: A graph of contributions (de-aggregation) of tsunami wave source for a 500-year return period tsunami wave at Milford Sound for different faults (source: GNS Science 2021 National Tsunami Model).

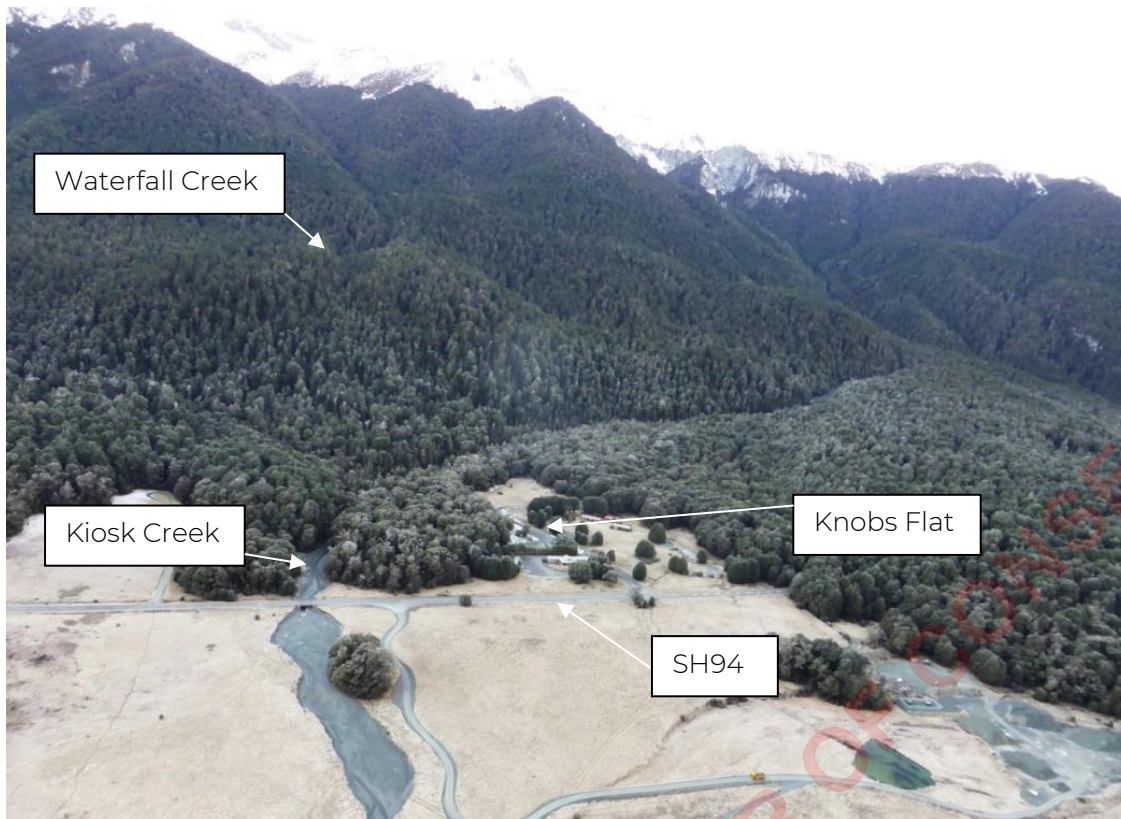
Figure 7: An aerial photo of the Te Huakaue Knobs Flat site (source: Geosolve 2019).

Te Huakaue Knobs Flat (Node 3) is situated on an active alluvial fan located in the Eglinton River Valley and is assessed as being exposed to flood and debris flows from Kiosk Creek and Waterfall Creek which are tributaries of the Eglinton River (Figure 7¹²).

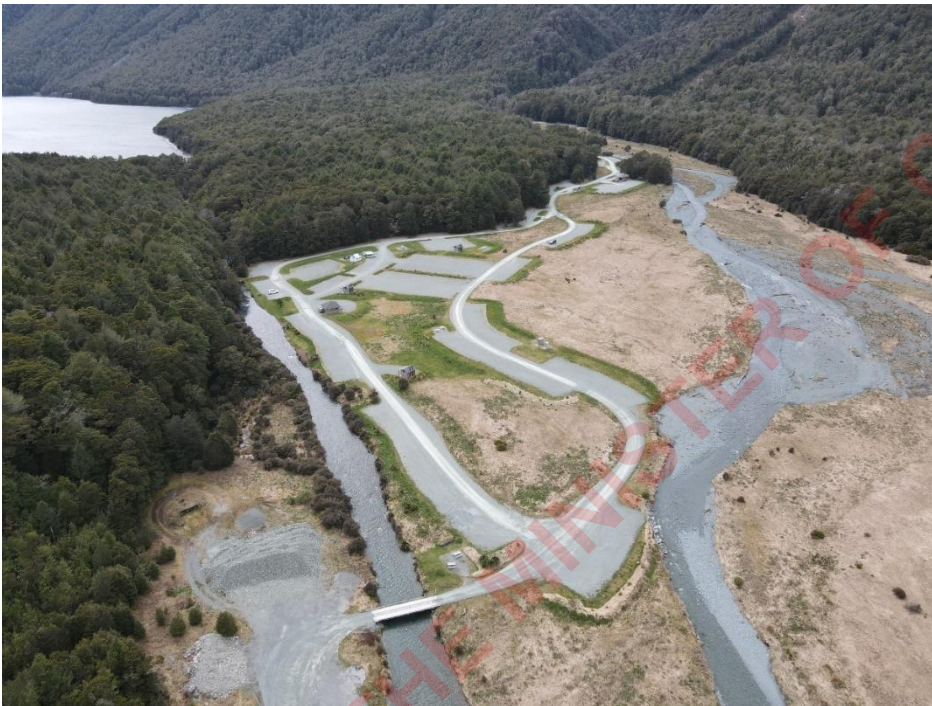
Figure 8: Drone image of Ōtāpara Cascade Creek Campsite with Lake Gunn in the top left of the image (source: Boffa Miskell).

The campsite is low-lying and is potentially exposed to flooding from both waterways.

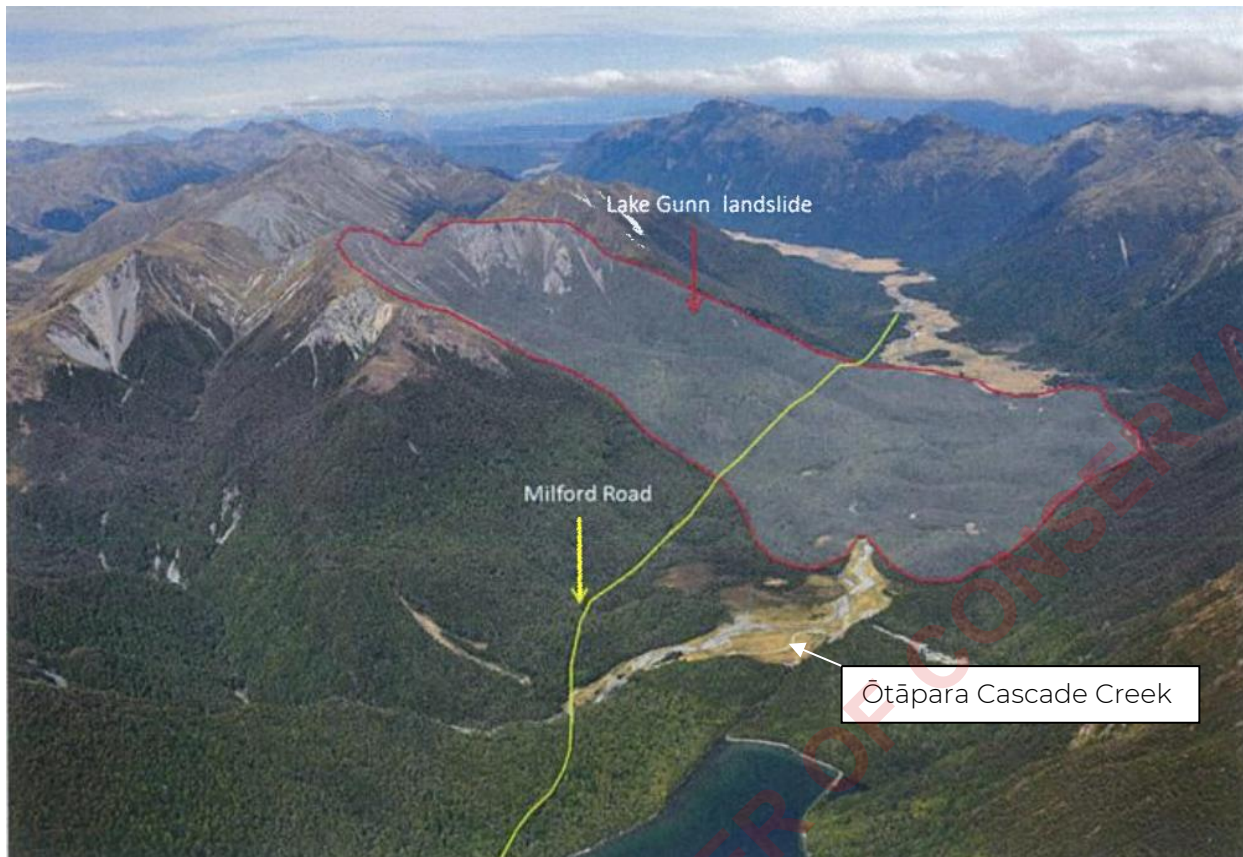
Figure 9: An aerial photograph of the Lake Gunn landslide (source: GNS Science).

Large but infrequent landslides are also known to occur in the area such as the large-scale Lake Gunn landslide (Figure 9).

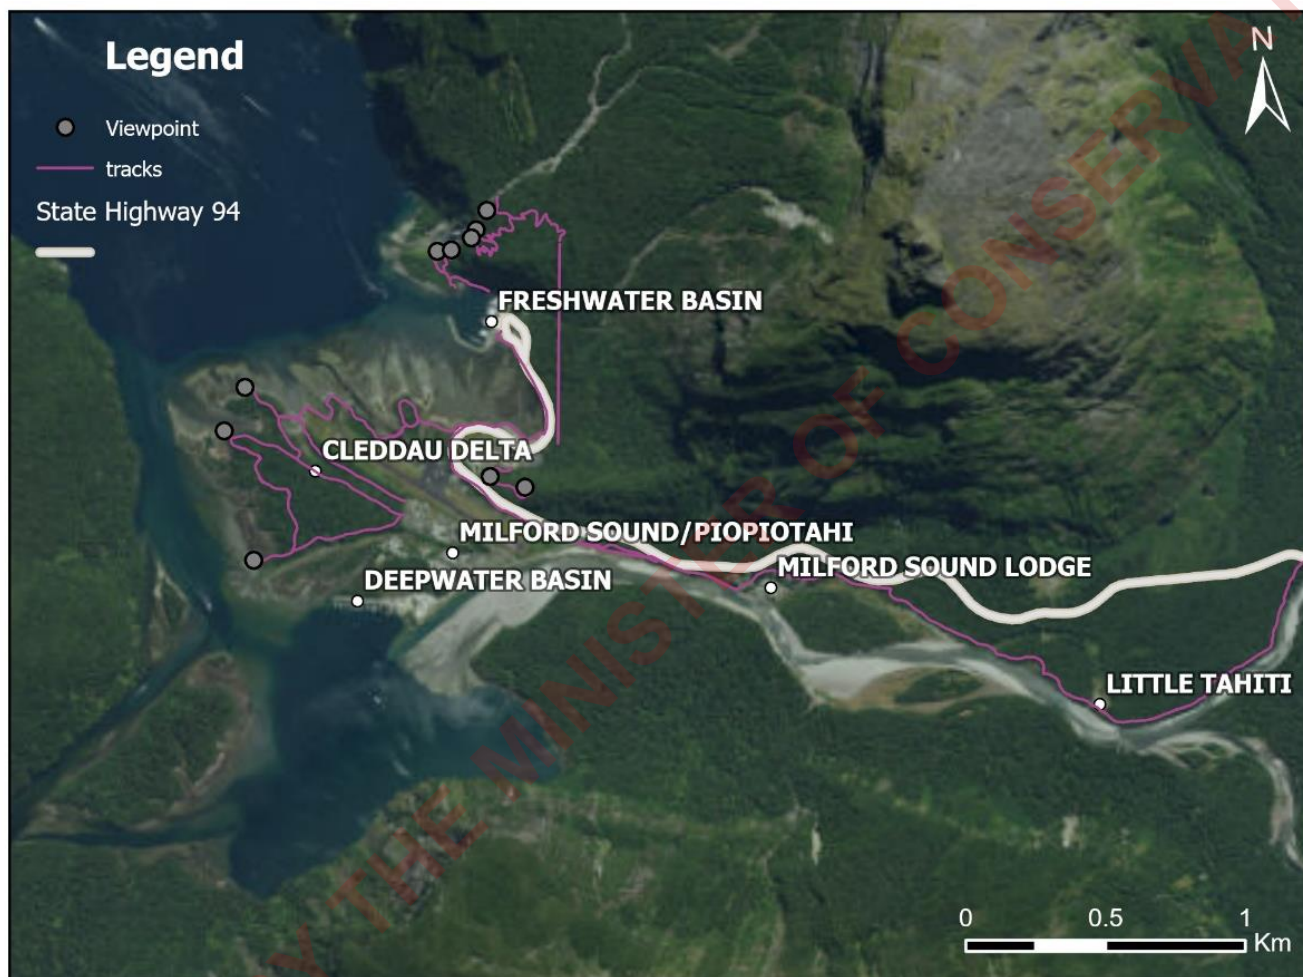
Figure 10: Aerial map of Milford Sound Piopiotahi.

This area includes the following key sites: Little Tahiti, Milford Sound Lodge, Deepwater Basin, Cleddau Delta, and Freshwater Basin (Figure 10).

The surrounding terrain is typically described as being steep heavily vegetated mountainous terrain (Figure 10). Previous studies and reports detail the extent of flood risk at Deepwater Basin and across the Cleddau Delta associated with the Cleddau River. There is extensive stop bank and rock armouring mitigation and control measures in place along the banks of the Cleddau at this site as a direct result of previous investigations and assessments of flood risk (Figure 12).

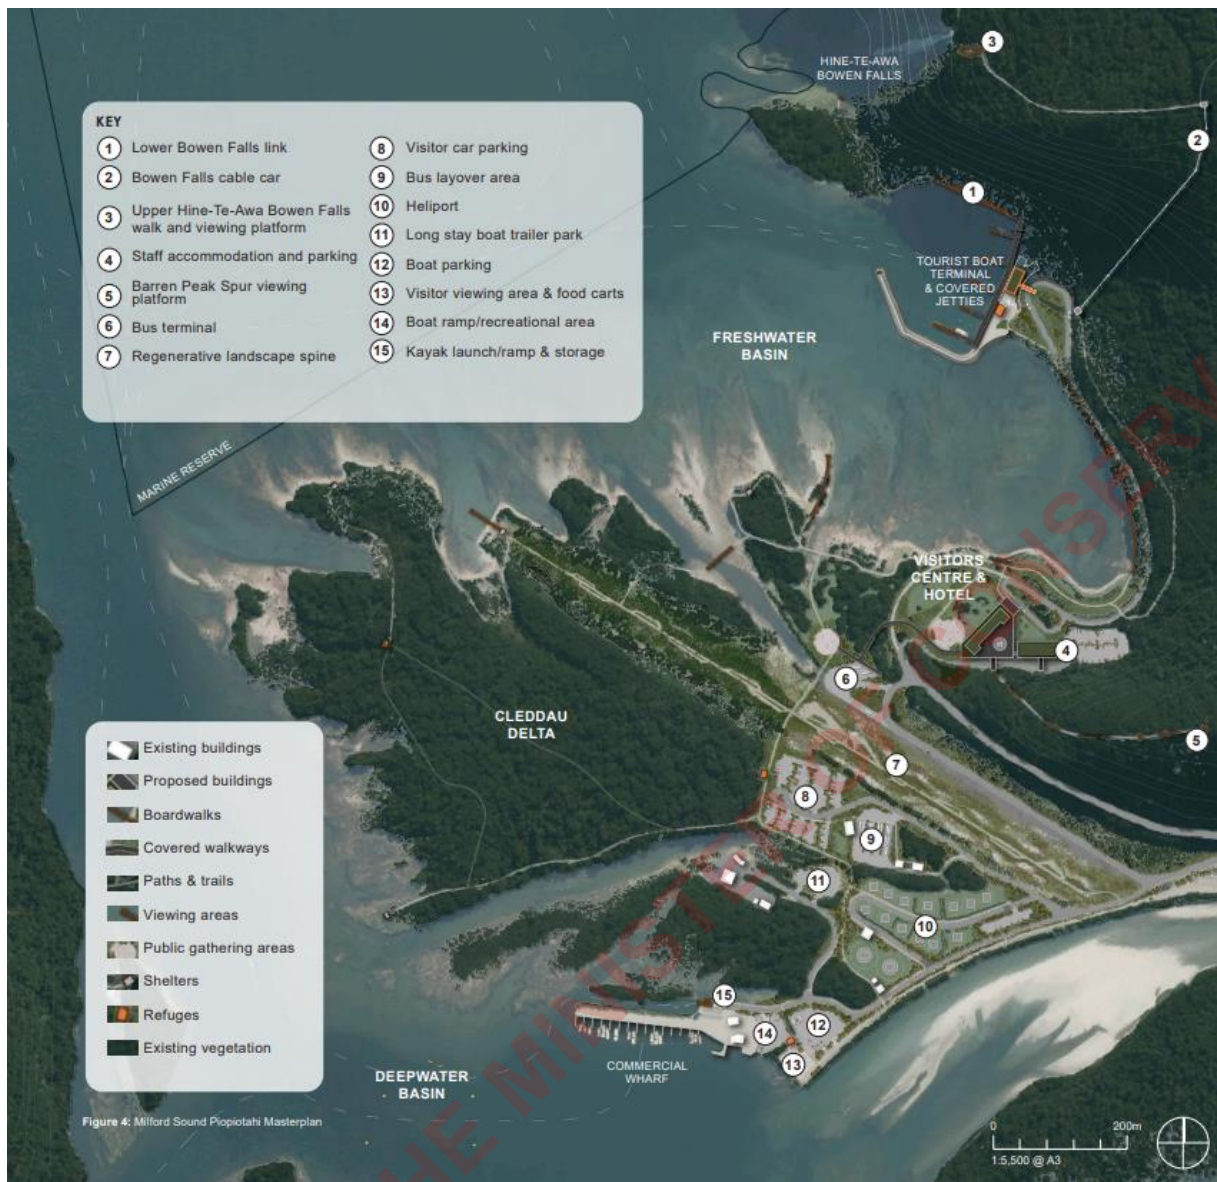
Figure 11: Milford Sound Piopiotahi sites under the MOP Master Plan (source: Stantec and Boffa Miskell).

In Milford Sound Piopiotahi the Barren Peak Spur Track (see Figure 11) is the only track assessed as Class 1. This is due to its elevation above any flooding or tsunami sources, and lack of identified immediate rockfall/landslide sources.

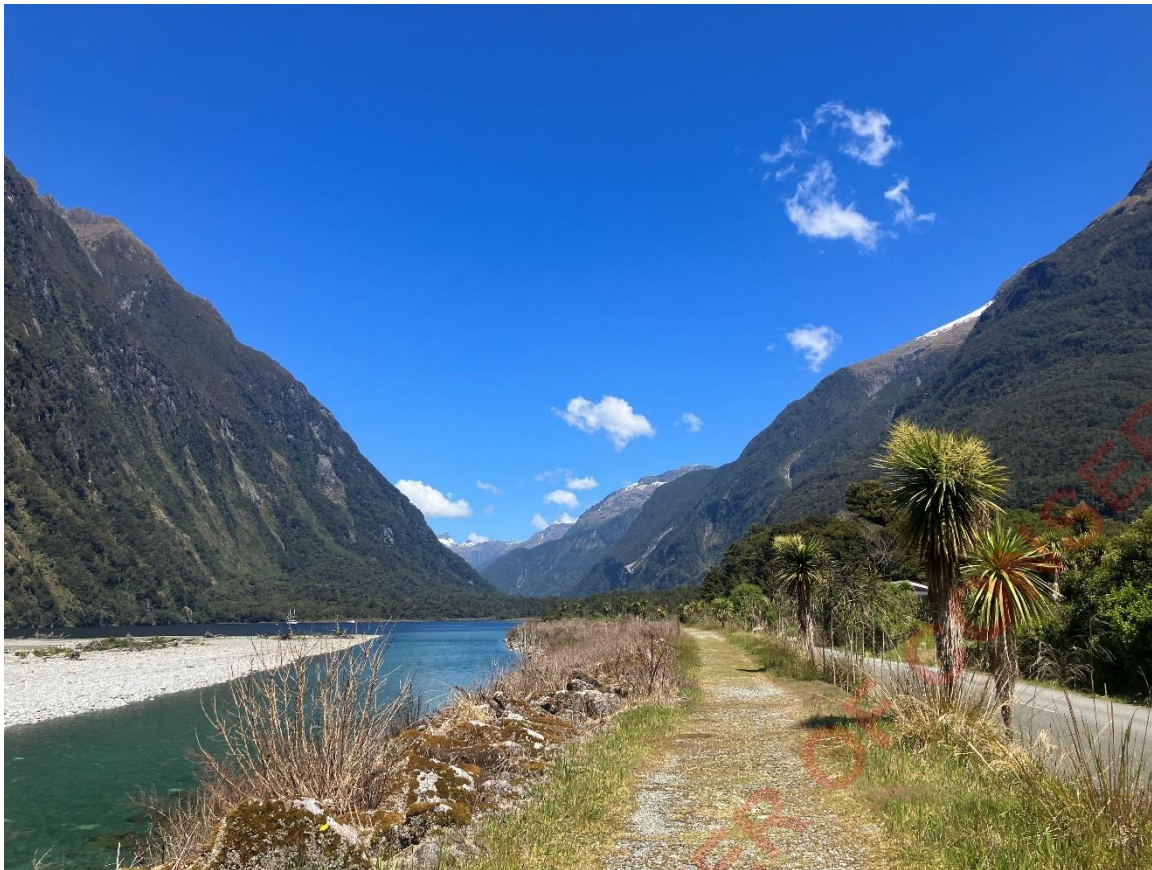
Figure 12: The flood mitigation stop bank on the northern margin of the Cleddau River looking out towards Milford Sound.

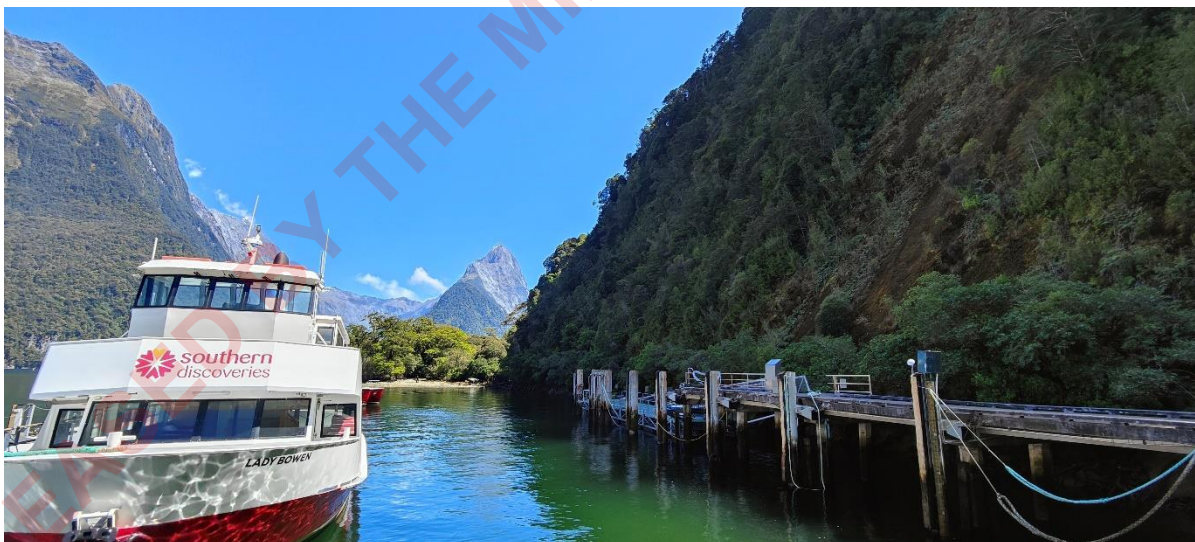
Figure 13: Freshwater basin with an old tree slide scarp to the right of the image.

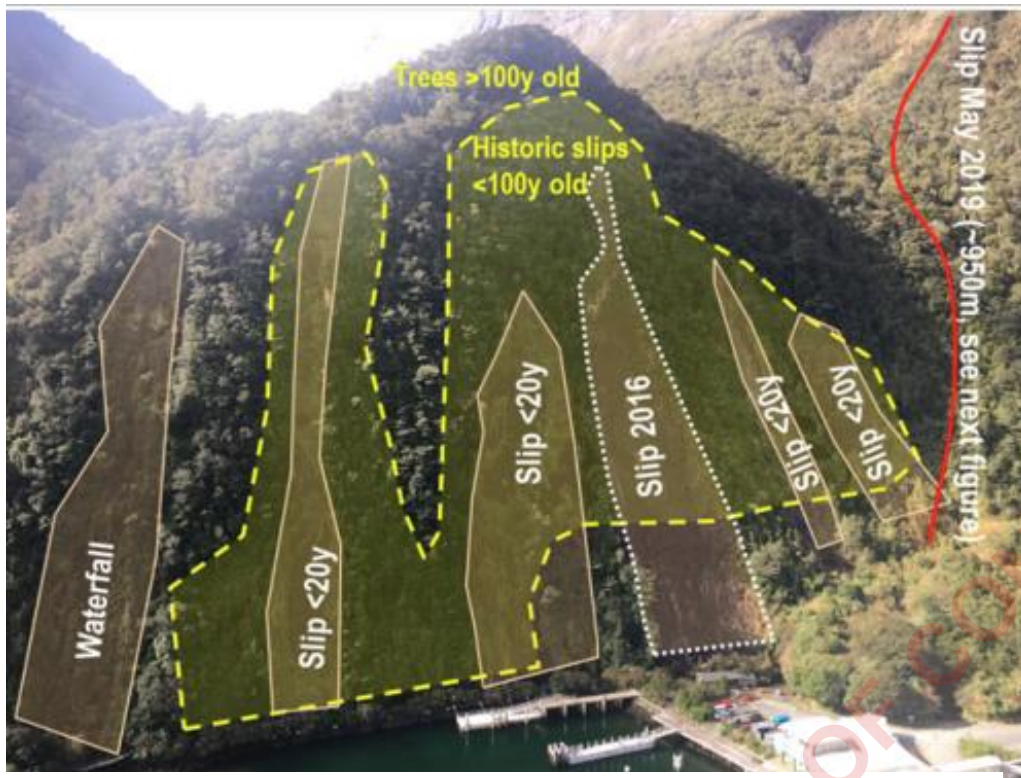
Figure 14: Tree slides and landslides in the hillslope next to freshwater basin in Milford Sound (source: Stantec 2021).

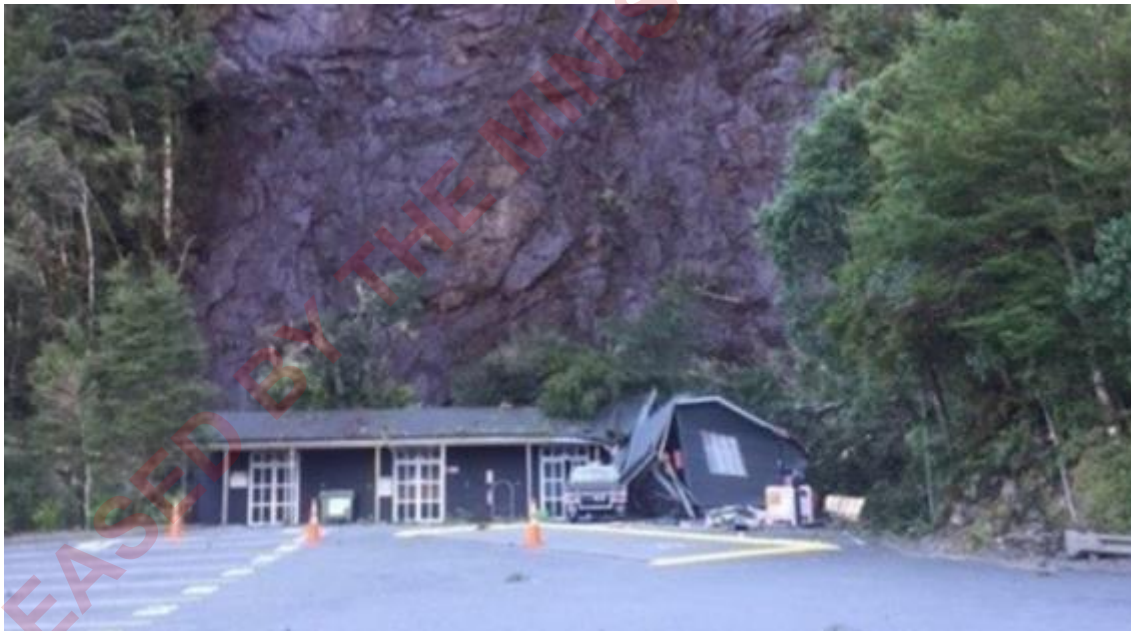
Figure 15: Damage to a storage building in Milford Sound from a rockfall in 2016 (source: Tim Holland).

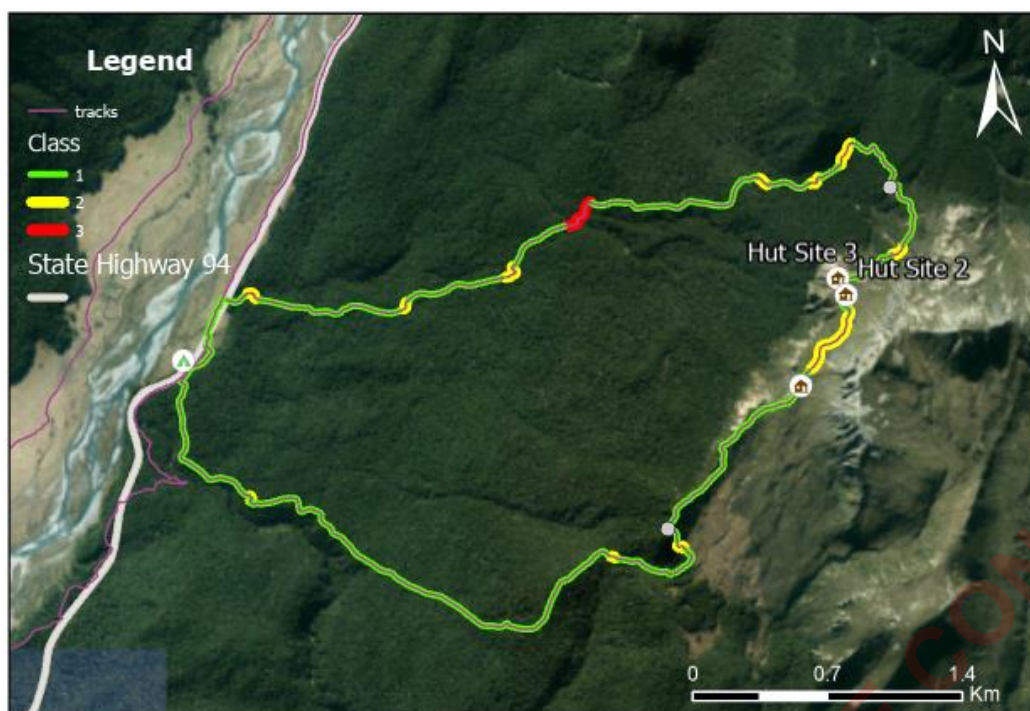
Figure 16: Plan of the Countess Range Track with sections marked with Preliminary Assessed hazard Class.

Based on provided trail details from the trail designer and aerial imagery, the track is predominantly assessed as Class 1 with sections assessed as Class 2 or Class 3 as shown below in Figure 16.

The track is assessed as having several potential stream crossings where visitors are likely to be exposed to flooding and debris flow hazards. Exposure time is however relatively low on these sections, but hazard frequency is likely to be high.

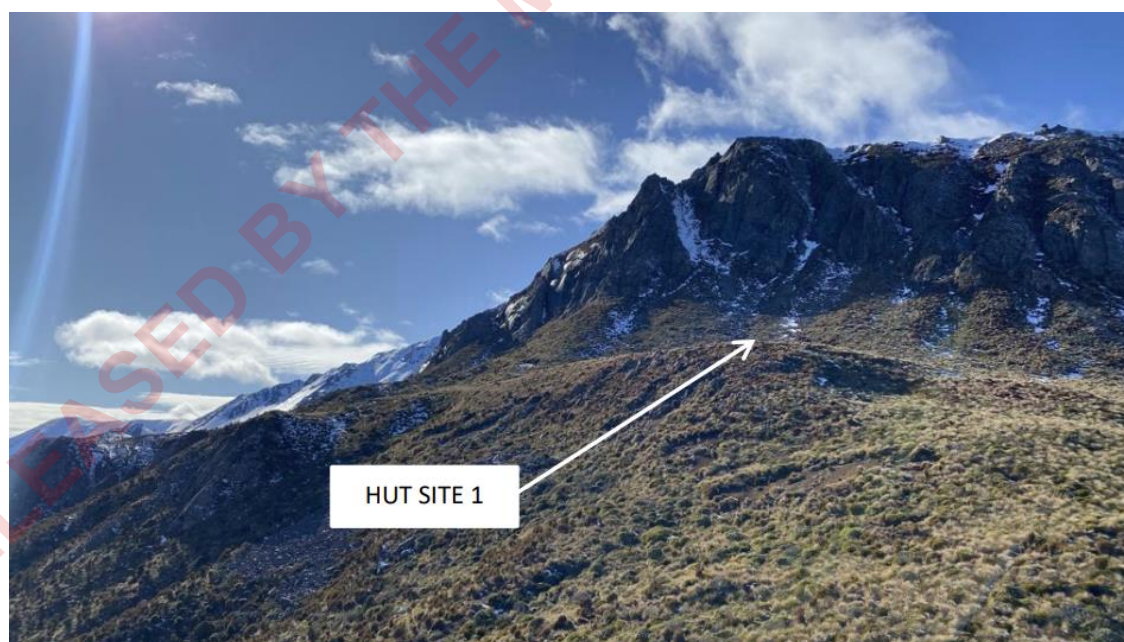
Figure 17: A proposed hut site along the ridge below the Countess Range (source: Southern Land 2023)

The track climbs away from the State Highway towards the east and an exposed plateau located below the Countess Range summit (Figure 17). On the higher sections track users are likely to be exposed to rockfall and landslides and are likely to be exposed to the hazard for a longer period of time.

The proposed hut locations have been identified by the trail designer, DoC representatives and MOP representatives as being areas of relatively lower risk of rockfall, landslide, and avalanche.

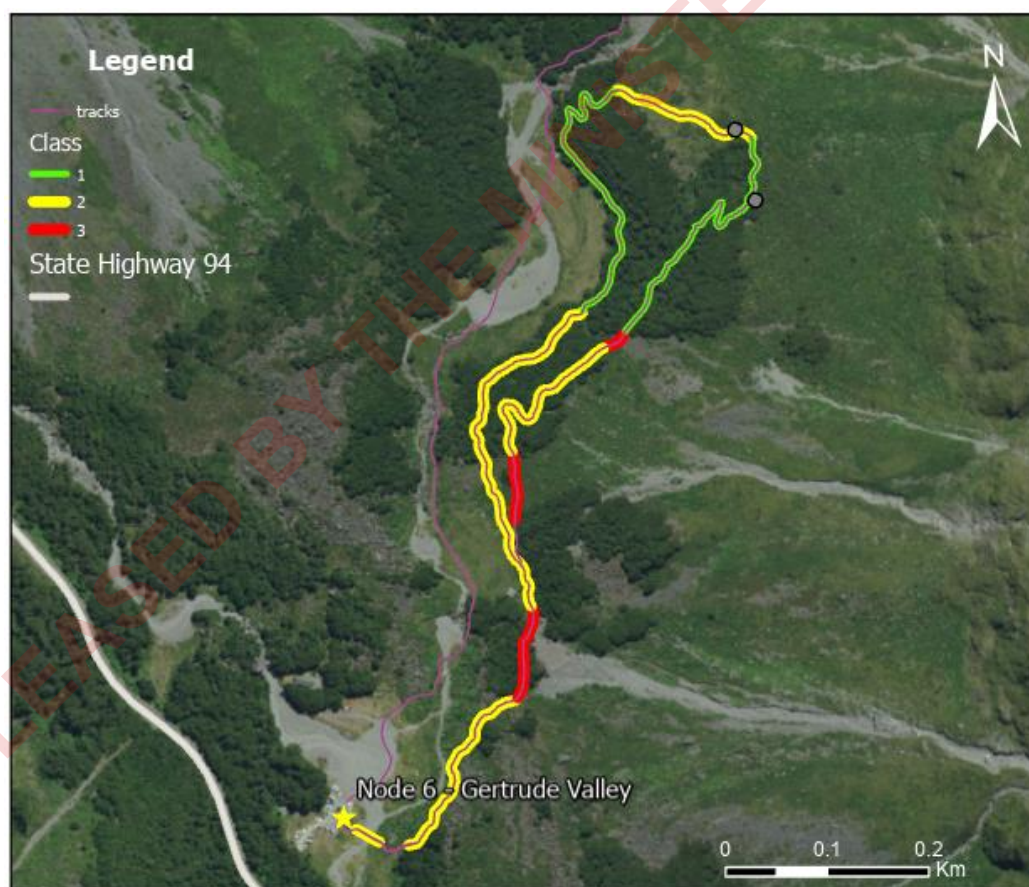
Figure 18: The proposed Gertrude Valley Loop Track and associated viewpoints.

On this basis the track is predominantly assessed as Class 2 with sections assessed as Class 1 and Class 3 as shown on Figure 18 below.

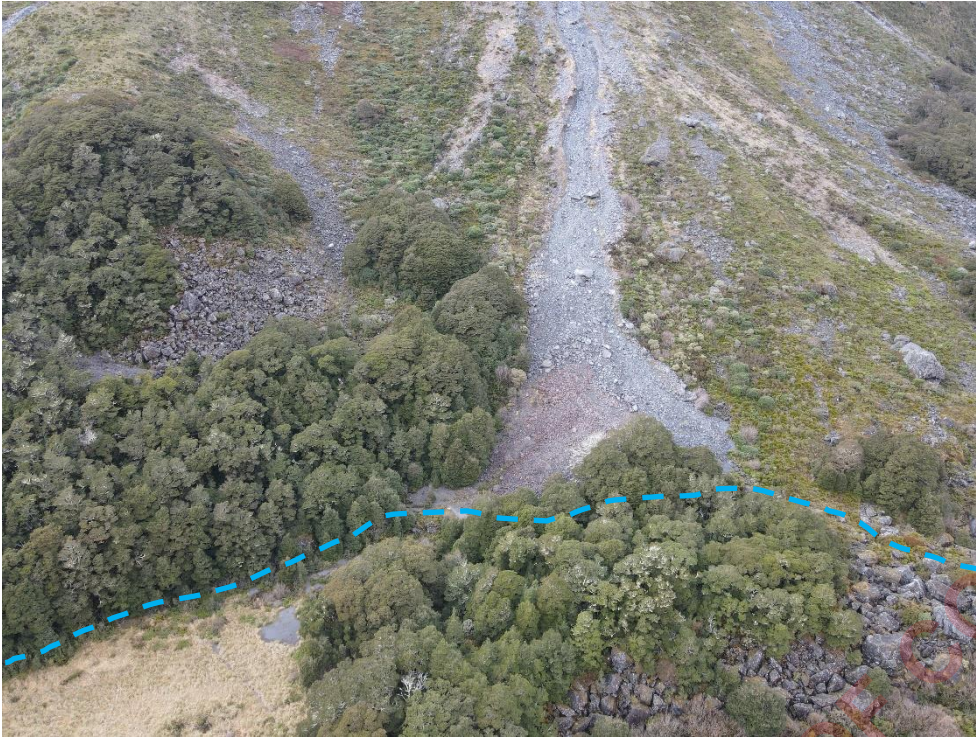
Figure 19: The active debris flow/rock avalanche path on the proposed Gertrude Valley Loop Track.

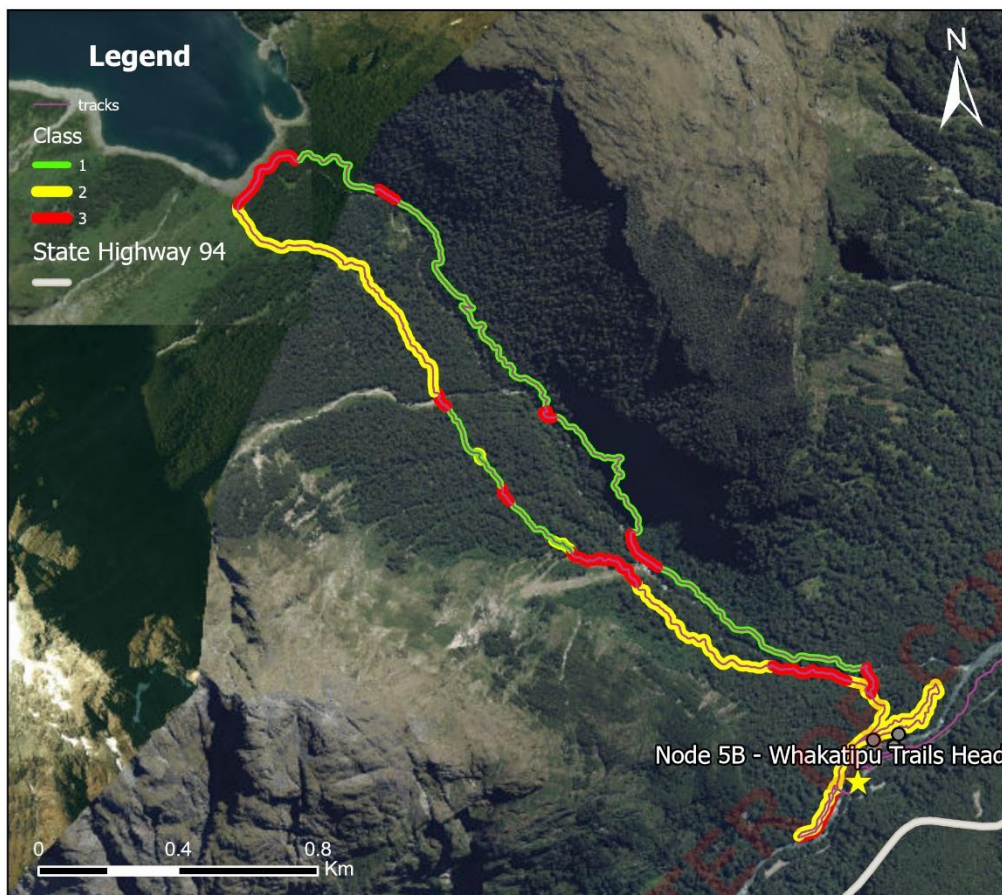
Figure 20: The Lake Marian Loop Track highlighted with preliminary hazard Classes for natural hazard risk.

Whilst the track is mostly cut above the stream channel various sections run along next to the stream. Due to the high flows the assessed hazard class for these sections is preliminary screened as Class 3.

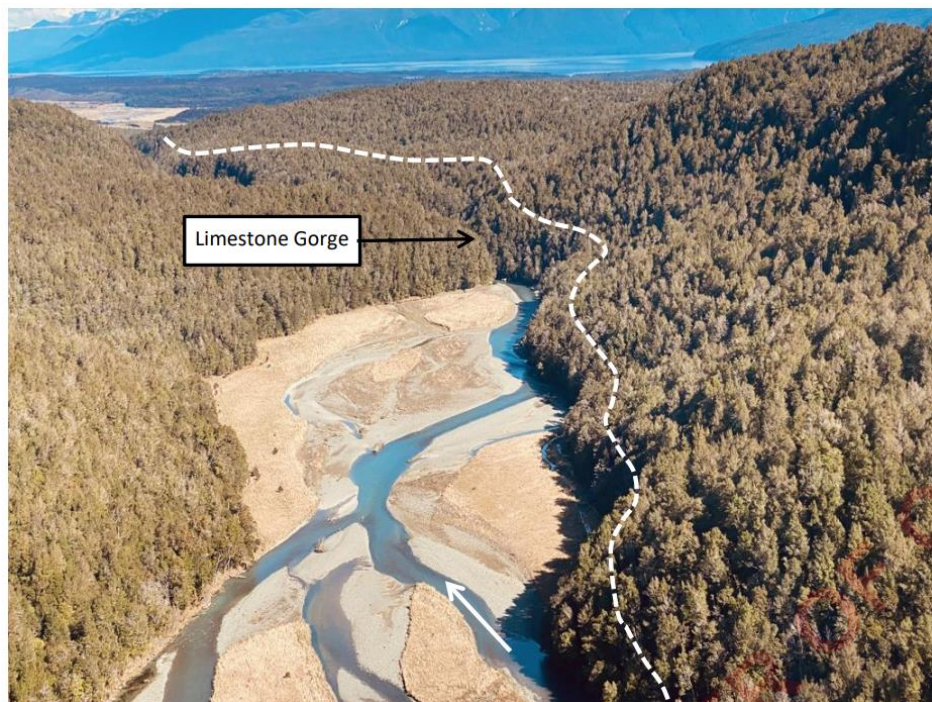
Figure 21: A section of the Option 1 trail looking south towards Limestone Gorge and Te Anau Downs. The vegetated area to the right of the image is prone to tree sliding (source: Southern Land (2023)).

A potential for tree slides has been identified in the area north of Limestone Gorge with ancient Beech Forest on steep terraces and various breaks in slope (Figure 21). Tree slides are assessed as a hazard with a high probability of occurrence.

In terms of hazard class this section of trail has been assessed as being Class 2.

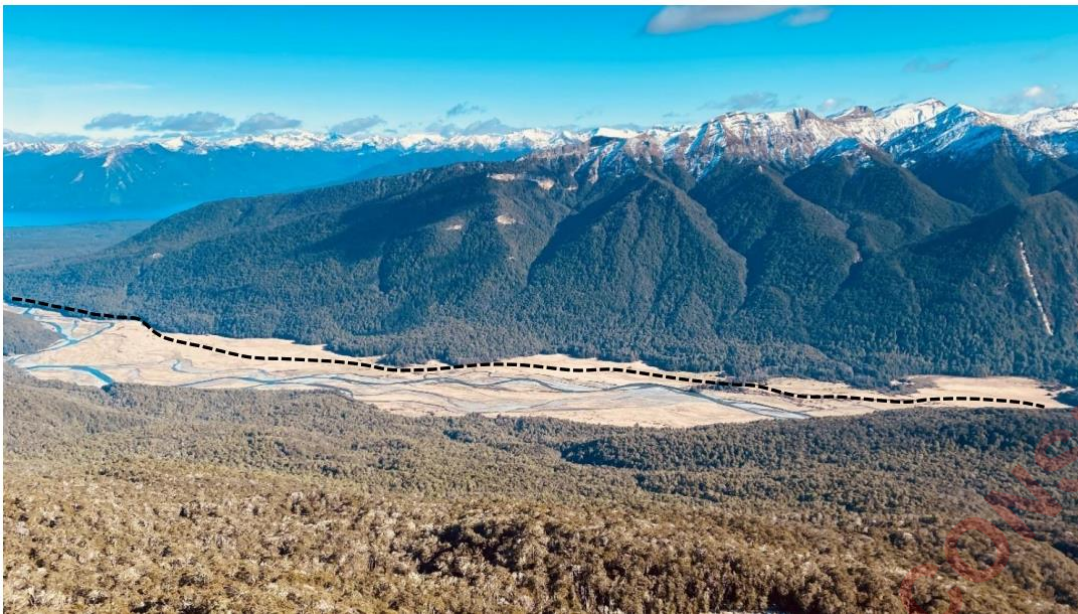
Figure 22: A section of the Option 1 trail from the Countess Range (source: Southern Land (2023)).

Trail users will be potentially exposed to further landslide, rock fall, as well as flood hazards from the adjacent Eglinton River. The preferred option is for the trail to run along the base of the slip requiring benching works and rock armouring to protect the trail from scour (Figure 23). Rock fall, landsliding, and flooding at this site are assessed as hazards with very high probability.

Estimated exposure times for this section of the trail is expected to be 2 to 30 minutes. However due to the likelihood of occurrence of a landslide/rockfall this section of trail has been assessed as being Class 3.

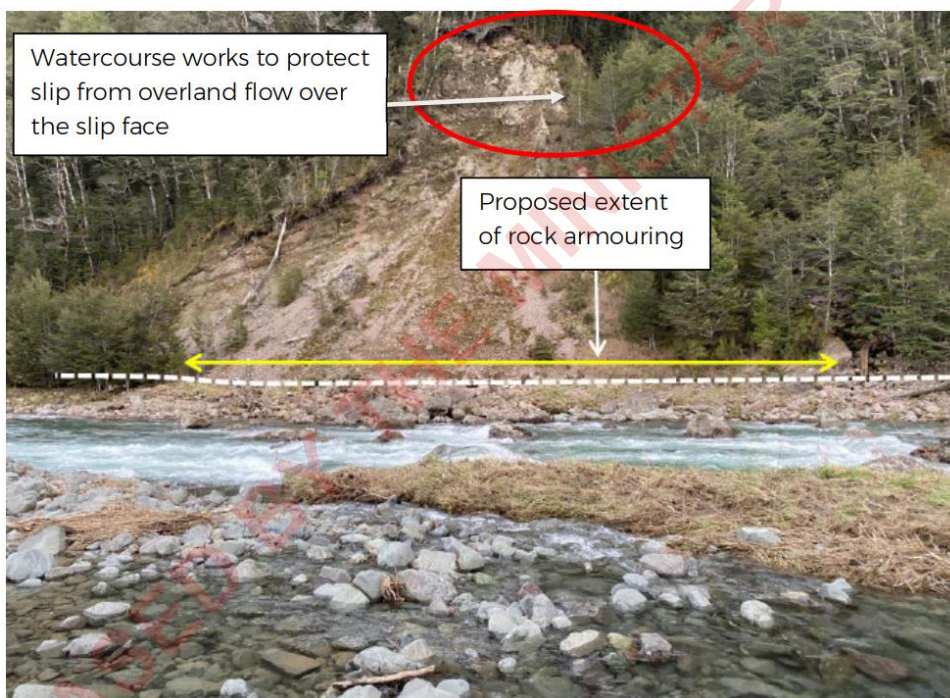
Figure 23: View of the East Eglinton River Landslide (Source: Southern Land (2023) with additional annotation by WSP).
